**Ground Investigation Report** [intrusive]

Land to rear of 141 Toftshaw Lane, Bradford

<b>Project Number</b>	20529
<b>Report Number</b>	001
<b>Revision</b>	V01 – Issue for information
<b>Date Issued</b>	05 September 2025 (V01)

Soil and Structures Ltd were instructed by Belinda Starky (the Client) in July 2025 to prepare an intrusive Ground Investigation Report (*this Report*) for a parcel of land to the rear of 141 Toftshaw Lane, Bradford (*the Site*)

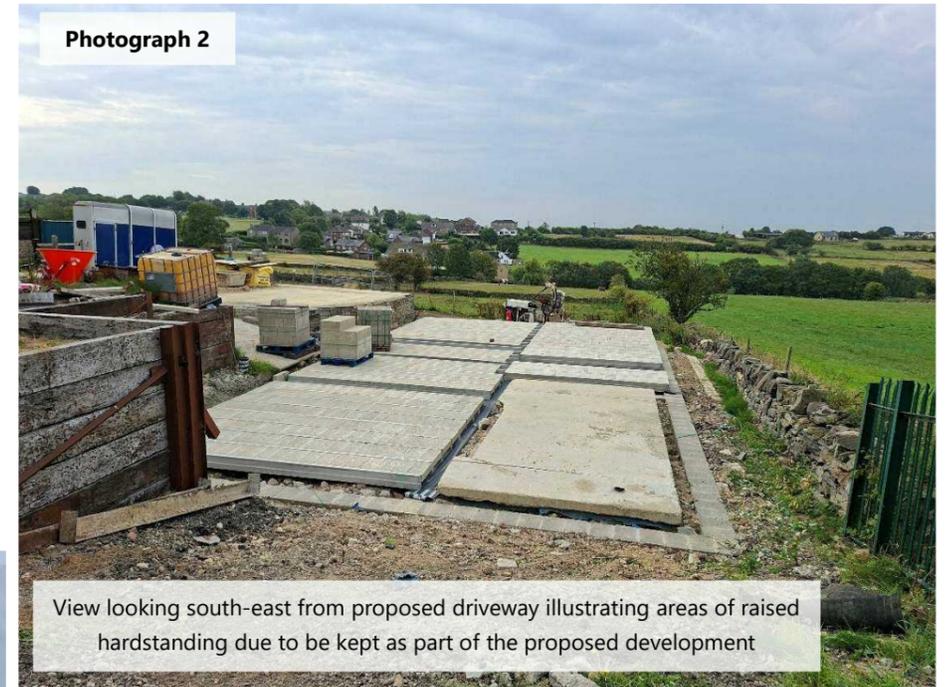
Photograph 2

View looking south-east from proposed driveway illustrating areas of raised hardstanding due to be kept as part of the proposed development

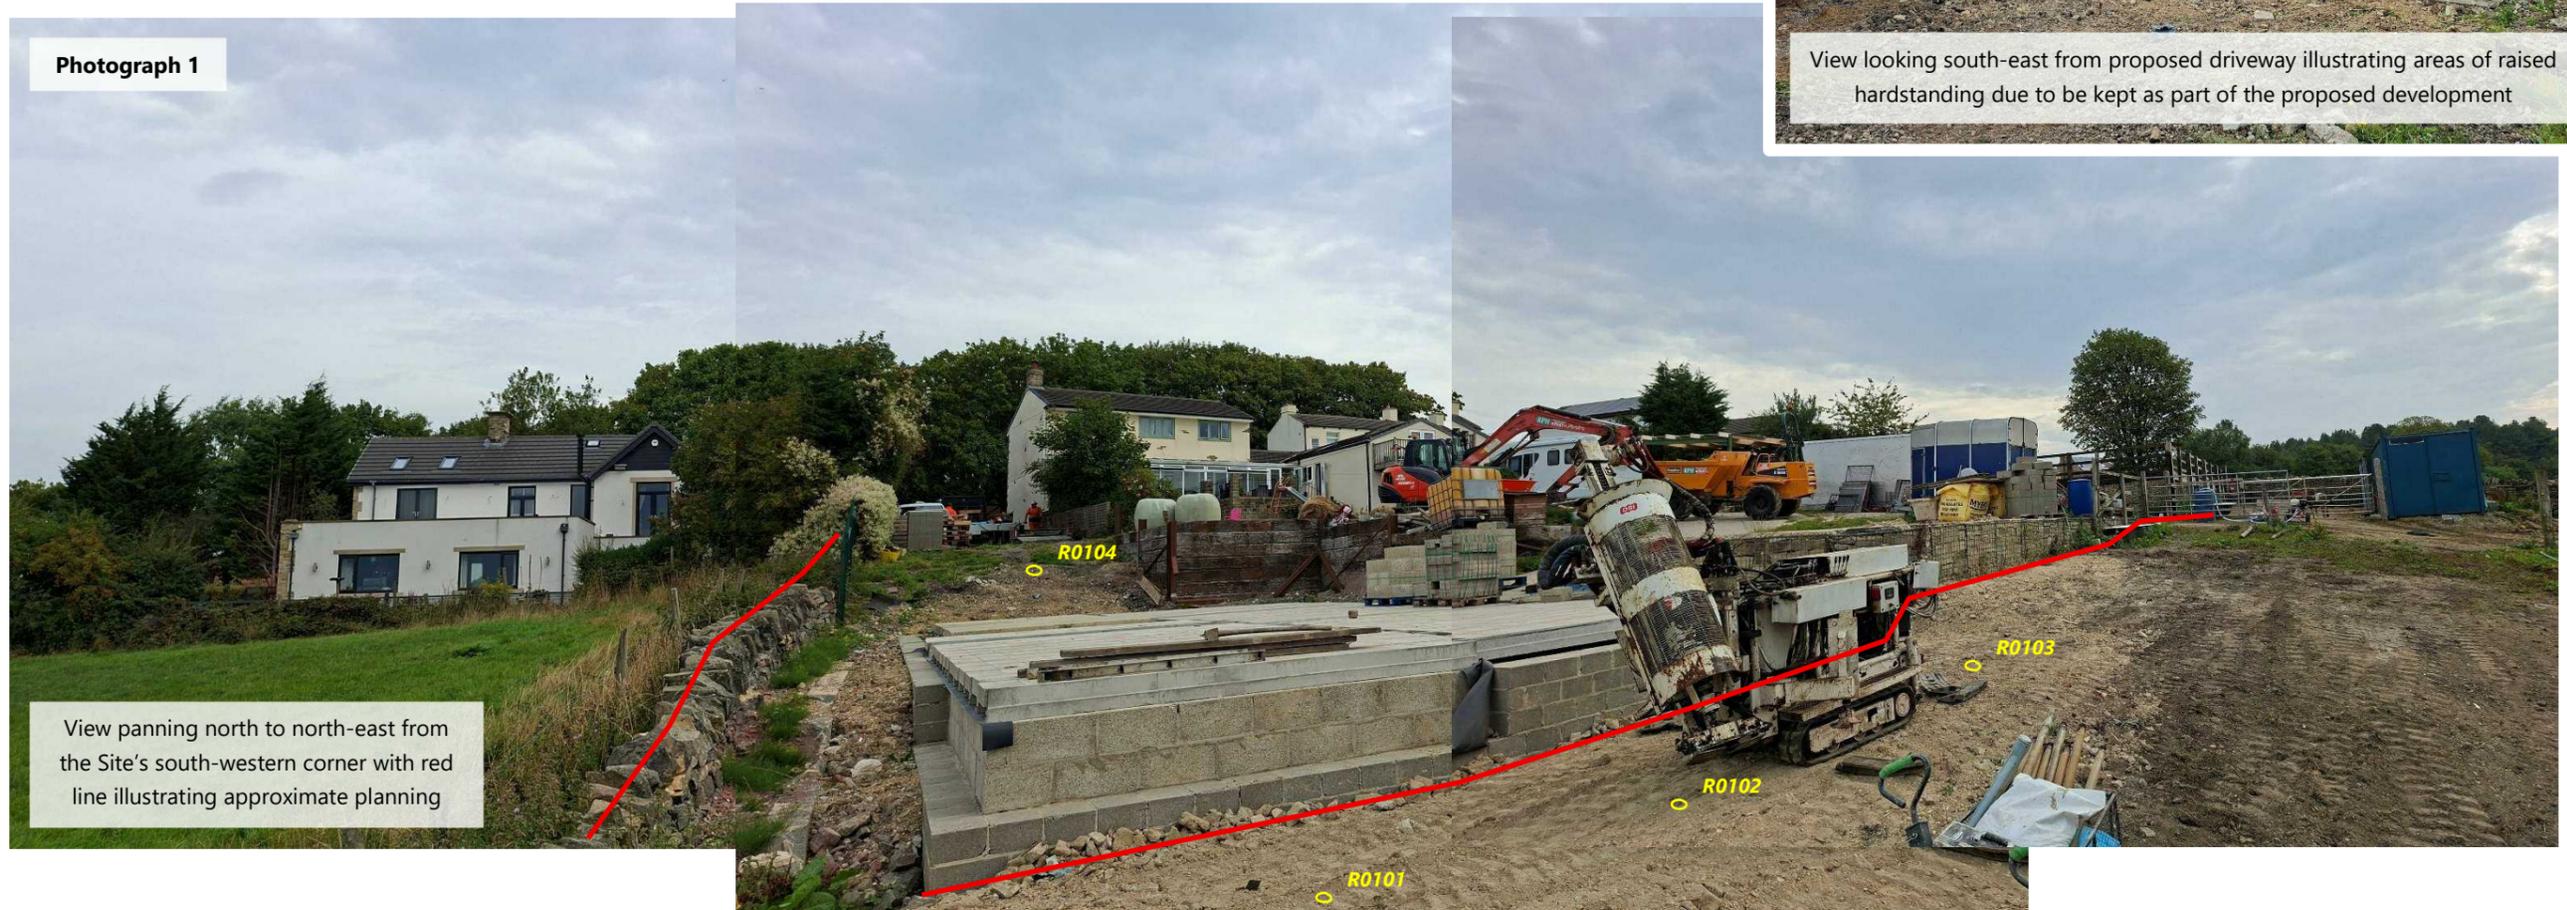
Photograph 1

**Condition:** At the point of fieldworks, demolition works were completed with ground beams for the proposed suspended slab in place - *Photograph 1*.

View panning north to north-east from the Site's south-western corner with red line illustrating approximate planning
