Roof A Platform 4 Columns Context

Huddersfield Station

Roof A - Column Pre-emptive Interventions Proposals Sketchbook

151667-TSA-30-MVL3-SK-S-006 Rev P03

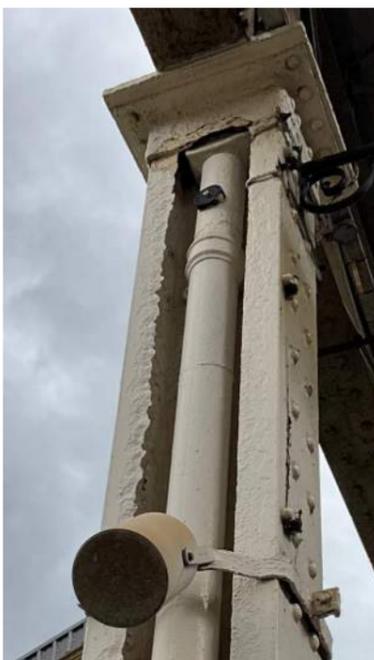
C1 - Upper Column Corrosion (1 Location)

The upper column section within the depth of the longitudinal trusses at the junction of Roof A and the start of roof B was visibly corroded to the outside flange on the exposed edge. This is likely due to the roof junction detailing which may have resulted in rainwater runoff down this column.

This isolated detail has been reviewed and the section loss is deemed to be insignificant to the required capacity of the column from a structural perspective.

In line with the conservation objectives of this project, this element will be retained and repainted with no further intervention beyond the surface and edge treatment noted below.

Works should be undertaken to restore the corrosion protection system to prevent further deterioration and in line with Network Rail Guidance NR/L3/CIV/040 (Specification for the use of protective coating systems) as per the rest of the structure.

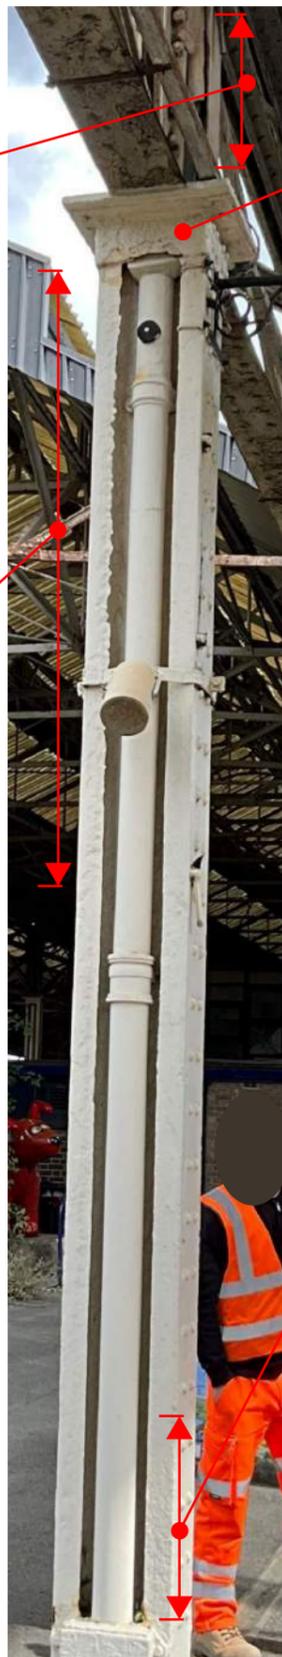
C3 - Column Channel Sawtoothing (~10 Locations)

The compound columns supporting Roof A along platform 4 have significant corrosion to the inside flanges of the PFC sections. This primarily relates to the location of the rainwater down pipes.

This detail has been reviewed and the overall column is deemed to have sufficient capacity to resist the design loads despite the anticipated section loss to the channel section flanges.

For reference we have conservatively assumed the channel flange in question has completely corroded to 50% of its original length (from 76mm down to 38mm) and the remaining flange has lost 2mm thickness to both faces (from 9.5mm down to 5.5mm).

In line with the conservation objectives of this project, the proposed intervention is only considered whereby the corrosion has a significant aesthetic impact on the form and lines of the existing structure. As such, where extent of the section loss is localised to a length of less than 200mm and above a limit of section loss depth of 30mm against the original line of the structure, a cover plate is proposed to maintain the line of the existing structure. Where section loss is less than 30mm from the original line of the structure or where the section loss is over 30mm but consistent along a longer length of the column, then no additional plate is proposed and the structure is to be ground back to a consistent line.

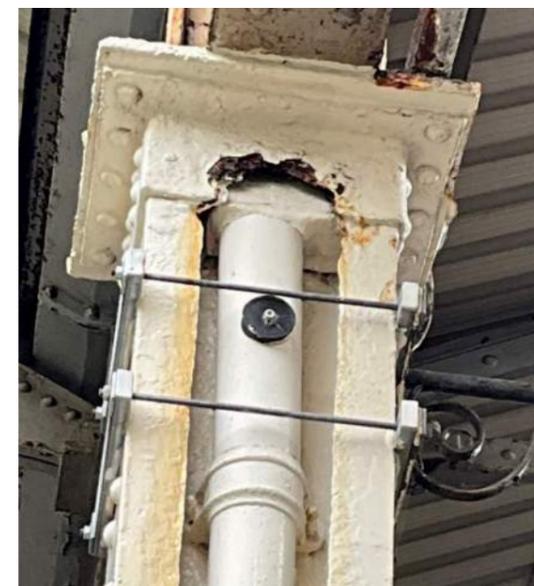
C2 - Column Cap Horizontal plate missing or corroded (~10 Locations)

The compound columns supporting Roof A along platform 4 have significant corrosion to the horizontal plates of the column caps primarily relating to the location of the rainwater down pipes. The horizontal plates have full thickness corrosion and are largely missing, which will be exacerbated by the blast cleaning process.

Following the conservation principles of the project, should the section loss extend past a reasonable tolerance, the pre-emptive proposal is to restore the original lines of the structure for aesthetic purposes only. This is to be done in a manor consistent with the language of the existing structure.

Where the section loss of the plate is less than 30mm from the original plate profile at narrowest and minimum 3mm of thickness of plate remains, plate to be prepared and treated as per surrounding structure. Where section loss is above these limits, implement below detail.

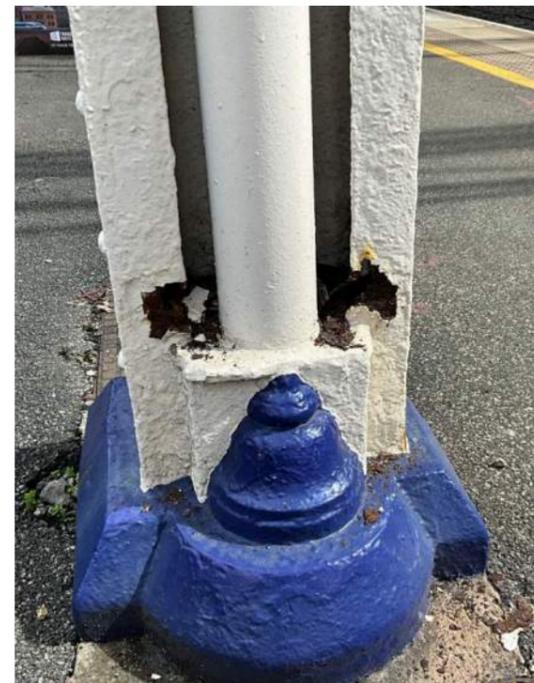
C4 - Column Channel Foot Corrosion (~4 Locations)

The compound columns supporting the Roof A trusses on platform 4 have full thickness corrosion to the PFC flanges where water / debris has pooled around the base. This is particularly prevalent at down pipe location on exposed (edge) columns,

In line with the conservation objectives of this project, the proposed intervention is only considered whereby the corrosion has a significant aesthetic impact on the form and lines of the existing structure. As such a limit of section loss depth of 30mm against the original line of the structure is used to determine the level of intervention.

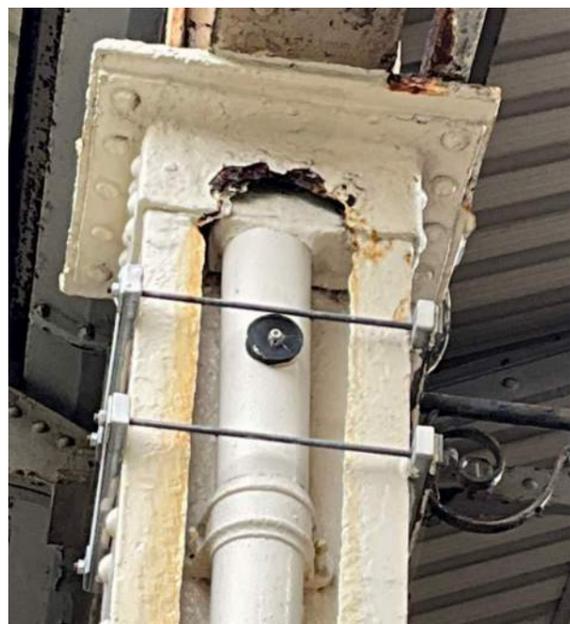
The column caps along platform 4 has been previously surveyed in Nov '21 during a weekend possession, which identified the likely cause to be the transfer of rainwater between downpipes via a hopper which would be susceptible to blockages and or overflows.

Worst cast column cap corrosion

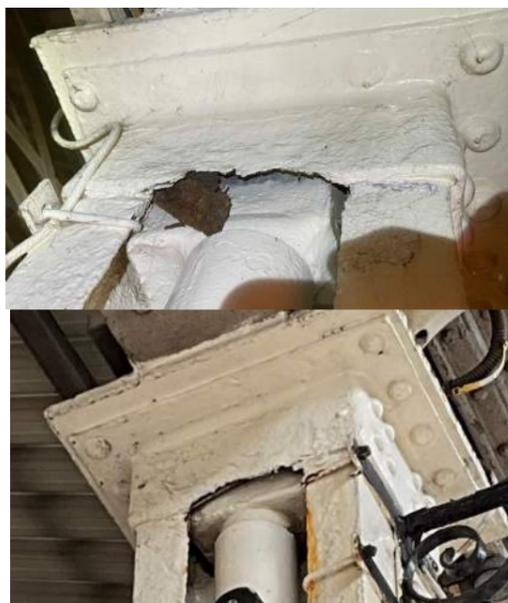
Partial and limited damage examples of column cap corrosion

As above, various conditions of the horizontal plate are present, and shot blasting is expected to cause further section loss where the remaining steel is thin.

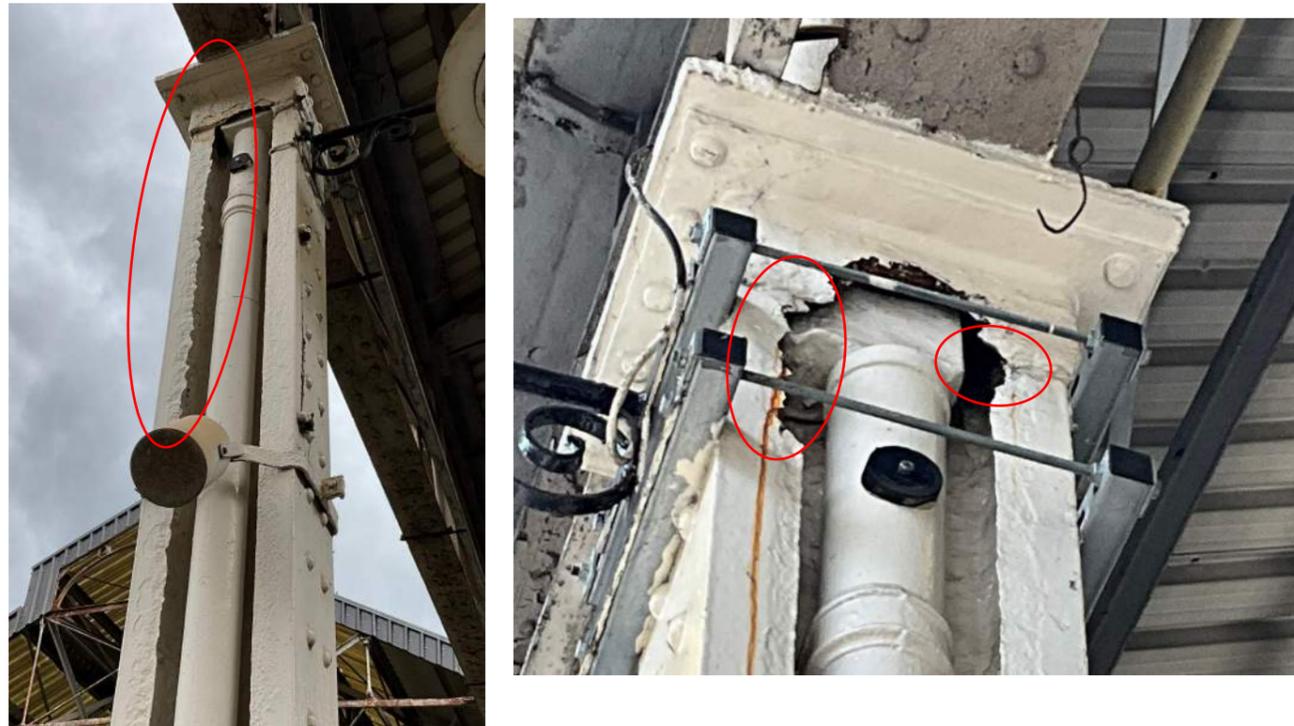
Platform 4 compound column saw tothing examples

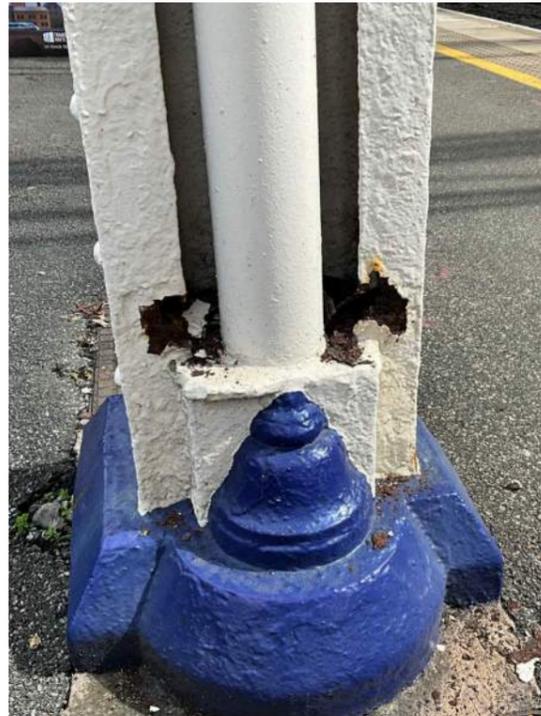
Platform 4 compound column foot corrosion - Worst case

Proposal B: where section loss fouls proposed Aesthetic limit

Works as per detail below.
