# Water Street Holmfirth

Condition Survey and Remediation  
Statement rev 3

December 2025

Project number 2501

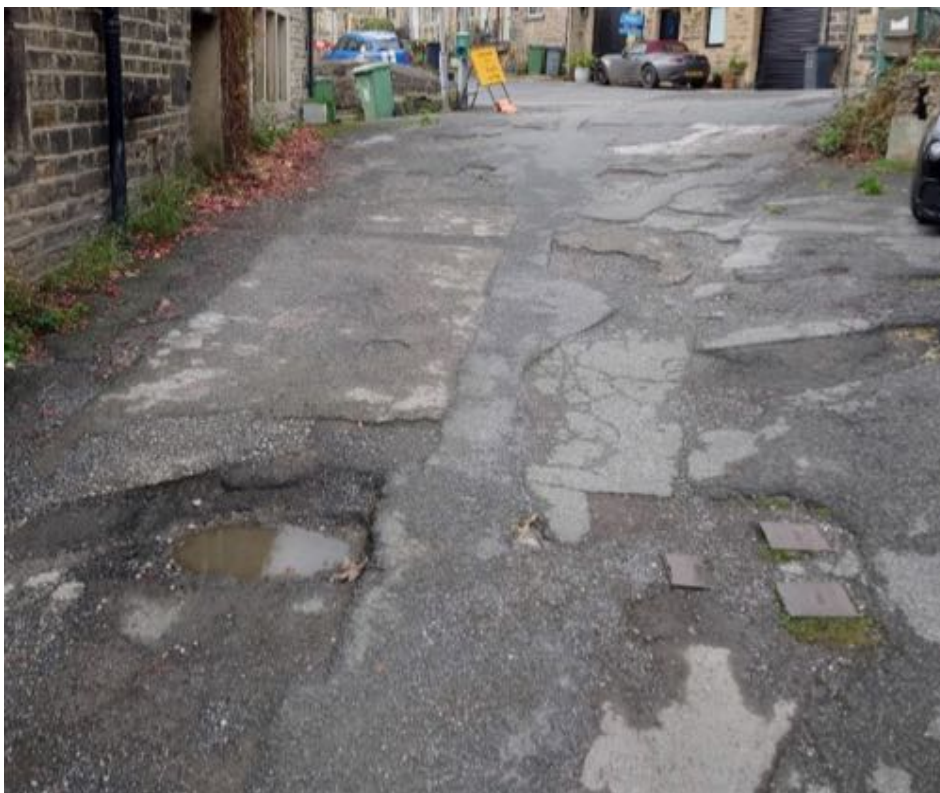
*Figure 14 Water Street location L*

- 2.2.1.2 The carriageway comprises several bituminous finishes with extensive statutory undertaker trenches and patching. Multiple potholes are present, many exhibiting lifting of patch material, alongside several uneven areas. The overall carriageway condition is poor.

- 2.2.2.2 Remediation will require planing and resurfacing along the majority of Water Street's length. Areas exhibiting foundation failure will require excavation of existing bituminous material and reconstruction with surface and binder courses over a regulating Type 1 sub-base.

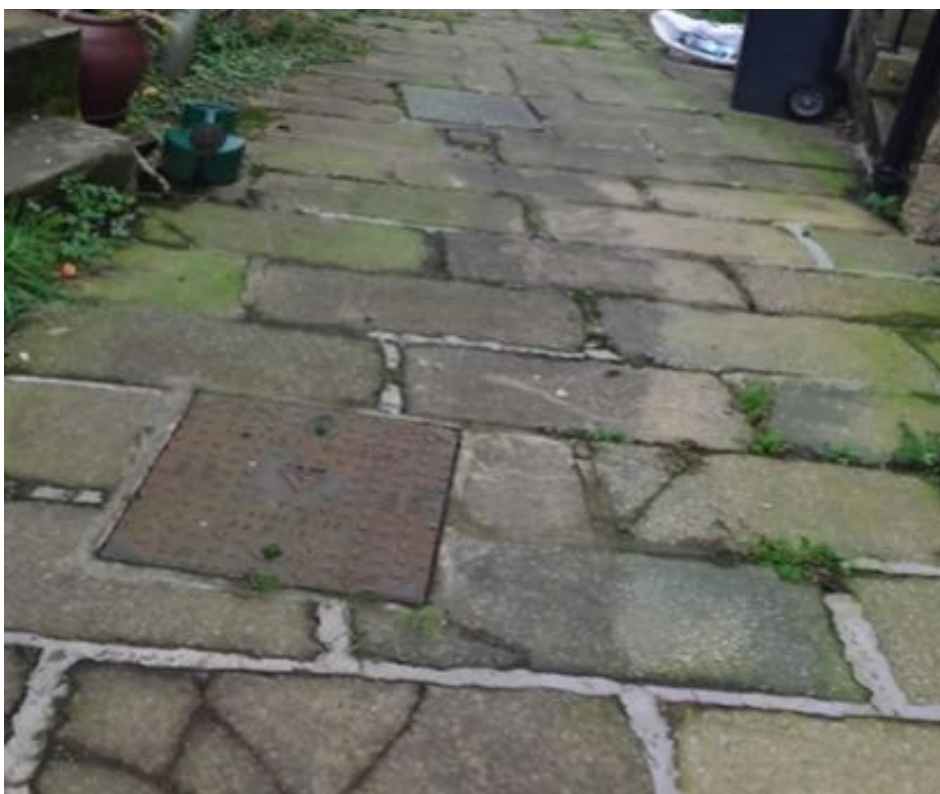
*Figure 84 Spring Lane location BZ*

- 2.6.1.3 The stone-paved surface comprises old flagging of varying dimensions showing signs of wear. Despite the worn nature of the flagging, the surface maintains good alignment and remains in fair to good condition overall.
