Gas Membrane Installation
Validation Report
Darren Smith Homes
Station Road
Mirfield
WF14 8NL

| Housebuilder Name: Darren Smith Homes | | Plot Number: Block A | | |
| Site Name: Station Rd, Mirfield. | | Detached House | <input type="checkbox"/> | |

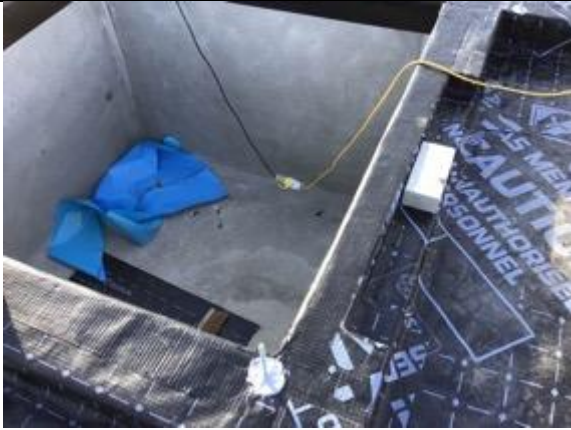
Surveyors Comments
 Juta GP Sealant has been used to seal around the base of the threaded bolts within the block work, both at the perimeter and internal walls.
 The membrane has been sealed to the top of the lift pit using SAGM.

Lift Pit edge

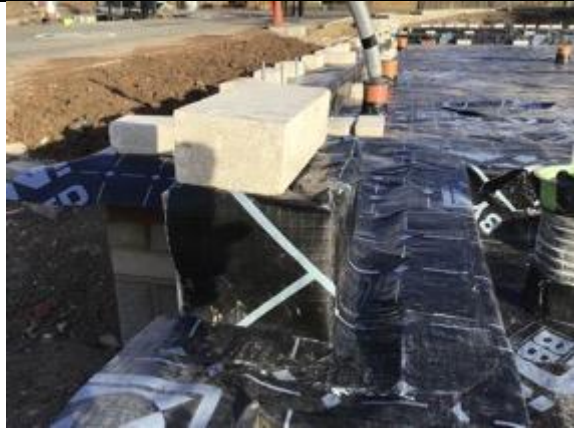
Cavity vent cloak
