## Structural Assessment

**157763-JBL-XXX-ZZZ-RP-SE-900 D01**

The Monal  
40, Bradford Road  
Cleckheaton  
West Yorkshire  
BD19 3LW

September 2025

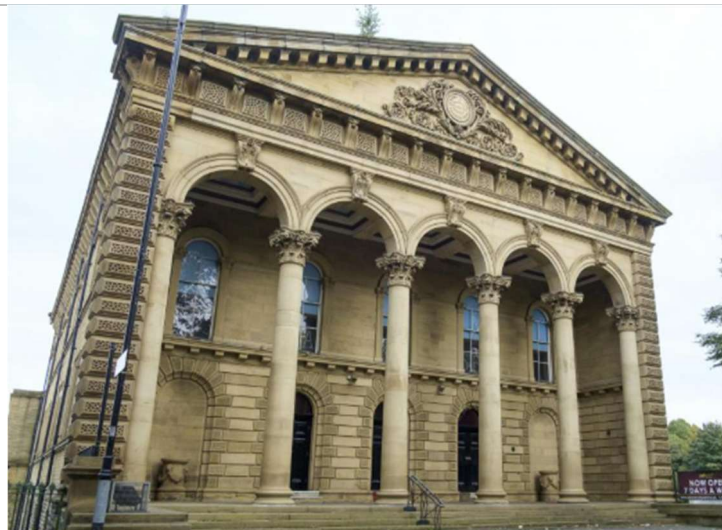
- 3.3 Photo No 1 shows the building as originally built, with Photos No 2 & 3 showing the front elevation immediately after the collapse.
- 3.4 The feature coping stones atop the front elevation gable, along with their support corbel stone and some of the feature lower cobbles and shelf have collapsed.

**Photo 1:**  
Front elevation of (circa  
2022 from the T&A)

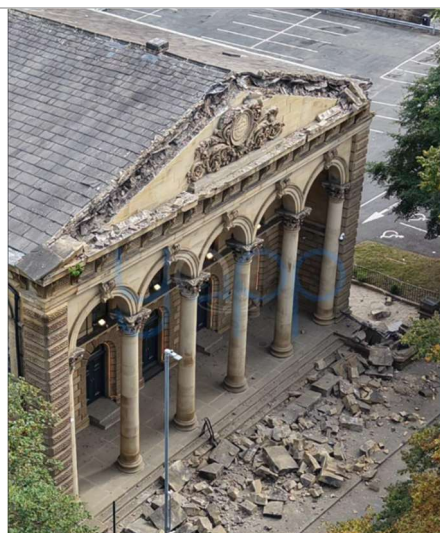
- 3.1 On Saturday 6<sup>th</sup> September 2025, a larger portion of the upper front elevation gable collapsed onto Bradford Road below.
- 3.2 Since the incident the road has remained closed while a demolition company cleared away all debris and erected a structural scaffold to prevent any further collapse and protect the entranceway into the building.

**Photo 2:**  
Drone footage taken directly  
after the collapse  
(taken from 'Yapp App')

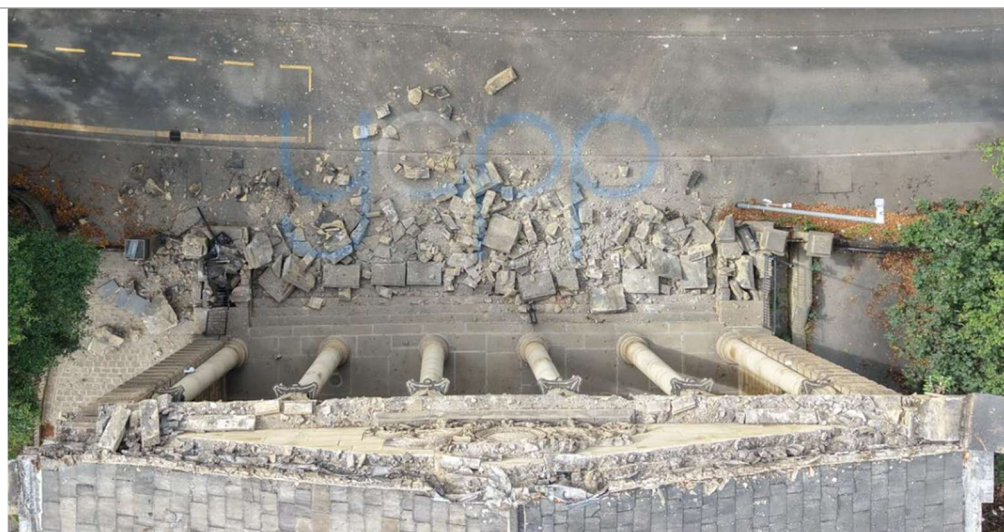
**Photo 3:**  
Drone footage taken directly  
after the collapse  
(taken from 'Yapp App')

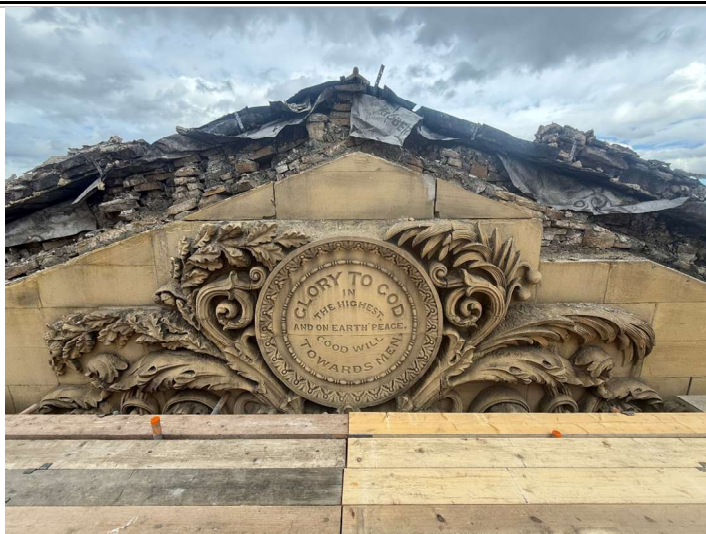
**Photo 4:**  
Front elevation view from  
the top level of scaffold

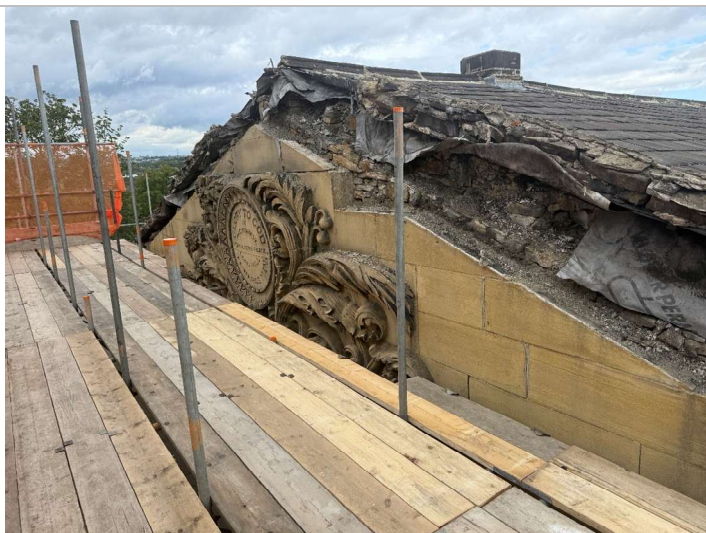
- 3.10 At ground level, there has been damage to the stone podium, mainly on the left-hand side where falling debris has cracked, broken and dislodged the podium capping stones. It is likely there is similar damage to the right-hand side, however access was restricted.  
*Photo 5*

**Photo 5:**  
Front elevation view from  
the top level of scaffold

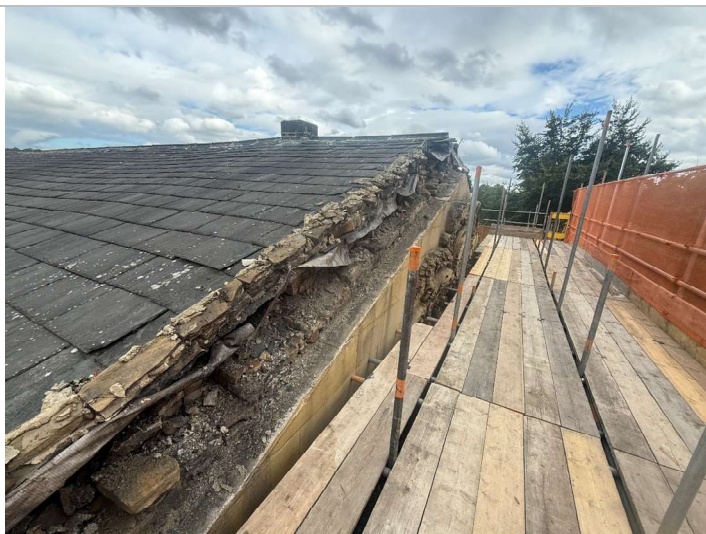
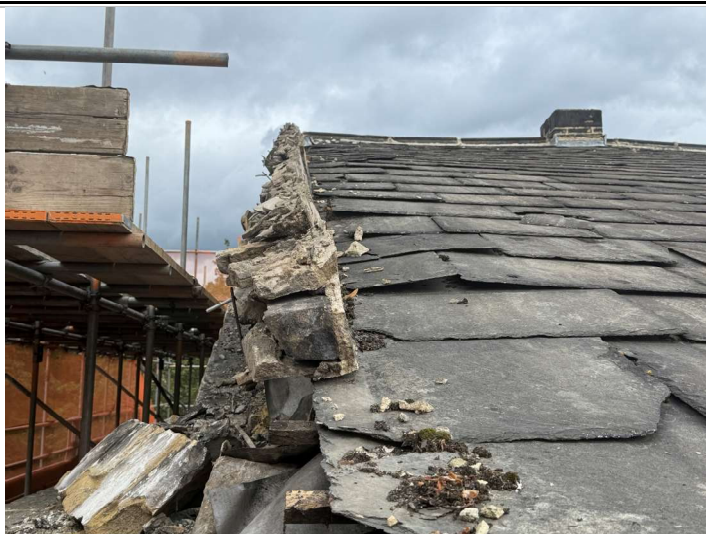
- 3.5 The inner skin of 150 – 200mm thick stone remains and is providing support to the incoming roof purlins.  
*Photos 16, 17 & 18*
- 3.6 Where the roof battens and slates lap onto the inner skin of stone, there is a further upstand of 150mm stonework that has been left balanced atop the slates.  
*Photos 6 & 7*

**Photo 6:**  
Remaining stonework atop  
the roof slates (left-hand  
side)

**Photo 7:**  
Remaining stonework atop  
the roof slates (right-hand  
side)

- 4.2** We would recommend the stone upstand, currently only sat and supported on the roof slates is carefully removed. As there is very little support to this section of stonework, and the stones are currently loose and easily moved by hand, this should be carried out immediately by a competent contractor.

- 4.3** Following this removal, any loose stonework to the 'cavity' section of the wall should be removed or made secure where possible.
- 4.4** Any removed stonework should be safely stored for the rebuild.

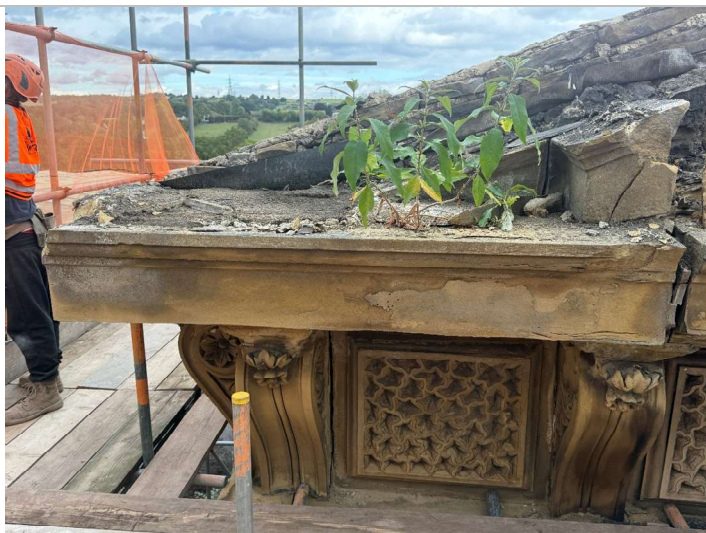
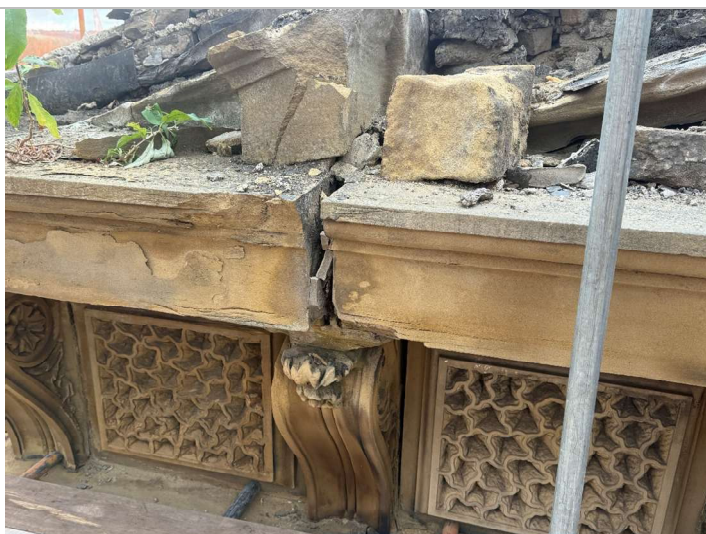
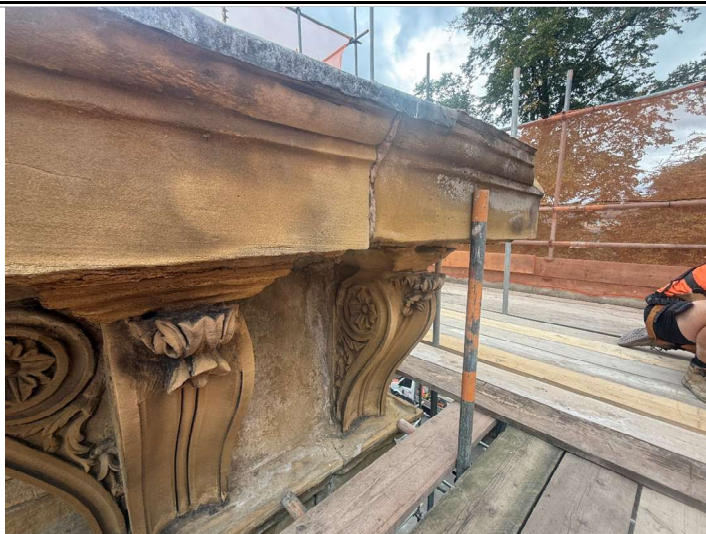
- 3.8 The left-hand corner remains intact; however, movement has occurred with rotation of bed stone and opening of the joints to the support corbels.  
*Photos 8, 9 & 10*

**Photo 8:**  
Lower level stonework  
support (left-hand side)  
showing movement

**Photo 9:**  
Lower level stonework  
support (left-hand side)  
showing movement

**Photo 10:**  
Lower level stonework  
support (left-hand side)  
showing movement

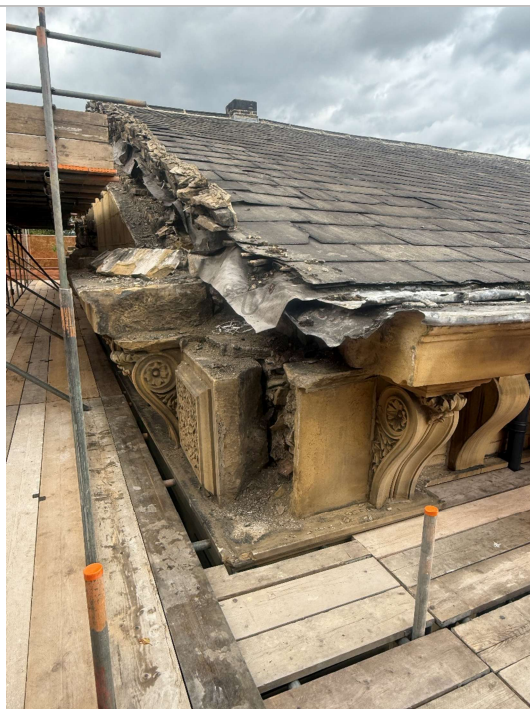
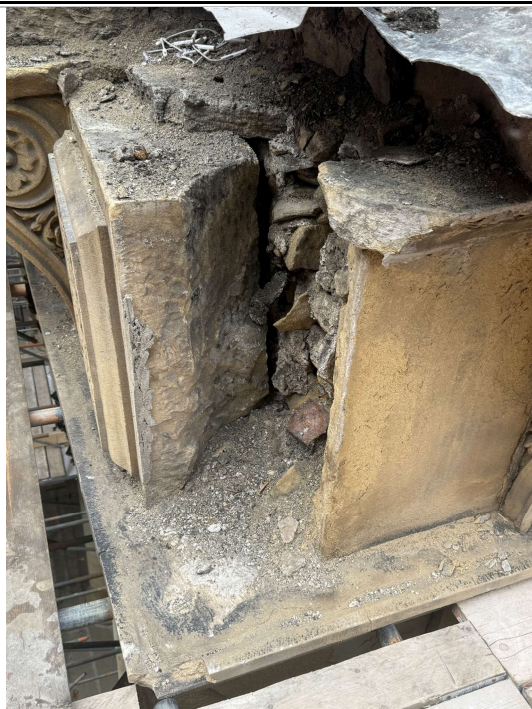
- 3.7 The right-hand corner has suffered more collapse at the lower level of the feature gable, with the corner corbels now missing along with a large corner bed stone.  
*Photos 11 & 12*

**Photo 11:**  
Lower level stonework  
support (right-hand side)  
missing decorative corner  
corbels and large stone bed  
stone

**Photo 12:**  
Lower level stonework  
support (right-hand side)  
missing decorative corner  
corbels and large stone bed  
stone

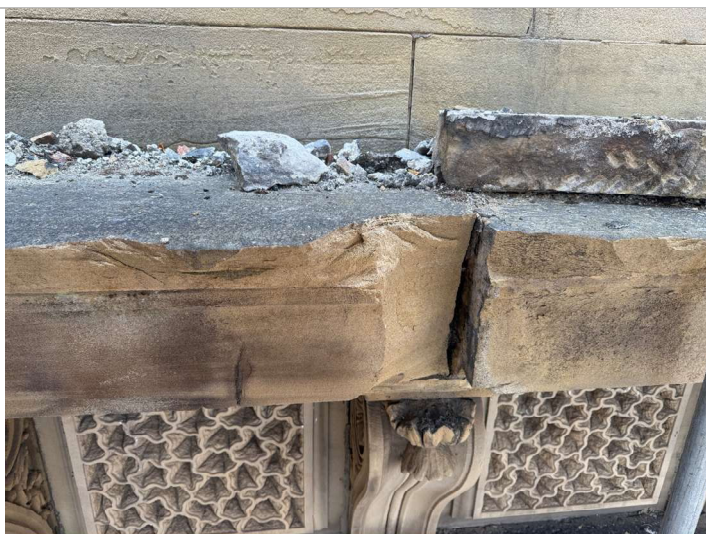
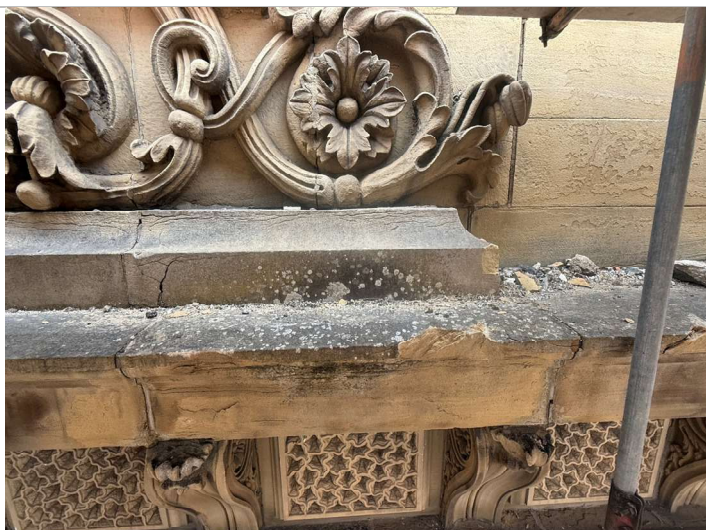
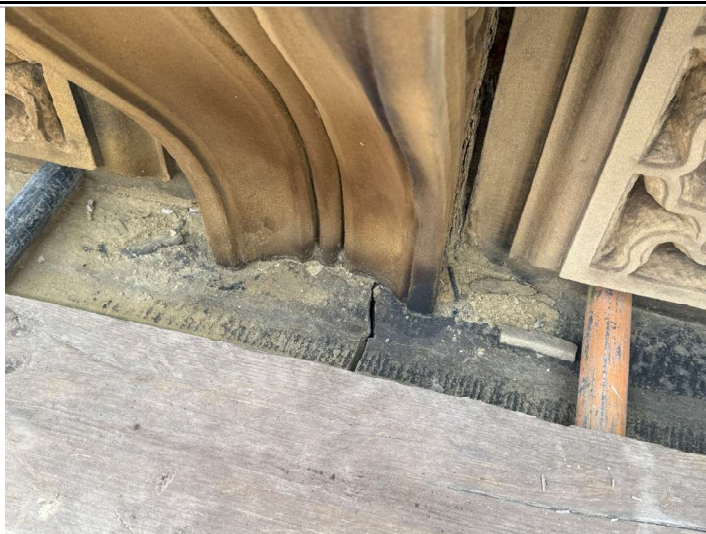
- 3.9 There are several areas of chipped / damaged stonework to the lower gable plinth where debris has damaged it during the collapse.  
*Photos 13, 14 & 15*

**Photo 13:**  
Damage to the lower level  
plinth stonework

**Photo 14:**  
Damage to the lower level  
plinth stonework

**Photo 15:**  
Damage to the lower level  
plinth stonework

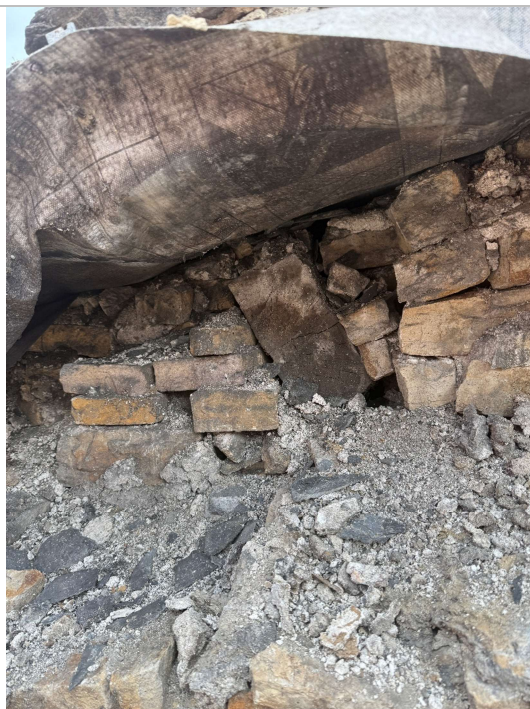
**Photo 16:**  
Inner stonework leaf  
supporting timber purlin

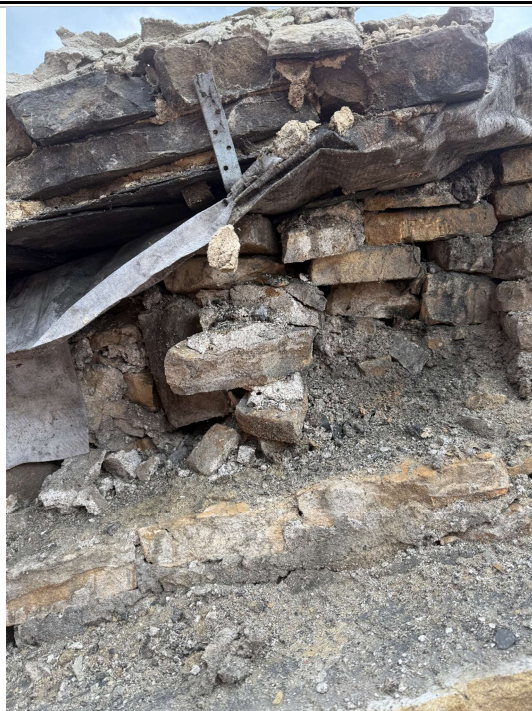
- 4.9** There were noticeable modern restraint ties left insitu fixed to the underside of the roof covering that had been screwed into the back of the stonework, however these have easily pulled out due to the weight of the material as it has fallen away.

**Photo 17:**  
Inner stonework leaf and  
modern restraint straps

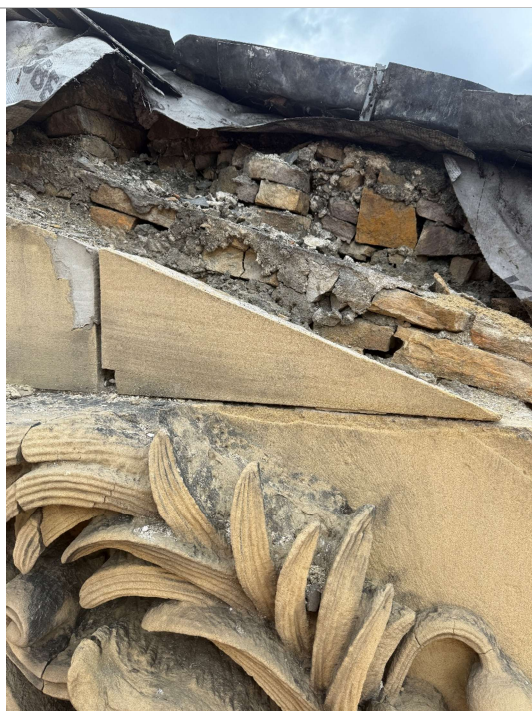
**Photo 18:**  
Inner stonework leaf

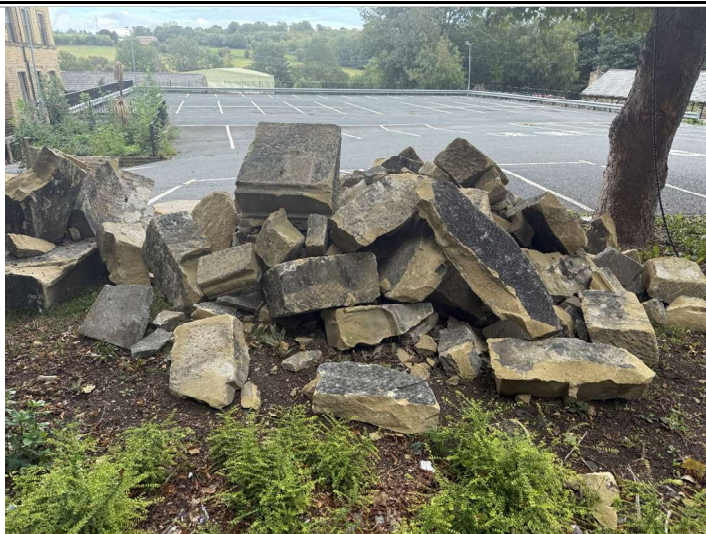
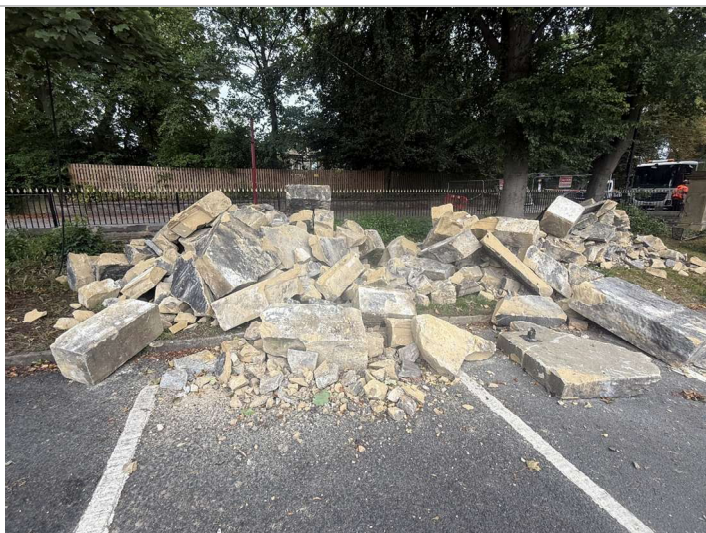
- 3.13 There was 1No stepped crack noted to the inner stonework leaf, which appeared historic and of no immediate concern.  
*Photo 26, 27 & 28*
- 3.14 The stone debris collected from the road has been moved to the adjacent car part, which can be reviewed, cleaned up and hopefully reused as part of the remedial works.  
*Photos 19 & 20*

**Photo 19:**  
Stonework removed and  
stored within carpark

**Photo 20:**  
Stonework removed and  
stored within carpark

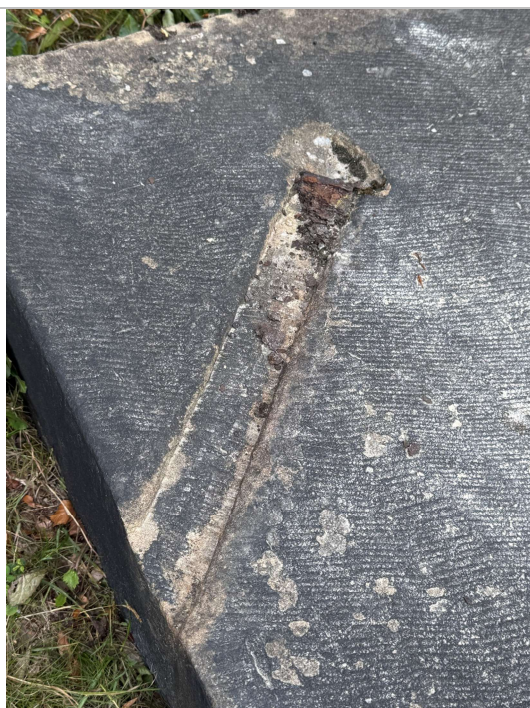
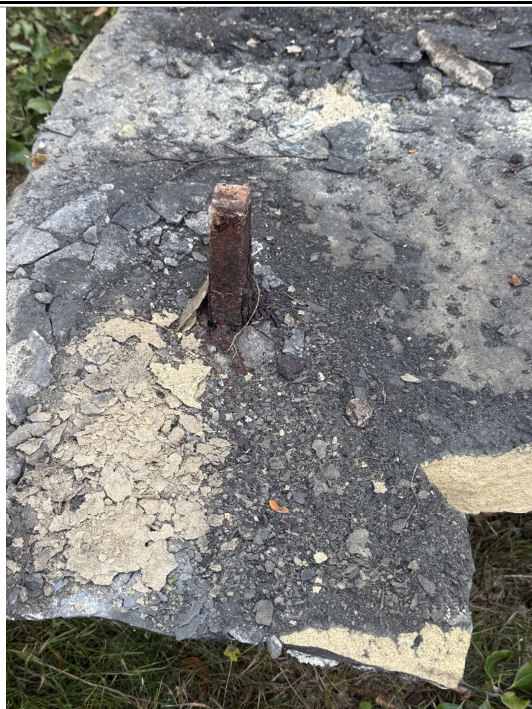
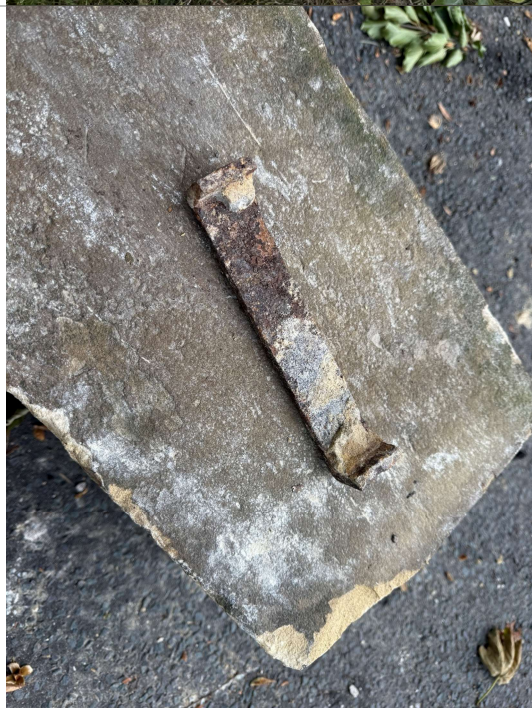
- 4.8** In our opinion, and based on our visual inspection, the collapse has occurred due to the age of the building and degradation of the materials. The mortar to some of the stonework appears to have eroded, likely due to exposure. From the stonework reviewed on the ground there are signs of iron cramps and dowels that have clearly rusted and expanded.

**Photo 21:**  
Evidence of historic iron  
cramps

**Photo 22:**  
Historic iron dowel

**Photo 23:**  
Historic iron cramp

- 4.11** The structural remedial works will likely include:
- i. Stone replacement sourcing strategy
  - ii. Stainless / bronze replacement fixings
  - iii. Compatible lime mortar for bedding and pointing

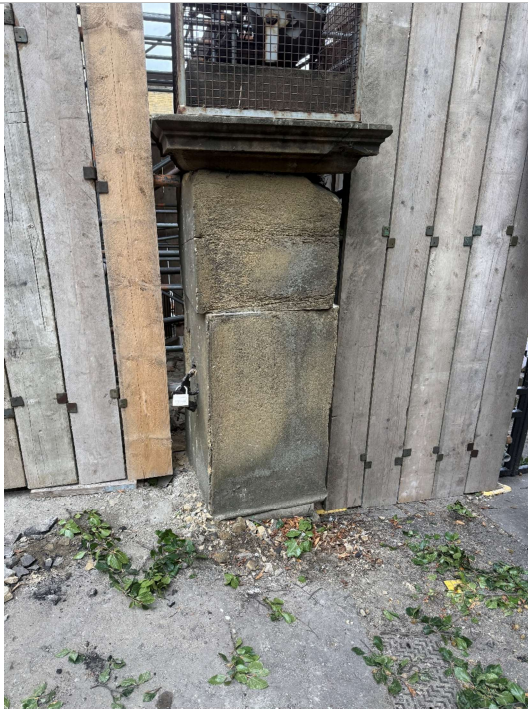
- 3.11 There are 5 ashlar gate pillars, the 2 on the left-hand side appear fine but access was limited. Then 2 out of the 3 on the right-hand side (the 2 closest the building), have suffered damage. The one closest the building suffering impact damage, with a section of stonework missing and the second one appearing intact but has rotated round in location.  
*Photo 24*

**Photo 24:**  
Twisted stone gate pillar

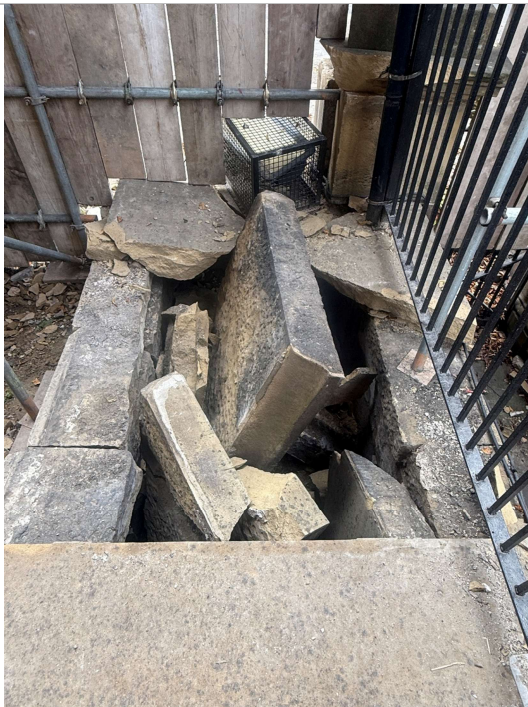
**Photo 25:**  
Damage to stone podium

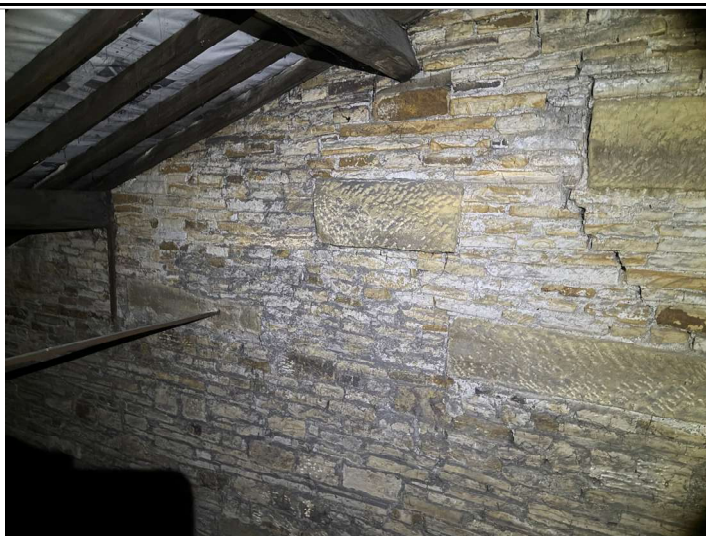
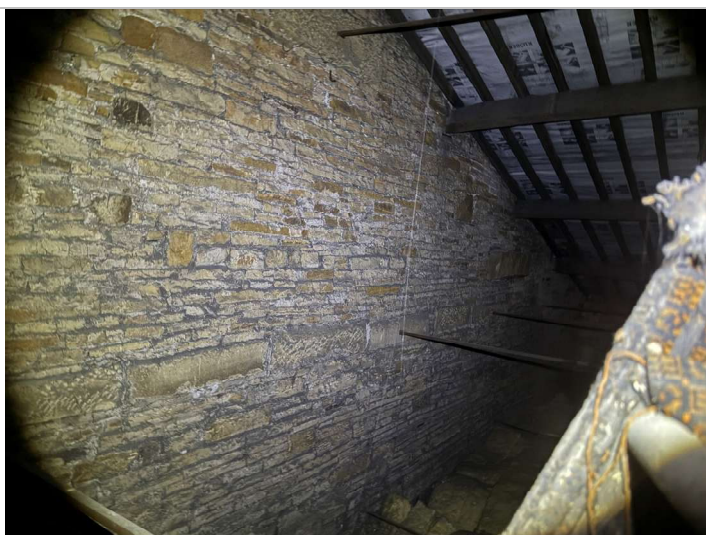
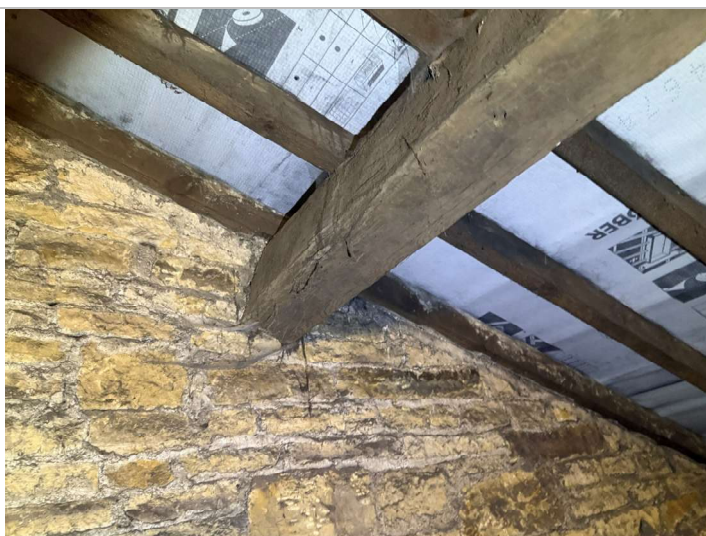
- 3.12 Internally, access was possible through a hatch in the feature ceiling where the inner stonework leaf of the front gable was visible. There were no noticeable defects to the inner face, with all timber purlins and tie rods still in place without signs of movement.

**Photo 26:**  
Internal stonework face of  
gable – stepped crack

**Photo 27:**  
Internal stonework face of  
gable

**Photo 28:**  
Internal stonework face of  
gable – purlins still securely  
supported
