STRUCTURAL CONDITON INSPECTION

Client: **John Edward Crowther (Holdings) PLC**

Site Address: **New Mills
Brougham Road
Marsden
Huddersfield
HD7 6AZ**

Report Reference (Revision): **23421-DCE-XX-XX-T-S-003-P01**

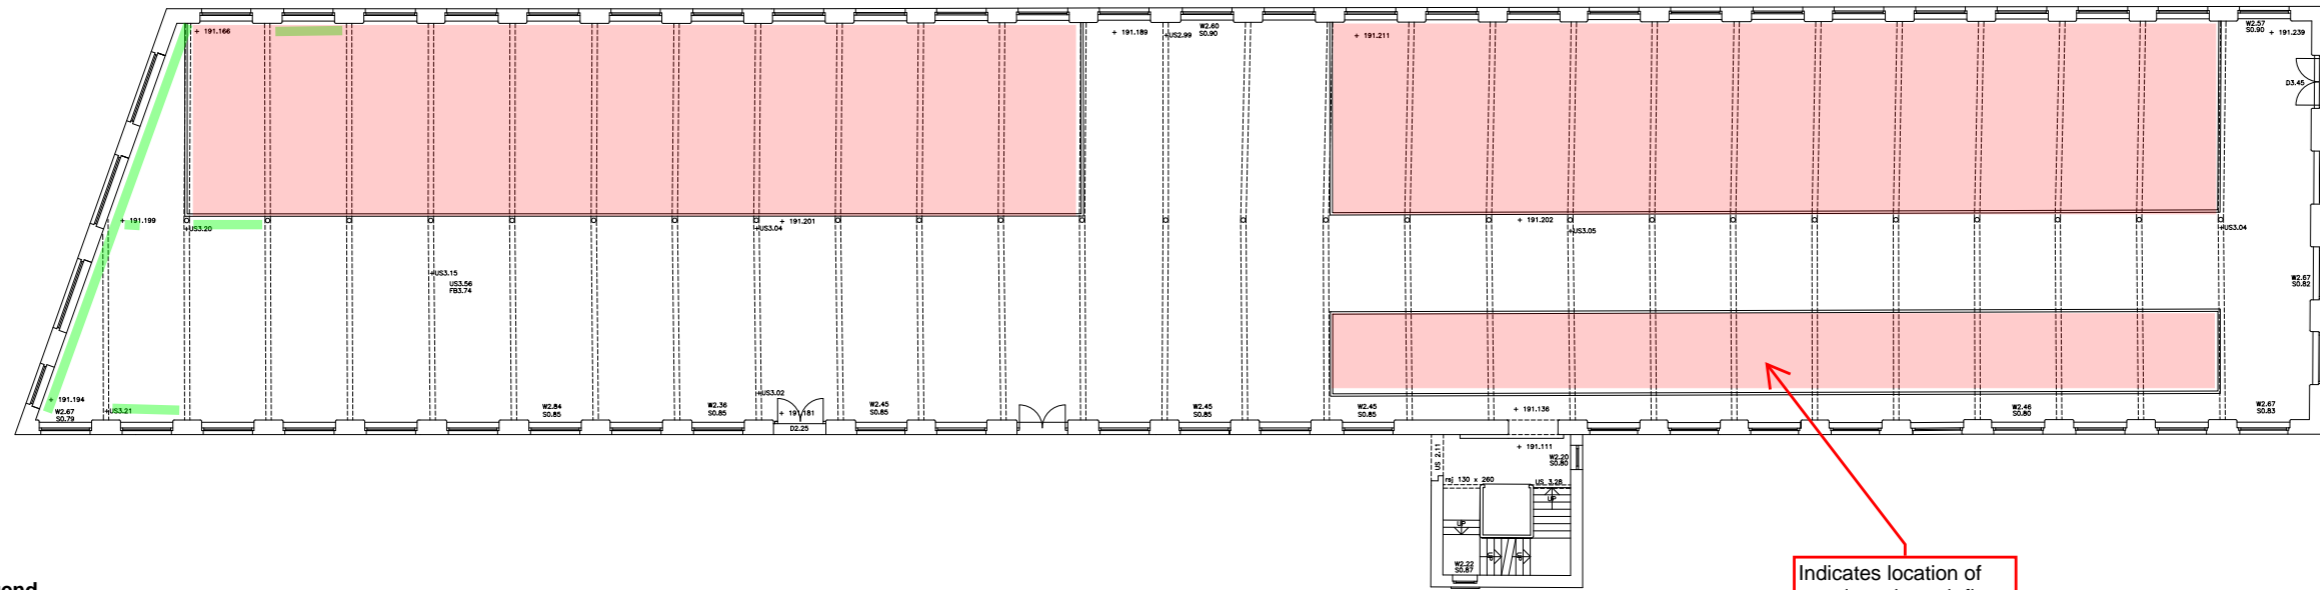
Second Floor

Indicates location of openings through floor deck, i.e. no floor boards or joists, however primary steel floor beams on column lines remain in place

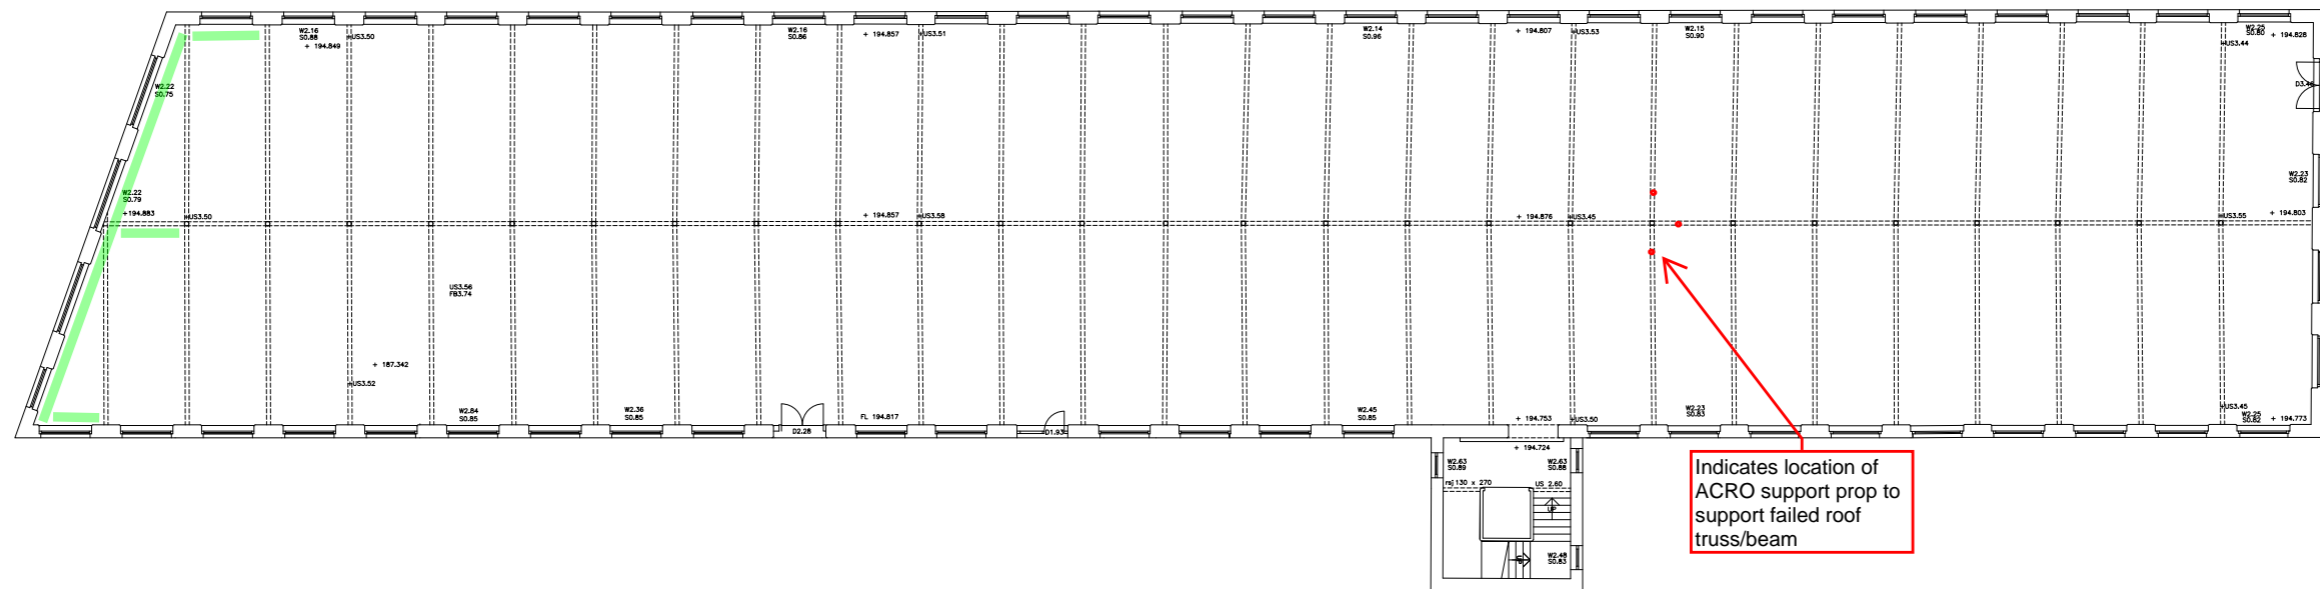
Third Floor

Indicates location of ACRO support prop to support failed roof truss/beam

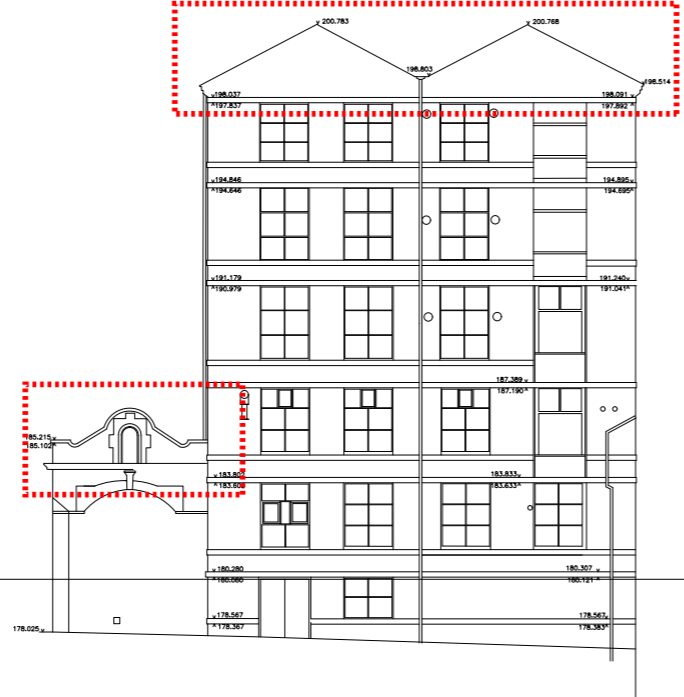
Assumed newer mill construction with stone piers between windows

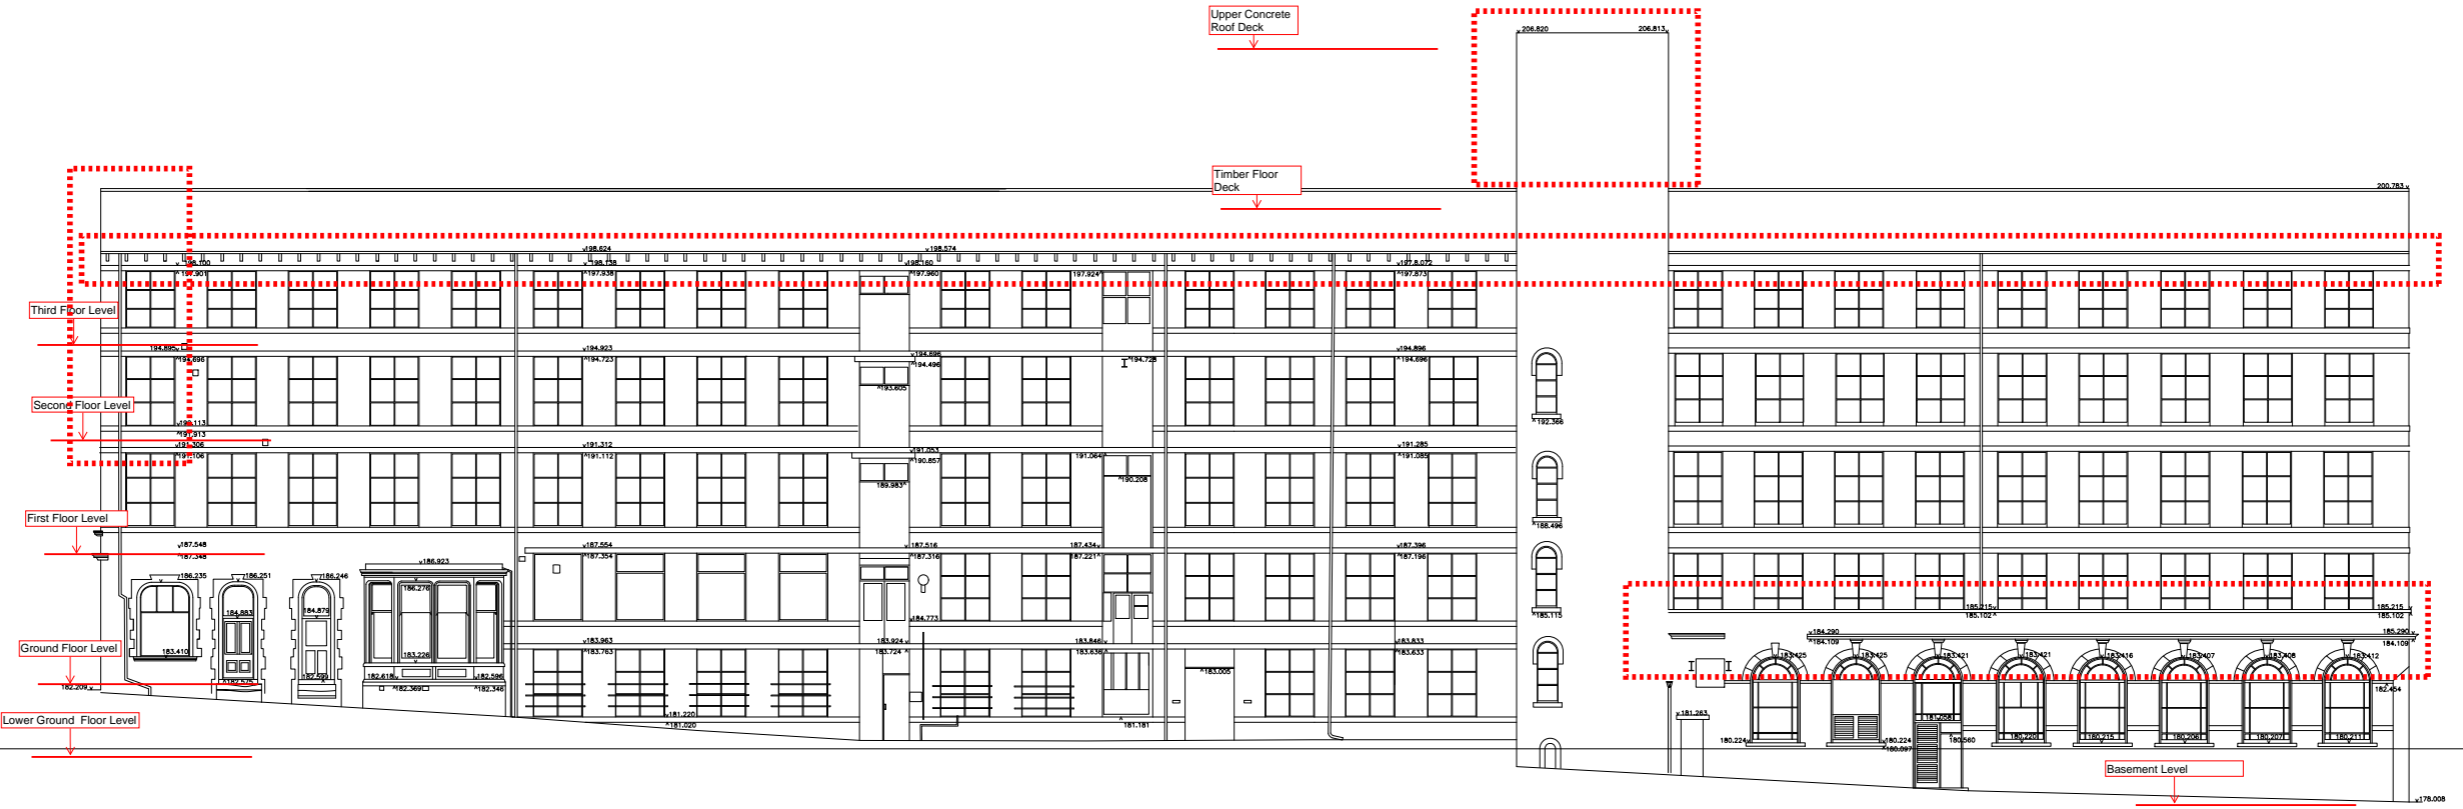
Dashed outline indicates areas where wholesale rebuilding of existing masonry structure is anticipated
