Engineers Site Inspection

Dilapidations Report

Existing Retaining Wall

Bell Cabin, Long Lane

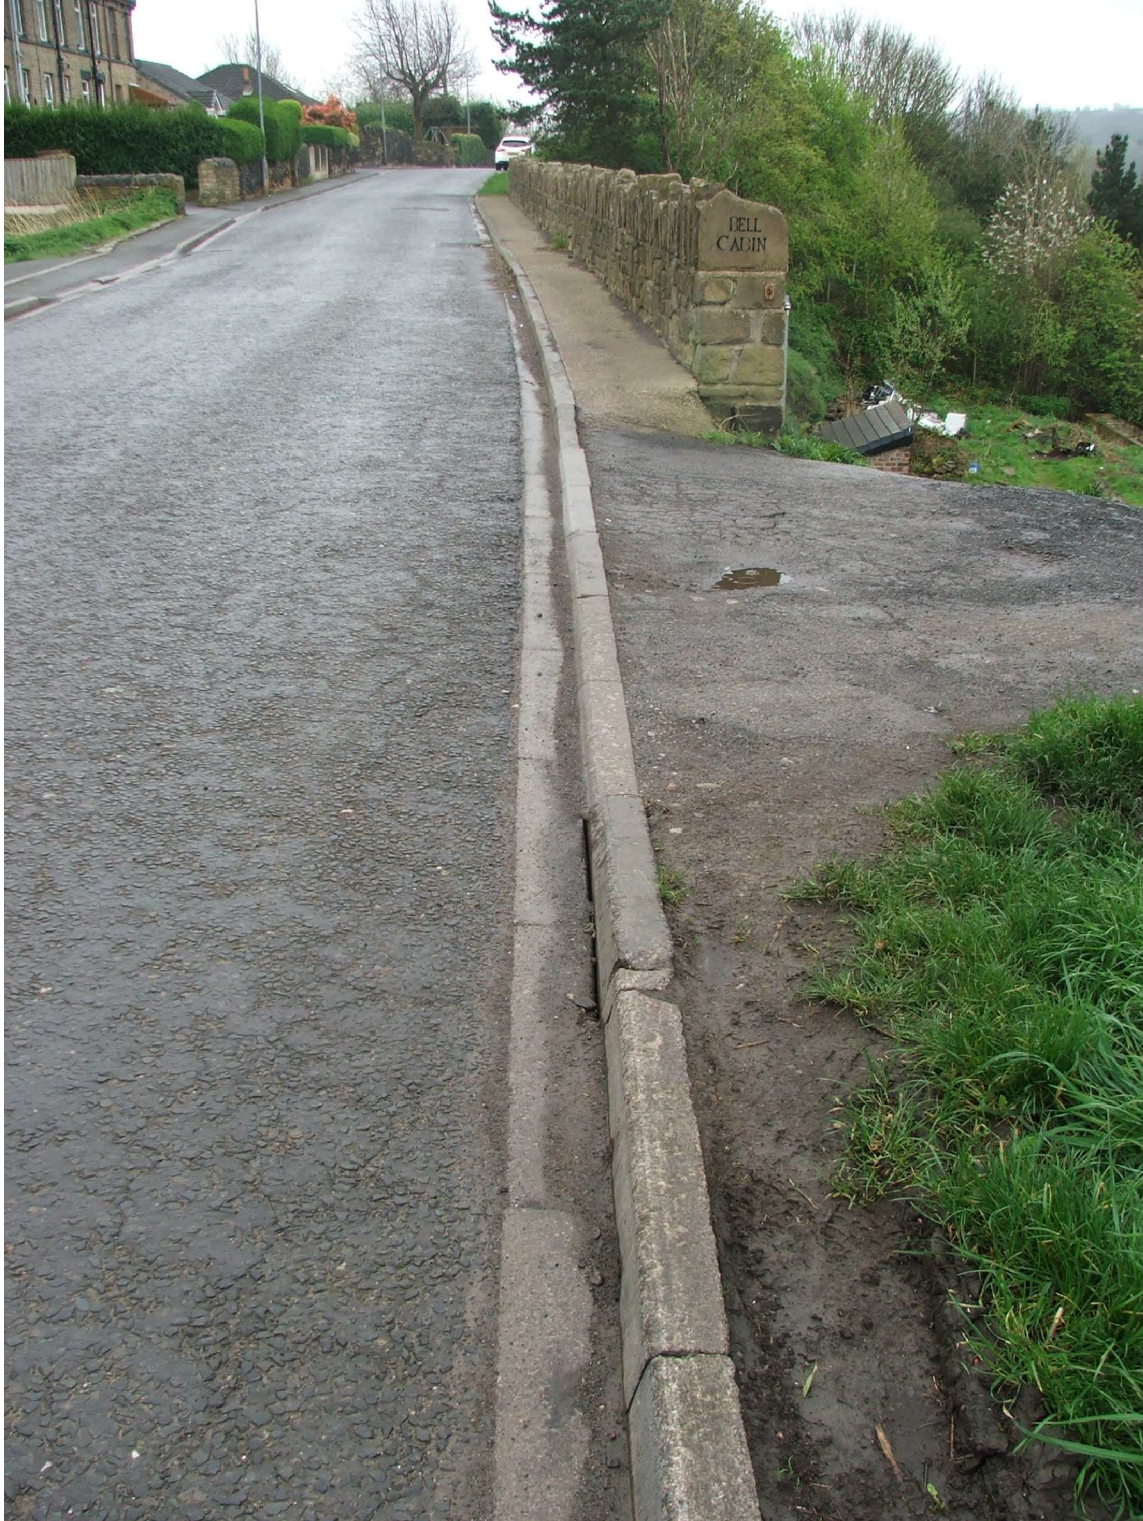
The transition kerb at the start of the dropped kerb access to the site has been displaced and the adjacent full kerb has a crack at the end. The dropped bullnose kerbs across the site access are in reasonable condition.

Kerb line across site access showing displaced transition kerb and cracked full kerb.

The minor adopted highway kerbing repairs should be undertaken prior to completion of the site works to the satisfaction of Kirklees Highways Department.

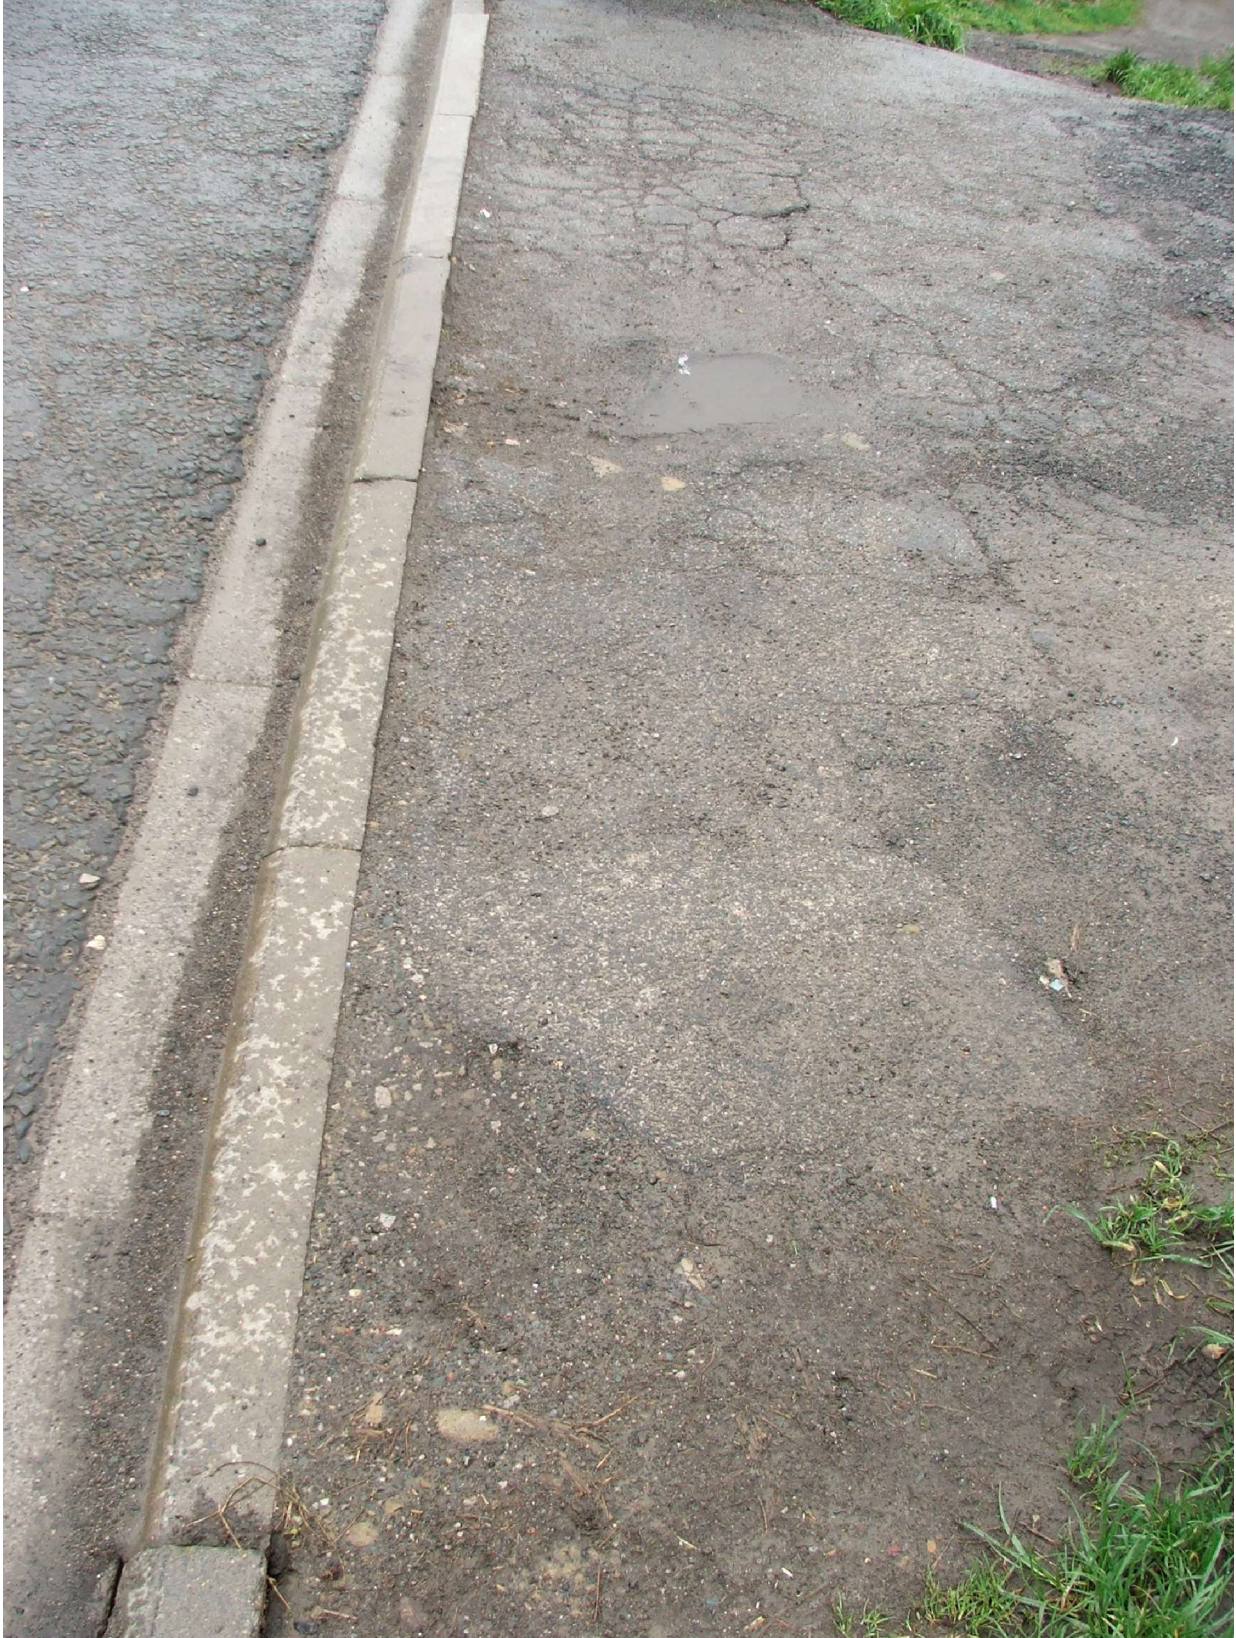
Dropped bull nose kerb across existing site access

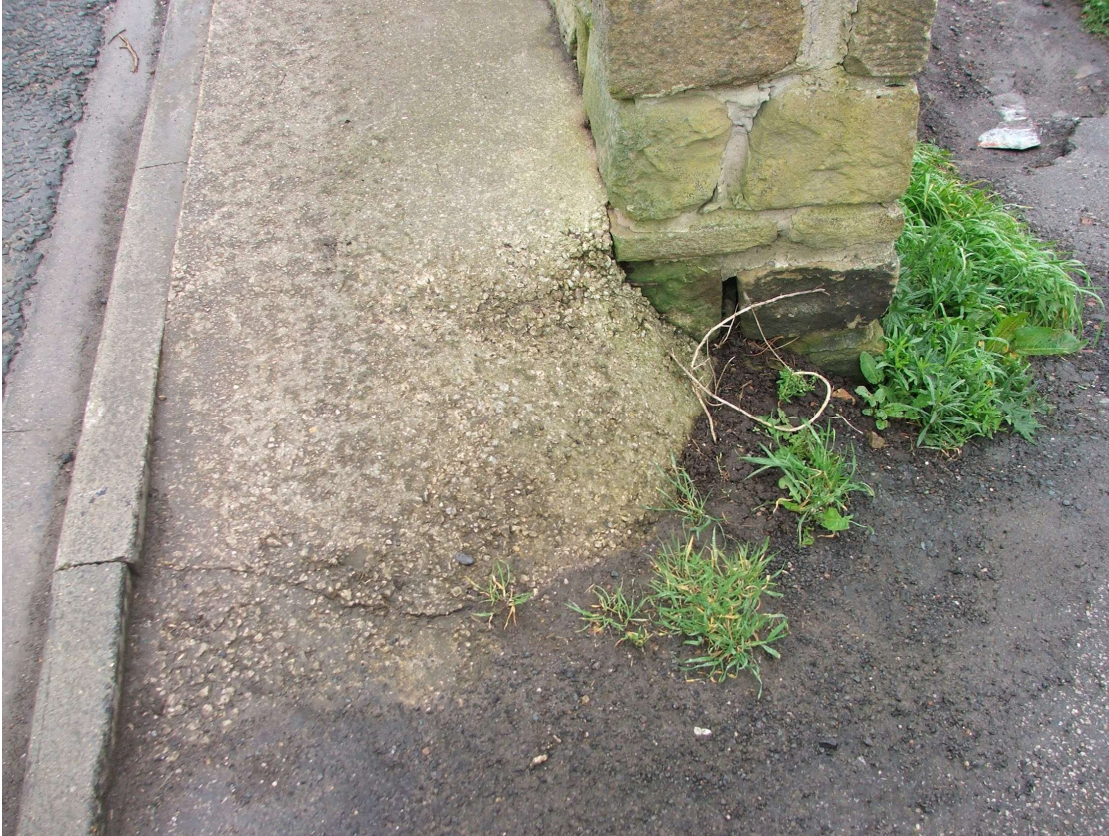
Start of concrete verge.

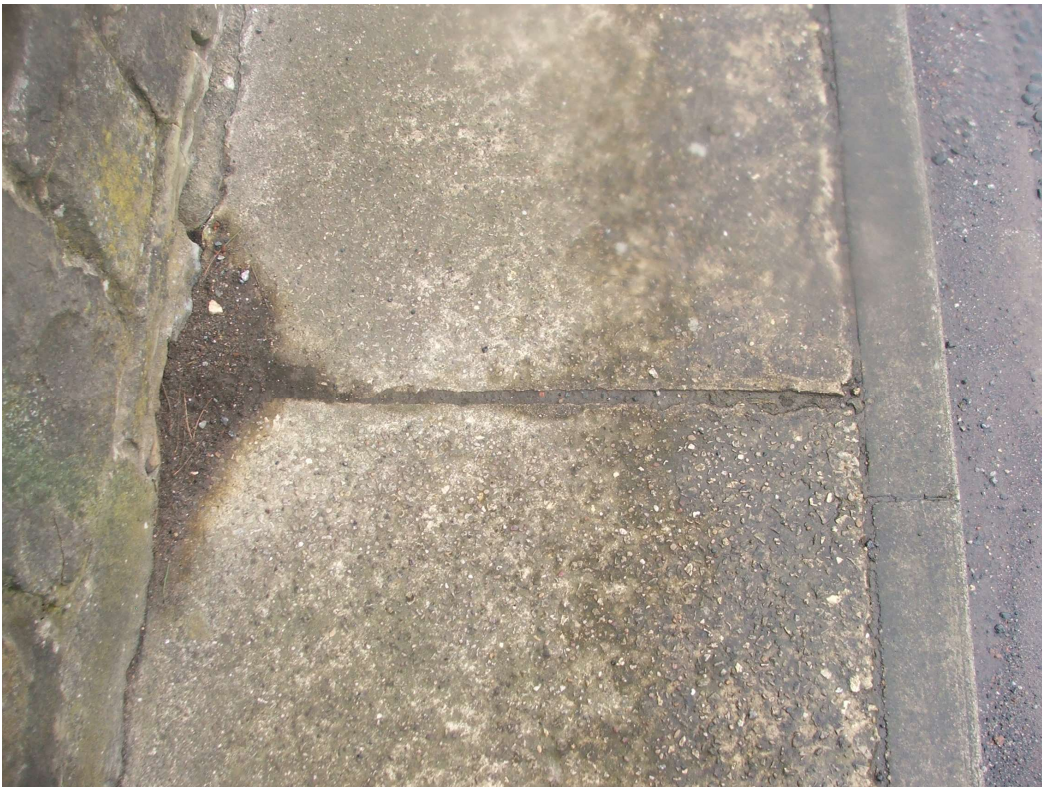
Typical formed contraction joint in concrete verge.

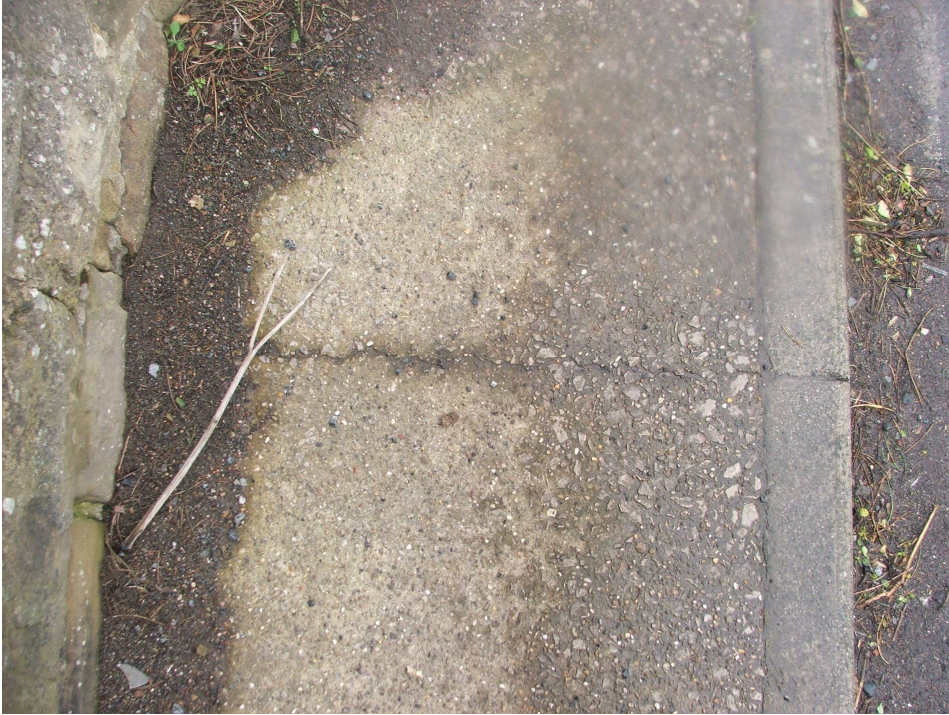
that run almost straight across the full width of the verge which appear to be shrinkage cracks caused by contraction of the concrete and have no structural significance.

Typical shrinkage crack concrete verge.

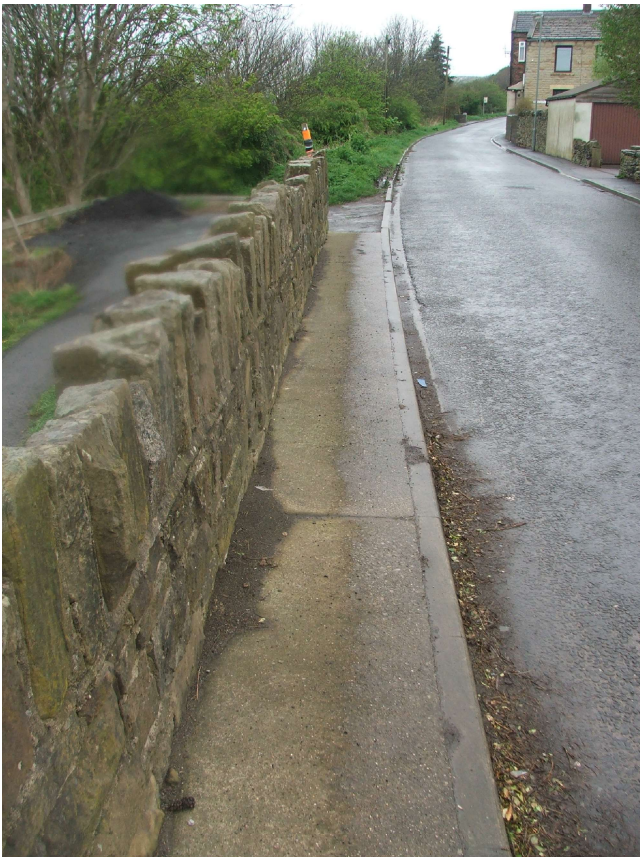
Concrete verge.

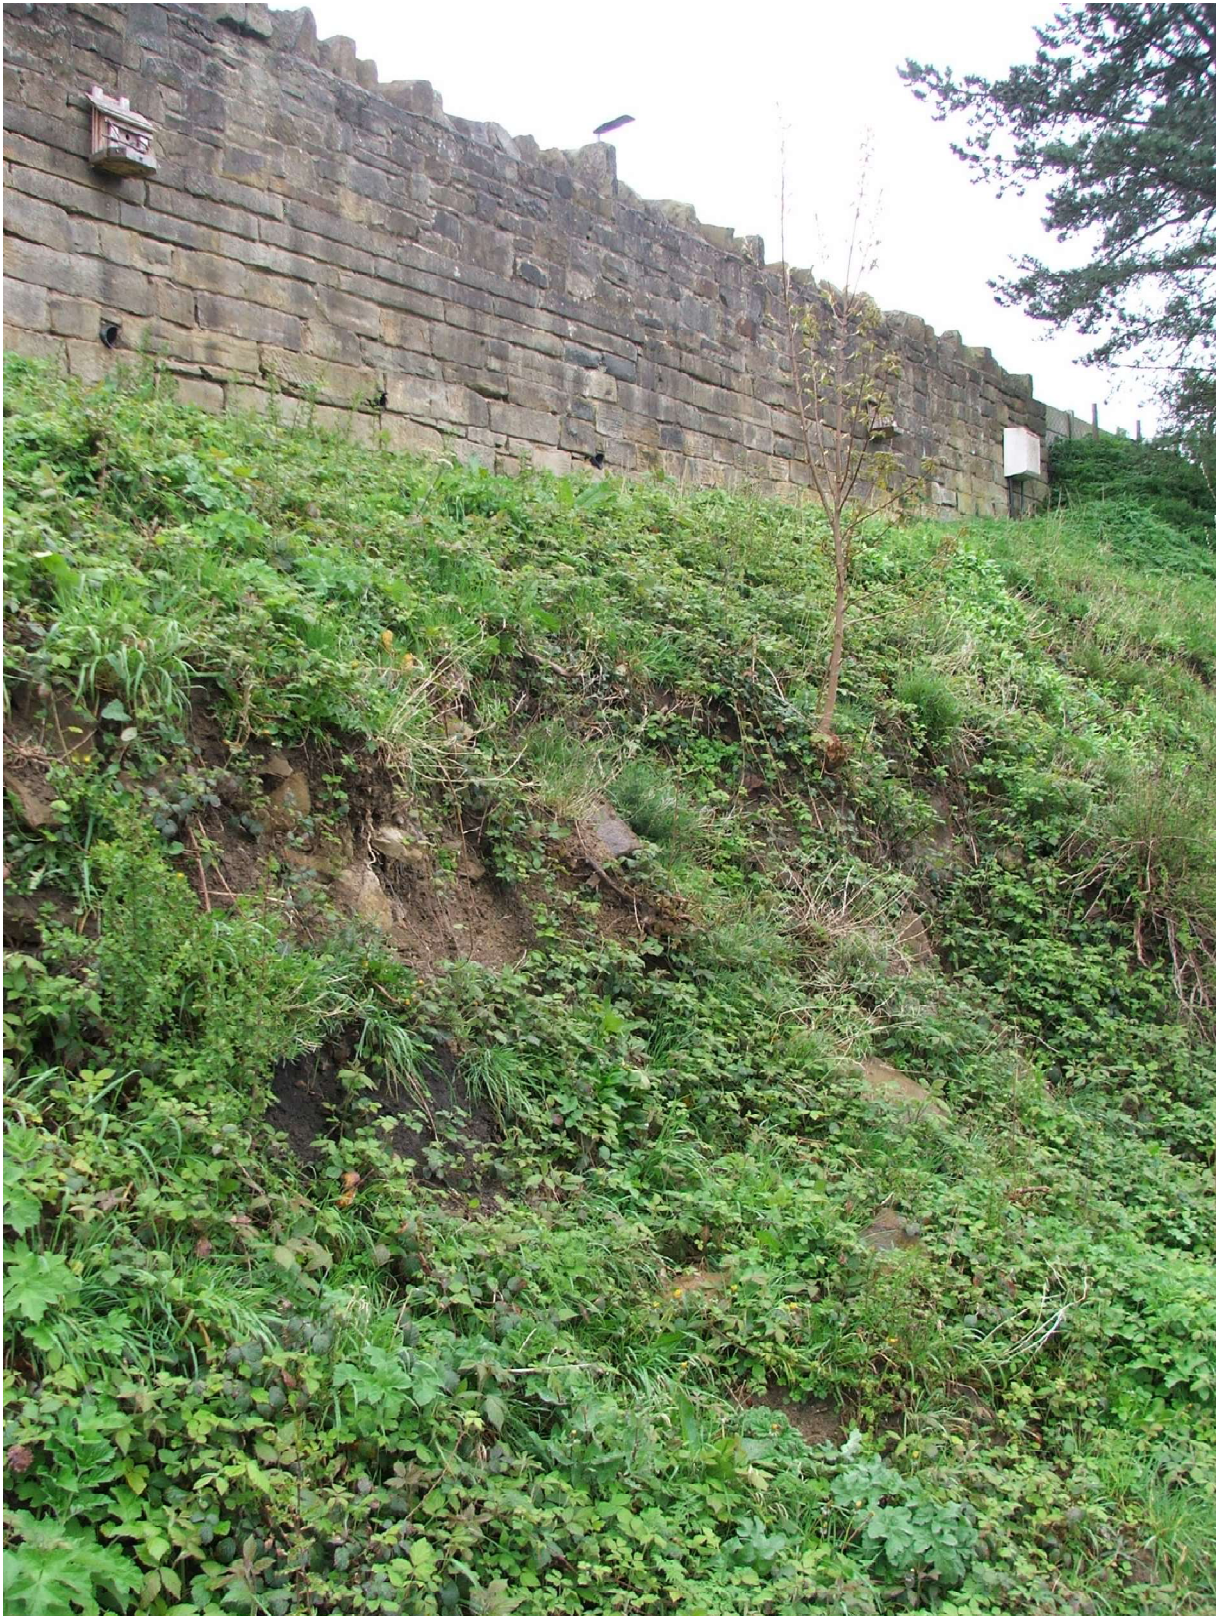
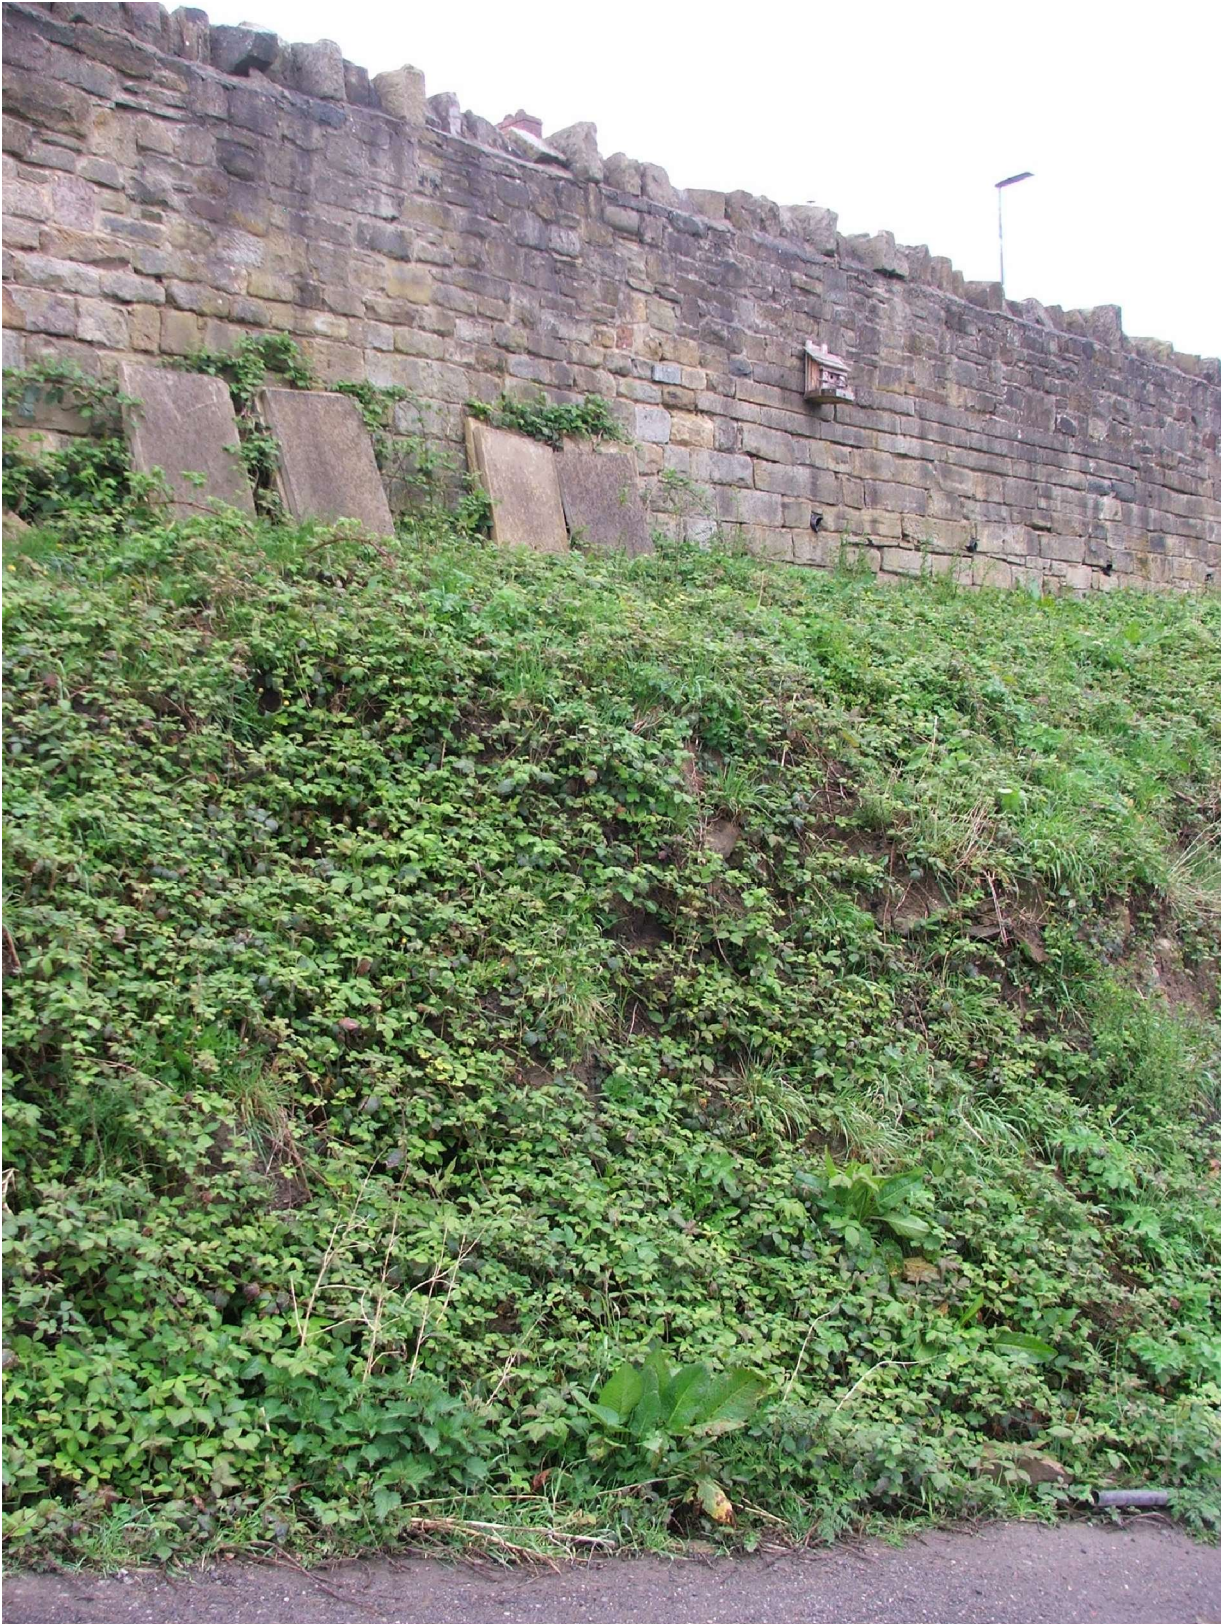
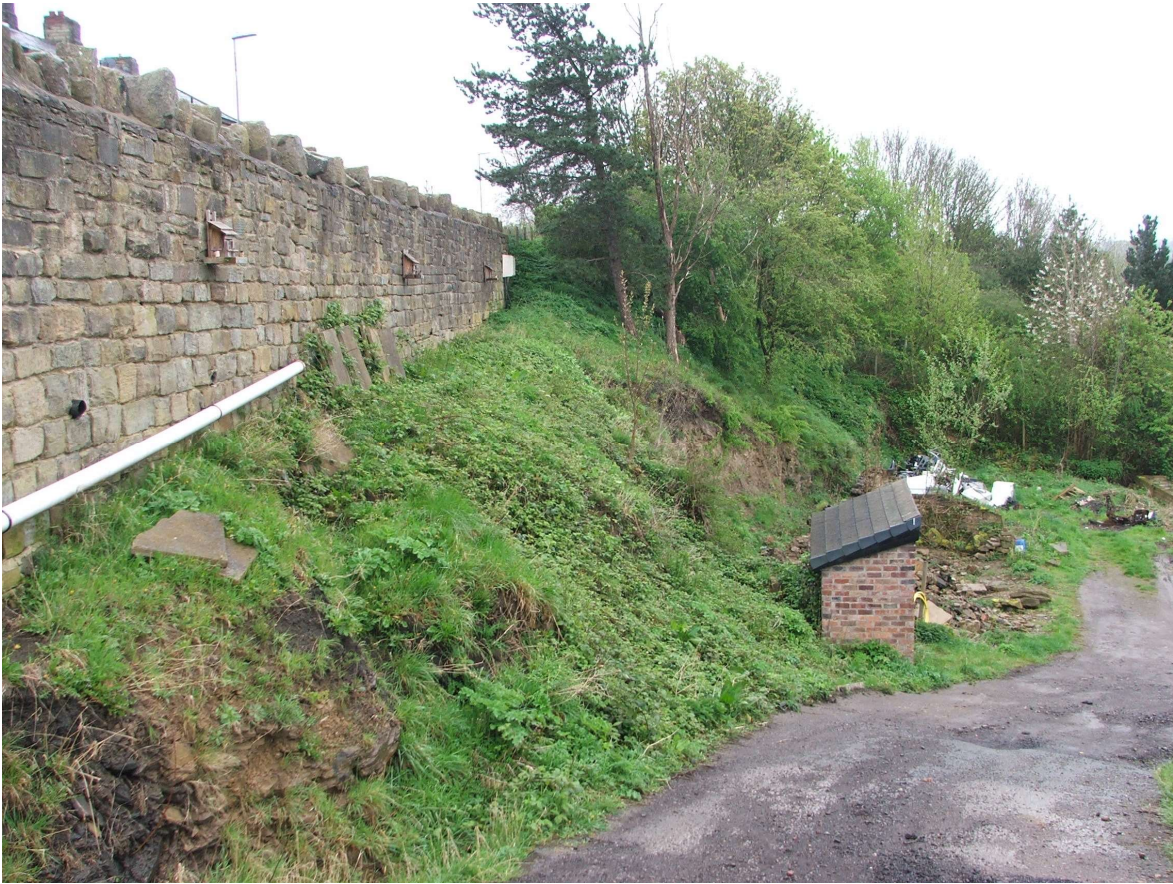
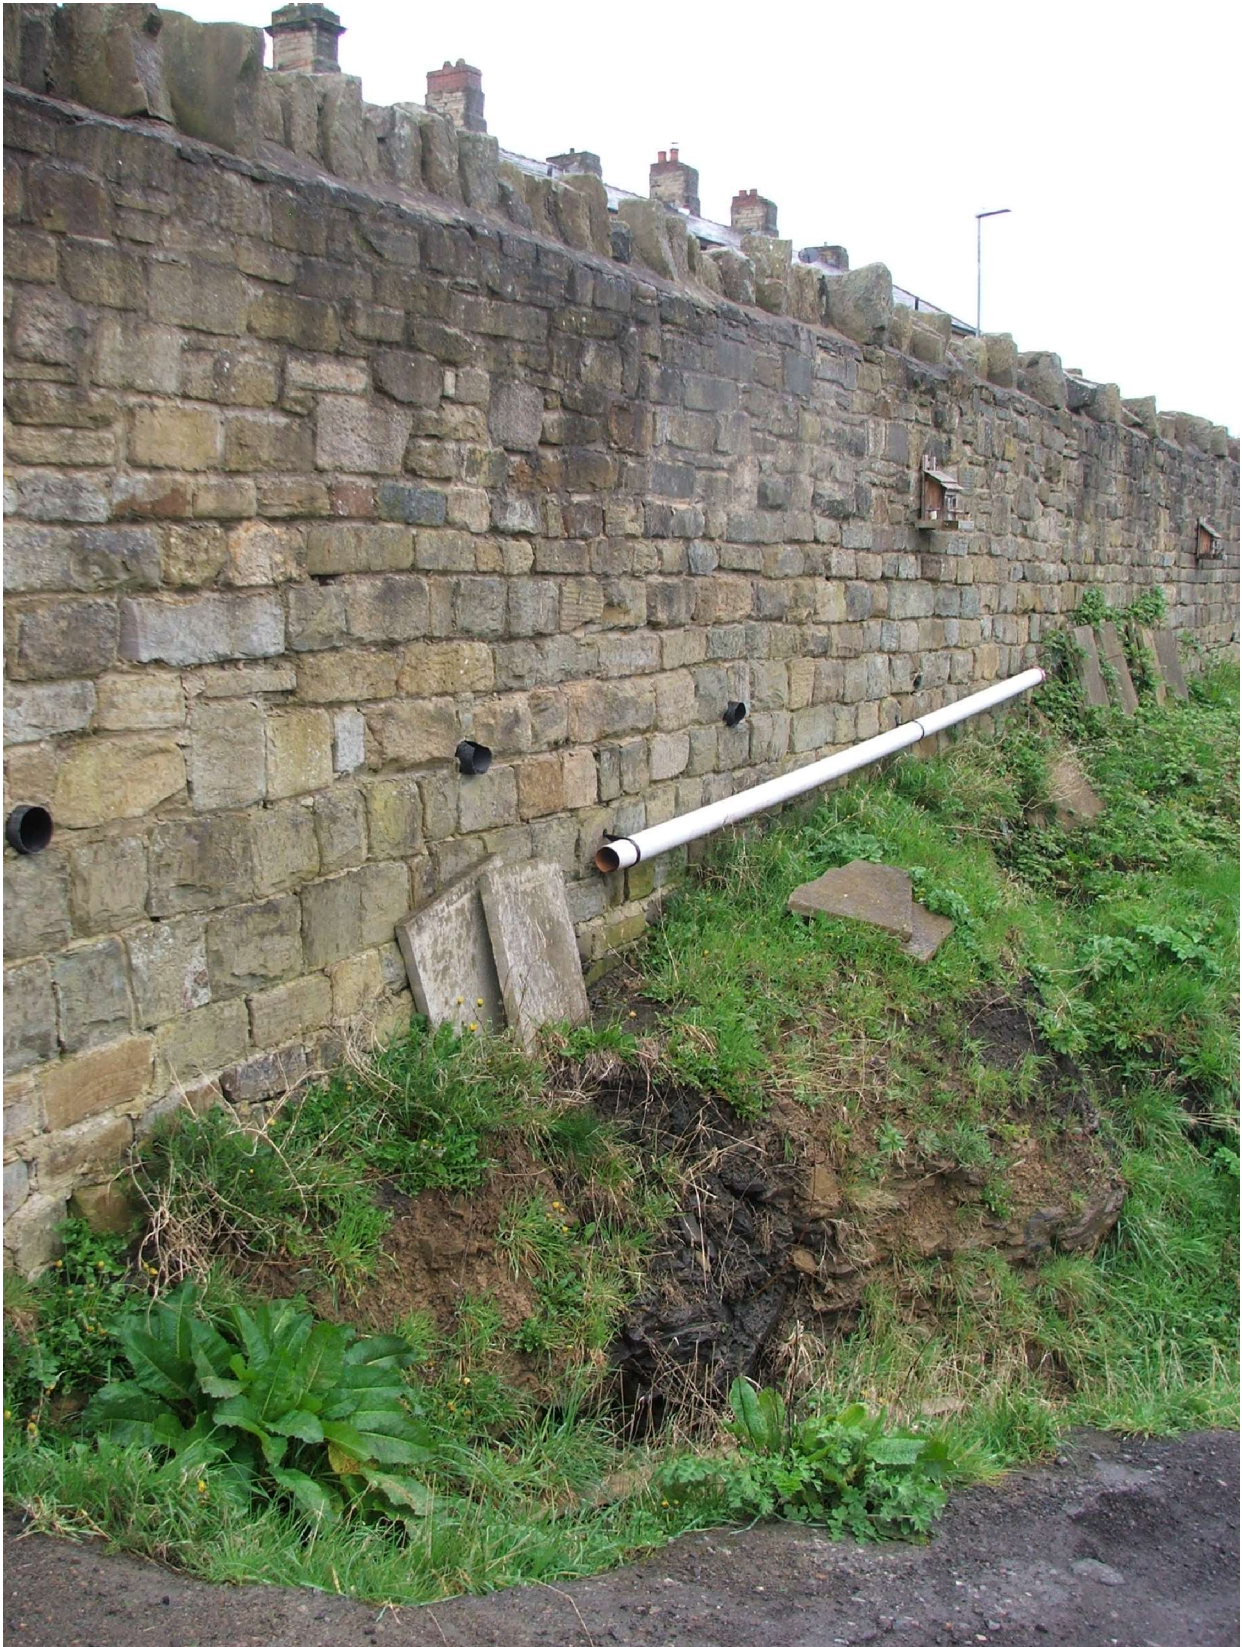
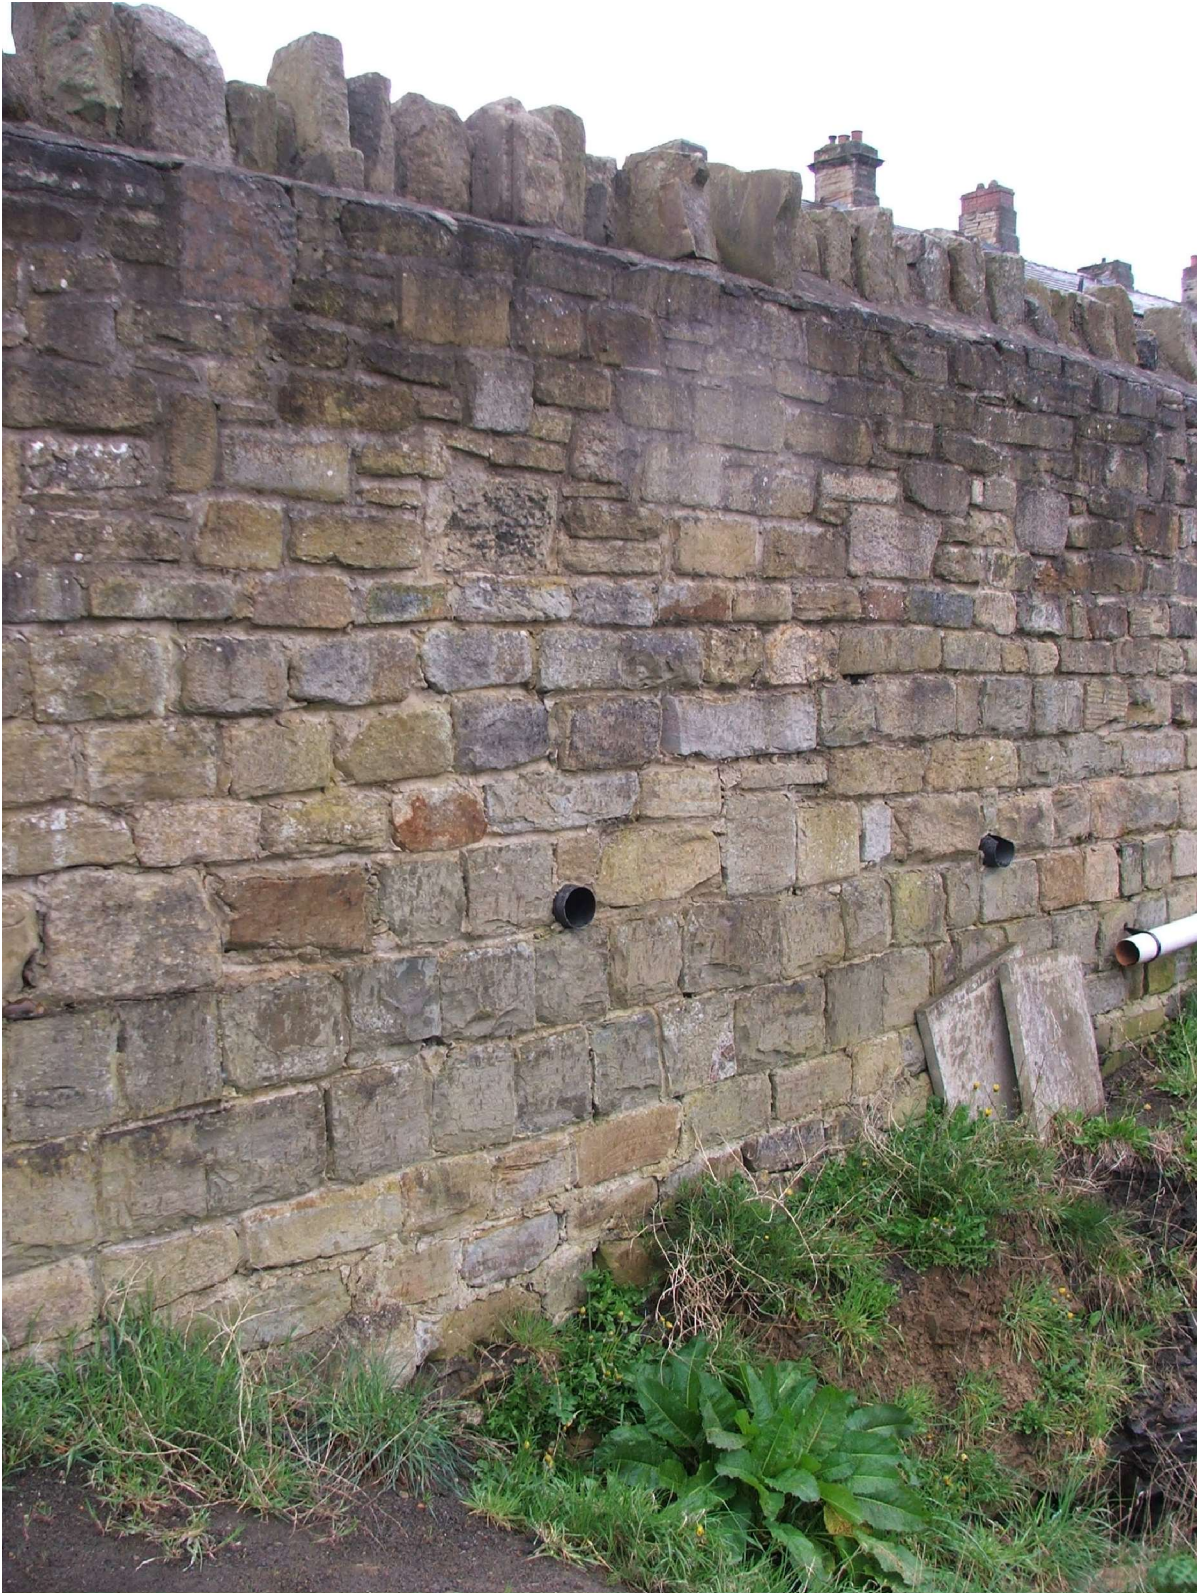
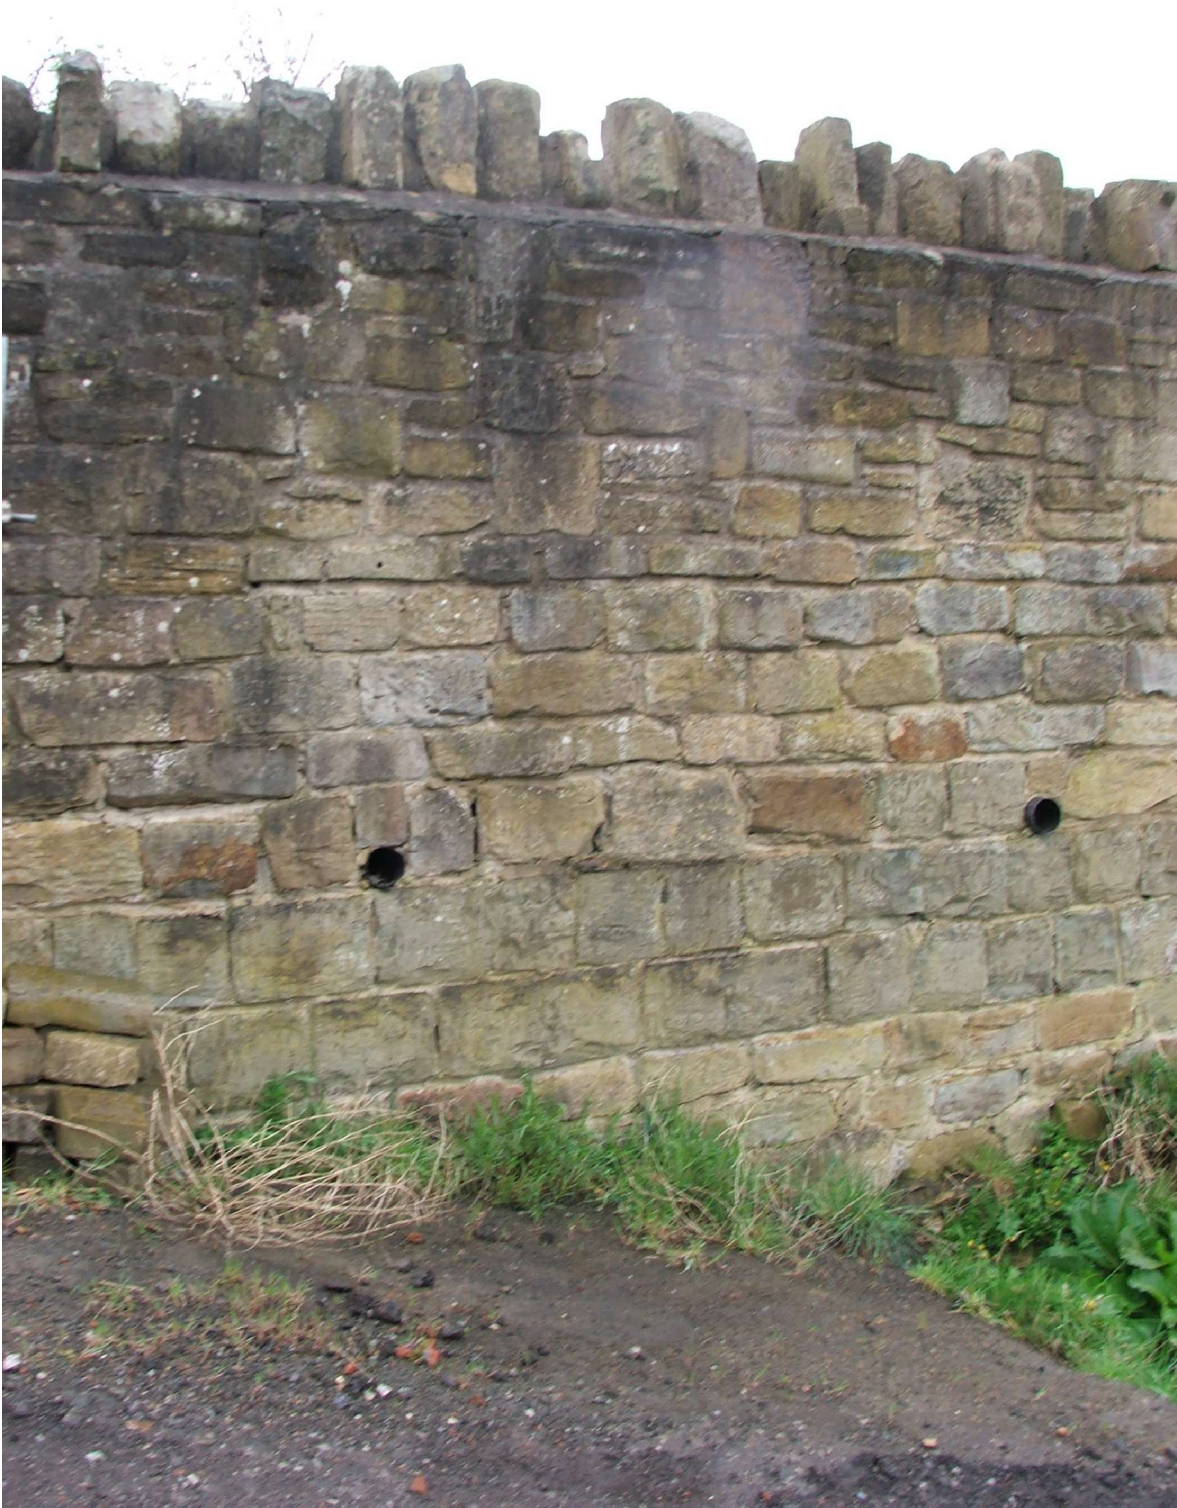
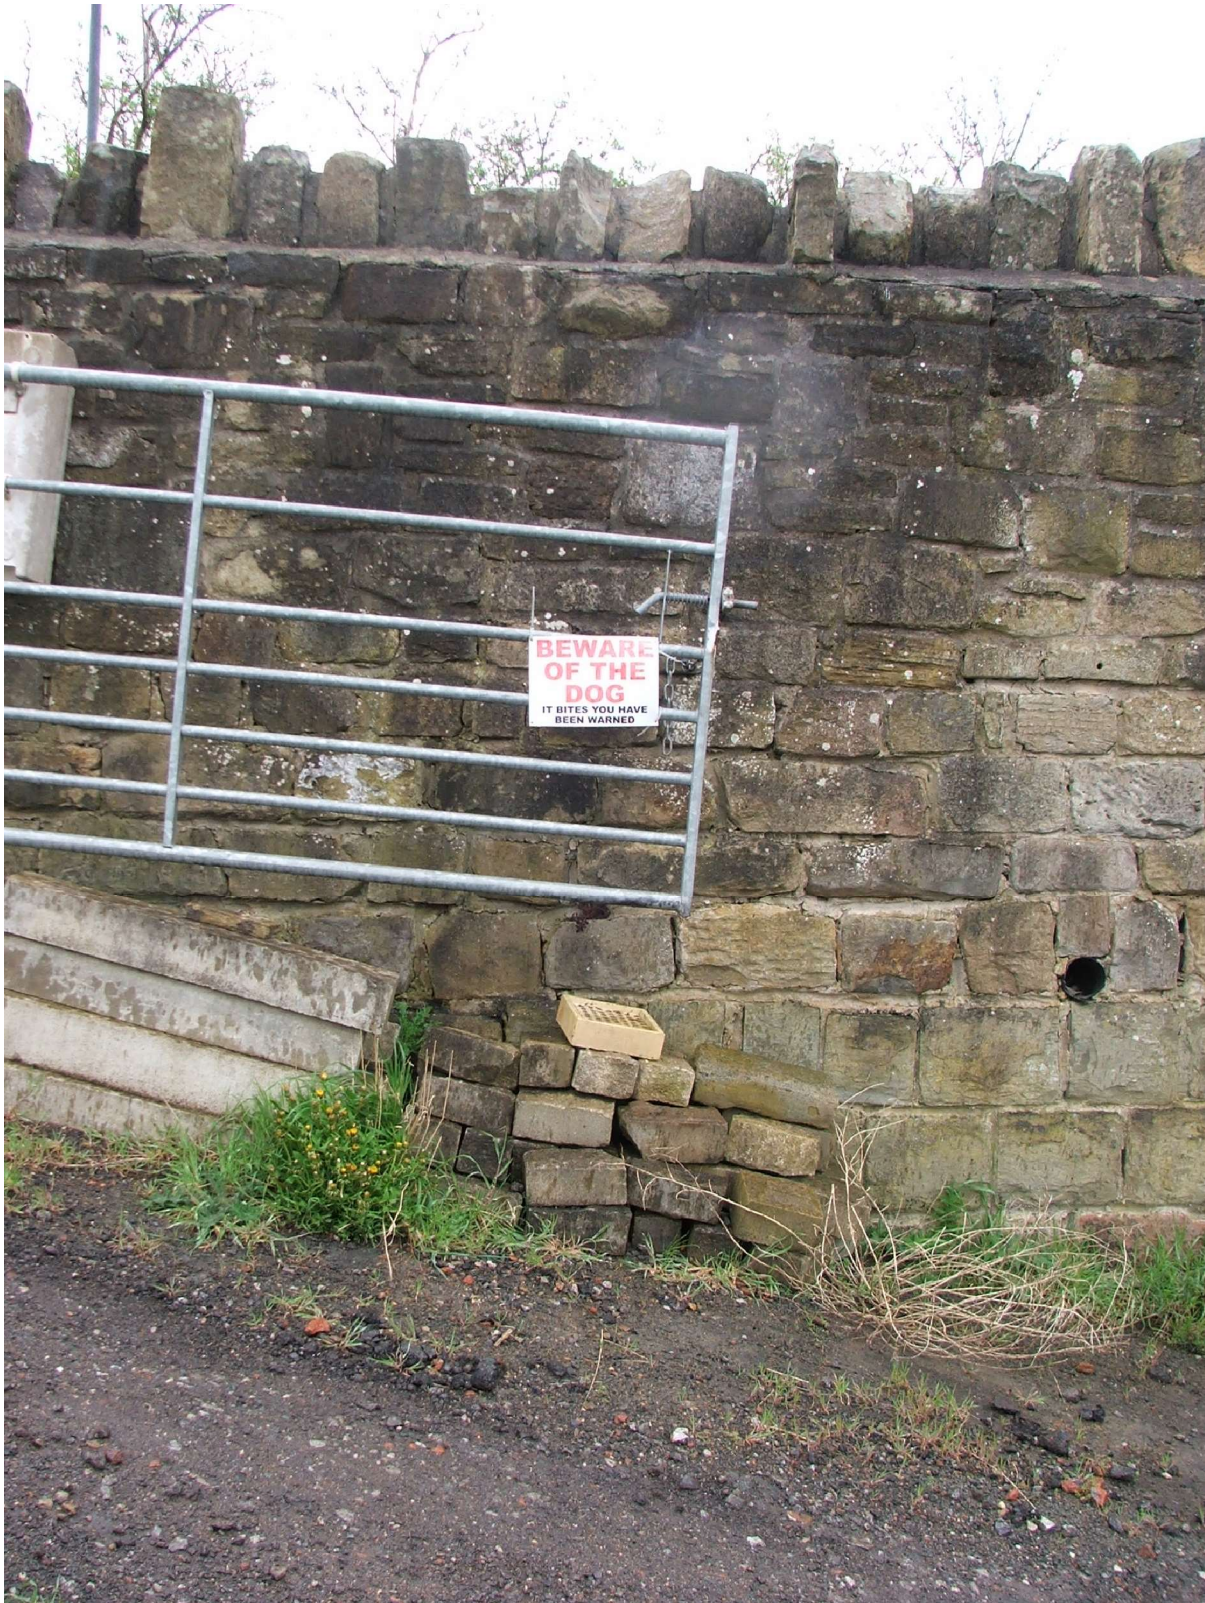
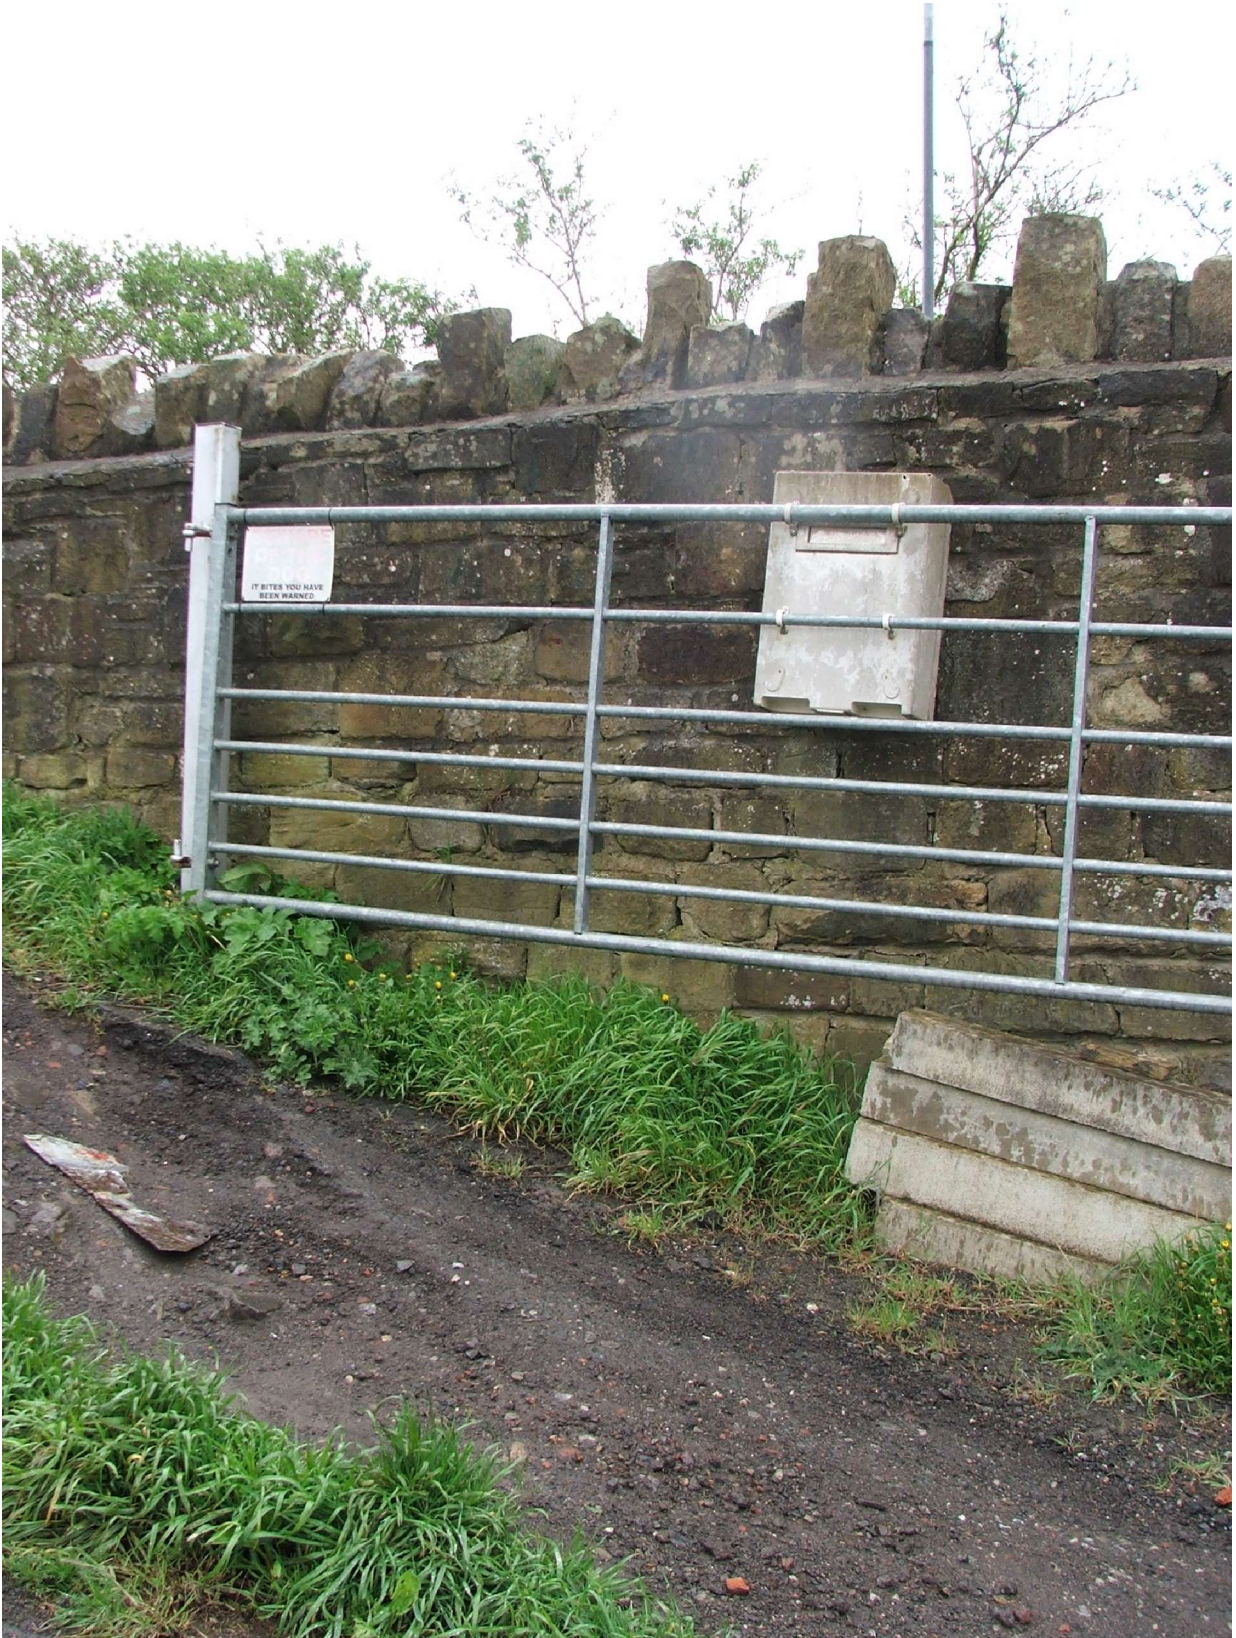
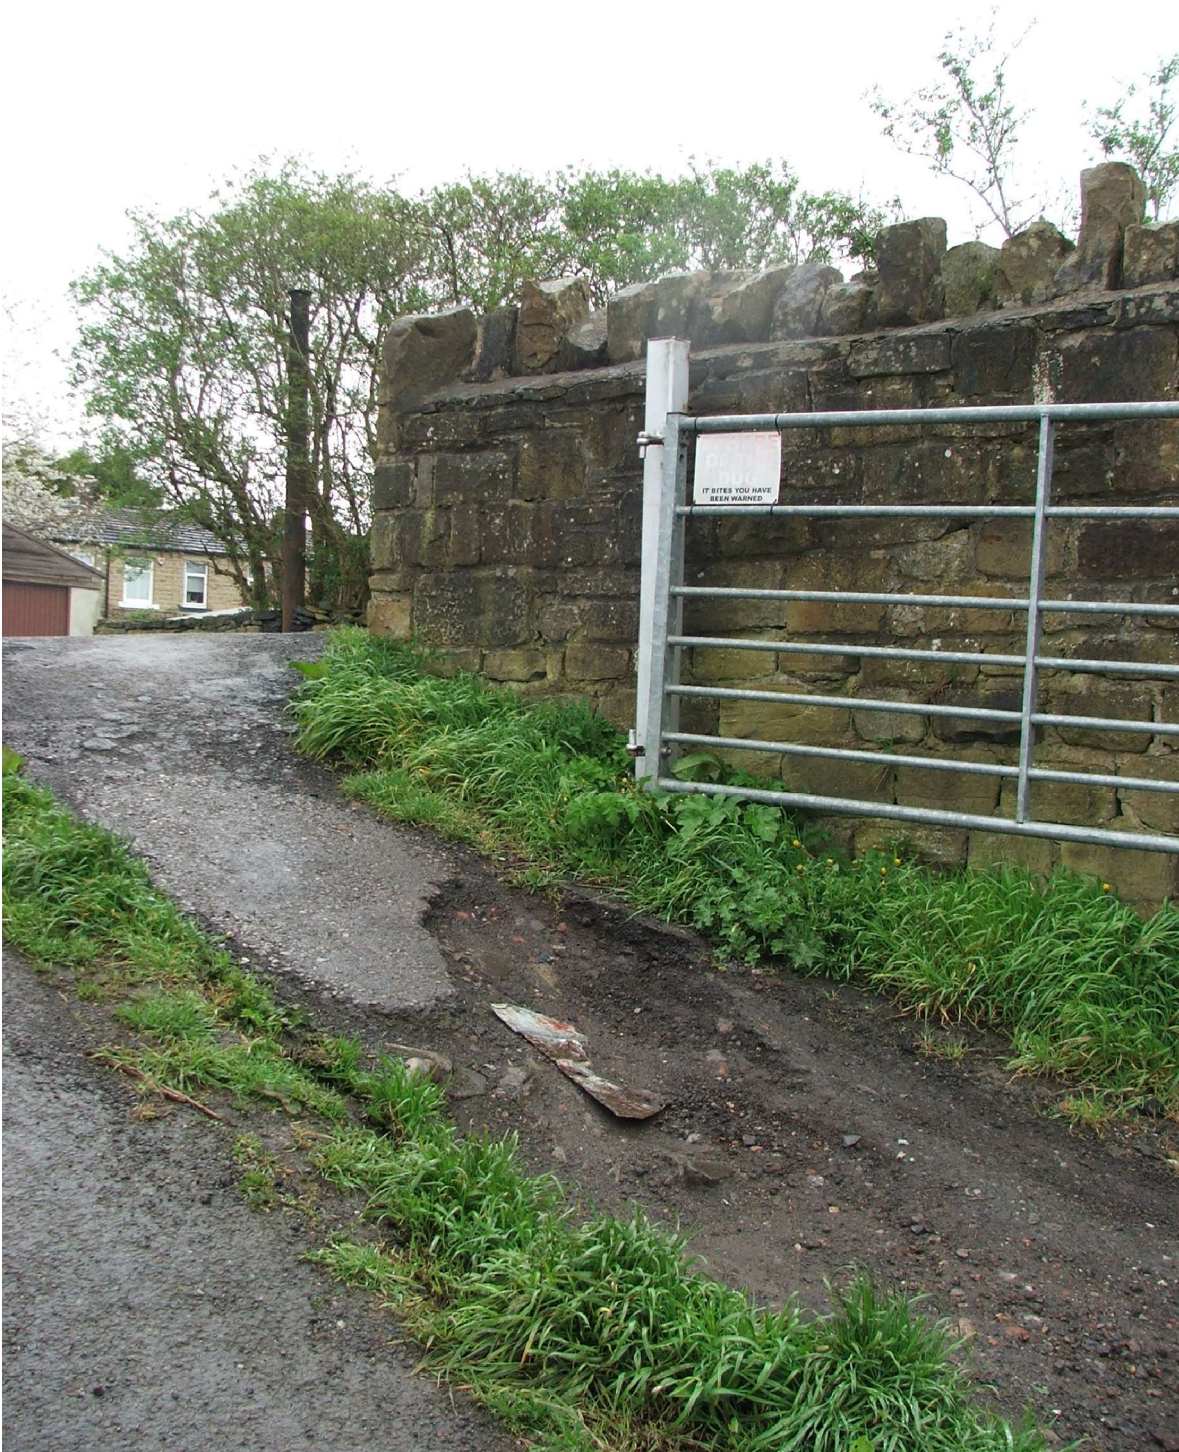
The sandstone retaining wall appears to be in good condition. Generally coursing is good and mortar jointing sound, except for some minor areas at ground level. The wall appears to be founded on the natural sandstone and shows no signs of distress.
