Engineers Site Inspection

Dilapidations Report

Existing Retaining Wall

Bell Cabin, Long Lane

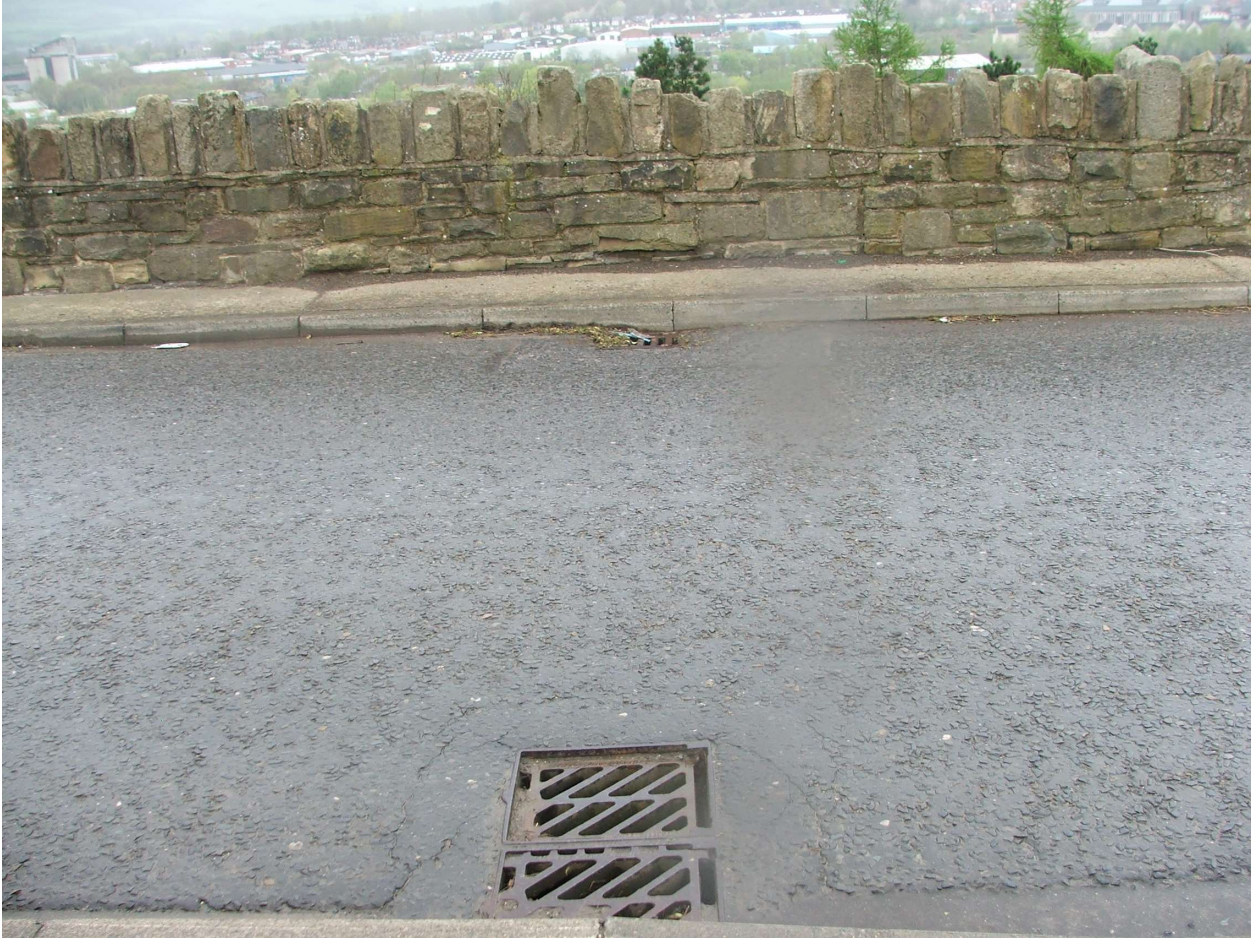
There are several drainage holes through the retaining wall. One in particular appears to be discharging surface water drainage from a gully on the highway directly on to the escarpment. It is unclear how long this discharge has been in place. However, it is likely that this may be contributing to erosion of the escarpment and ultimately to instability of the highway.

Highway drainage gullies

The existing highways surface water discharge on to the escarpment should be remedied by Kirklees Highways Department as soon as possible and prior to works commencing on the site.
