Ground Investigation Report [intrusive] and
Remediation Strategy

4a Bridge Street, Batley

Project Number	20549
Report Number	001
Revision	V01 – Draft for comment V02 – Issue for information
Date Issued	19 January 2026 (V01) 04 February 2026 (V02)

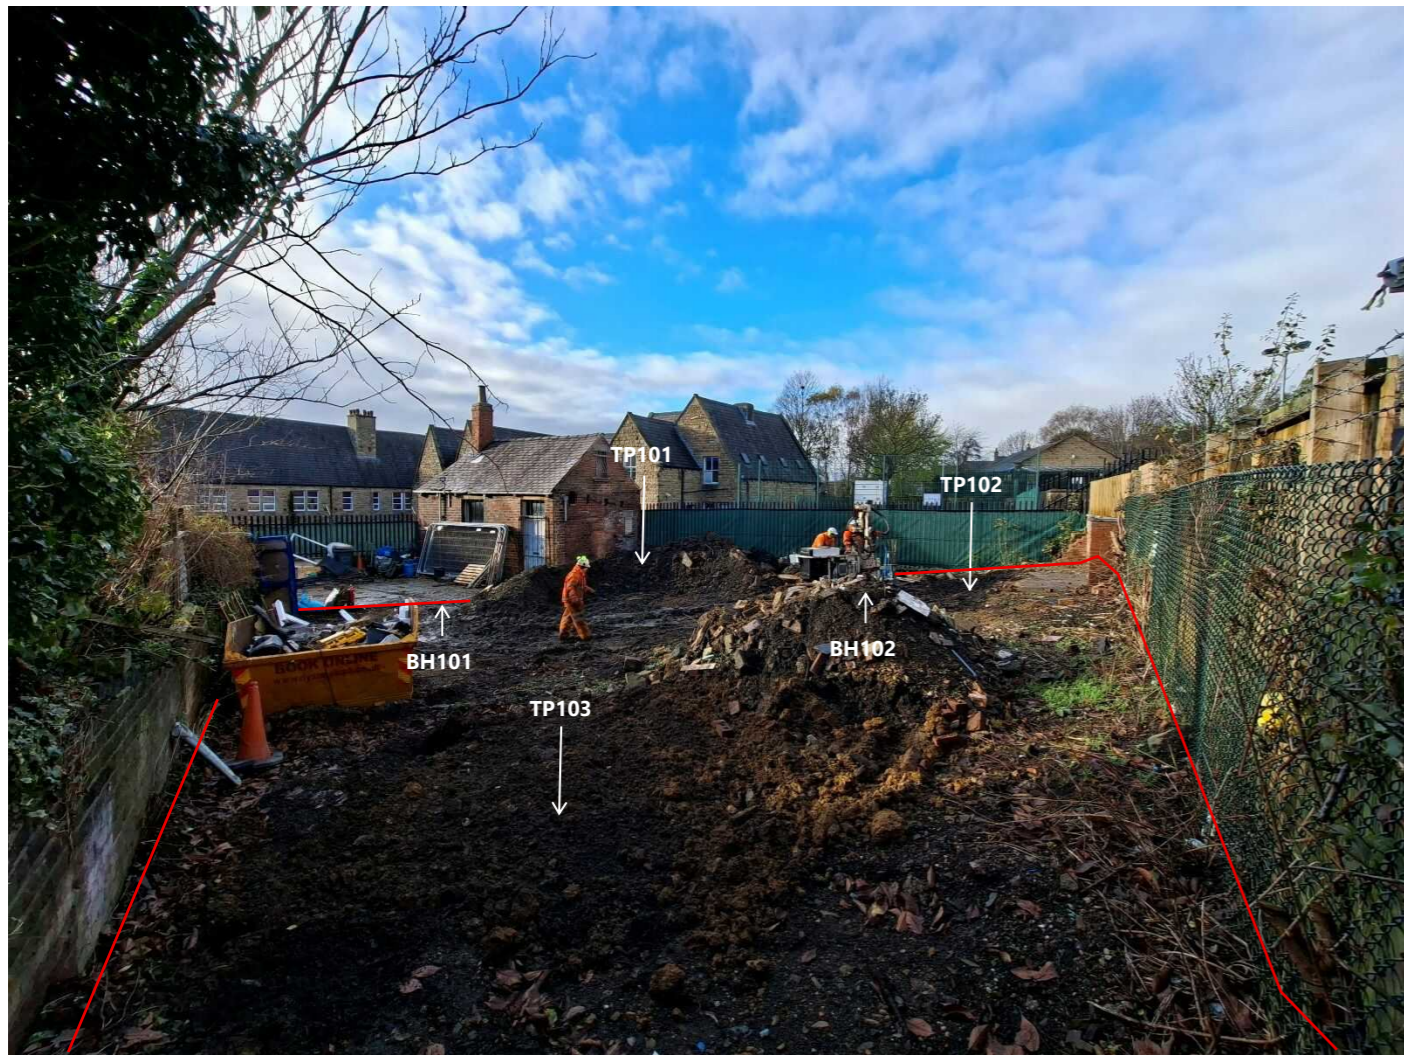
Condition: At the point of fieldworks, the Site was occupied by two mounds of demolition arisings and a partially filled skip with the demolition works largely completed with only material recovery and off-Site disposal remaining – *Photograph 1 and 2*. Immediately south-west of the Site, the existing, masonry structure of 4a remained together with an associated area of concrete hardstanding.

^^^ Photograph 1: General arrangement of the Site (looking south-west)

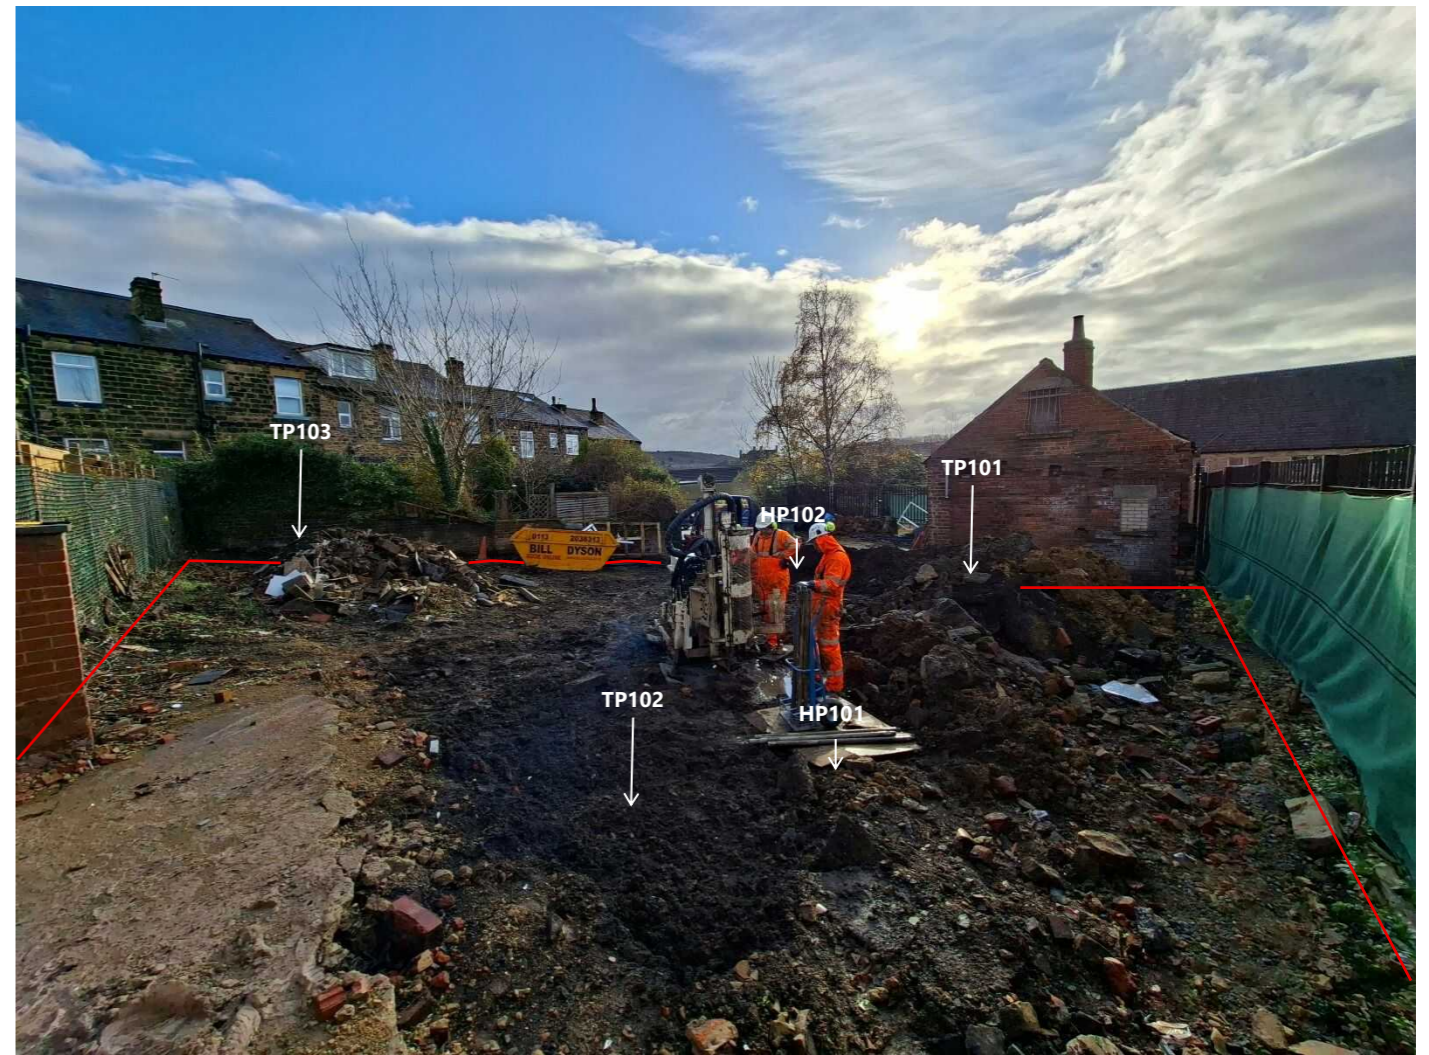
^^^ Photograph 2: General arrangement of the Site (looking south-east)

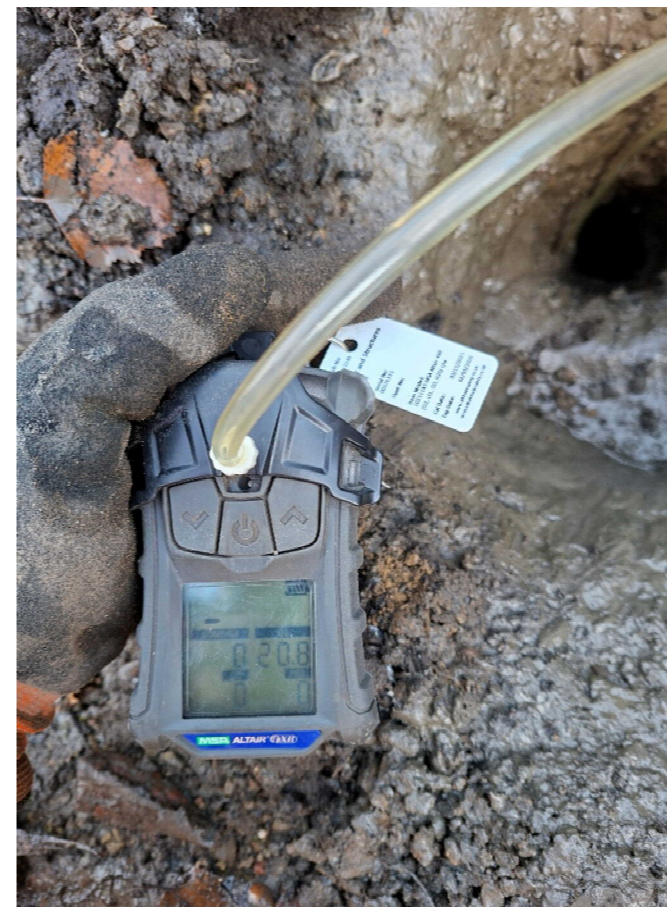
Was completed within the rotary borehole cavities during drilling and on completion with no detectable methane, carbon dioxide or hydrogen sulphide and no depleted oxygen detected – Photograph 3.

^^^ **Photograph 3:** Ground gas monitoring in R0101

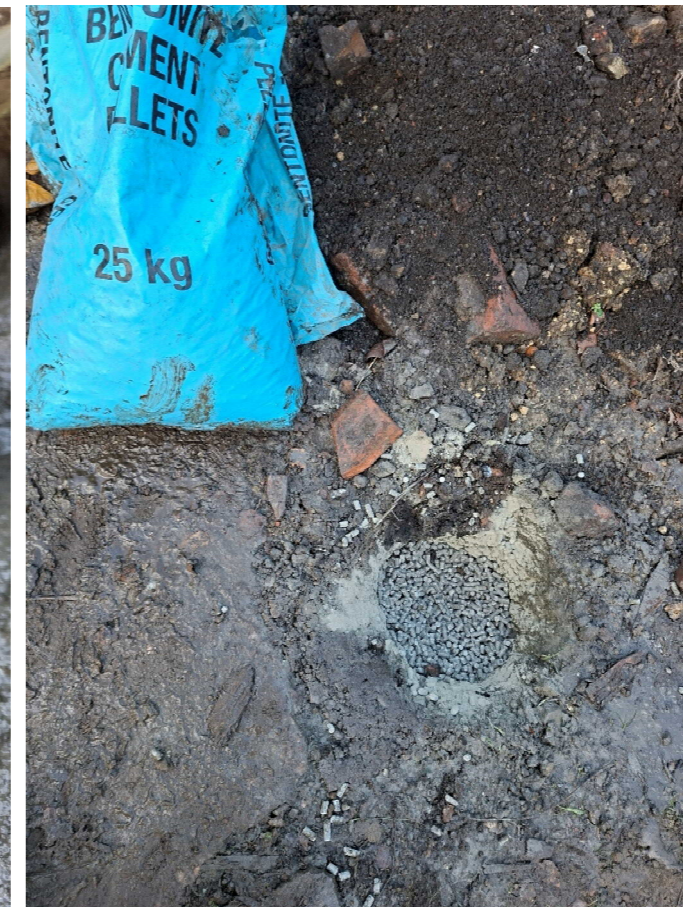
^^^ **Photograph 4:** Backfilling/sealing of R0101

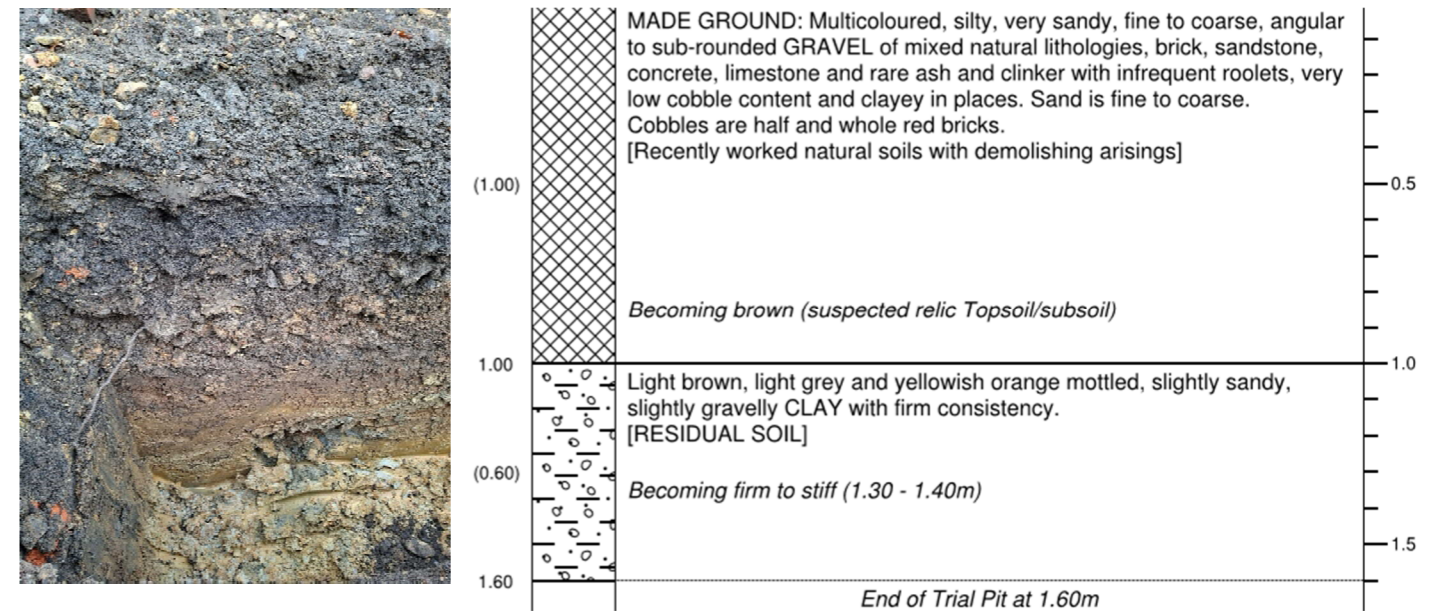
^^^ **Figure 3:** TP102 side profile alongside extract of the exploratory hole log illustrating generalised profile of the ground that, apart from varying depths, is typically of the other exploratory holes

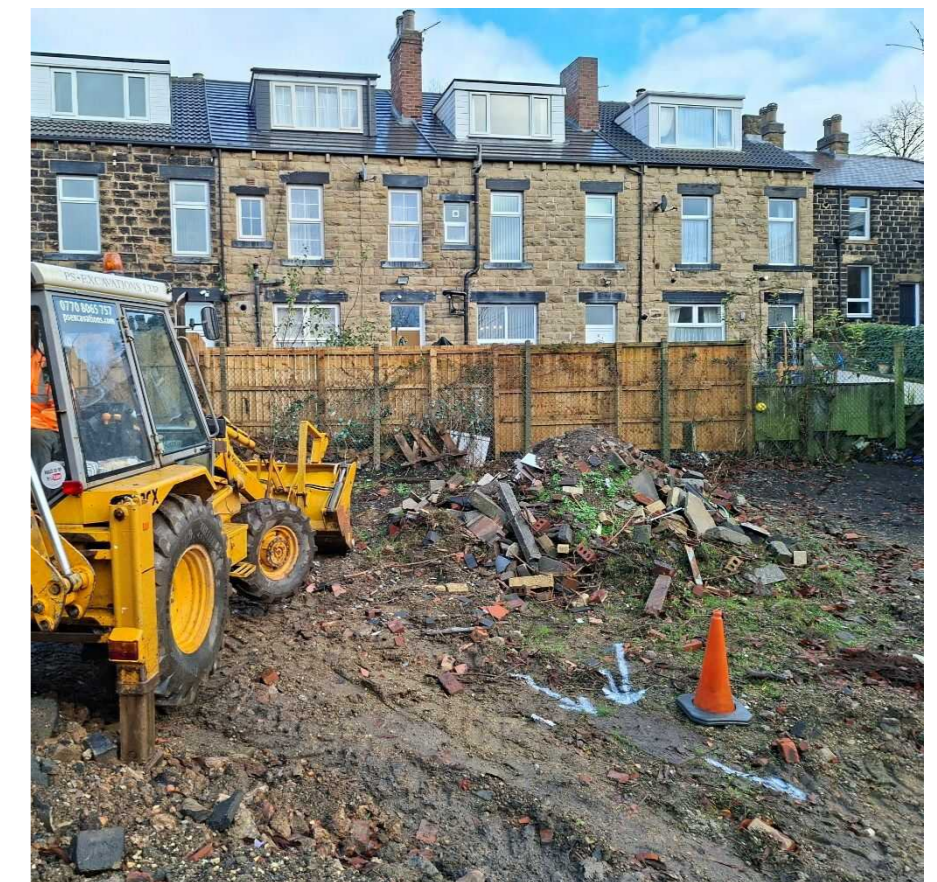
^^^ **Photograph 3:** Approximate alignment of drainage infrastructure within the central portion of the Site restricting access for investigation

The presence of 'soft spots' should be anticipated given the presence of the existing drain and, where encountered, will require excavation and replacement with a suitable, well-compacted granular fill.

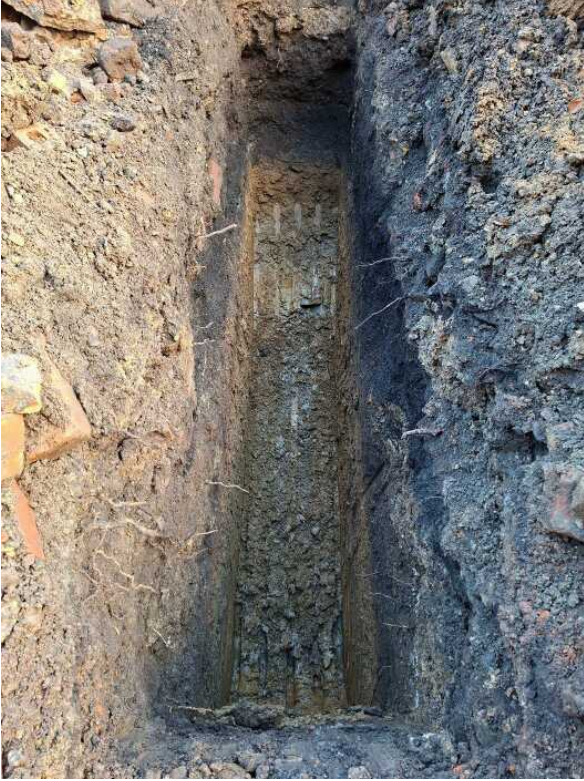
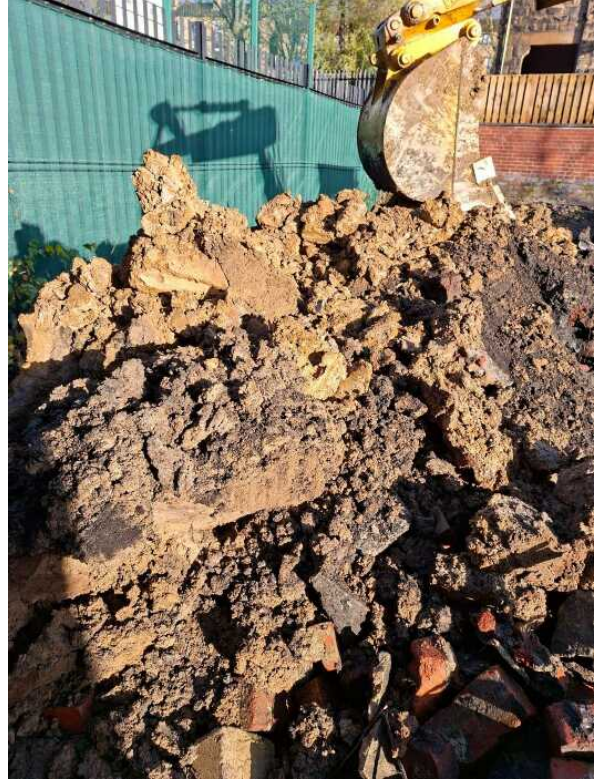
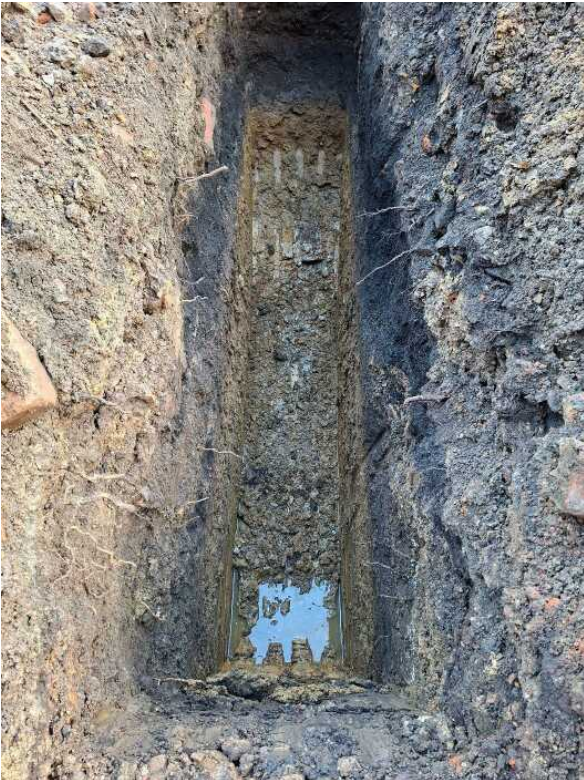
PURPOSE: Targeting western corner of the Site, former building footprint and proposed dwelling footprint. TERMINATION: Engineer's decision, stiff Till confirmed for 0.50 m. LOCATION: Opensource grid reference finder on Site with levels taken off satellite imagery. OTHER: Evidence of potentially harmful or polluting material - ash and clinker deposits across shallow depths.

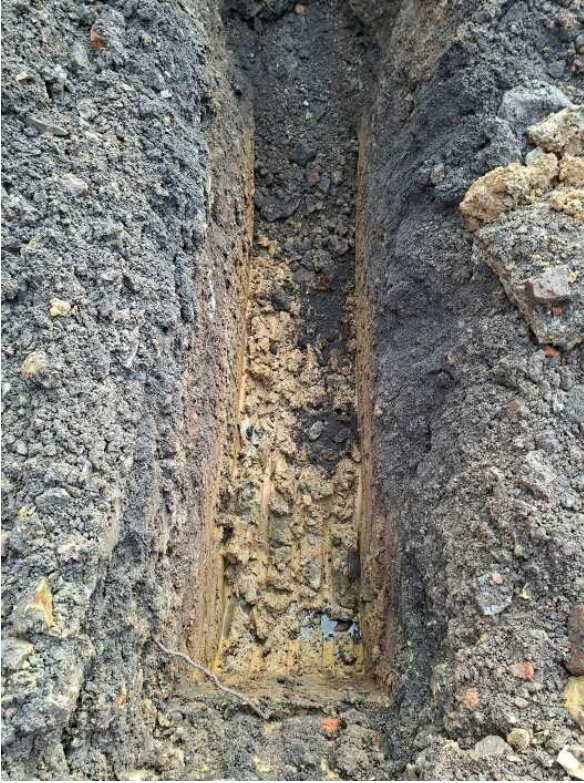
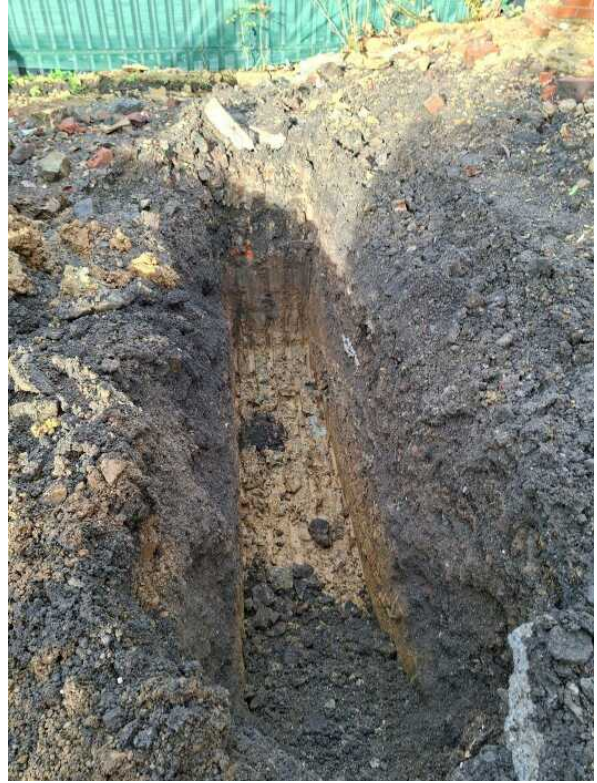
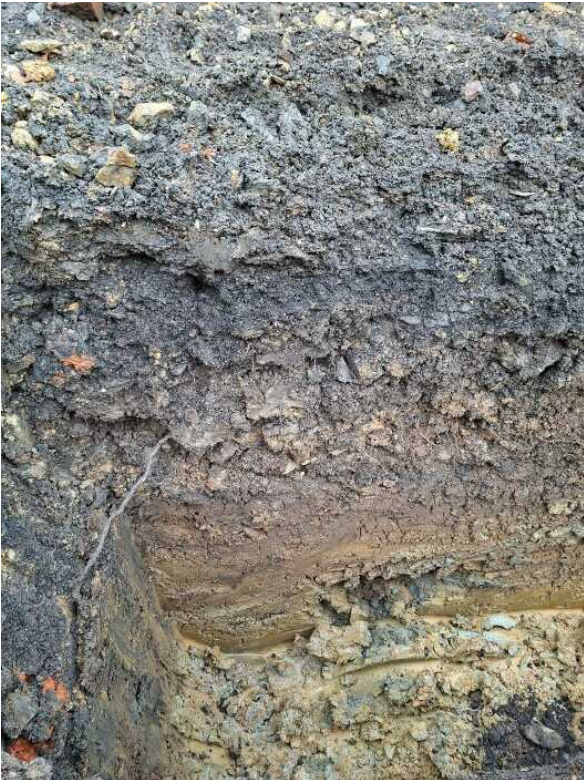
Remarks
 PURPOSE: Targeting north-western corner of the Site, former building footprint and proposed dwelling footprint.
 TERMINATION: Engineer's decision, stiff Till confirmed for 0.50 m. LOCATION: Opensource grid reference finder on Site with levels taken off satellite imagery. OTHER: No evidence of potentially harmful or polluting material.

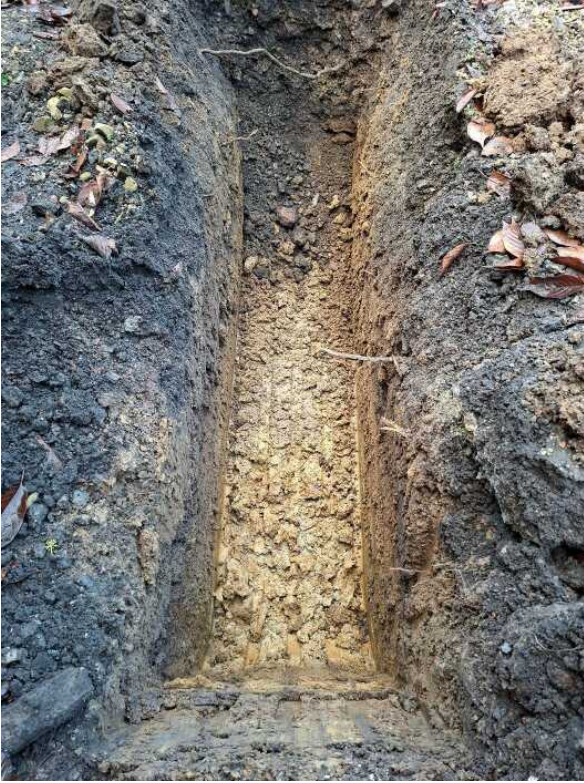
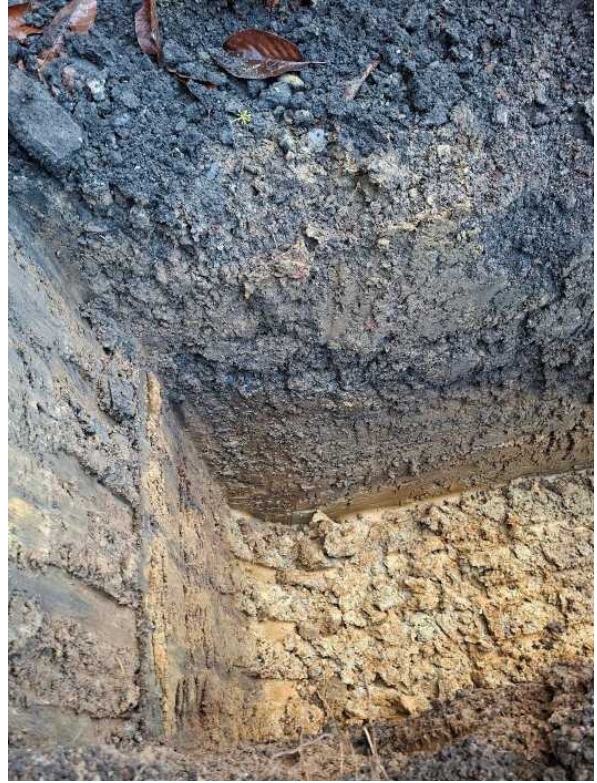
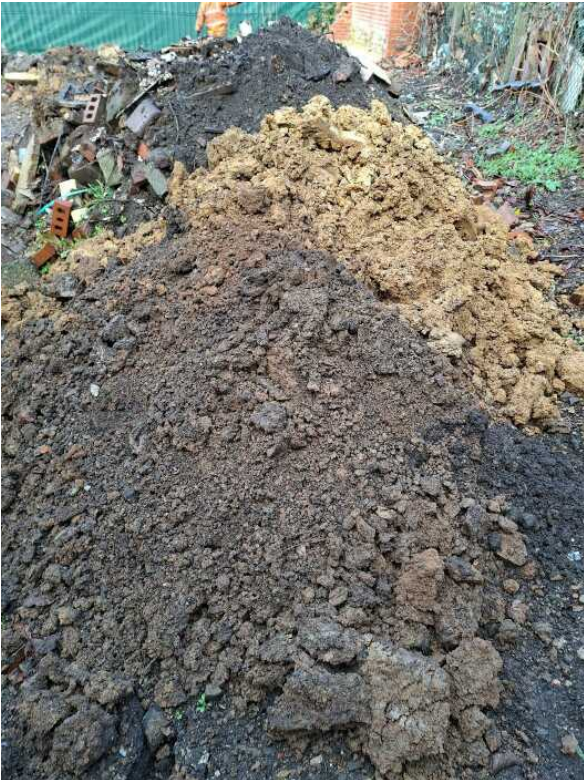
PURPOSE: Targeting eastern corner of the Site, proposed . TERMINATION: Engineer's decision, stiff Till confirmed for 0.50 m. LOCATION: Opensource grid reference finder on Site with levels taken off satellite imagery. OTHER: No evidence of potentially harmful or polluting material.
