## RICS LEVEL 3 EXECUTIVE SUMMARY BUILDING SURVEY

45 Fenay Bridge Road  
Fenay Bridge  
Huddersfield  
HD8 0AY

**Date of inspection:** 14<sup>th</sup> January 2025

**Reference:** 25-1997/JD/ER

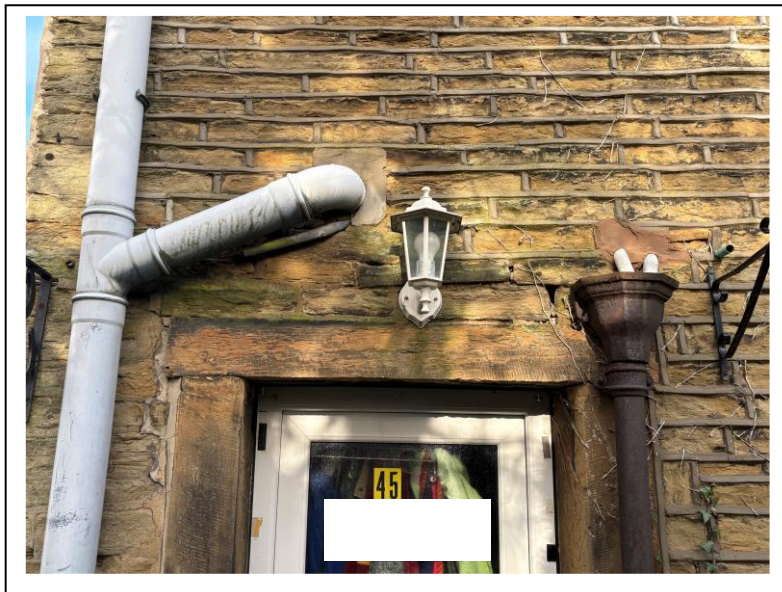
Plate 3

There are areas of vertical cracking between the subject and the neighbouring property. We also note vertical cracking adjacent to the neighbouring uPVC downpipe. We believe that this is ongoing and as a result of the guttering and roof upstand, as the cracks have appeared since the elevation has been repointed. We recommend that the roof and guttering works are addressed, and the cracking is monitored by way of calliper and studs over a period of 12 months to identify the extent of the movement, however in the first instance, we recommend raking out and repointing the area in a soft lime-based mortar.

Cracking between the two properties and vertical cracking adjacent to rainwater downpipe.

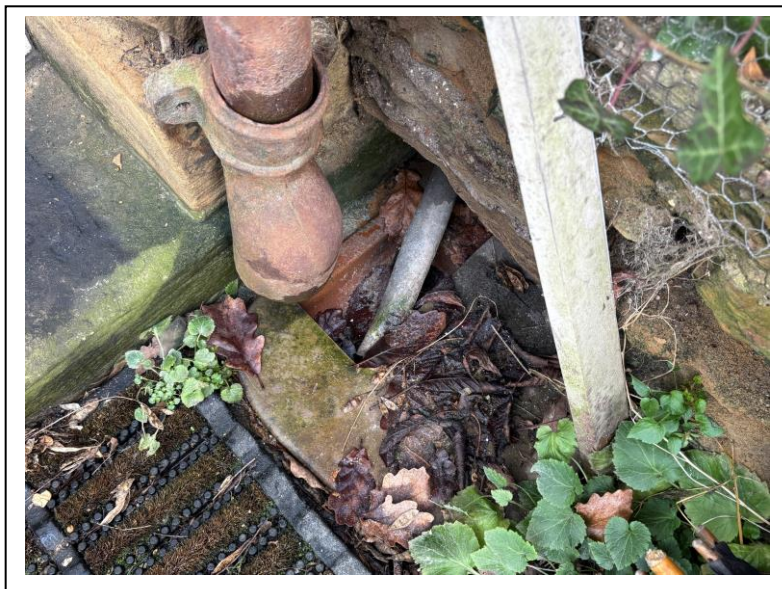
Plate 4

Waste pipes from bathroom draining into rusted cast iron downpipe.

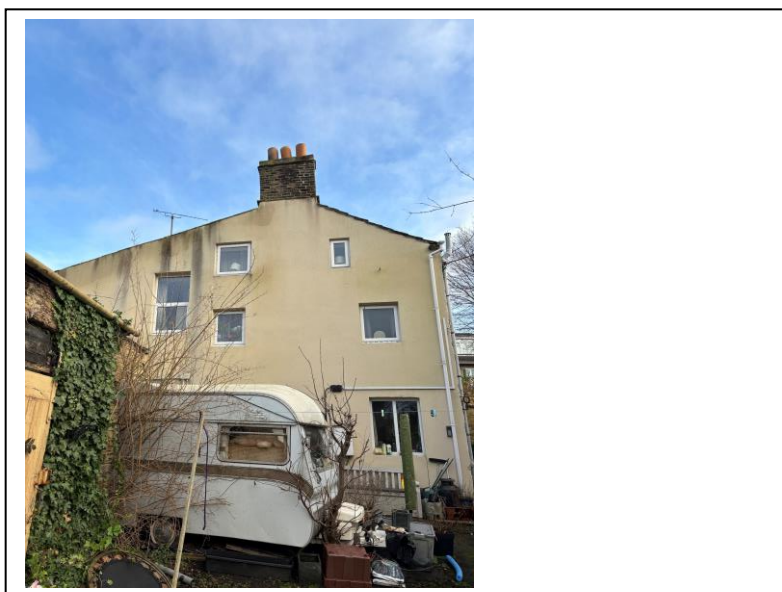
Plate 5

There is a lack of surface water drainage to the perimeter of the property, with one heavily choked gulley adjacent to the front door which appears to drain wastewater from the bathroom and kitchen. This downpipe does not disperse water directly into the gulley, which is potentially is causing subsidence as the incorrect diversion of water can undermine foundations, affecting the structural stability.

There is a gulley adjacent to the entrance door on the front elevation, this collects drainage from the bathroom sink, bath and kitchen sink. We recommend that a drainage survey is undertaken to establish whether this links into a combined system or into the surface water system, which is against current statutory regulations. The cast iron downpipe has started to rust, with the painted finish delaminating. We recommend that this is redecorated and the downpipe re-positioned so that waste water does not disperse outside of the gulley, as currently indicated by the high levels of moss growth to the surrounding tarmac surfacing. This may also be causing minor subsidence, by evidence of the cracked mortar joint around the door, as the incorrect diversion of water can undermine foundations, affecting the structural stability. In the first instance we recommend that the downpipe be refitted to ensure water is correctly diverted into the gulley and that moss growth to the stonework at low level and the tarmac be cleaned down and treated with herbicide. The gulley is also heavily choked with leaves. We recommend that this is cleaned out and left running free. We also recommend that this area is monitored for the next 12 months for signs of movement.

Heavily choked gulley. Downpipe dispersing water not directly into gulley.

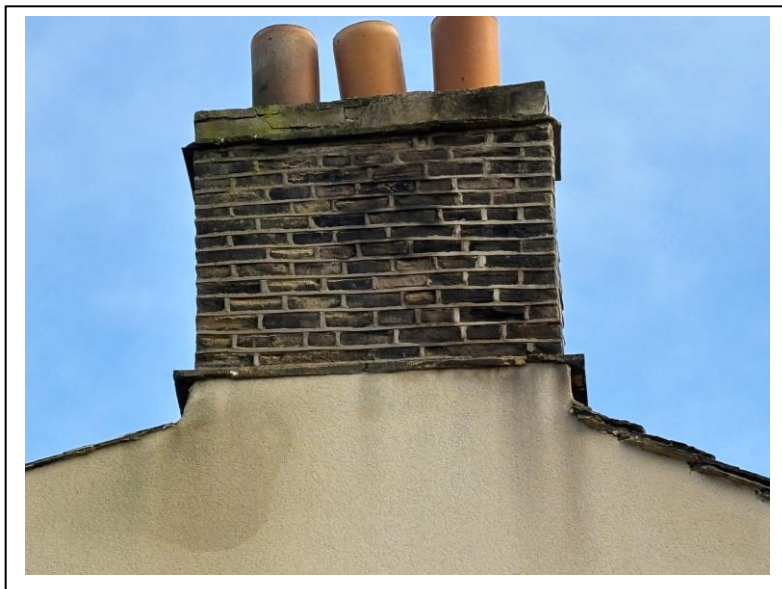
Plate 7

There are areas of water staining at high level to this elevation. We believe that this is due to the lack of overhang by the verge roof tiles. We recommend that the roof tiles be repositioned to provide a minimum overhang of 50mm and the verge repointed to prevent any water ingress.

Due to the internal cracking and the direction of it (identified in the internal section), we believe that the left elevation lacks restraint which has subsequently caused structural movement of the elevation. We recommend that tie restraints are installed to help the stability of the elevation.

Water staining at high level to left elevation. Wall restraints to pull the structure into shape. Cracking at high level at the top of the stairs at second floor.

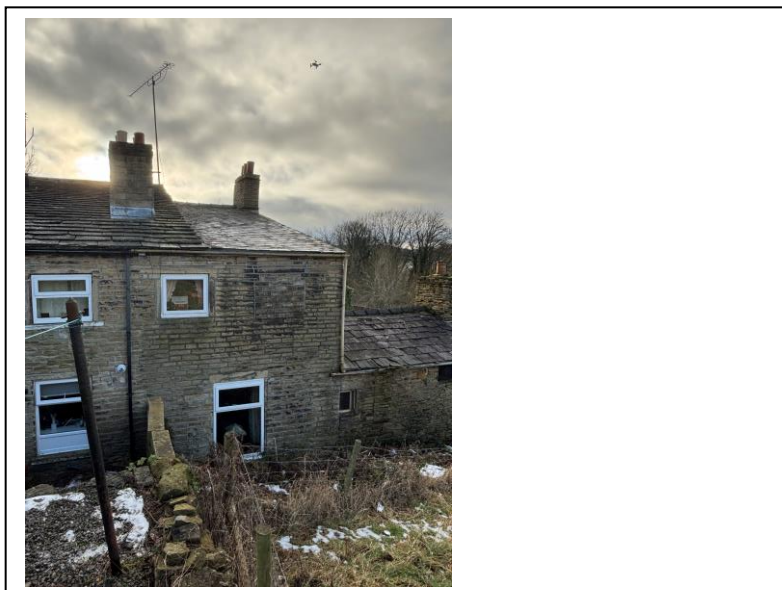
Plate 8

We note that the left chimney stack leans outwards. We do not believe this should be a cause for concern as generally they tend lean towards to sun. There are cracks to the flaunching to the chimney which we recommend are repaired in order to prevent water ingress. This chimney stack appears to have been repointed recently and is to be repointed in a lime-based mortar as previously described.

Left elevation chimney stack with areas of water staining and cracked flaunching.

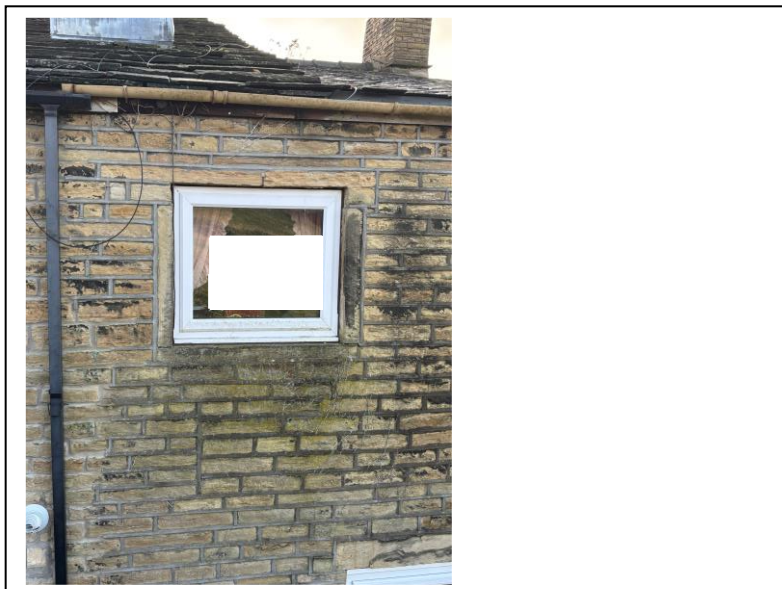
Plate 10

The external ground level is significantly higher than the internal ground level within the property. This could cause damp related problems as properties of this age do not benefit from a damp proof membrane.

Lounge rear window in comparison to external floor level.

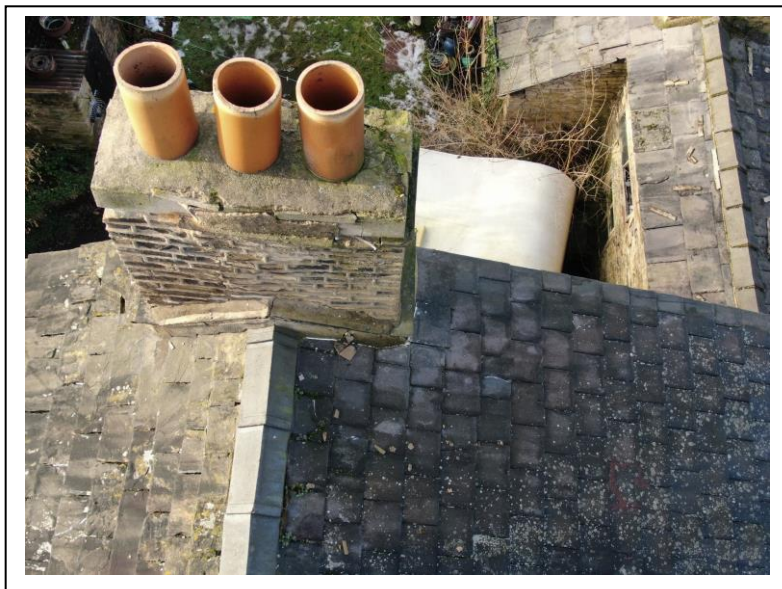
Plate 13

To roof 1, there are a number of cracked, missing and slipped tiles which we recommend are replaced and repositioned to prevent any water ingress to the property. To the front pitch, one tile has broken into two pieces and is being held in place by the guttering. From a health and safety perspective, we recommend that this tile is immediately replaced to mitigate the risk of harm or injury should it fall. There is moss growth to the roof throughout which we recommend is cleaned down with herbicide to prevent the potential risk of water ingress.

Generally, the uPVC gutters to the property appear to contain a build-up of dirt and debris and we recommend that they are cleared and left running free.

The roof tiles to the front pitch of roof 1 appear to overhang the gutters too much, which causes the water to run off directly onto the stone soffit beneath. Overtime, this has weathered the pointing to the joints between the stone soffit and caused water staining to the front elevation. We recommend that the gutters and front row of tiles are repositioned to allow for correct dispersing of rainwater and that the joints between the stone soffit are repointed to prevent further water staining to the elevation.

Front roof pitch showing build-up of dirt and debris in guttering and broken roof tile.

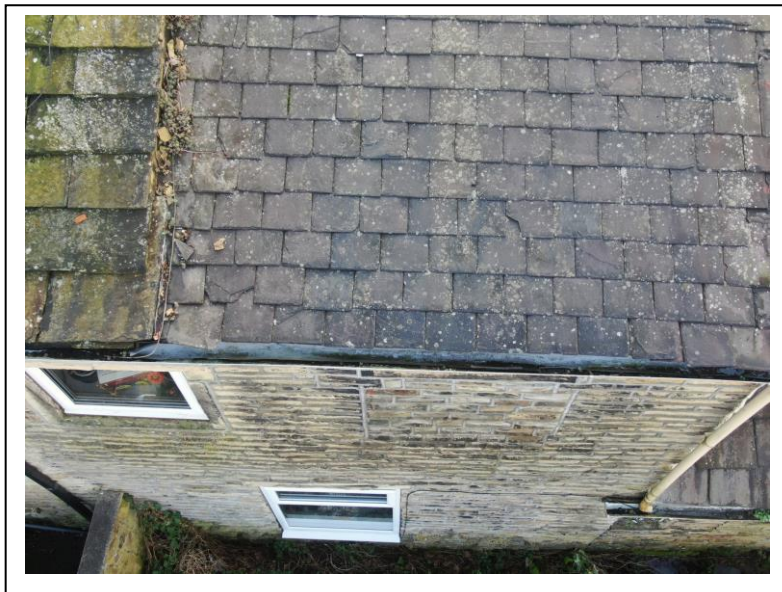
Plate 15

Between the two roofs there is a rendered upstand, with no lead flashing. There is also a build-up of debris and vegetation. We recommend that these are removed and cleaned down and a lead flashing installed in order to prevent water ingress into the property and allow water to correctly disperse away from the property toward the rear gutter. The verge pointing to the roof 2 has also cracked. We recommend that this is repointed to prevent further water ingress.

Rear pitch showing difference in roof levels. Build up of vegetation and debris to joint between the two rear pitches.

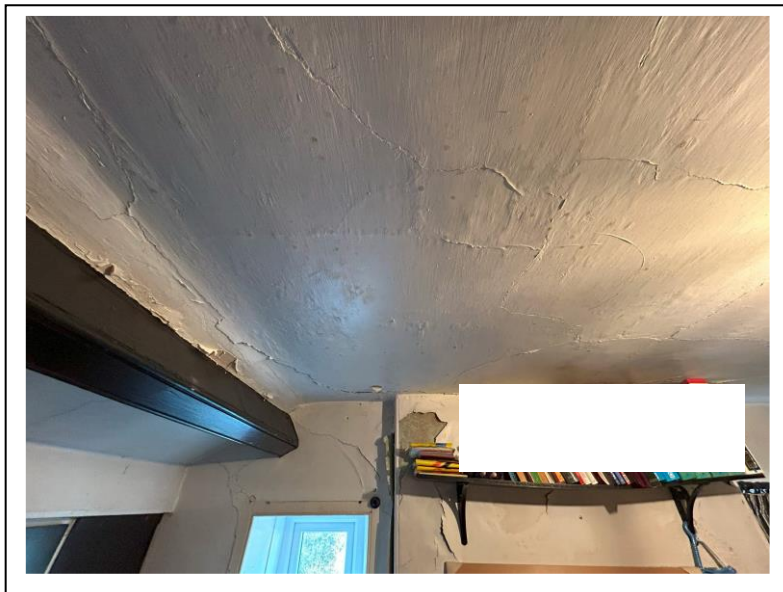
Plate 18

There are a number of cracks throughout, concentrated around the right spine wall elevation. There is also a crack to the corner between the rear wall and the left party wall, which we believe is due to water ingress caused by the defective roof.

Cracking around structural openings to gable wall.

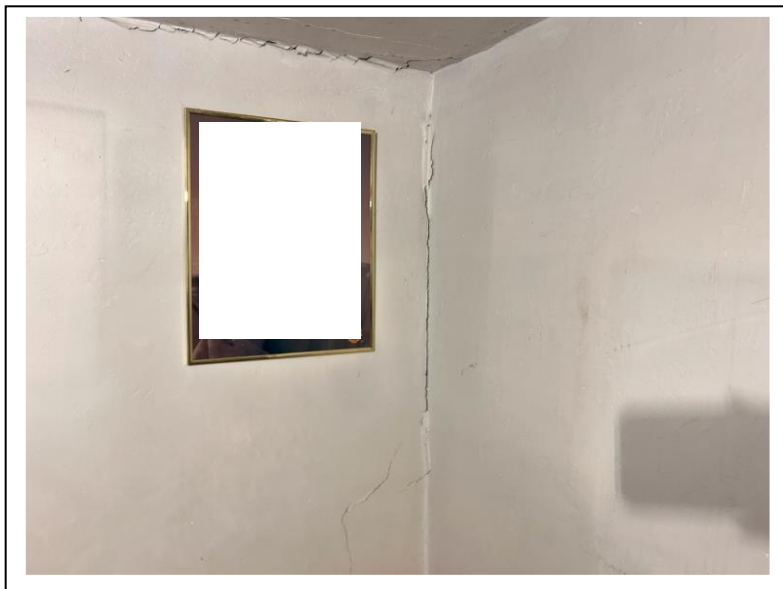
Plate 19

There are also multiple cracks to the lathe and plaster ceiling. We believe that this is due to the cracked and slipped roof tiles above allowing water to penetrate through the roof and walls, causing movement and a loss of adhesion between the lathe and plaster. It is recommended that the ceiling is pinned back against the joists or that the ceiling is replaced.

Cracking to ceiling and chimney stack, with delaminating wallpaper.

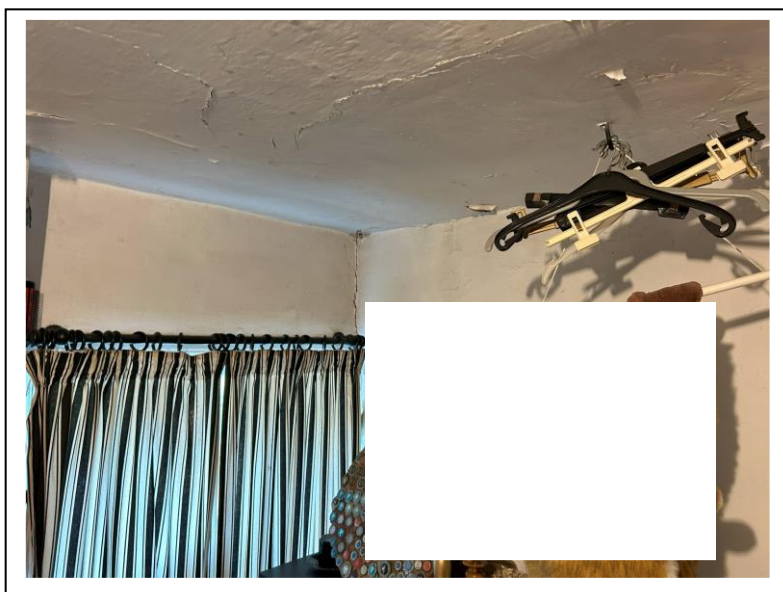
Plate 20

Vertical cracking to corner between rear bedroom wall and party wall. Horizontal cracking between rear bedroom wall and ceiling.

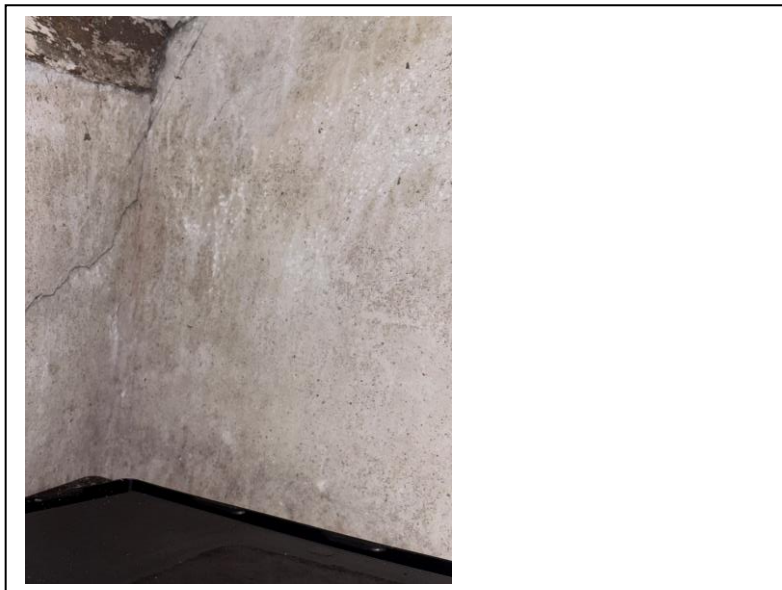
Plate 21

Cracking around structural openings to gable wall and rear bedroom wall.

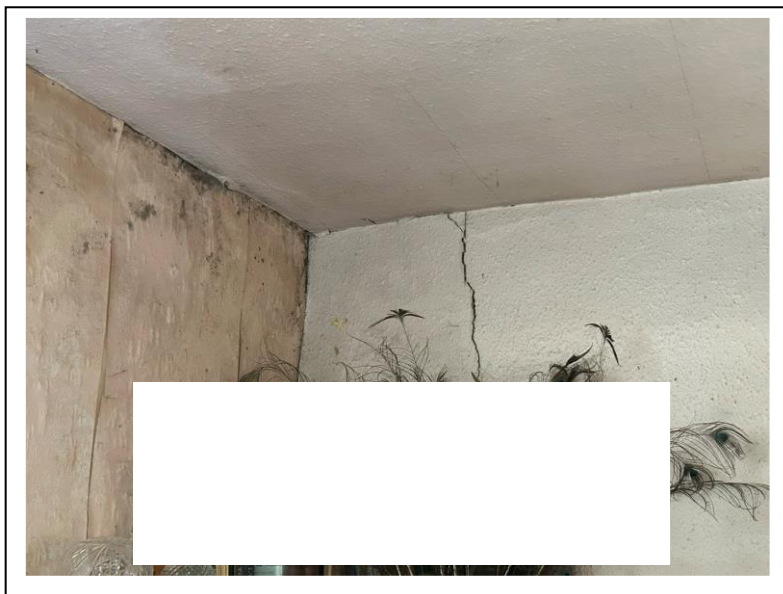
Plate 27

There is an exposed roof timber which appears to be suffering from damp and early onset rot. We believe that this is caused by the vegetation growth to the joint between the two roofs, which has caused water ingress. Following the repairs to the roof and external façade, it is recommended that the roof timbers are investigated for wet and dry rot, the timber is cleaned down and then monitored to establish any further deterioration.

Damp roofing timbers.

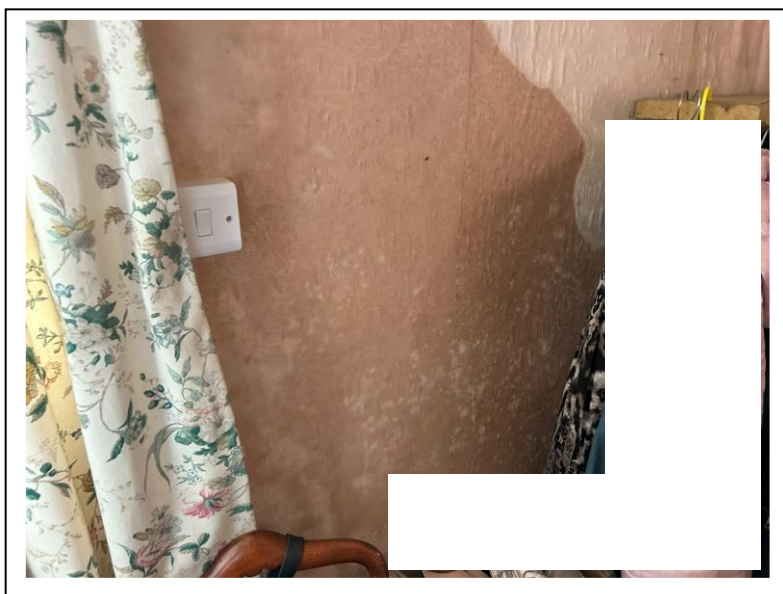
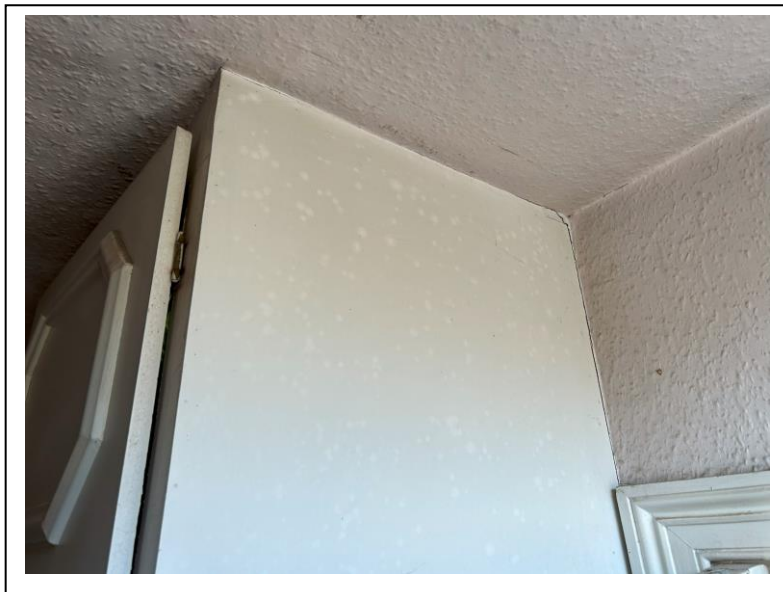
Plate 29

The left gable wall appears to have been subject to historic water ingress. We believe that this is due to the lack of overhang from the ridge tiles above which has caused water to ingress through the walls. There are areas of damp spots visible on the wardrobes, we believe that these are due to lack of ventilation and lack of central heating throughout the property.

Historic water ingress to left elevation.

Same as above.

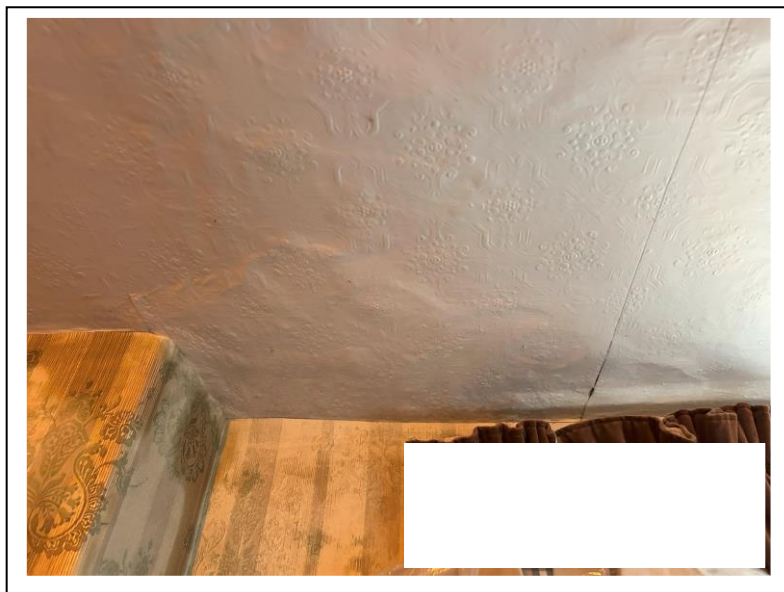
Plate 33

Beneath the window there is an area of historic water staining at low level adjacent to first floor staircase. Adjacent to the window, there appears to be an aperture within the wall which has been covered over with paper and cellotape. We recommend that this is infilled, replastered and redecorated.

Damp below window to first floor landing.

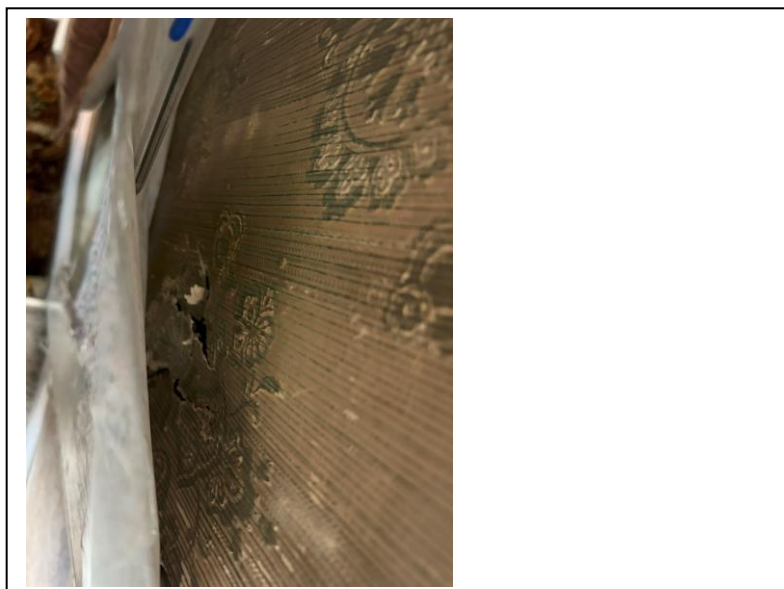
Plate 34

The wallpaper at high level appears to be peeling, which we believe is due to moisture from the water ingress. We recommend that the walls are relined after the roof repairs have been undertaken and the area monitored.

Delaminating wallpaper  
to first floor hallway  
ceiling.

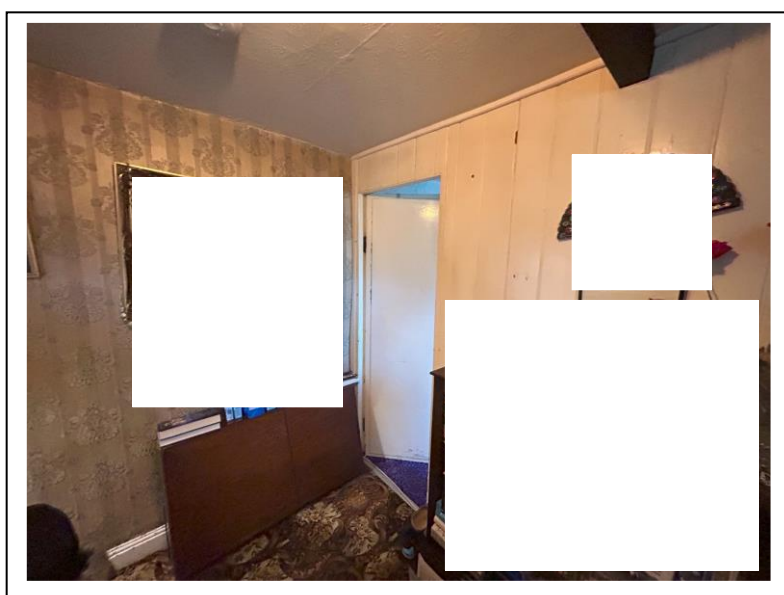
Plate 35

Aperture within wall to  
first floor landing.

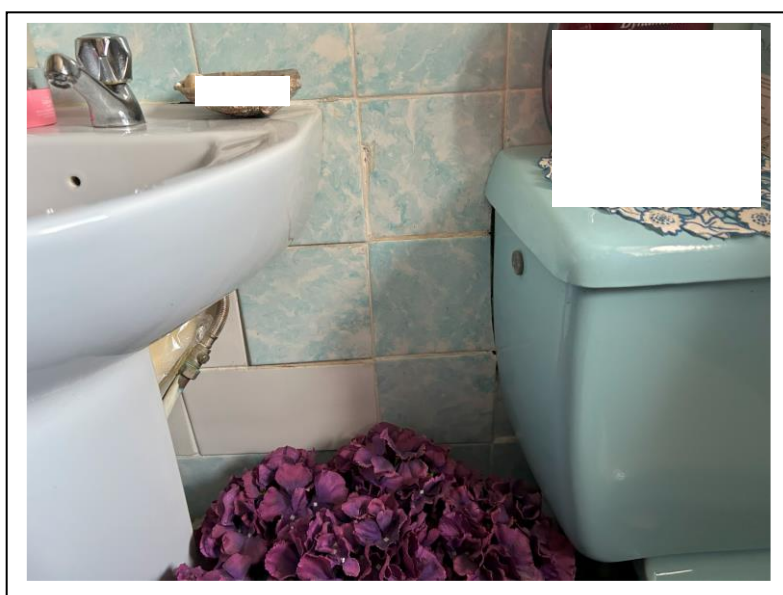
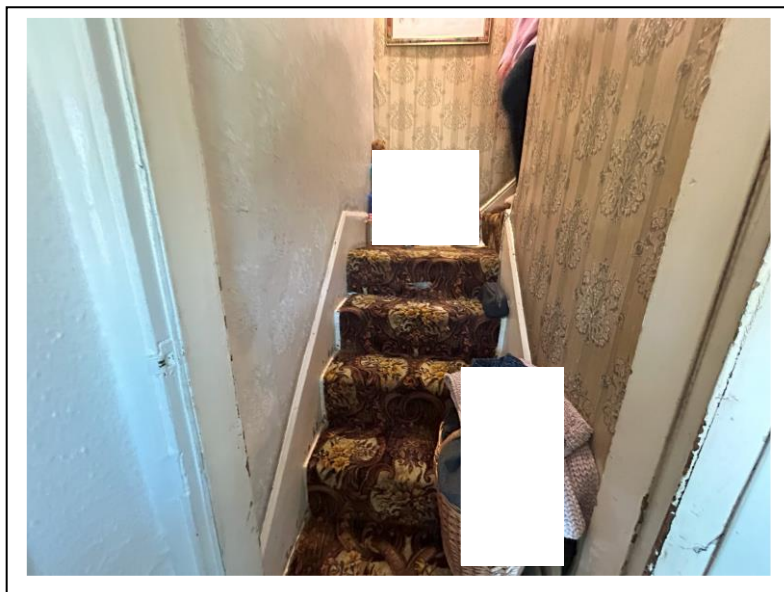
Plate 38

There are areas of cracking to the grout of the wall tiles, which we believe is due to movement over many years. The resident confirmed that her husband tiled the walls and had to offset many of them because of the unevenness of the walls some 40 years ago. As such, we do not consider the cracked grout to be of significance.

Cracked tiling.

As above.

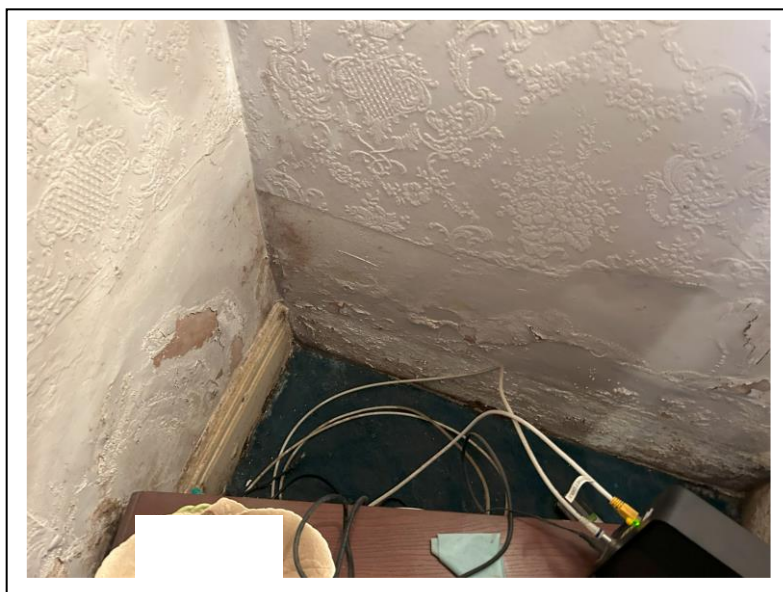
Plate 44

There is a large area of damp to the left side of the party wall and chimney stack at low level. There are areas of blown plaster and delaminating wallpaper. We believe that this is due to a mixture of rising damp and the reported issues with the neighbour's sink. We recommend that a CCTV drainage survey is undertaken on the neighbours drains and that the external ground level is lowered.

Damp to left of chimney stack.

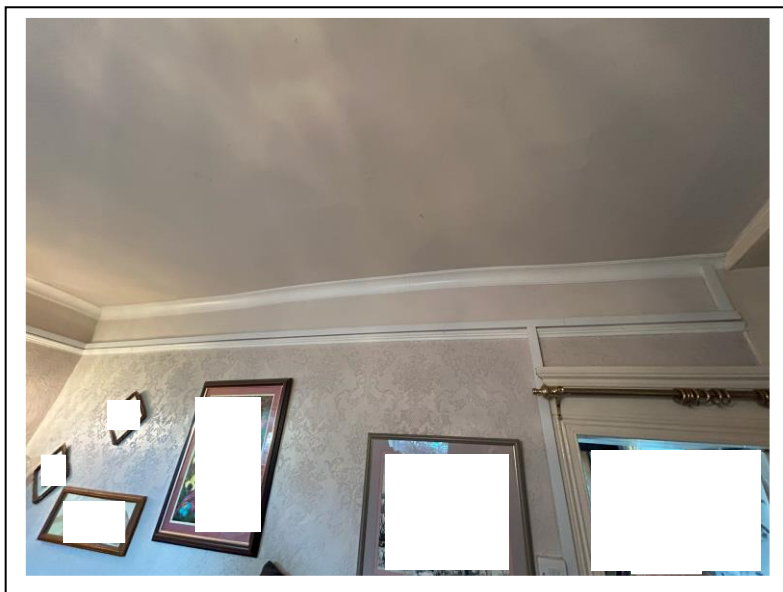
Plate 45

Damp to right alcove.

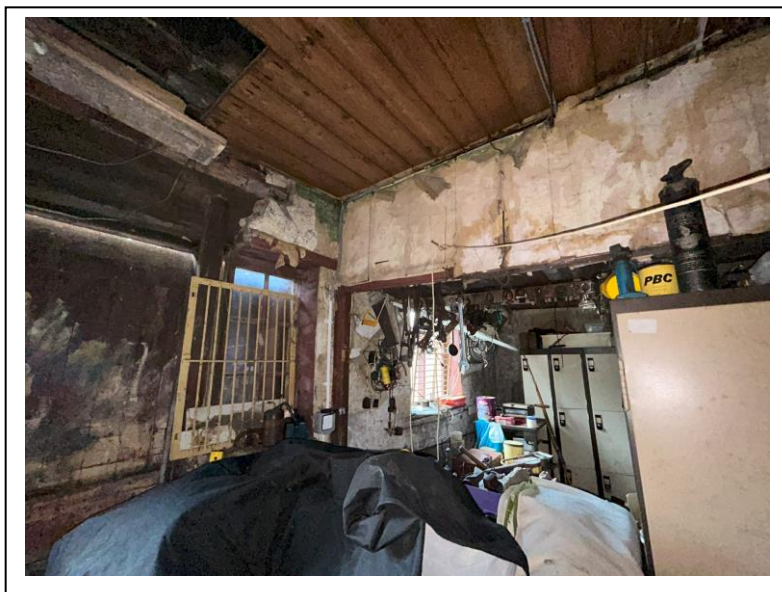
Plate 56

Cracking to render in first section of outbuilding 1.

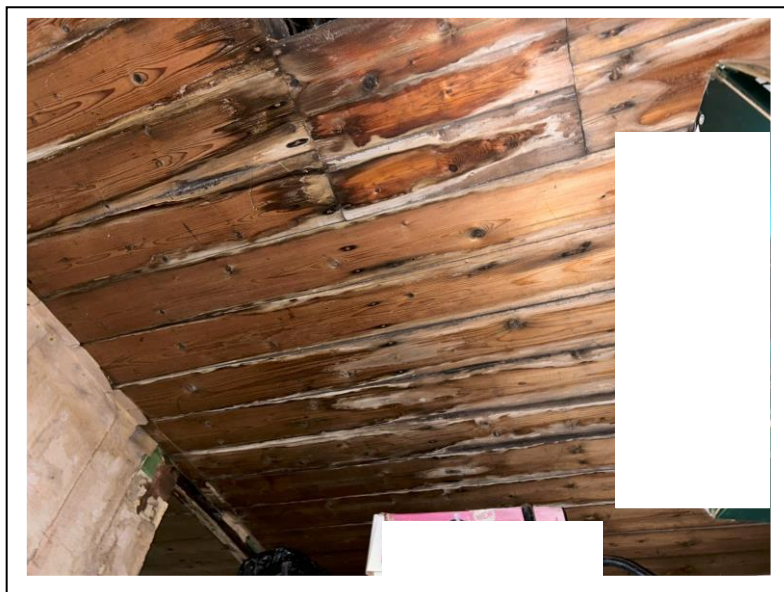
Plate 57

Damp in middle section of outbuilding 1.

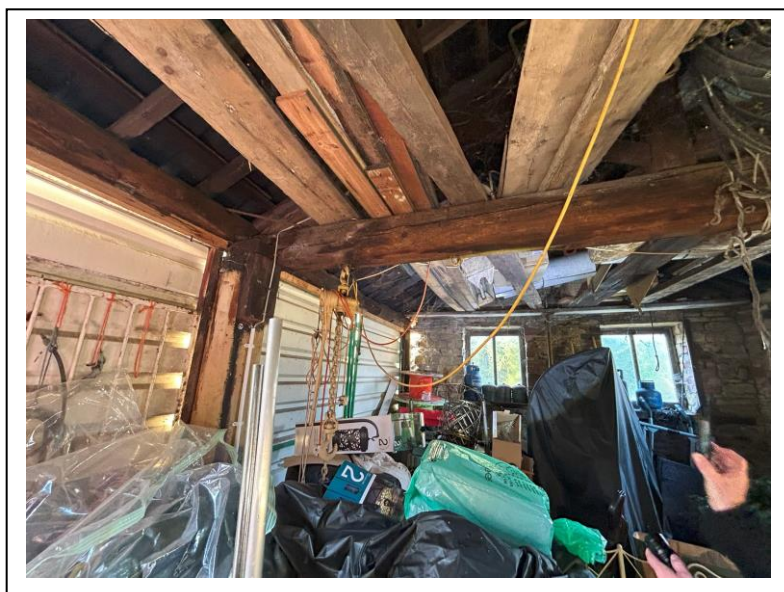
Plate 59

Gap between profile steel roof and middle section of outbuilding 1.

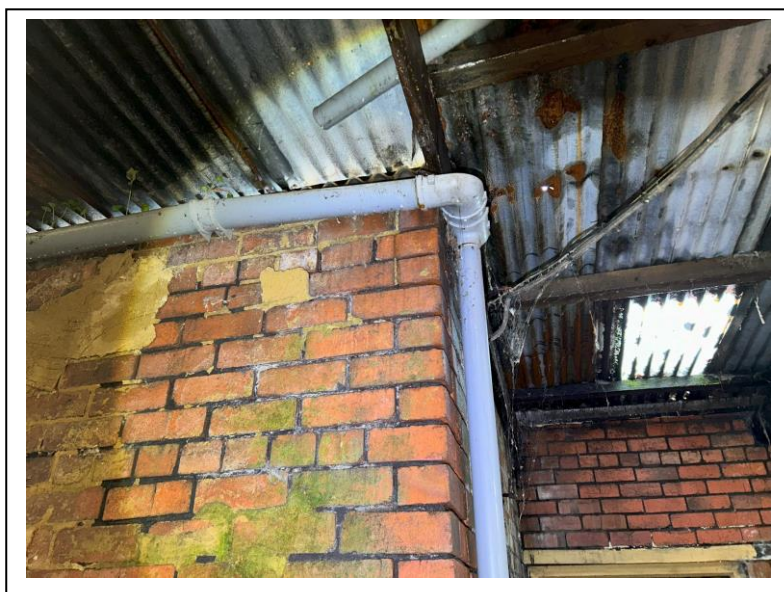
Plate 68

General overview of outbuilding 2, showing acro propping the flat roof up.

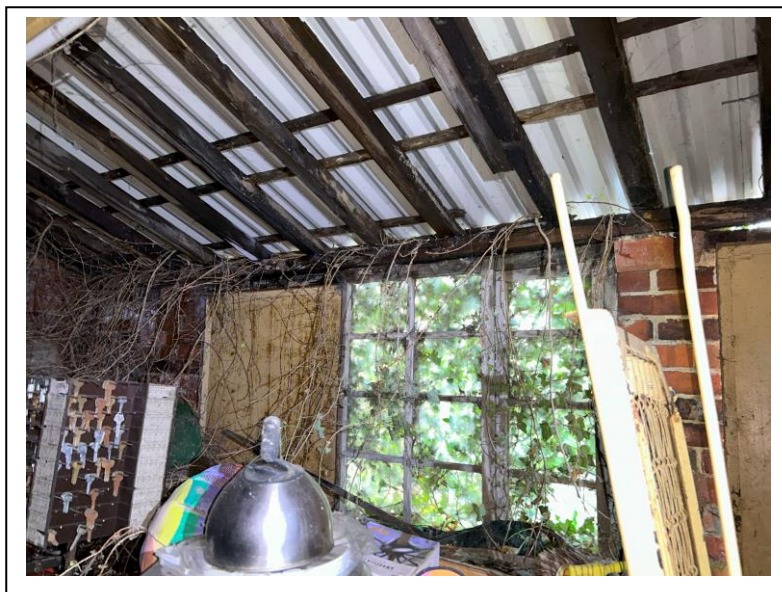
Plate 69

Damp elevations within outbuilding 2.

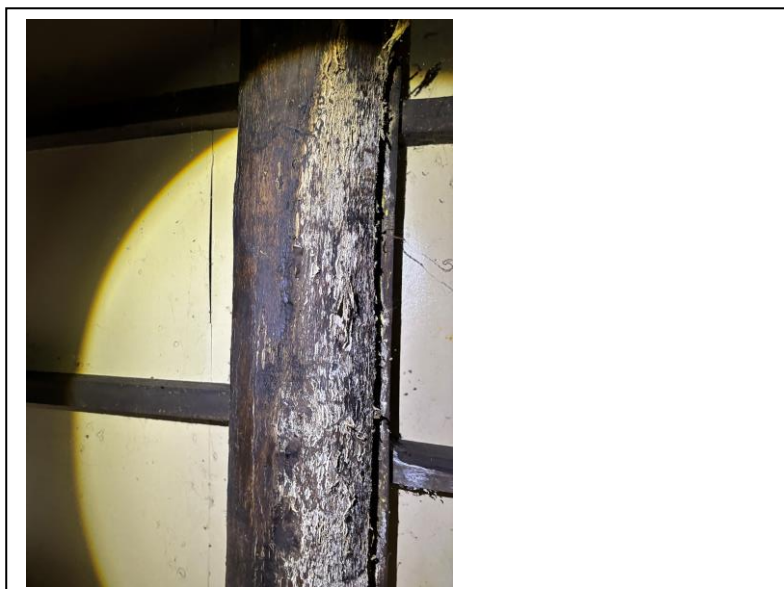
Plate 73

Cracking to first floor of stables.

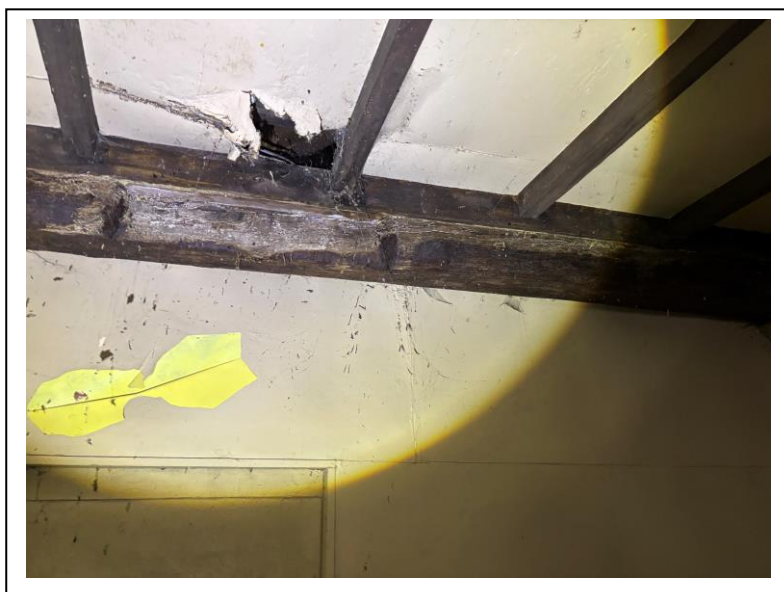
Plate 74

Timbers to first floor stables suffering from rot.

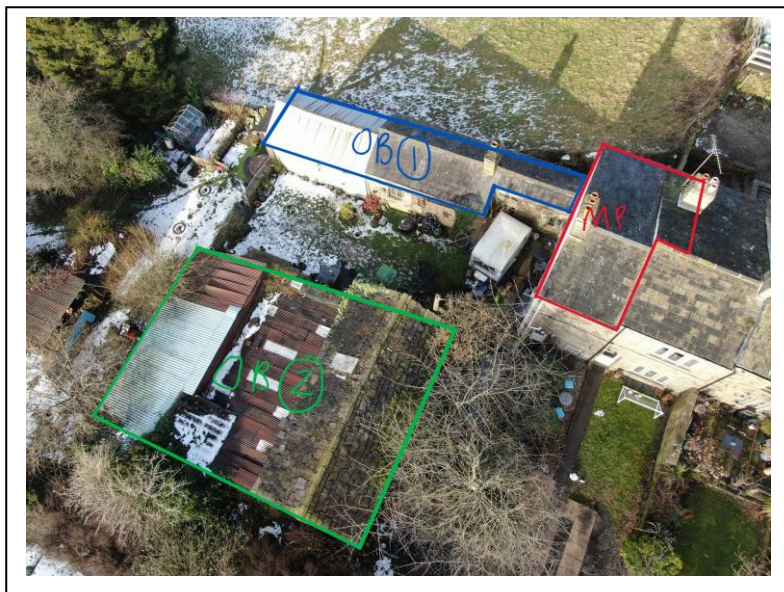
Plate 84

Suspected asbestos profile sheeting to outbuilding 2 roof.
