Gleesons
Cockley Hill Lane, Kirkheaton,
Huddersfield
Pre-Construction Visual Condition Survey

PRE-CONSTRUCTION VISUAL CONDITION SURVEY

Ref: 25-353-001.01

February 2026

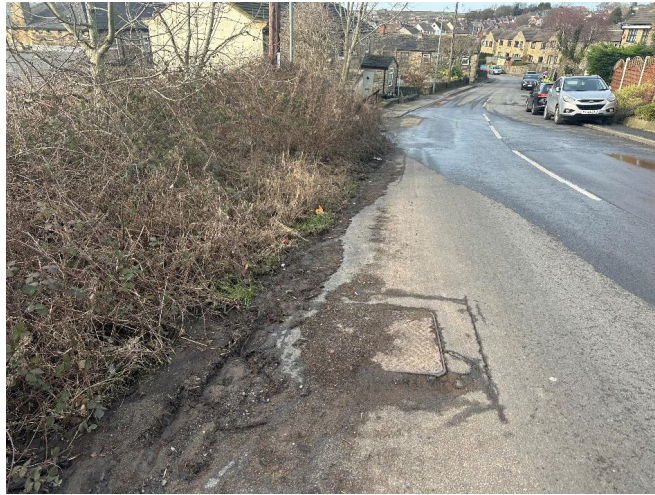
Photo 1

Cockley Hill Lane Site Frontage (South)

Carriageway edge deterioration present with associated utility ironwork defect, which shows cracks are present.

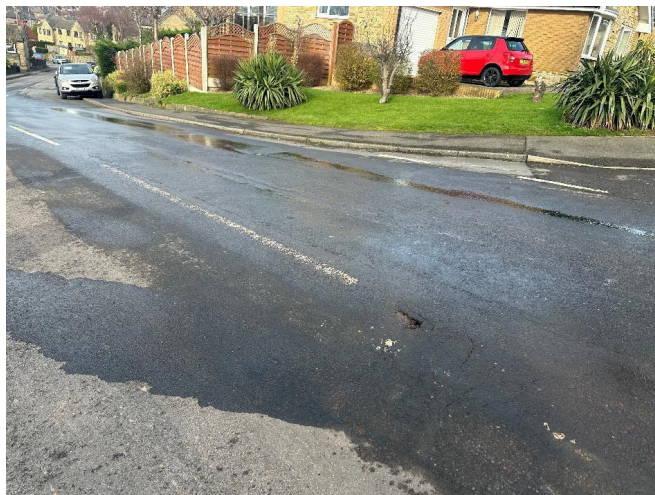
Photo 2

Cockley Hill Lane Site Frontage (South)

Deterioration of lining with visible pothole within centre of carriageway.

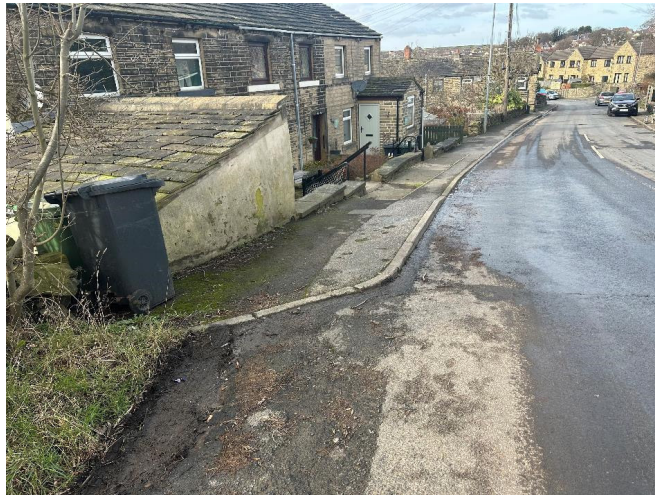
Photo 4

Cockley Hill Lane (South)

Intermittent gaps between individual kerb units and cracks.

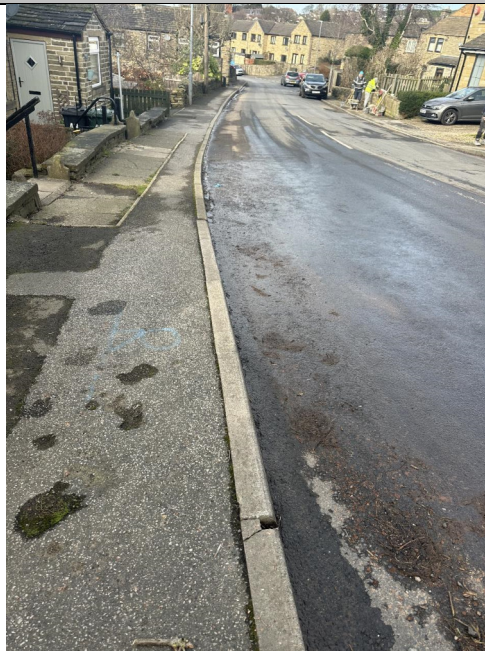
Photo 5

Cockley Hill Lane (South)

Intermittent gaps between individual kerb units and cracks.

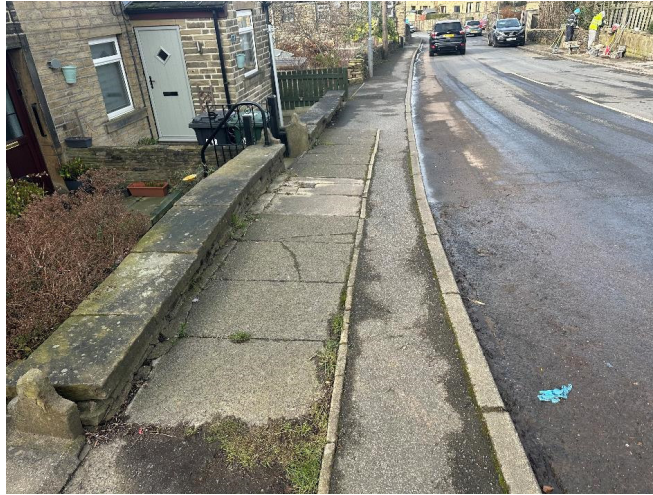
Photo 6

Cockley Hill Lane (South)

Multiple slabs show visible cracking with uneven slabs. Surface wear and deterioration present. Vegetation growth in joints between slabs and along edges. Edge deterioration with crumbling and breaking at slab corners and edges.

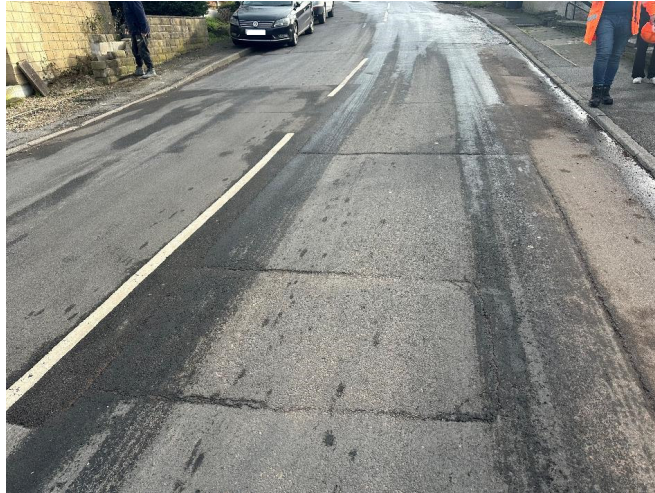
Photo 8

Cockley Hill Lane (South)

The carriageway shows reinstatement patch consistent with previous utility trenching, it was commented by Kirklees representative that it could be gas works. Joint failure is visible at the edges of the reinstatement.

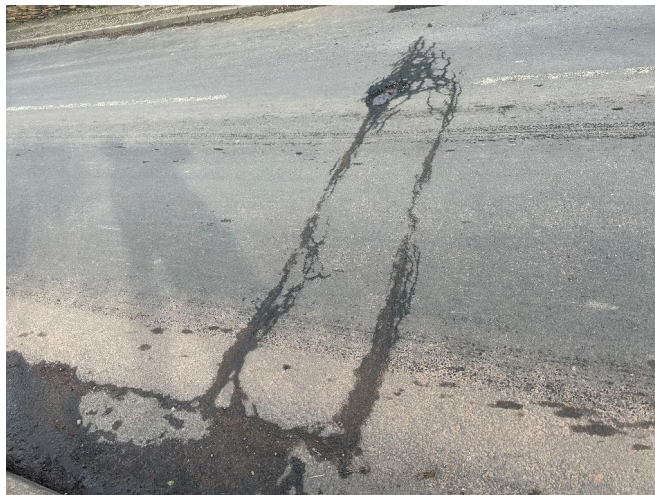
Photo 9

Cockley Hill Lane (South)

Joint failure is visible at the edges of the reinstatement, with a pothole in the centre of the carriageway.

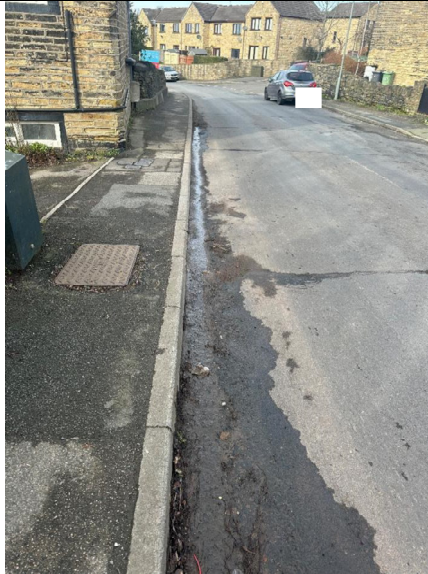
Photo 10

Cockley Hill Lane (South)

The road surface shows signs of deterioration on the edges. Surface deterioration also present within the footway.

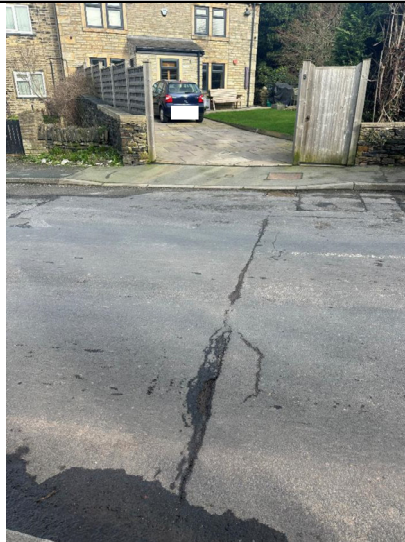
Photo 11

Cockley Hill Lane (South)

Joint failure is visible.

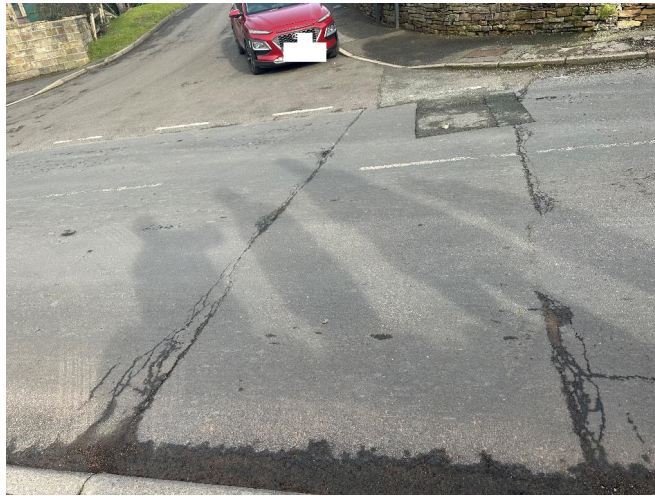
Photo 14

Cockley Hill Lane (South)

Joint failure is visible with failure to patchwork on opposite side.

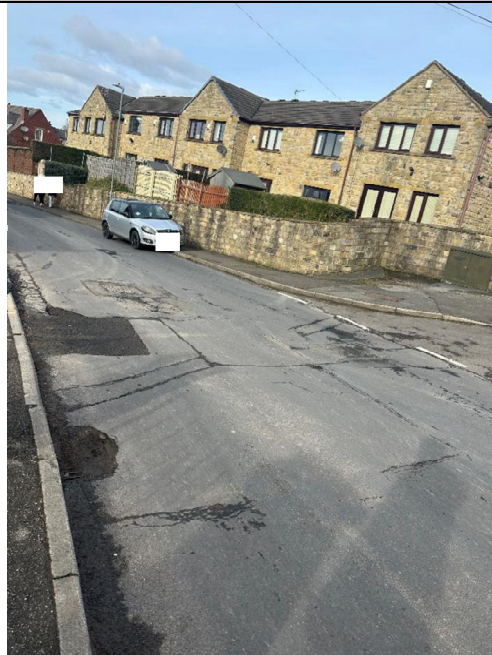
Photo 15

Cockley Hill Lane (South)

Joint failure is visible with numerous trench reinstatements present.

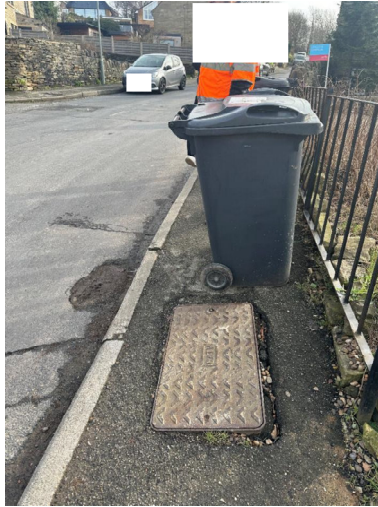
Photo 16

Cockley Hill Lane (South)

The utility cover doesn't sit flush with the surrounding pavement. Deterioration of footway surfacing in the vicinity of utility cover.

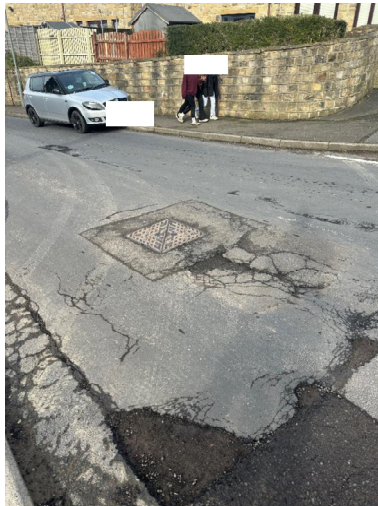
Photo 17

Cockley Hill Lane (South)

Carriageway surfacing is cracked in multiple places. Irregular patches where previous repairs were made are present. Manhole surrounding area shows deterioration edges between the cover frame and the road surface.

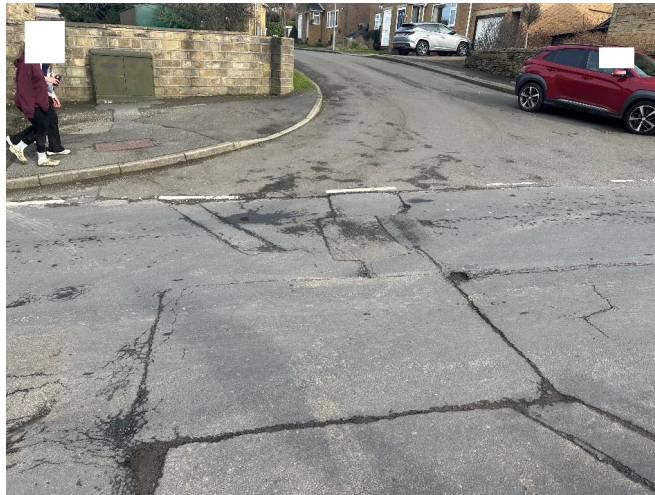
Photo 18

Cockley Hill Lane (South)

Numerous joint failures are visible.

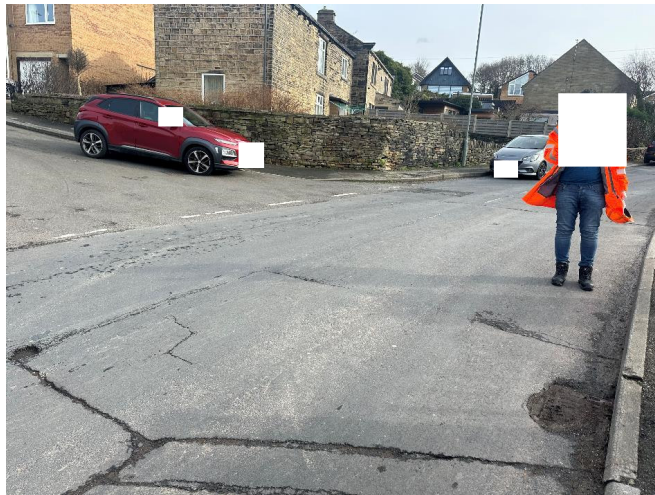
Photo 19

Cockley Hill Lane (South)

Numerous joint failure are visible.

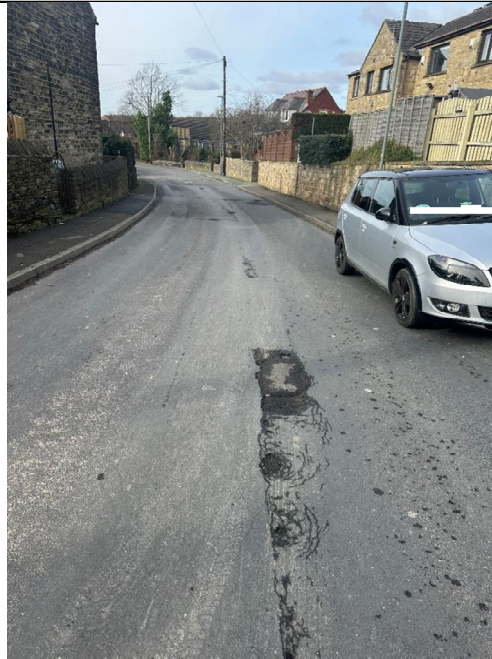
Photo 20

Cockley Hill Lane (South)

Carriageway surface cracking down the centre with surface deterioration .

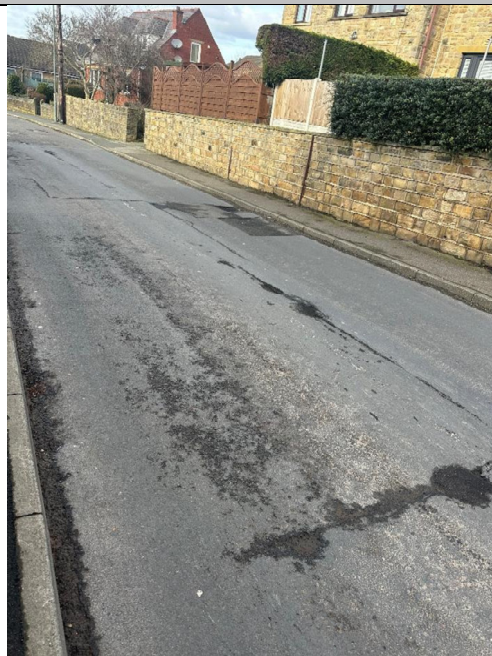
Photo 21

Cockley Hill Lane (South)

Joint failure visible.

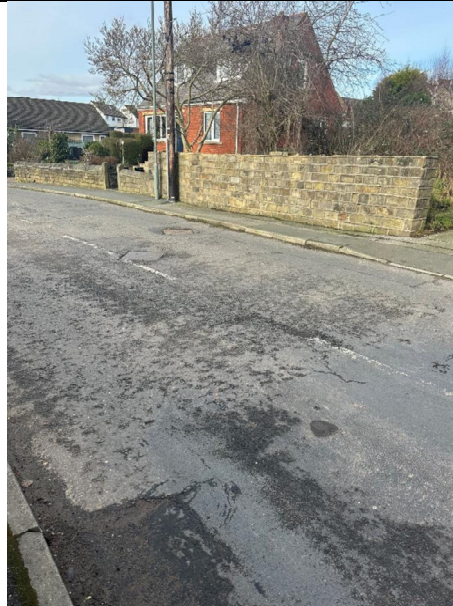
Photo 22

Cockley Hill Lane (South)

Multiple cracks visible in carriageway surface, patch repair area present. General surface degradation.

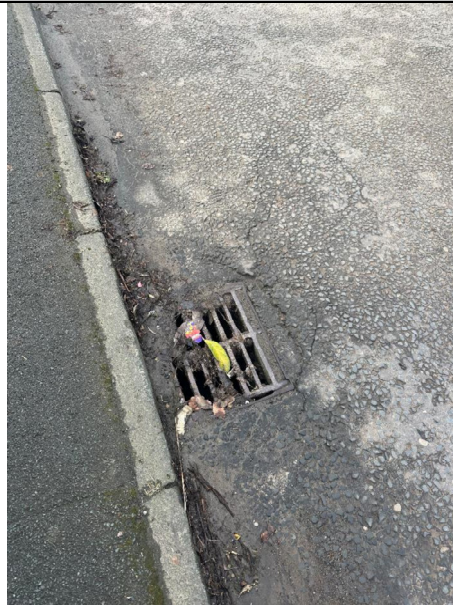
Photo 23

Cockley Hill Lane (South)

Gully observation to be full of silt.

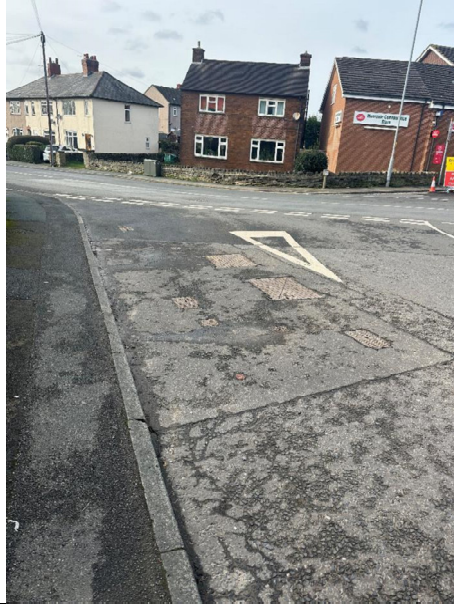
Photo 24

Cockley Hill Lane (South)

Multiple cracks observed in carriageway surface.

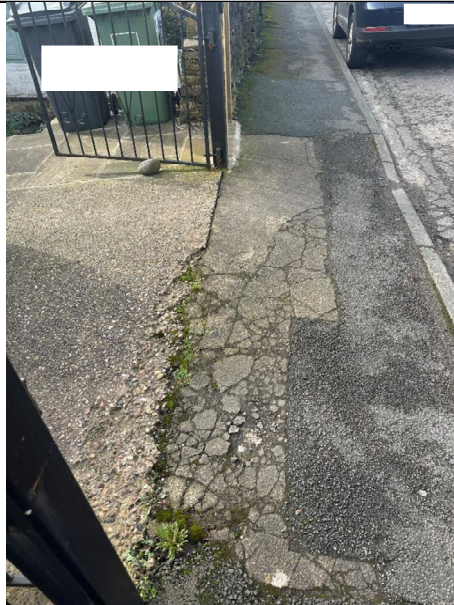
Photo 25

Town Road (East)

Multiple cracks present within concrete footway reinstatement.

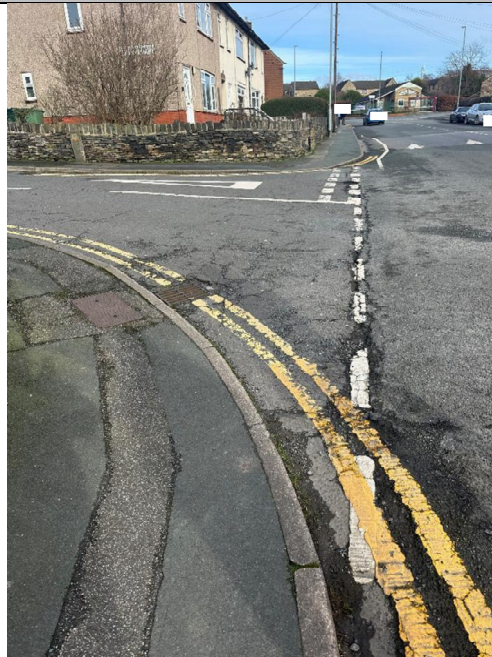
Photo 27

Town Road (West)

Visible deterioration of existing carriageway joints junction below existing road markings.
Carriageway damaged around gully.

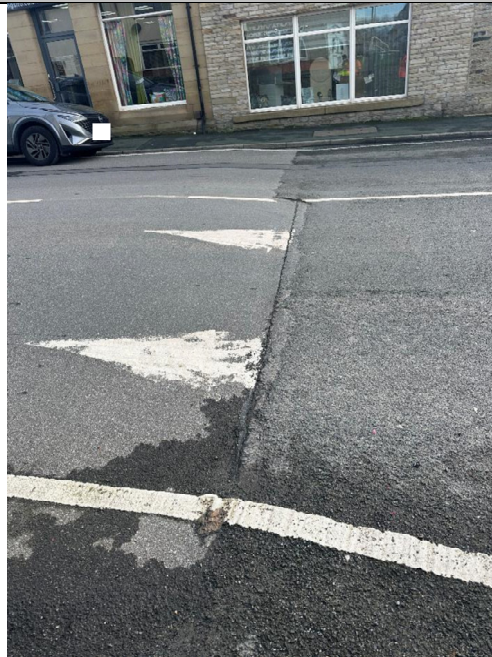
Photo 29

Town Road (West)

Cracks and deterioration at hump joint.

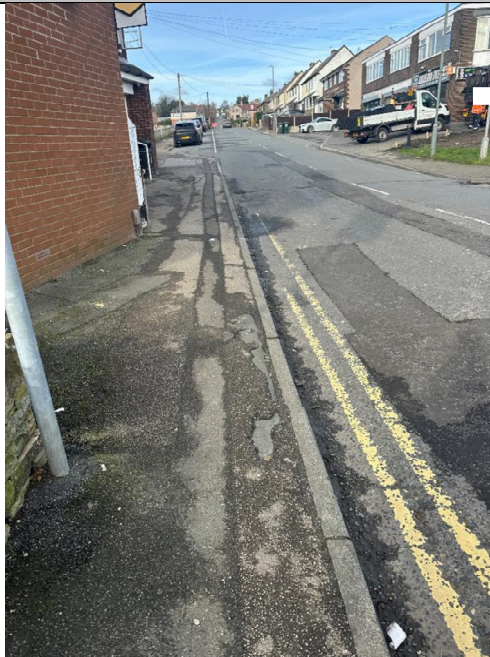
Photo 31

Heaton Moor Road (West)

Widespread deterioration of footway surfacing. Existing waiting restrictions in the form of double yellow lines are worn with sections partially missing.

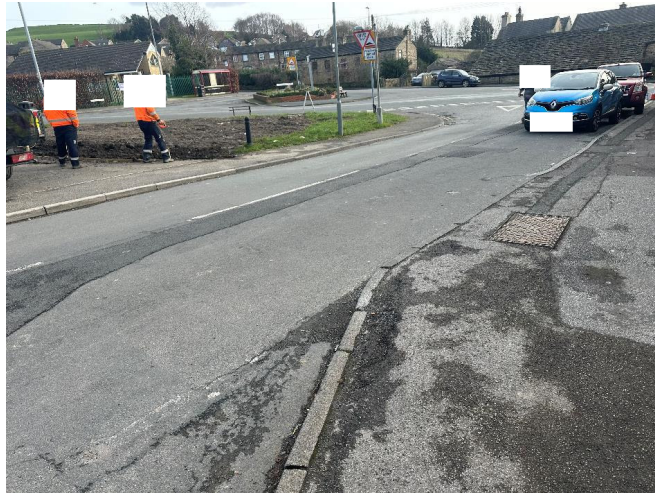
Photo 32

Moorside Road (South corner)

Intermittent gaps between individual kerb units and cracks.

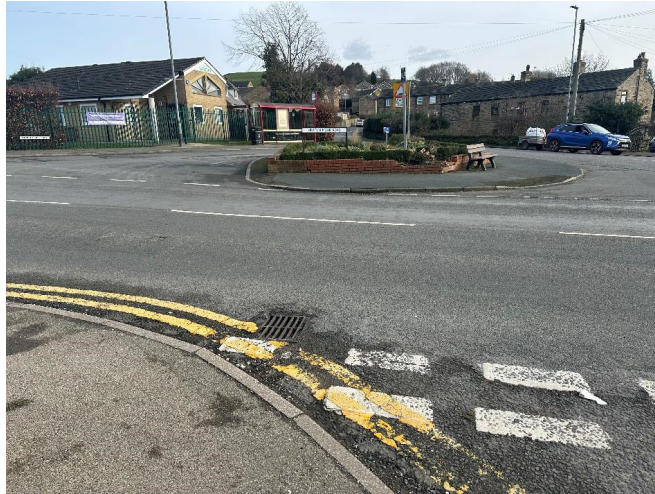
Photo 34

Moorside Road (North corner)

Deterioration of carriageway surfacing around gully.

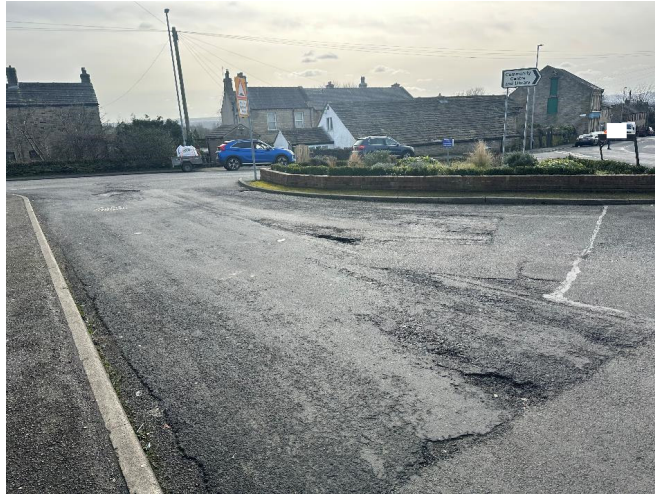
Photo 36

Cockley Hill Lane (North of Island at Junction)

Numerous defects within carriageway surfacing

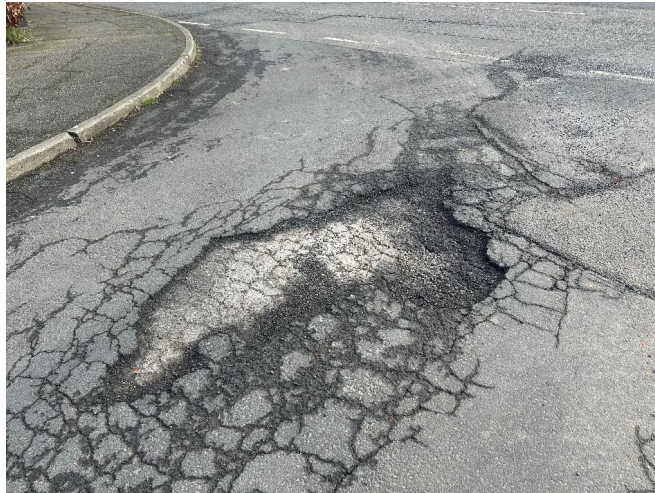
Photo 37

Cockley Hill Lane (North of Island at Junction)

Pothole with extensive Alligator / Crazing Cracks within carriageway.

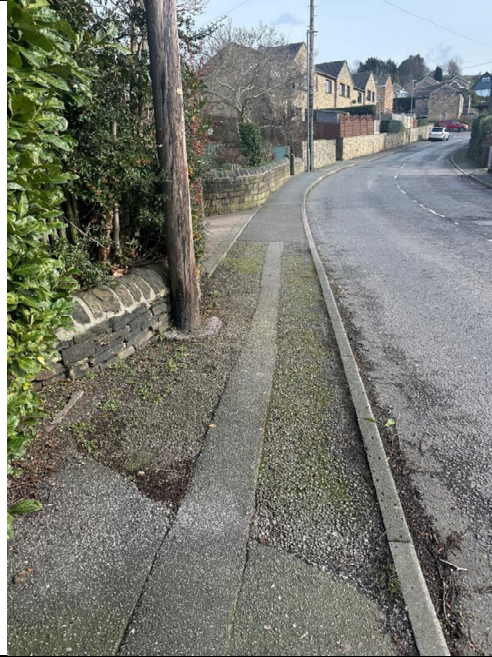
Photo 38

Cockley Hill Lane (North)

Footway surface showing signs of deterioration, with uneven texture and weathering.

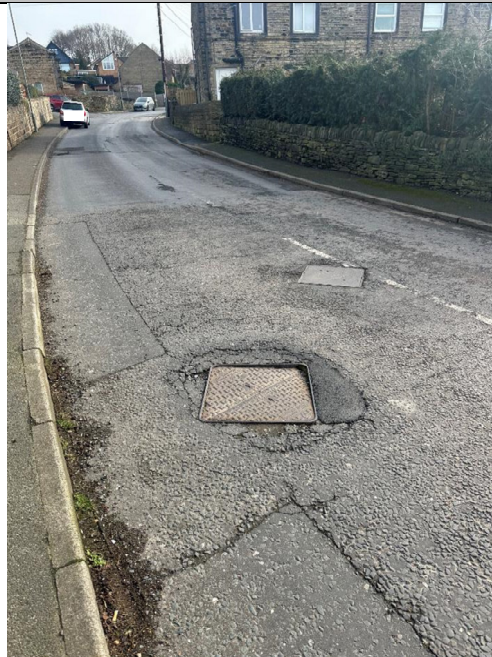
Photo 39

Cockley Hill Lane (North)

Existing manhole cover and frame has sunk resulting in carriageway surfacing around the cover and frame showing deterioration. Carriageway surface showing signs of wear and tear.

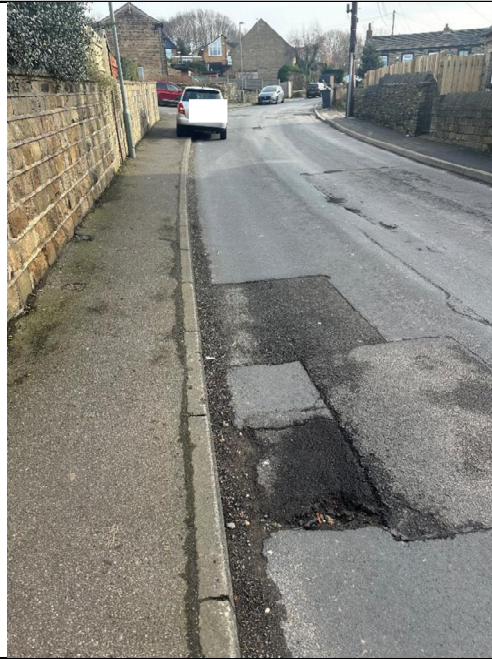
Photo 40

Cockley Hill Lane (North)

Existing carriageway has numerous patches with signs of failure

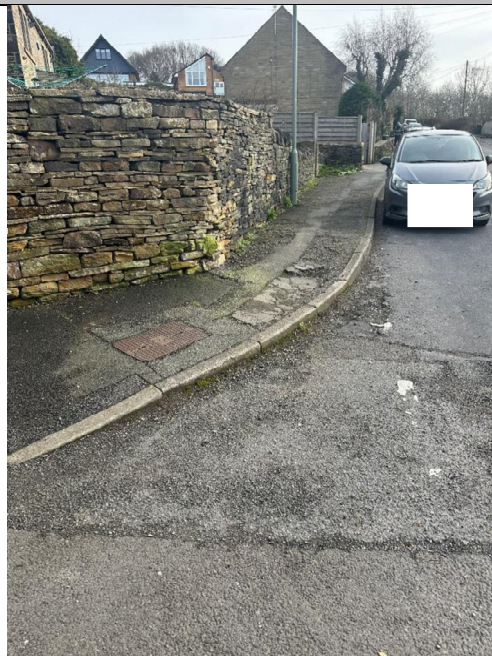
Photo 41

Cockley Hill Lane (North)

Carriageway surface shows of wear and tear. Footway shows signs of cracking and failure to surfacing.

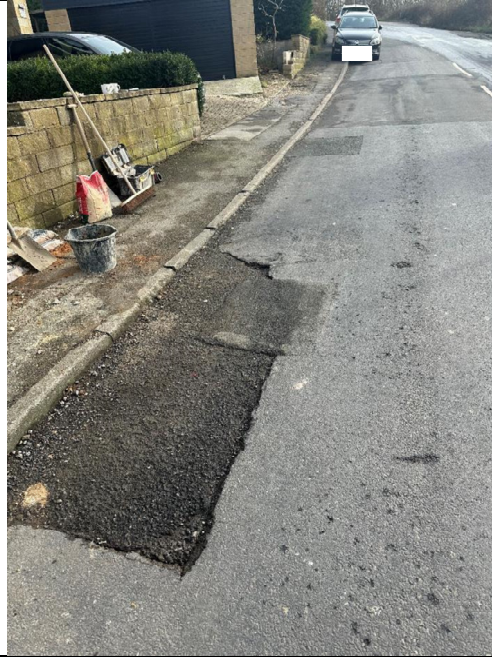
Photo 42

Cockley Hill Lane (North)

Existing carriageway reinstatement showing signs of failure.

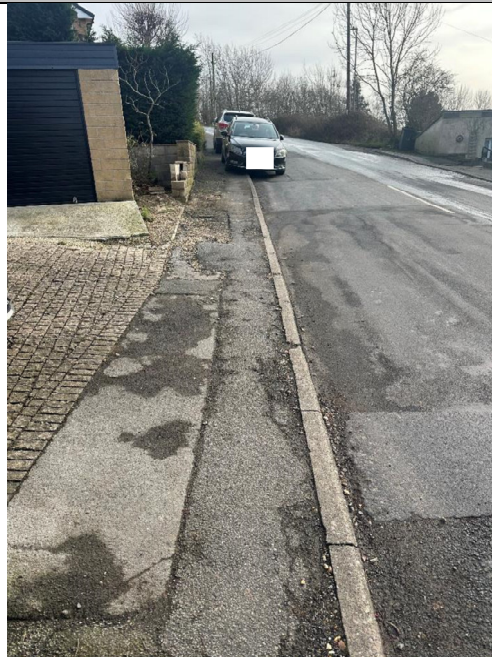
Photo 43

Cockley Hill Lane (North)

Footway surface uneven in places with existing reinstatements showing signs of deterioration.
