Client: Kirklees Council

Project: Oakwell Hall

Title: Proposed structural interventions
Roof level

Drawing No: 22333-Y-SK-008 Rev: P2

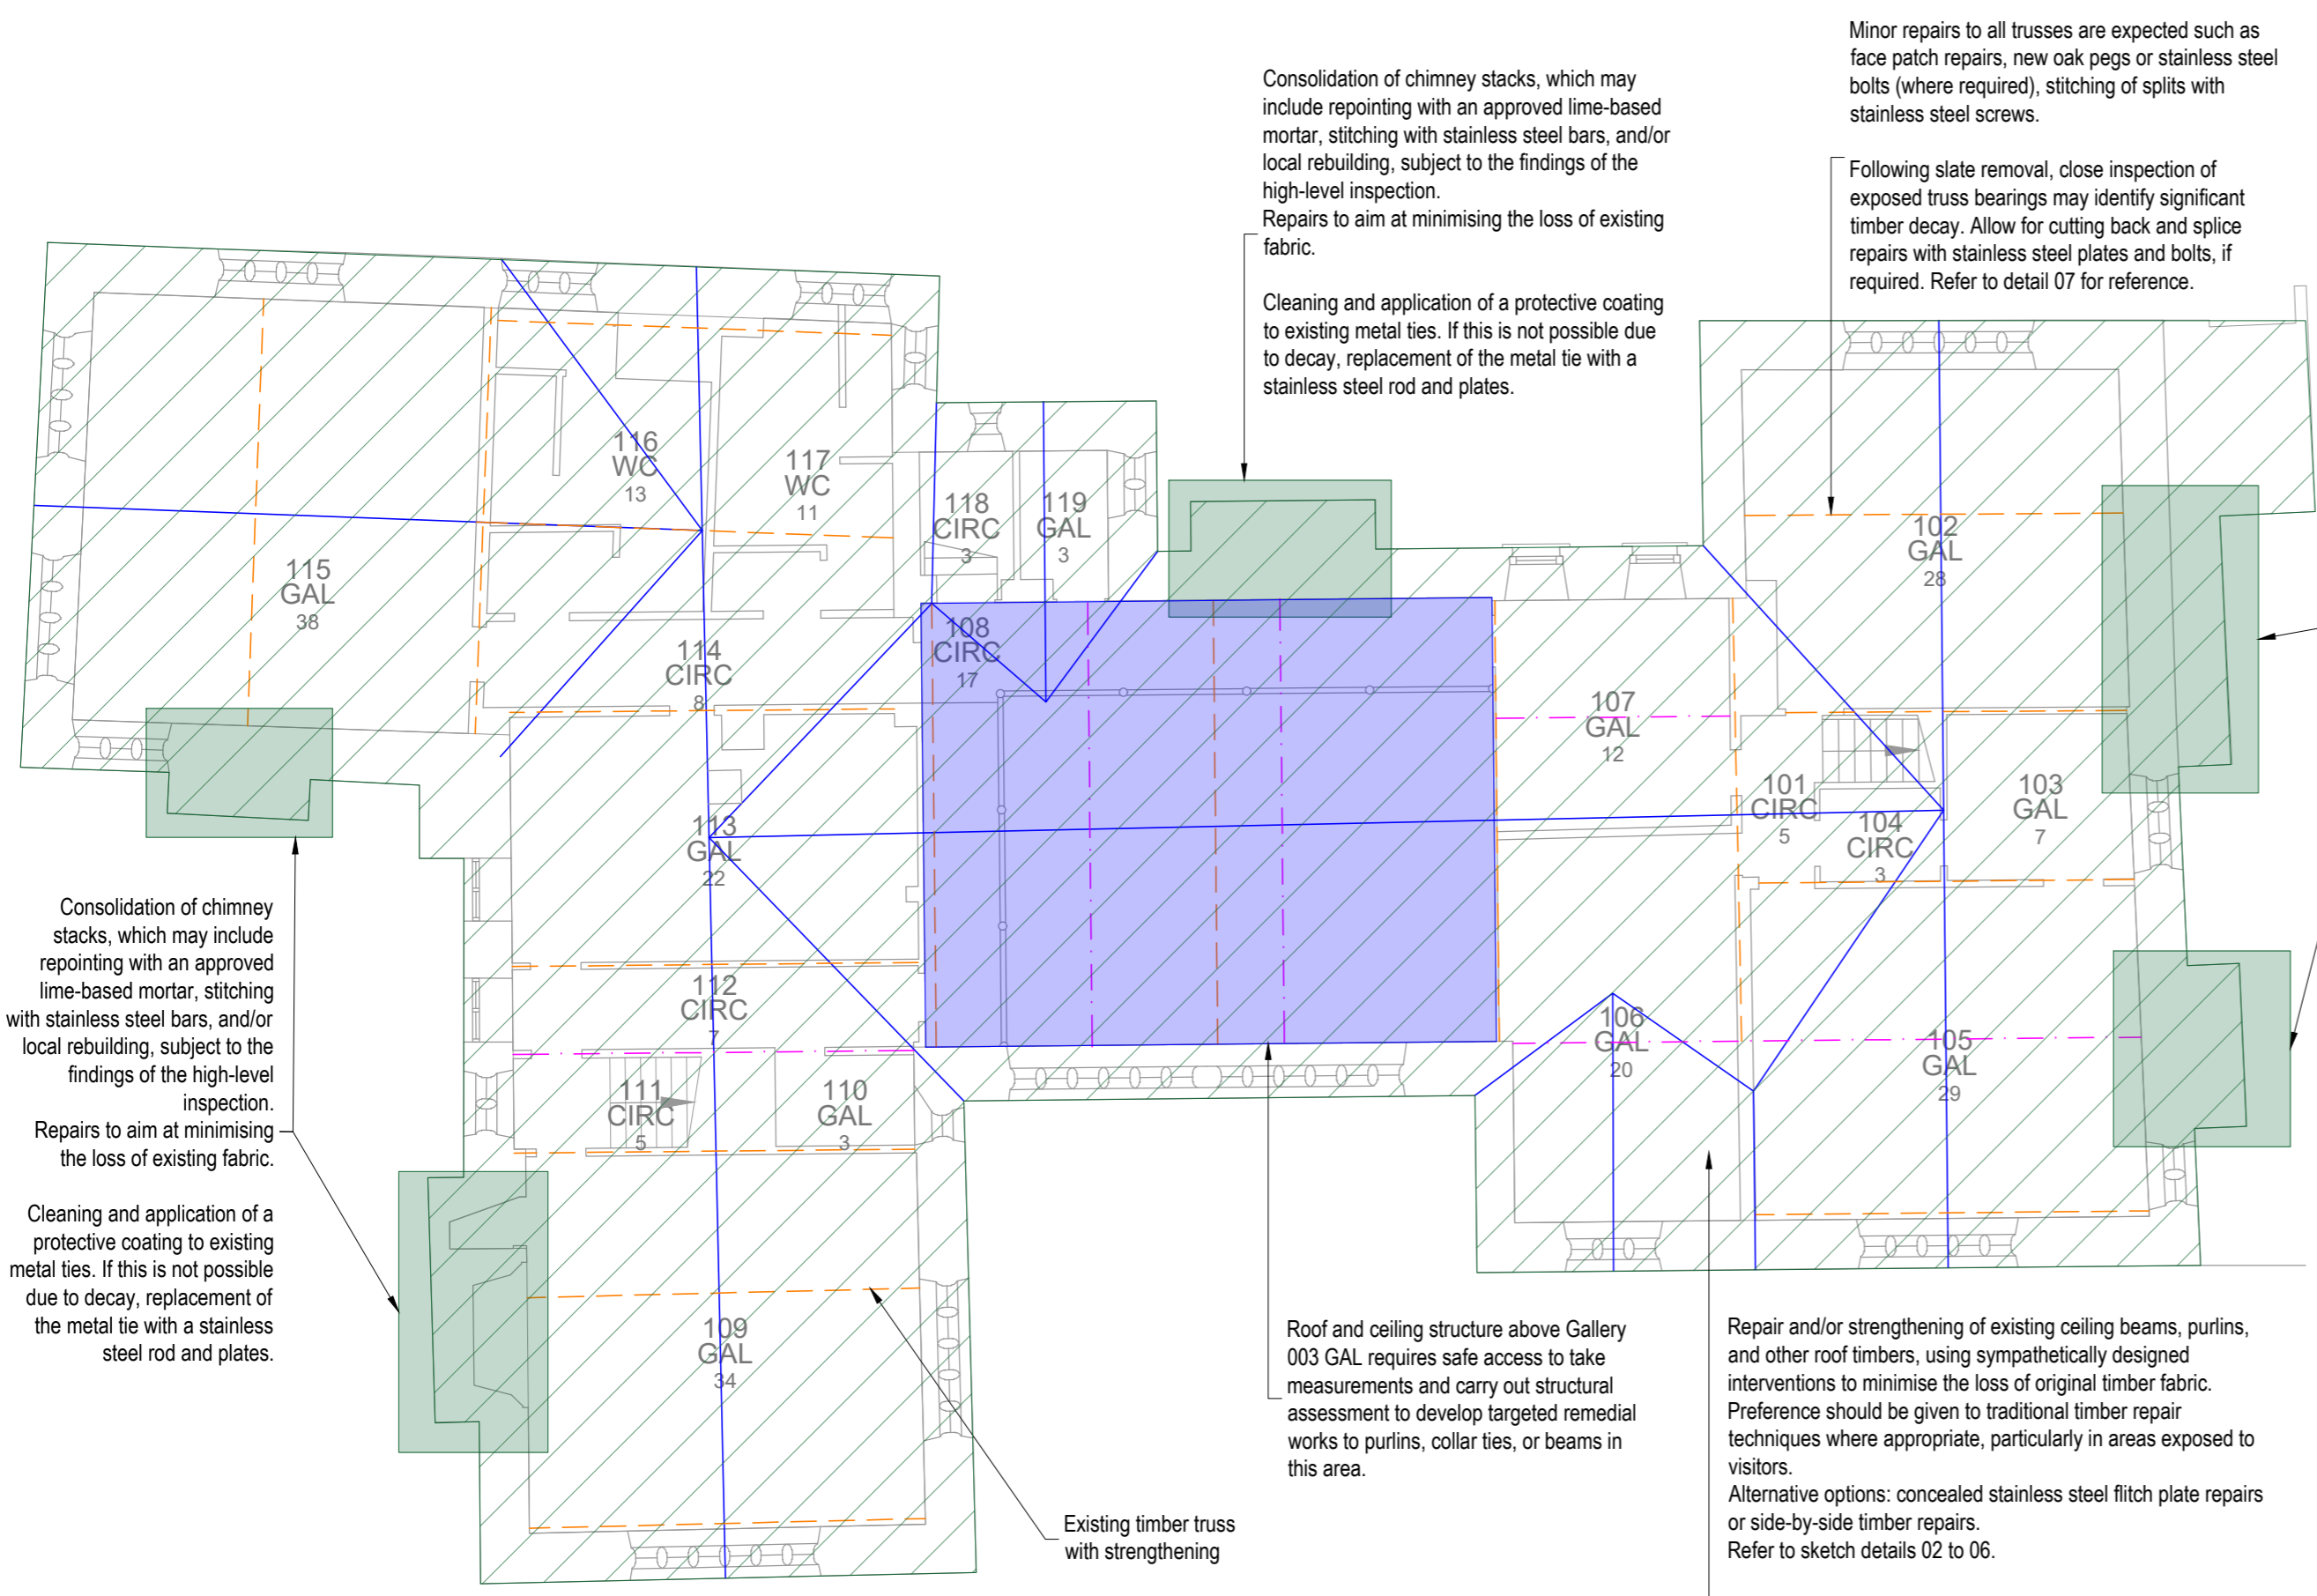
01 First floor plan with indicative location of the roof structural elements
Scale: 1:100

Roof and ceiling structure above Gallery 003 GAL requires safe access to take measurements and carry out structural assessment to develop targeted remedial works to purlins, collar ties, or beams in this area.

Consolidation of chimney stacks, which may include repointing with an approved lime-based mortar, stitching with stainless steel bars, and/or local rebuilding, subject to the findings of the high-level inspection. Repairs to aim at minimising the loss of existing fabric.

Cleaning and application of a protective coating to existing metal ties. If this is not possible due to decay, replacement of the metal tie with a stainless steel rod and plates.

Minor repairs to all trusses are expected such as face patch repairs, new oak pegs or stainless steel bolts (where required), stitching of splits with stainless steel screws.

Repair and/or strengthening of existing ceiling beams, purlins, and other roof timbers, using sympathetically designed interventions to minimise the loss of original timber fabric. Preference should be given to traditional timber repair techniques where appropriate, particularly in areas exposed to visitors. Alternative options: concealed stainless steel flitch plate repairs or side-by-side timber repairs. Refer to sketch details 02 to 06.

- Allow for repairs/strengthening as follows (estimated quantities):
- 4no. ceiling beams
 - 30% of ceiling joists
 - 30% of purlins
 - 30% of ridge beams
 - 30% of rafters and rafters' feet
 - 50% of wall plates (allow for half-lap joints with resin anchors to fix the new sections to the wall)
 - 50% of valleys, and hip rafters.

For short lengths of ceiling joists, ridges, wall plates, and rafters, replacement of the timber member may be considered where the scarf joint requires more than 50% of the total length.
