# Glass survey of Oakwell Hall

Undertaken by Dennis  
Eckersley 2025/2026

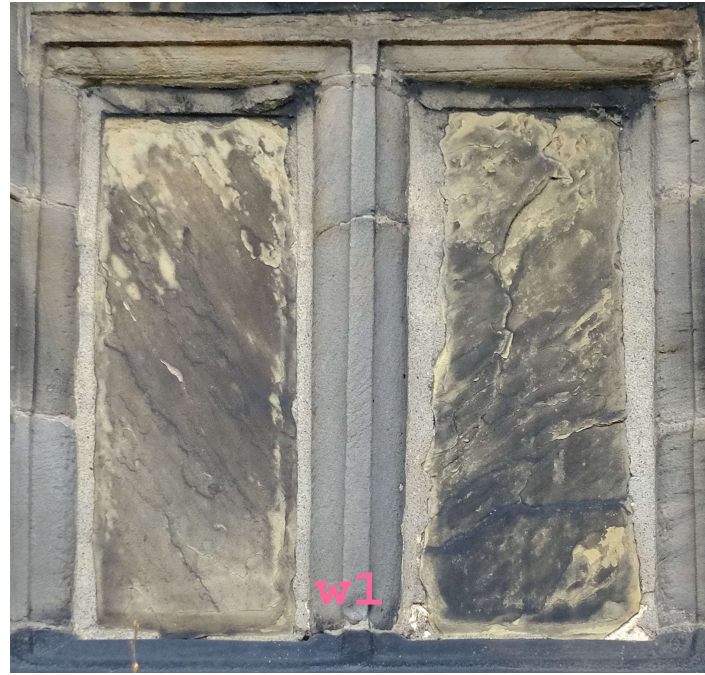
**w1 ref 008 (SW facing)**

*Size – 15" x 30". Two stone apertures are infilled with stone. Existing ferramenta still evident.*

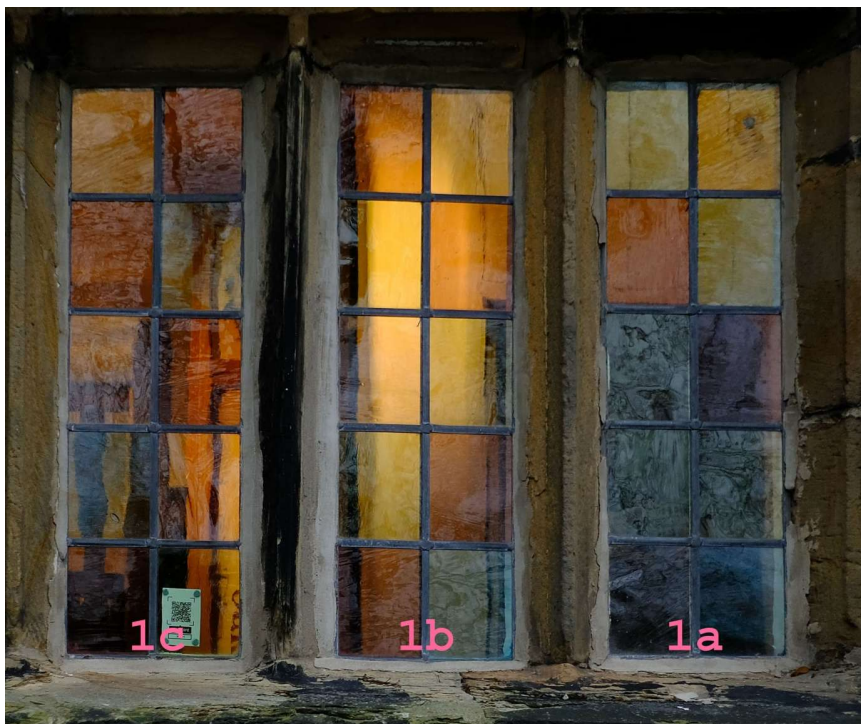
**w2 ref 006 (NW facing)**

*w2 is comprised of three lights sized 12" x 37.5". Block pattern leaded lights in reamy tinted glasses with ½ square ferramenta. All lights in a good condition.*

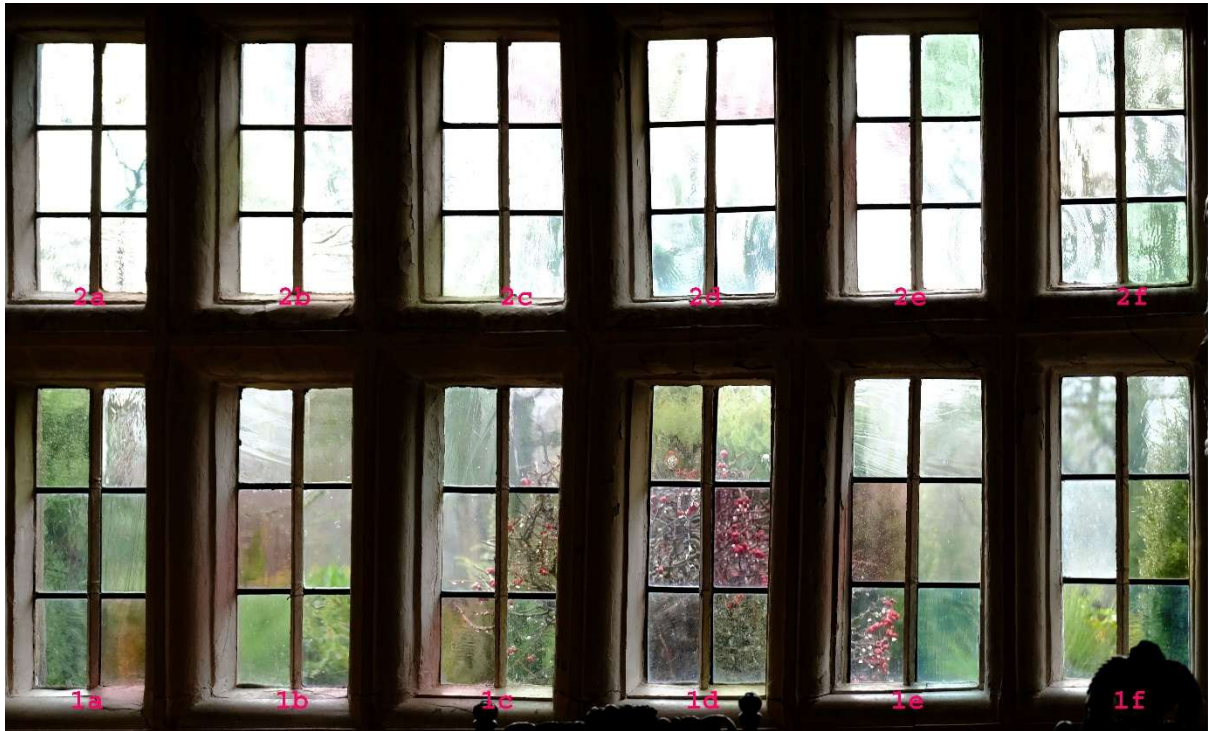
**w3 ref GAL 004 (SW facing)**

This is a 12 light window comprising of 6 main lights sized 11.5 x 24" and 6 transom lights sized 11.5" x 21".

Block pattern leaded lights in reamy and seedy glasses with vertical ferramenta to each. All leaded lights have a U/V museum film applied to the internal surface. There is one broken square quarry in 1d. All copper ties are attached.

As a consequence of the proposed replacement of the whole transom and the mullions below, all lights 12 in total requires removing and re-leading after the museum film has been carefully removed.

This is an ideal time to remove the ferramenta shotblast, treat, paint and caulked into sockets prior to the glazing into the improved stonework.

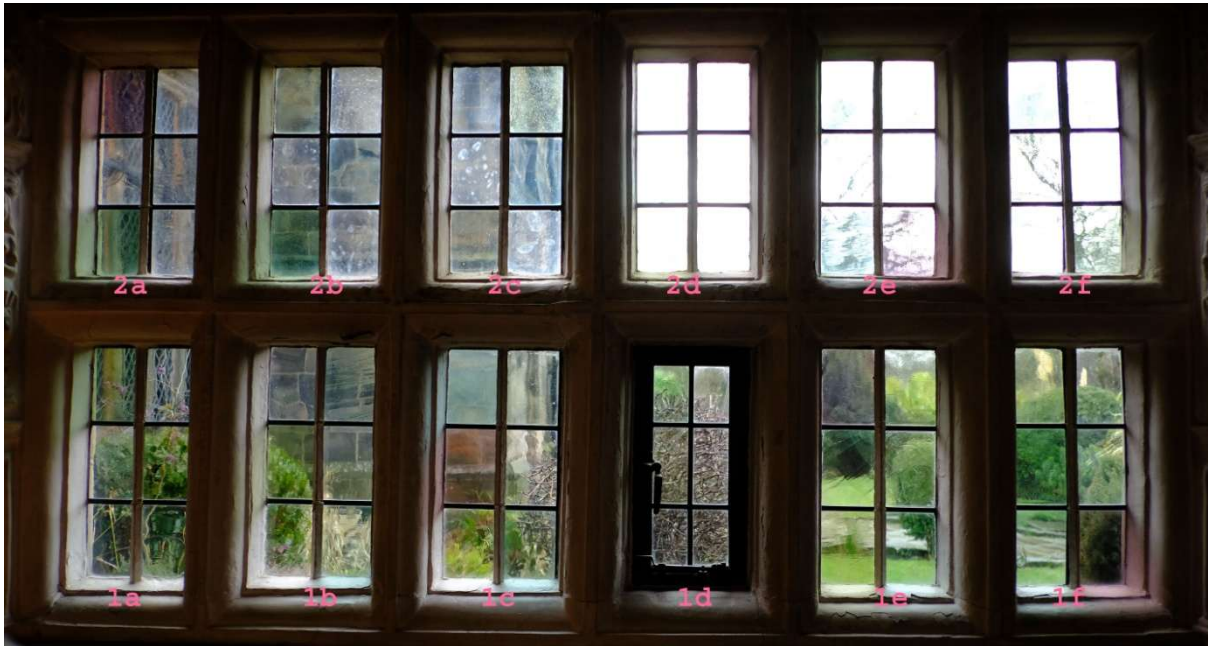
**w4 ref GAL 004 (SE facing)**

This is a 12 light window comprising of six main lights, size 11.5" x 24" and six transom lights size 11.5"-21.5". Block pattern leaded lights in reamy and seedy glasses in mixed tints. All lights have applied museum film. Metal casement is situated in 1d, along with vertical ferramenta to each light.

These lights are in a sound condition but in some cases the ferramenta is not aligned to the leaded panels causing the panels to distort with the tension on the wires. No breakages to the glass and all wires are secure.

To facilitate the stone repairs, lights 1c and 2c, the glass and casement of light 1d, and light 2d need to be removed. The lights need to be re-leaded and re-sited within the repaired stonework.

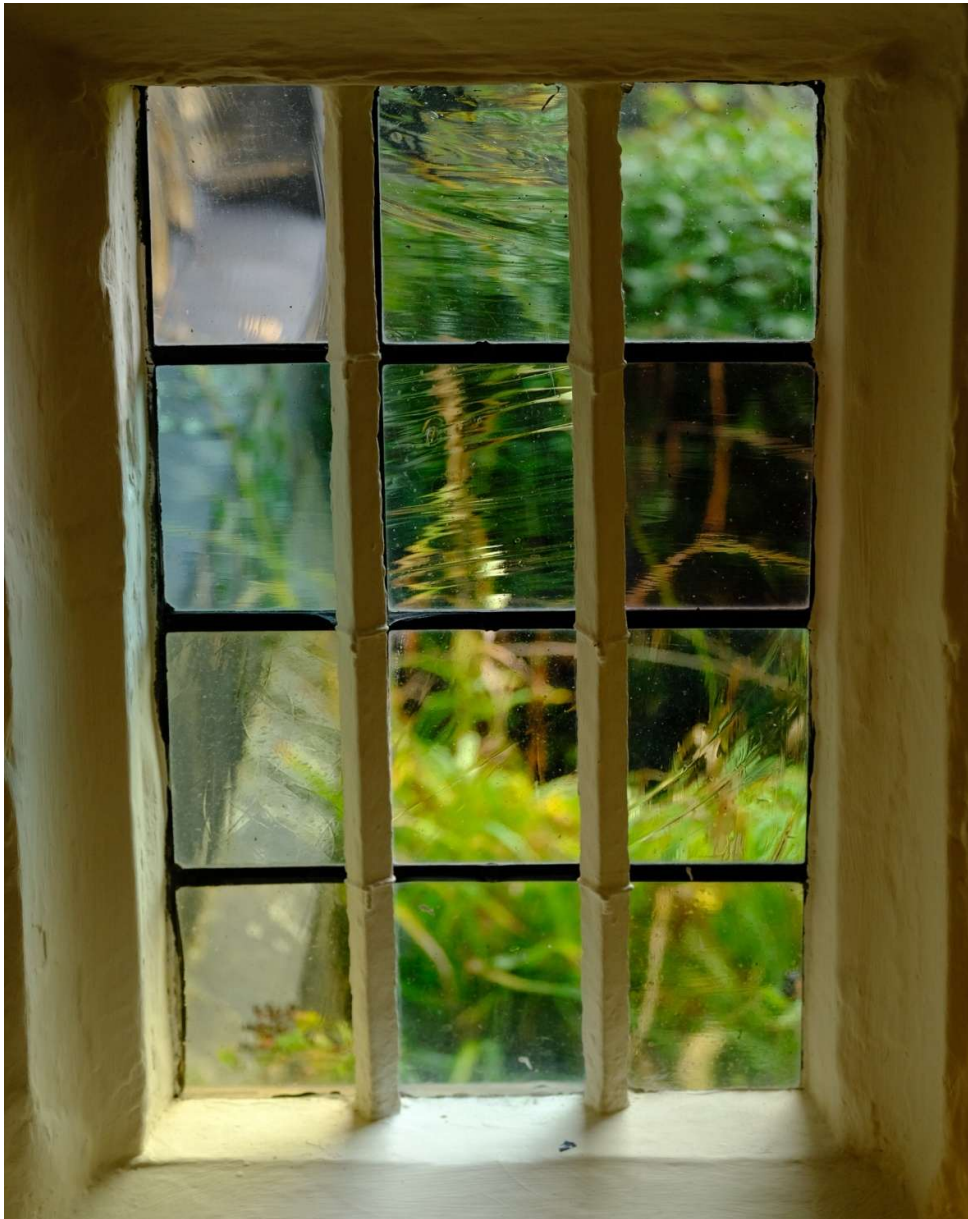
w5 ref GAL4 (SE facing)

w5 is a single leaded light size 15x27.5" in a block pattern with 2 vertical ferramenta. This light is in a good condition with no sign of wire detachment or breakage. Minor stone repair to cill can be left in situ.

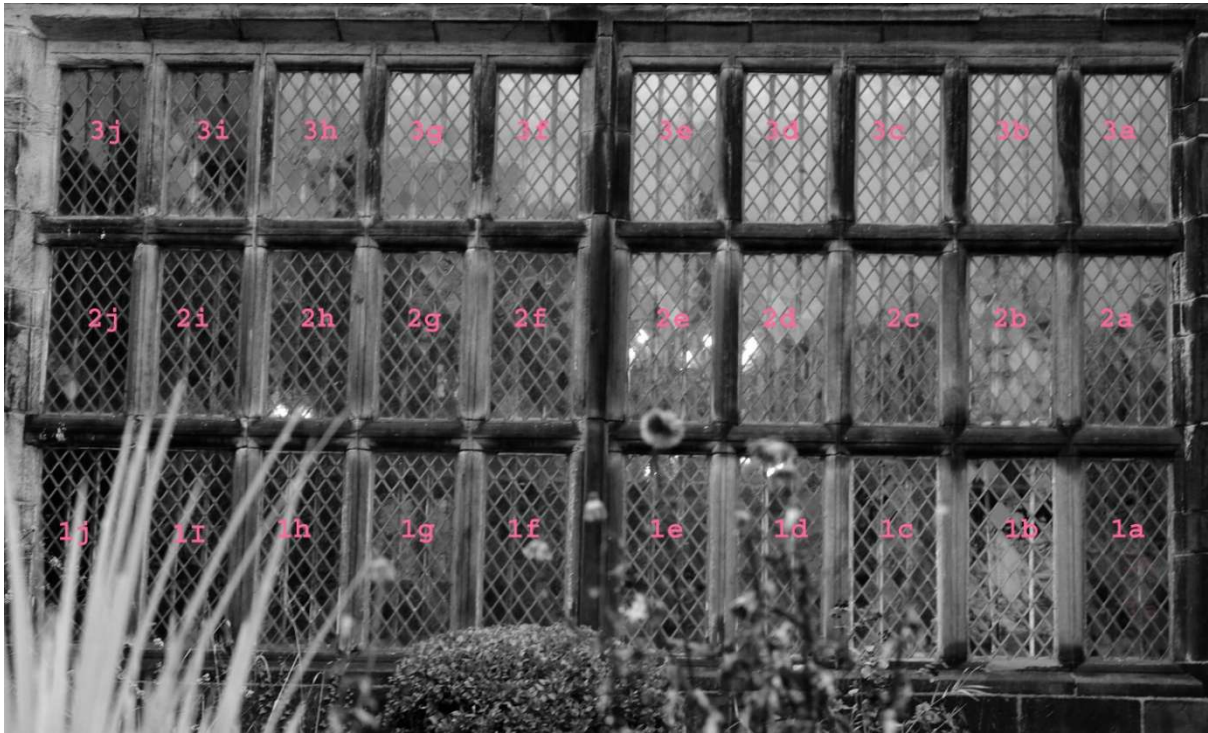
#### w6 Main gallery window ref Gallery (SW Facing)

This is a 30 light gallery window, which is subdivided into rows of 10. Each diamond quarry leaded light is made up of a combination of handmade glasses. These glasses are mouth blown seedy and reamy types with a small percentage of crown glass. All mentioned glasses being in pale tinted tones.

Each diamond light is supported utilising copper ties to attach two vertically situated ferramenta/saddlebars. The wires are twisted to the right tension and the ends snipped off. The lower row of ten lights, situated at cill level, are supported by 7/8 square wrought metal and the upper 2 rows (20 lights) with a timber saddlebars. They are each being held in position with socket in the stone cill and transom.

All lights are pointed into stone apertures with cement based mortar splayed on the inside and filleted on the exterior. The outer fillet has been overlayed with a red mastic pointing. Several cill sections are cracked due to expansion of the corroding ferramenta.

**1a** 17"x40" Diamond light with historic quarries, which have been plated prior to the leading up. One quarry is fractured in the upper portion. Copper ties not secured into the

ferramenta as they are too short. Leaded light is in a good condition. Cill is cracked due to ferramenta.

**1b 17"x40"** A poor replacement leaded light in modern sheet glass in oval lead profile rather than flat lead. Cill is cracked.

**1c 17"x40"** In sound condition with no breaks. No detached copper ties evident. Cill is cracked.

**1d 17"x40"** In a sound condition but with 2 broken quarries at the top. There is evidence of one previous in-situ repair. All copper ties are intact. Cill is cracked.

**1e 17"x40"** In a sound condition. However, the copper ties have been poorly tied off and trimmed. Cill is cracked.

**2a 17"x35"** Leaded light in a good condition. Copper ties are too short to reach round the wooden saddlebars.

**2b 17"x35"** Leaded light in a good condition with no copper ties available to support lead matrix.

**2f 17"x35"** Leaded light in a good condition but 2 diamonds have suffered single breaks.

**2g 17"x35"** Leaded lights are in a good condition. One diamond has multiple breaks. However, the copper ties are secure.

**2h 17"x35"** Leaded lights are in a good condition. However, the copper ties are secure. One diamond has multiple breaks.

**3c** 17"x30" Leaded light in a good condition, however, there are two quarry breaks. Copper ties are too short to reach round wooden saddlebars.

- 1) Take out panels that have short ties and panels directly adjacent to proposed stone repairs.
- 2) Replacement of the border leads and the removal of existing copper ties.
- 3) Manufacture of a new panel as the original.
- 4) The opening of the ferramenta sockets on the first row of leaded lights and the treatment of ferramenta ends and the caulking with lead wool into the sockets.
- 5) The in-situ repair of minor breakages
- 6) The installation into stone apertures with lime mortar.
- 7) The removal of all red mastic pointing outside to all.

Lights removal for stone repairs – 1c,1d,1e,1i and 1j. 2g,2h,2i, 3d,3e,3f,3g,3i and 3j.

Lights removal for replacement copper ties – 1a, 2a, 2b, 2c, 2d, 3a, 3b, 3c.

Treatment of ferramenta ends and the caulking with lead.

| W6 | Removal of 21 lights remove and replace edge leads and copper ties..... |

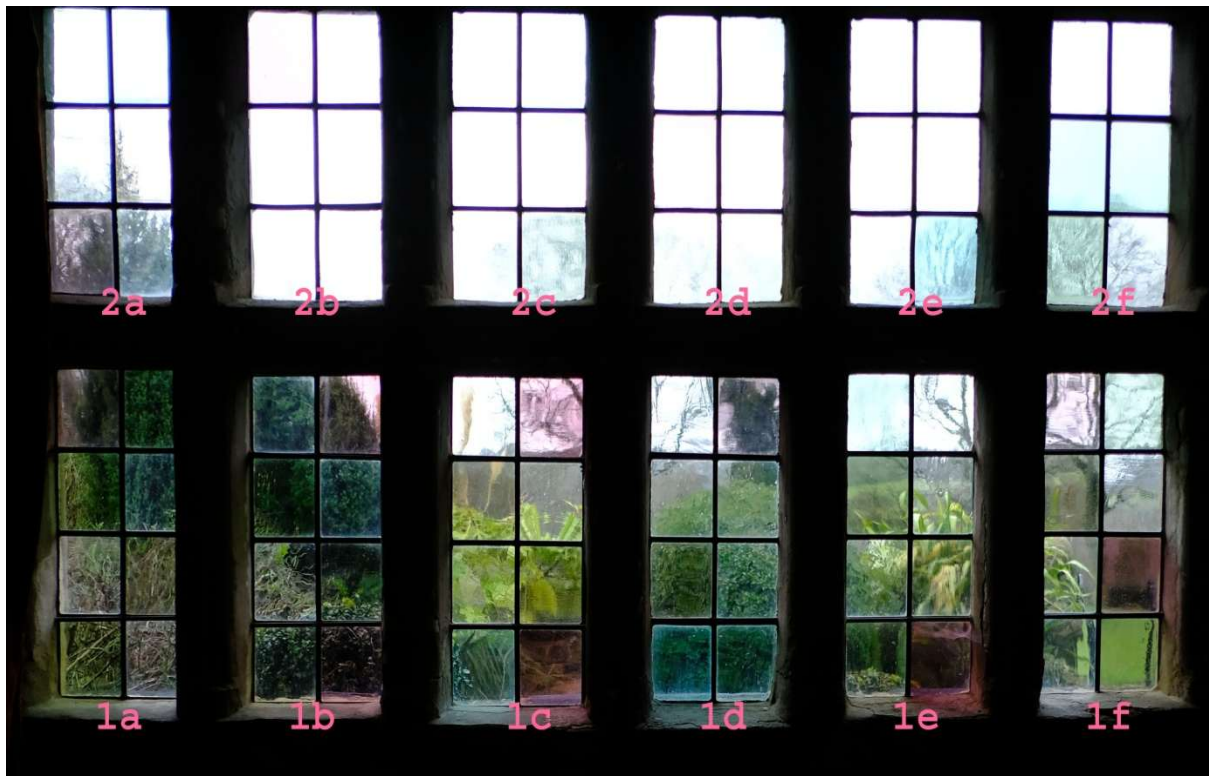
w7 ref GAL 015 (SW facing)

A bank of 12 lights, comprising of 6 lower lights and 6 transom lights. Dimensions of the 6 main lights – 12.5" x 27.5". Dimensions of the 6 transom lights – 12.5" x 24.5"

All lights are block pattern and are made up of mixed tinted mouth blown glasses. Each light is supported by horizontal 3/8 round saddlebars. The transom lights have U/V museum film applied. The lights are in a sound condition with no breakages. The ferramenta is showing minor oxidation. To facilitate stone repairs, the lower lights (total 6) will require the removal and re-leading.

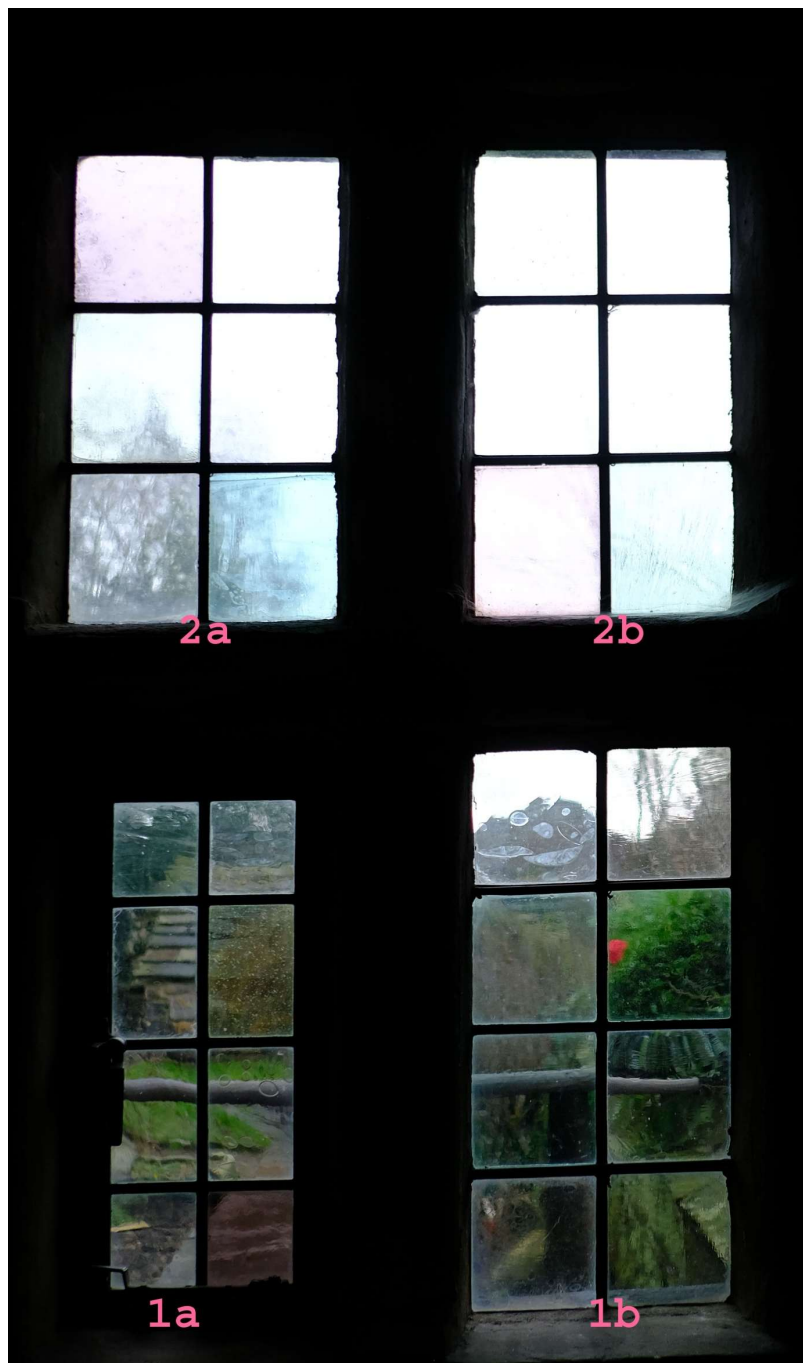
4 light window comprising of 2 main lights and 2 transom lights. Dimensions of 2 main lights – 12.5” x 27.5” 2 transom lights – 12” x 24”

These block pattern leaded lights are in a mix tinted mouth blown glass with an opening casement in 1a. All glasses are treated with U/V museum film. No breakages or wire detachment. To facilitate stone repairs, the removal of lower light 1a and 1b along with the metal casement is required.

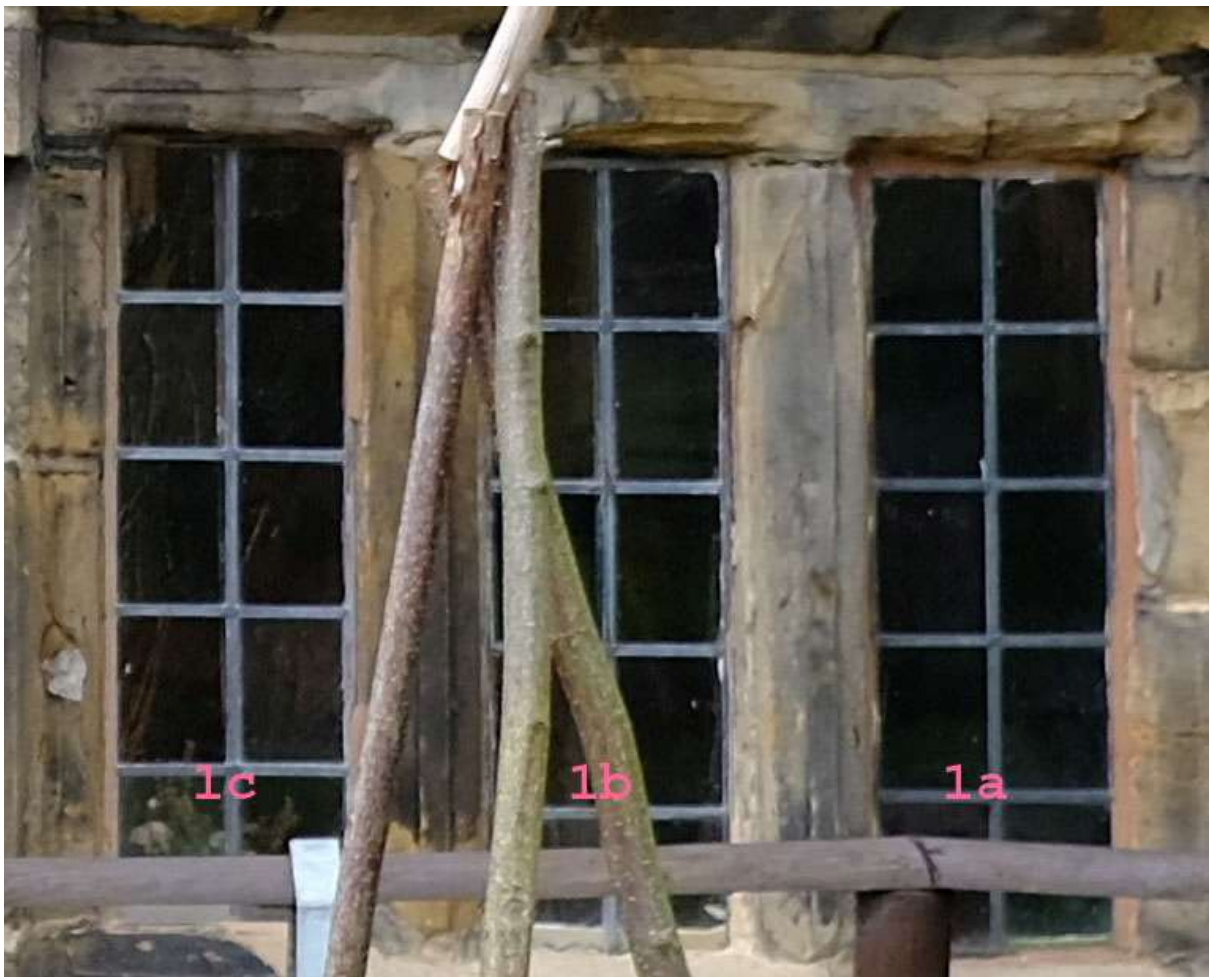
3 lights in a block pattern. Size 12"x37.5" Leaded lights are in a mixed tint mouth blown glass. Each supported by 7/8 ferramenta. One has been replaced with ¼ round bar. No breakages or tie detachment present. To facilitate the stone repairs, the removal of the three leaded lights and the re-leading as per the original. The removal and treatment of the ferramenta and replacement of one saddlebar.

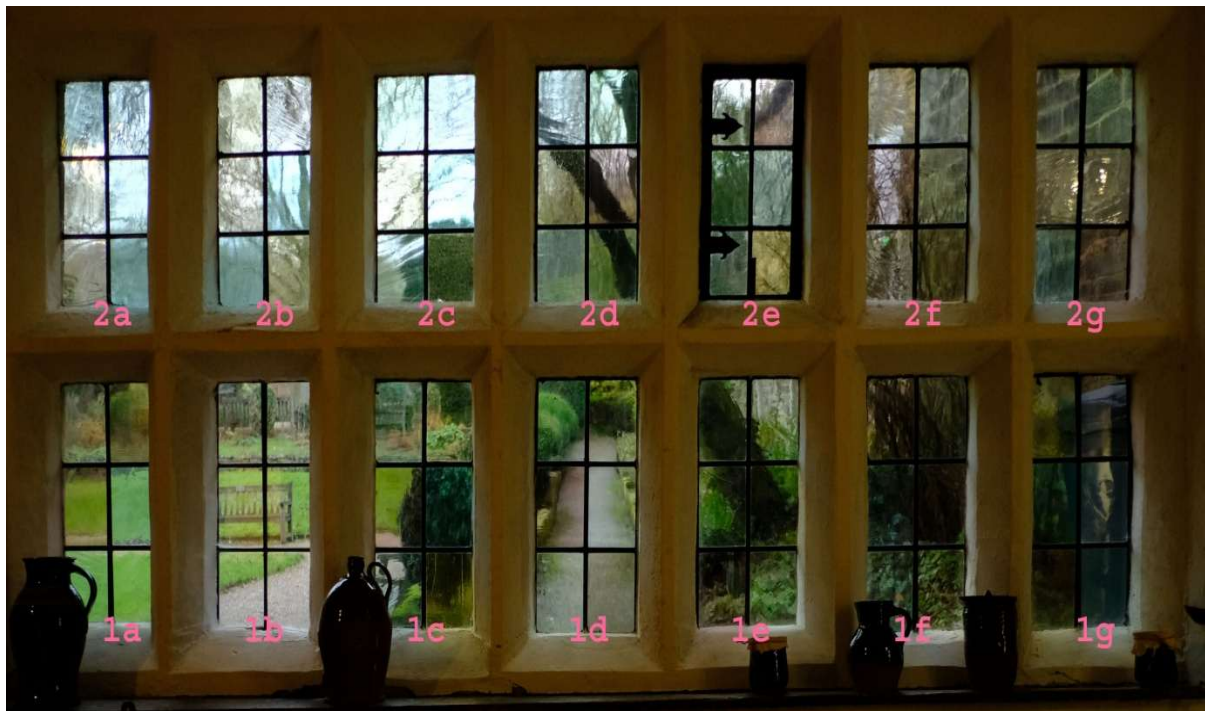
**w10 ref GAL 011 (N/E facing)**

14 light window, comprising of 7 main lights and 7 transoms. Dimensions of the main lights are 12"x24" and transom lights 12" x 22"

Leaded lights are block patterned in tinted reamy and seedy mouth blown glasses. Each have a ¼ round vertical ferramenta with opening casement in e2. All leaded lights are in a fair condition. 1b is a poor replacement being made in commercial sheet glass. There is corrosion to the saddlebars but no detached ties.

To enable stone repairs to the mullions and cill, all fourteen leaded lights, including the transom casement, need to be carefully removed. Thirteen lights to be re-leaded, and one new replacement light to be manufactured to match the original. New square ferramenta needs to be installed.

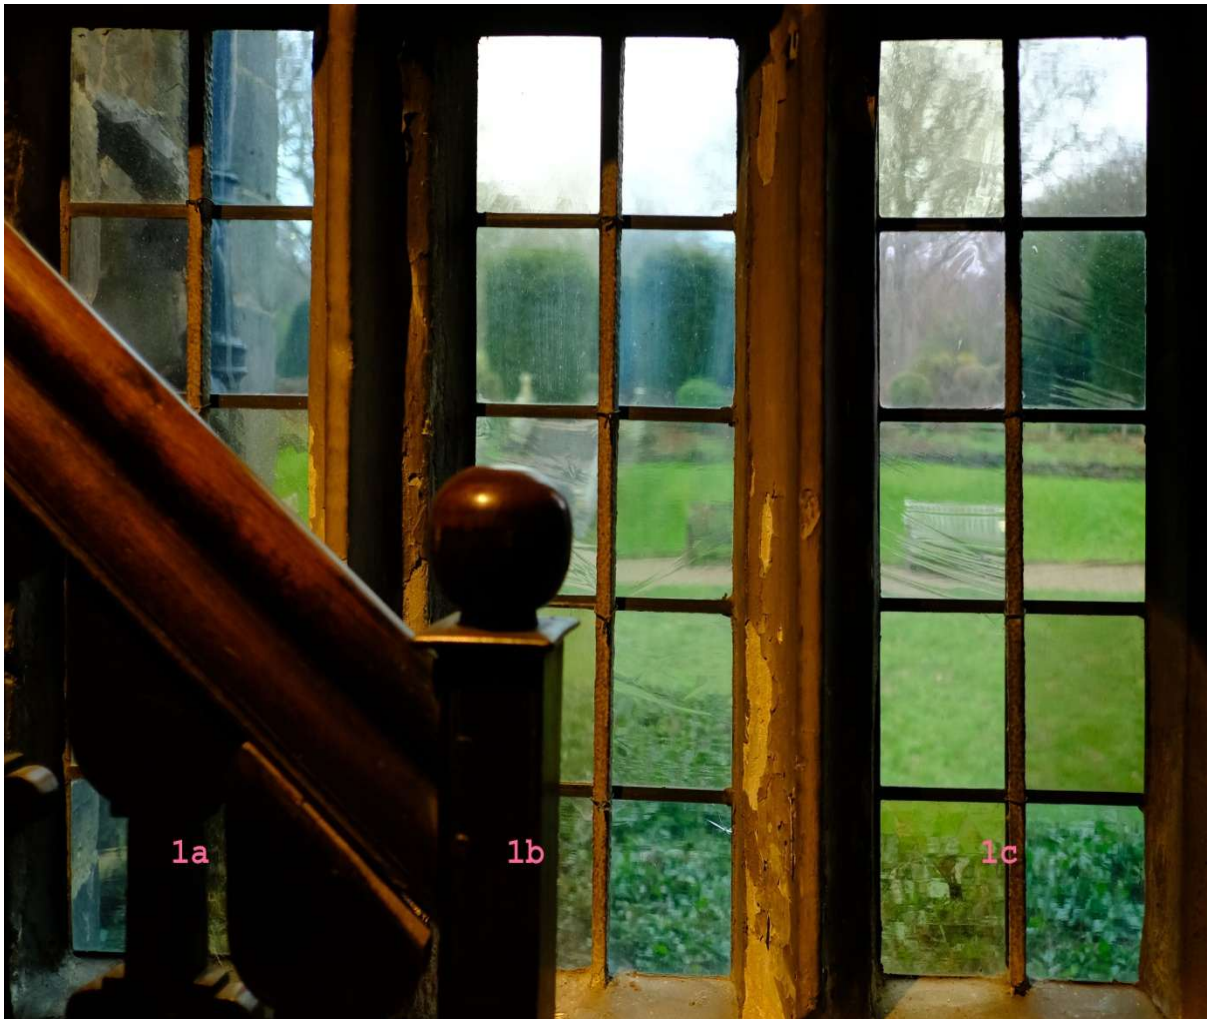
w11 staircase (NW facing)

This is a three light window with dimension of 11.5" x 35". Lights are in a block pattern in mixed tint mouthblown glasses with vertical ferramenta. They are all in a good condition with no breakages or tie detachment.

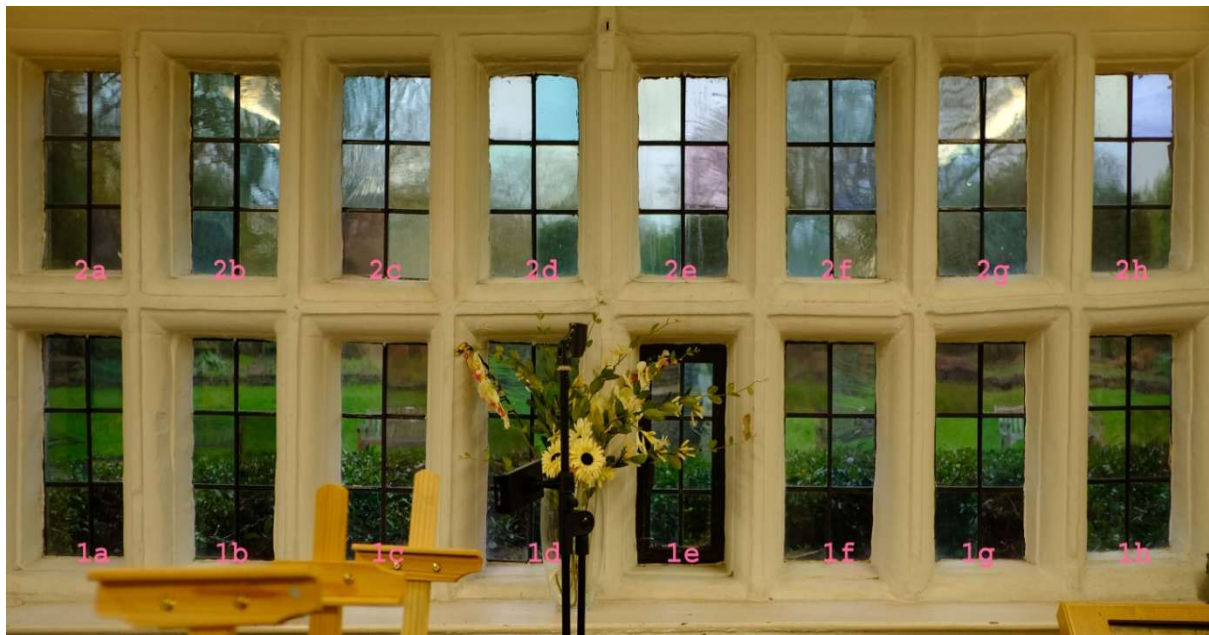
**w12 ref Staff 009 (NE Facing)**

16 light window comprising of 8 main lights (12"x24") and 8 transom lights (12"x22")

These are block patterned leaded lights in tinted and seedy mouth blown glass with an opening casement light 1e. Each is supported by 5/16 vertical steel ferramenta.

The leaded lights are in a fair condition, although the ferramenta to the transom lights is poorly aligned. The glass is starting to get stained due to condensation build up. All ties are attached.

To facilitate stone repairs, 12 lights are directly affected it would be prudent to remove all lights and opening casement and re-lead and replace ferramenta with suitable non-ferrous replacement.

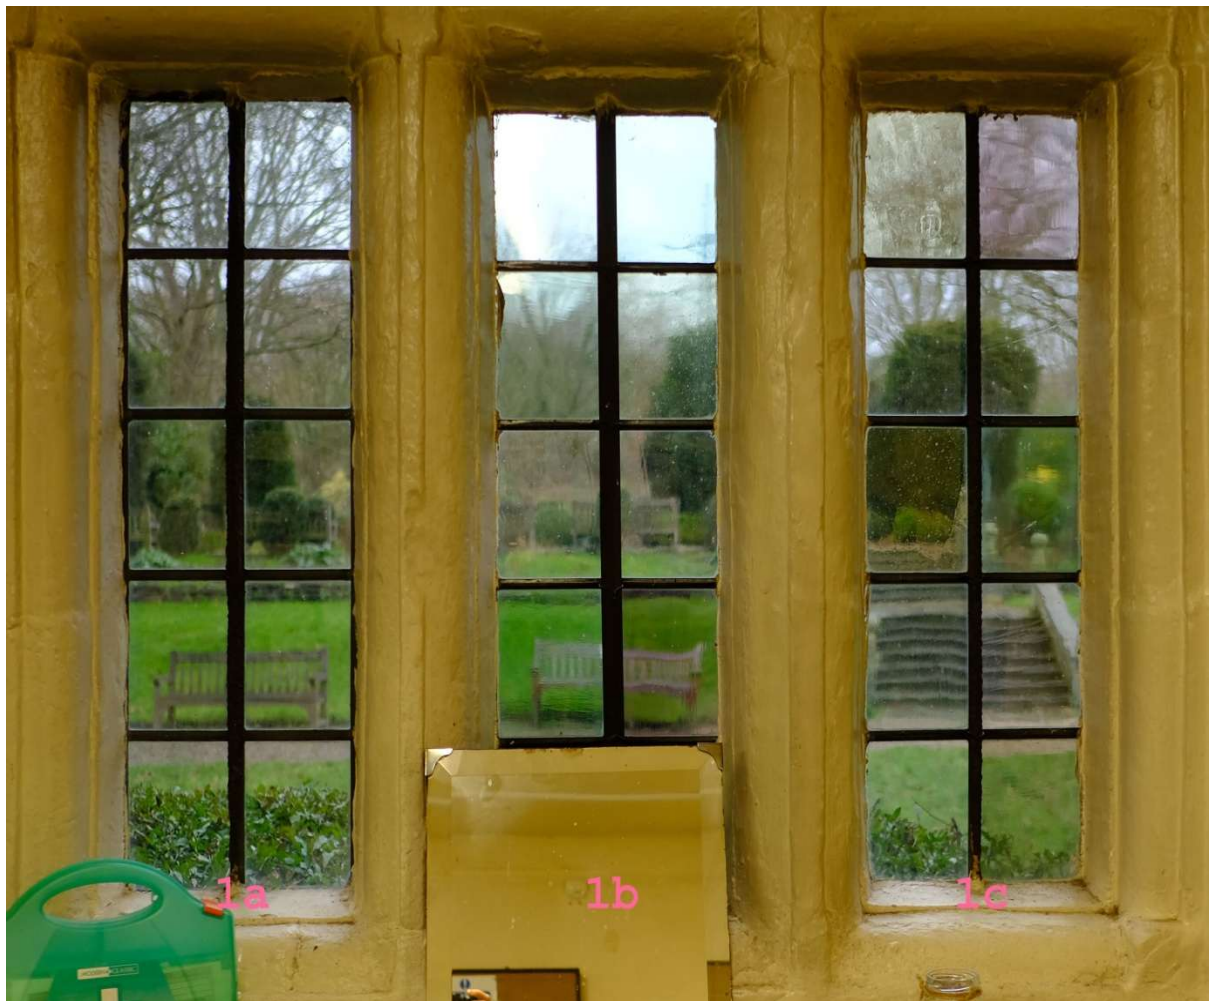
This is a 3 light window, which are all 12" x 34".

They are block pattern leaded lights in a pale tinted mouth blown glasses with vertical ferramenta. The lights are in a fair condition.

Light 1a is a poor replacement manufactured in commercial sheet, with no ties securing to the ferramenta. This needs to be replaced with a leaded light manufactured to the original specification.

Light 1b has a saddlebar that is round rather than square.

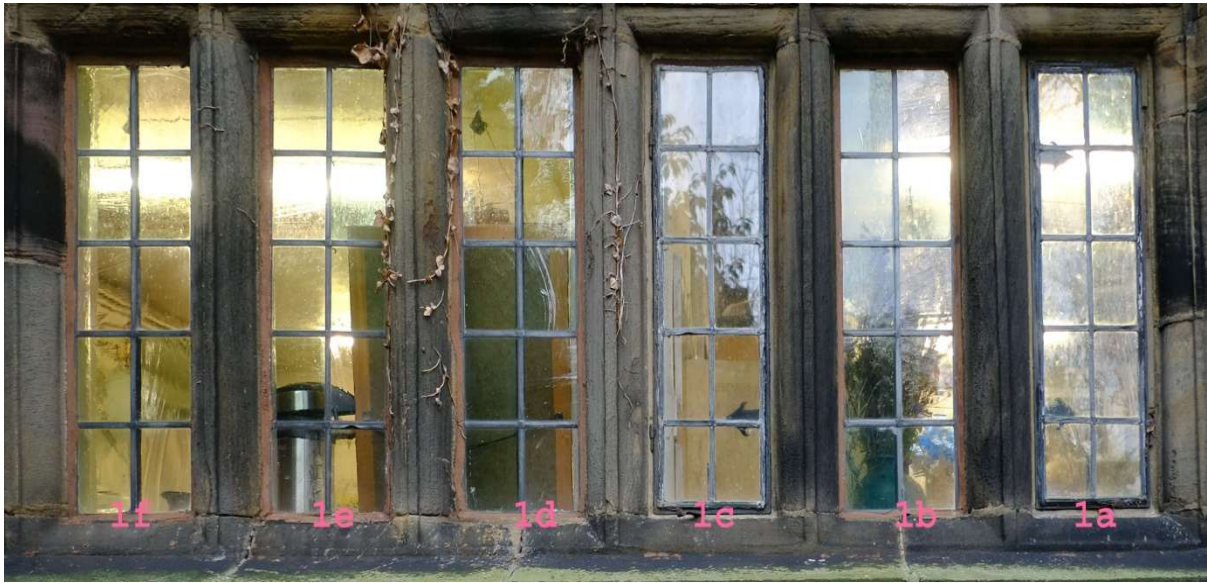
**w14 ref Staff 008 (N/W facing)**

This is a 6 light window in which are all 12"x36" in size.

Block pattern leaded lights in a pale tinted mouth blown glasses with vertical ferramenta. 1a and 1c contain a metal casement.

1a is in a poor condition. There is evidence of a previous in-situ repair. The metal casement is showing signs of corrosion, thus difficult to operate. It has an inadequate ¼ inch round ferramenta.

1b is in a poor condition. It has an inadequate ¼ inch round ferramenta.

1c leaded light is a poor replacement in commercial sheet and is in a weak condition due to previous in-situ repairs. The metal casement is showing signs of corrosion and is difficult to operate. It has an inadequate ¼ inch round ferramenta.

1d leaded light is in a fair condition with evidence of one in-situ repair. Ferramenta is the original 5/8" square.

1e leaded light is in a fair condition with evidence of one in-situ repair. It has an inadequate ¼ inch round ferramenta.

1f leaded light is in a fair condition. The ferramenta is original 5/8 square wrought iron.

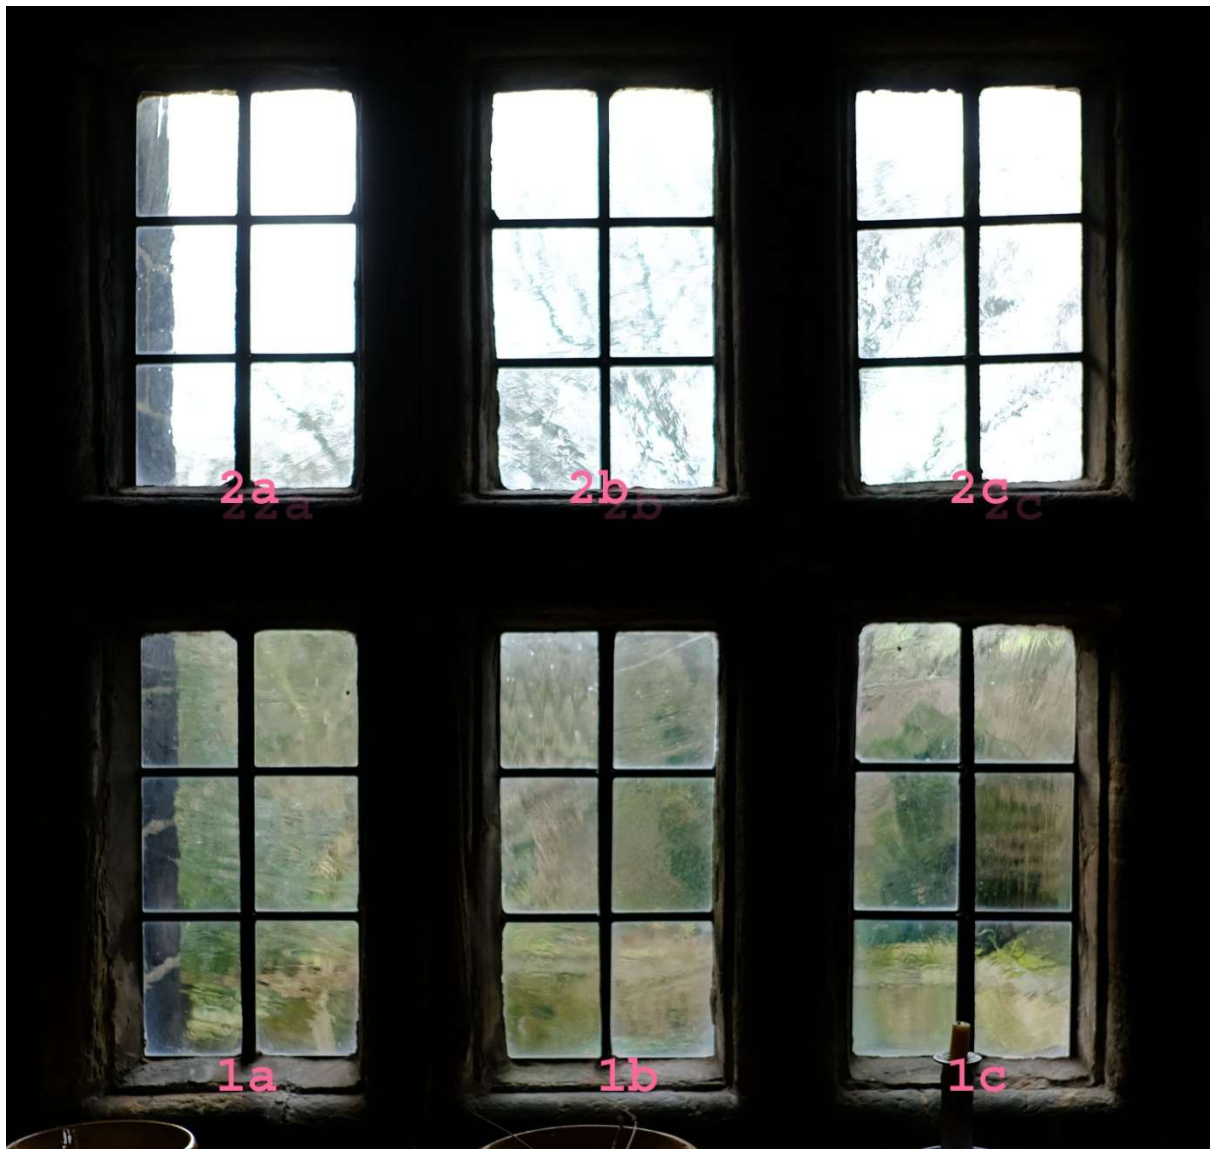
This is a 6 light window comprising of 3 main lights (11.5" x 22") and 3 transom lights (11.5" x 20")

6 leaded lights in block pattern in a pale tint mouth blown glass in reamy and seedy. All lights have U/V museum film applied, which has been poorly executed with air bubbles.

All leaded lights are in a reasonable condition with no breakages and all wire ties are connected. The ferramenta in 2b is underweighted in 5%. No stone repairs to U/W1.

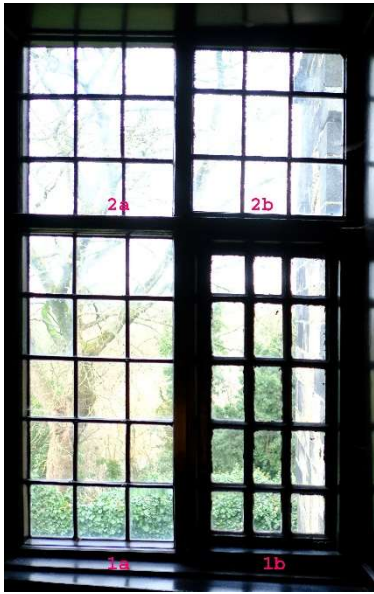
**u/w2 ref GAL 113 (N/W Facing)**

This is a 4 light window comprising of 2 main lights (16"x35") and 2 transom lights (16"x20")

The 4 light timber frame with an opening casement situated in 1b. This window has leaded lights made up in sheet glass with possible drawn sheet in the opening casement. The lights are supported by horizontal saddlebars.

Light 1a is in a good condition with no breaks and all ties are secure.

Light 1b is possibly early Victorian with the lead came painted in white and on to the glass. Otherwise it is in a fair condition with no breaks.

Lights 2a and 2b are poorly aligned to panels below. All ties are secure and there are no breakages.

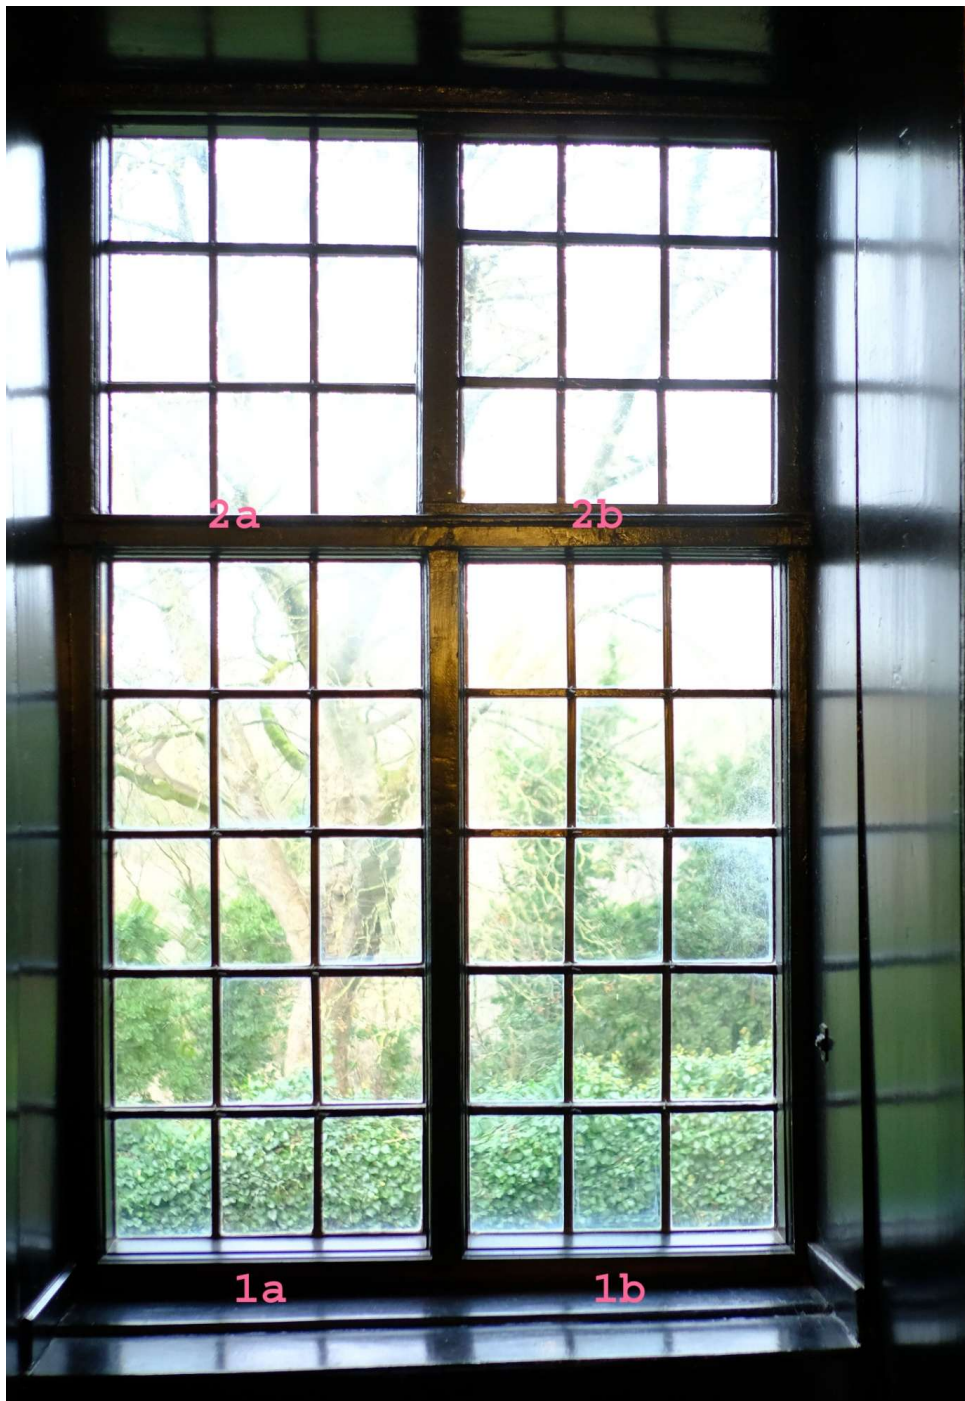
u/w3 ref circ 112 (N/W facing)

This is a 4 light with 2 main lights (16"x35") and 2 transom lights (16"x20")

The four light timber frame has an opening casement in 2b. This window has leaded lights made up in sheet glass and possible drawn sheet. Each light is supported by horizontal saddle bars. All lights are in a good condition with all ties secure. However, light 2b is slightly out of line.

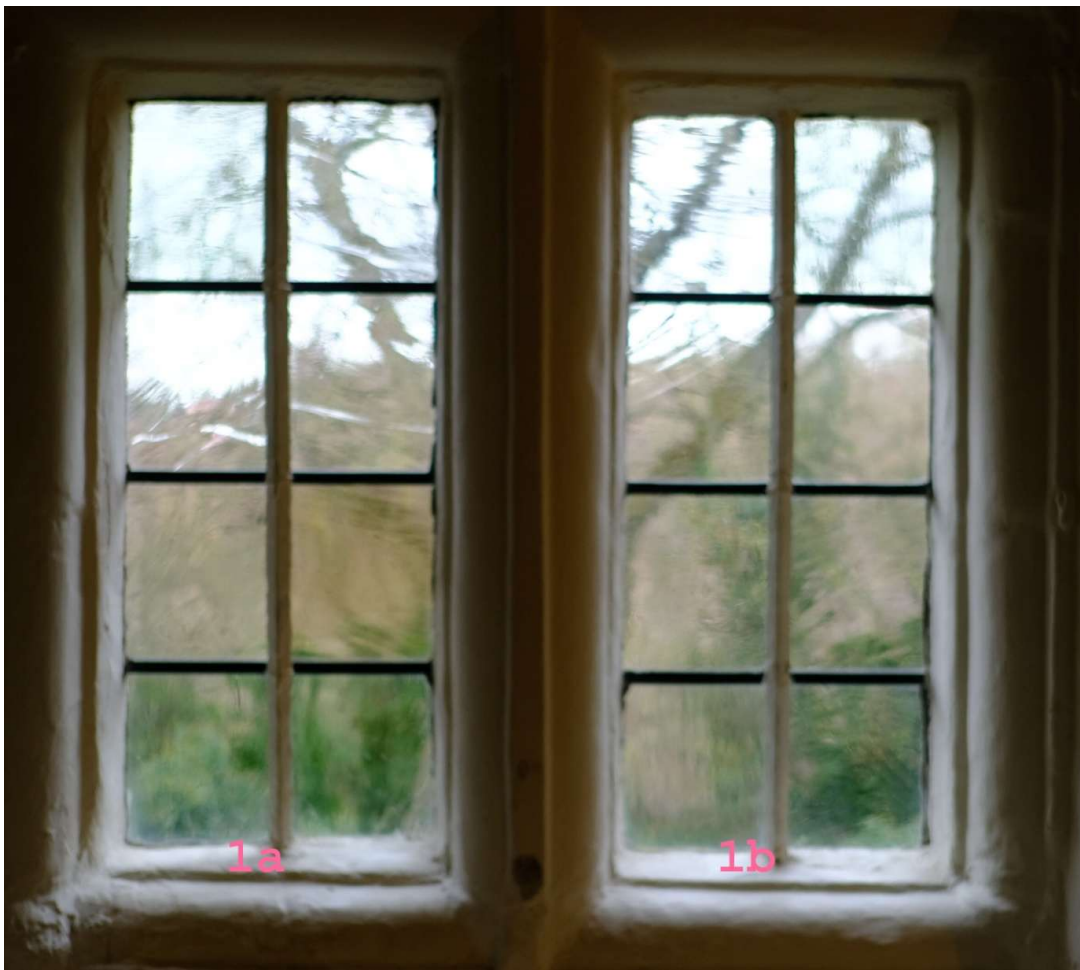
u/w4 ref circ 112 (N/W Facing)

2 light window with dimensions of 12" x 27.5". They are a 2 block pattern leaded lights in reamy mouth blown glasses with pale tints. Each light is supported by vertical ferramenta. Lights are in a reasonable condition and all ties are attached. Some evidence of verdigris build up at the base of the window caused by poor ventilation.

Recommended to clean the glass and paint the frame.

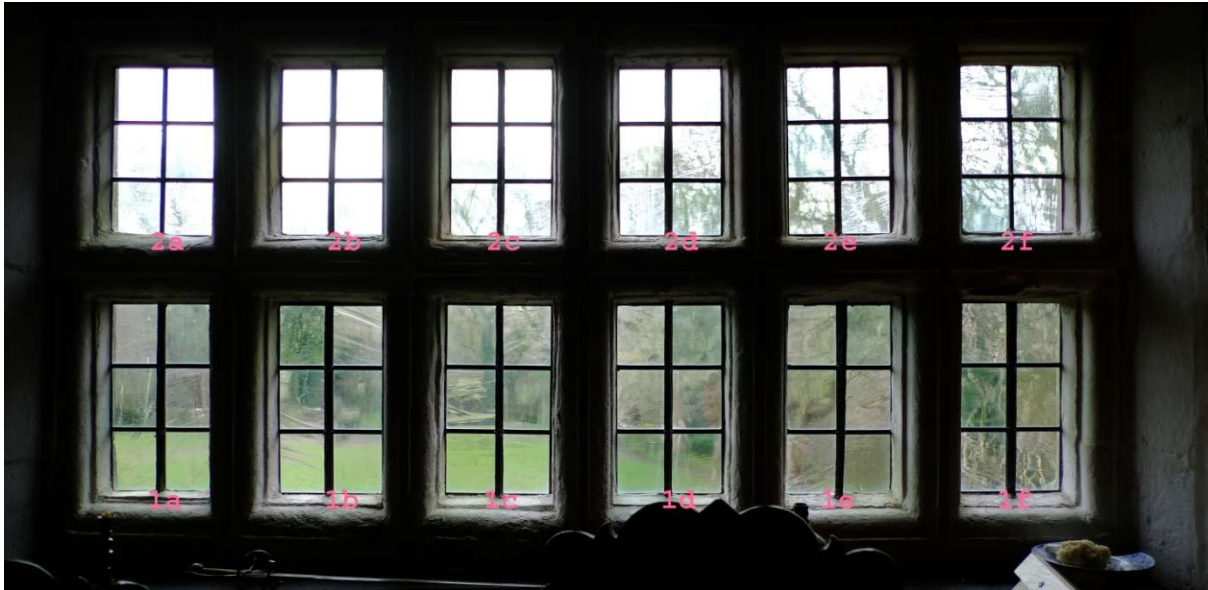
**u/w5 ref GAL 109 (S/W facing)**

It is a 12 light window, comprising of 6 main lights (size 12" x 24") and 6 transom lights (size 12"x21"

Block pattern leaded lights in a reamy mouth blown glasses in pale tints. Each light is supported by vertical ferramenta. These windows are not film coated. All lights are in a good condition 2a and 2f are supported by  $\frac{1}{4}$  round bar, and 2b contains one broken quarry. To facilitate stone repairs, the removal of 1a 1c +1d, 2a, 2c and 2d - re leading of 6 leaded lights and the treatment of ferramenta

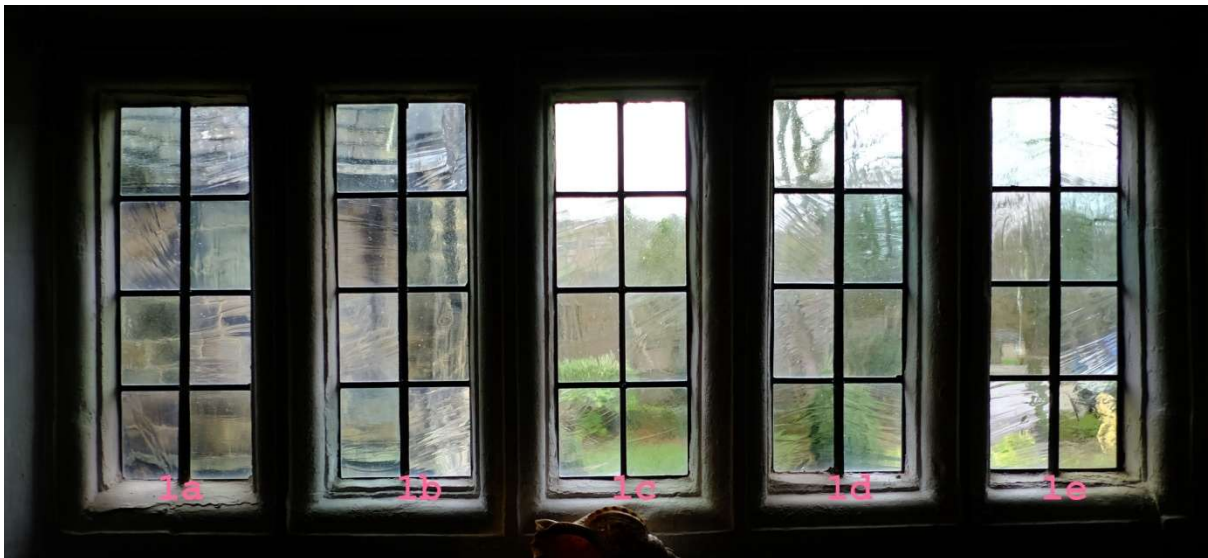
**u/w6 ref GAL 110 (S/E facing)**

5 light window sizes 11.5"x32".

Block pattern leaded lights in reamy mouth blown glasses in pale tints. Lights are in a reasonable condition. 1c has a  $\frac{1}{4}$  round bar. All copper ties are attached.

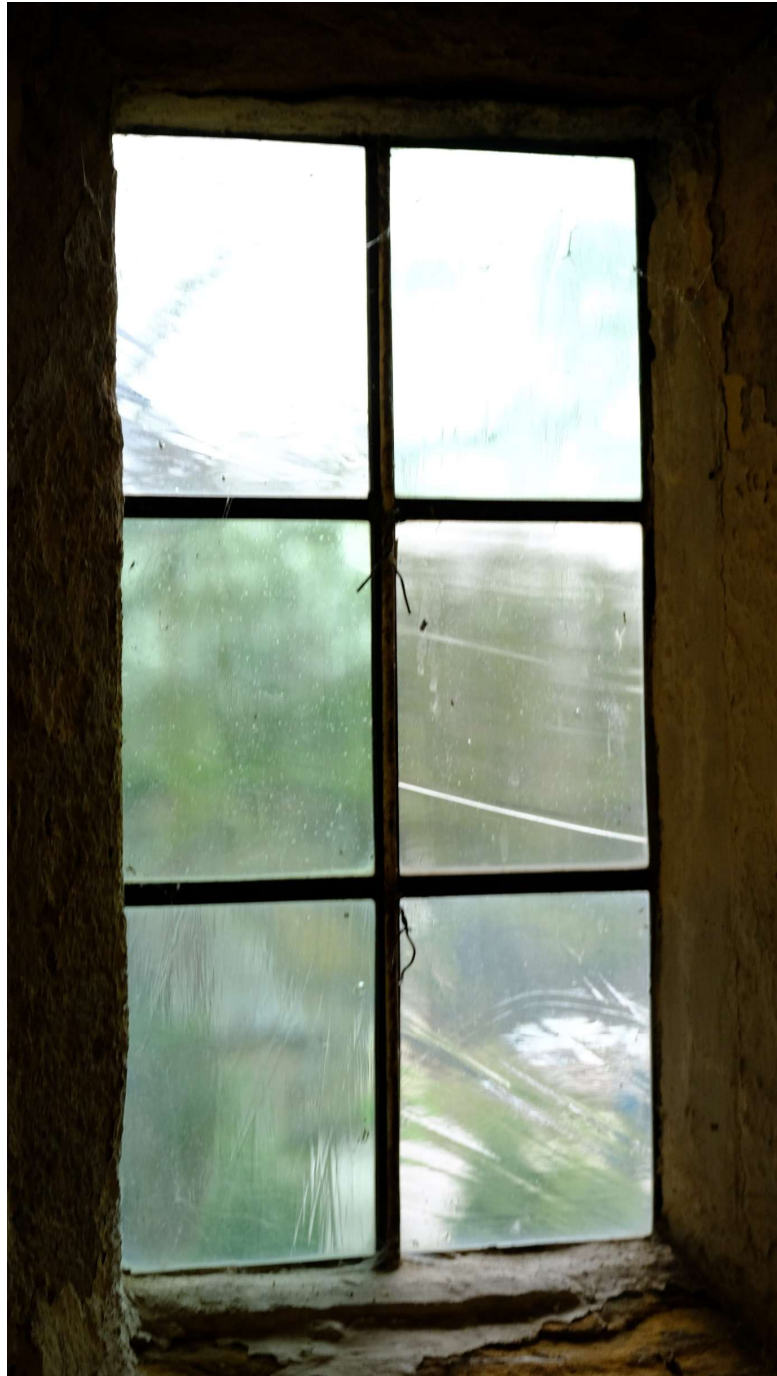
Single light size 13"x24.5". Leaded light made up in reamy tinted mouth blown glasses with vertical central ferramenta. This light is in a fair condition. However, the central ferramenta is inadequate and the ties are detached.

To facilitate stone repairs, the removal of leaded light and the re-leading also the replacement of the ferramenta.
