# Glass survey of Oakwell Hall

Undertaken by Dennis  
Eckersley 2025/2026

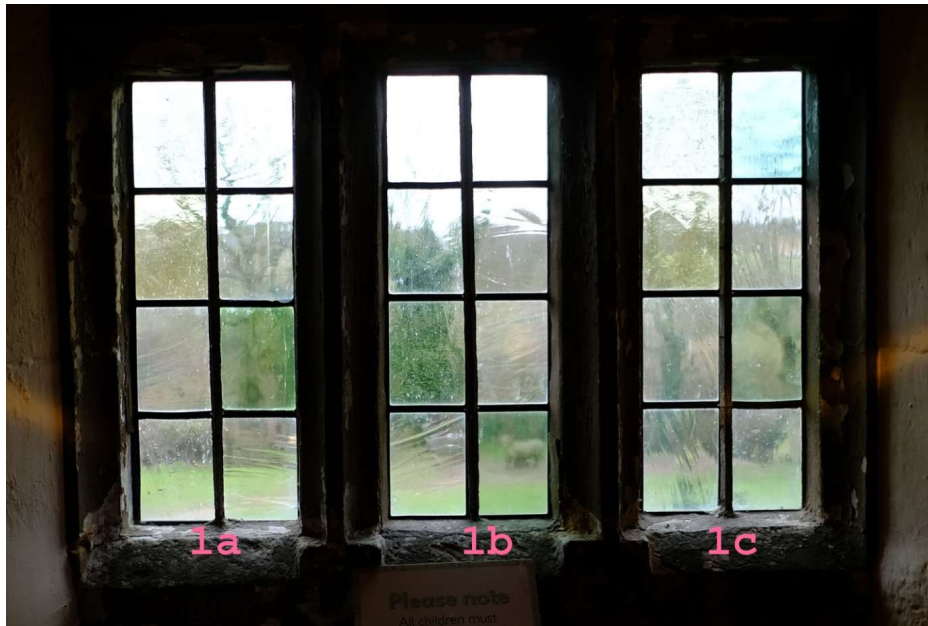
u/w8 ref GAL 106 (S/W facing)

3 light window size 11.5"x31".

Block pattern leaded lights in reamy and seedy mouth blown glasses with vertical ferramenta. All lights are in a reasonable condition. Light 1a has been repaired in-situ.

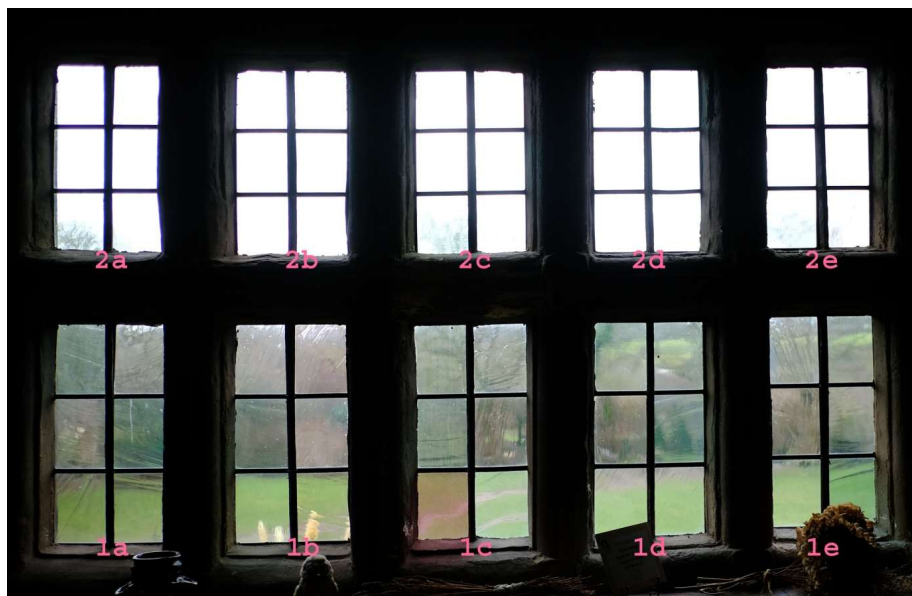
u/w9 ref 105 (S/W facing)

10 light window. 5 main lights are 12"x23" and 5 transom lights are 12" x19.5".

Leaded lights are made up in reamy tinted mouth blown glasses with central ferramenta to each. Both transoms and main lights do not sit up against the ferramenta and as a consequence have been pulled in as the wires were tightened. All ties twisted but not trimmed off.

To facilitate stone repairs, 6 lights are directly affected. I recommend the removal of all lights (10 in total), the re-leading of all and the treatment of ferramenta.

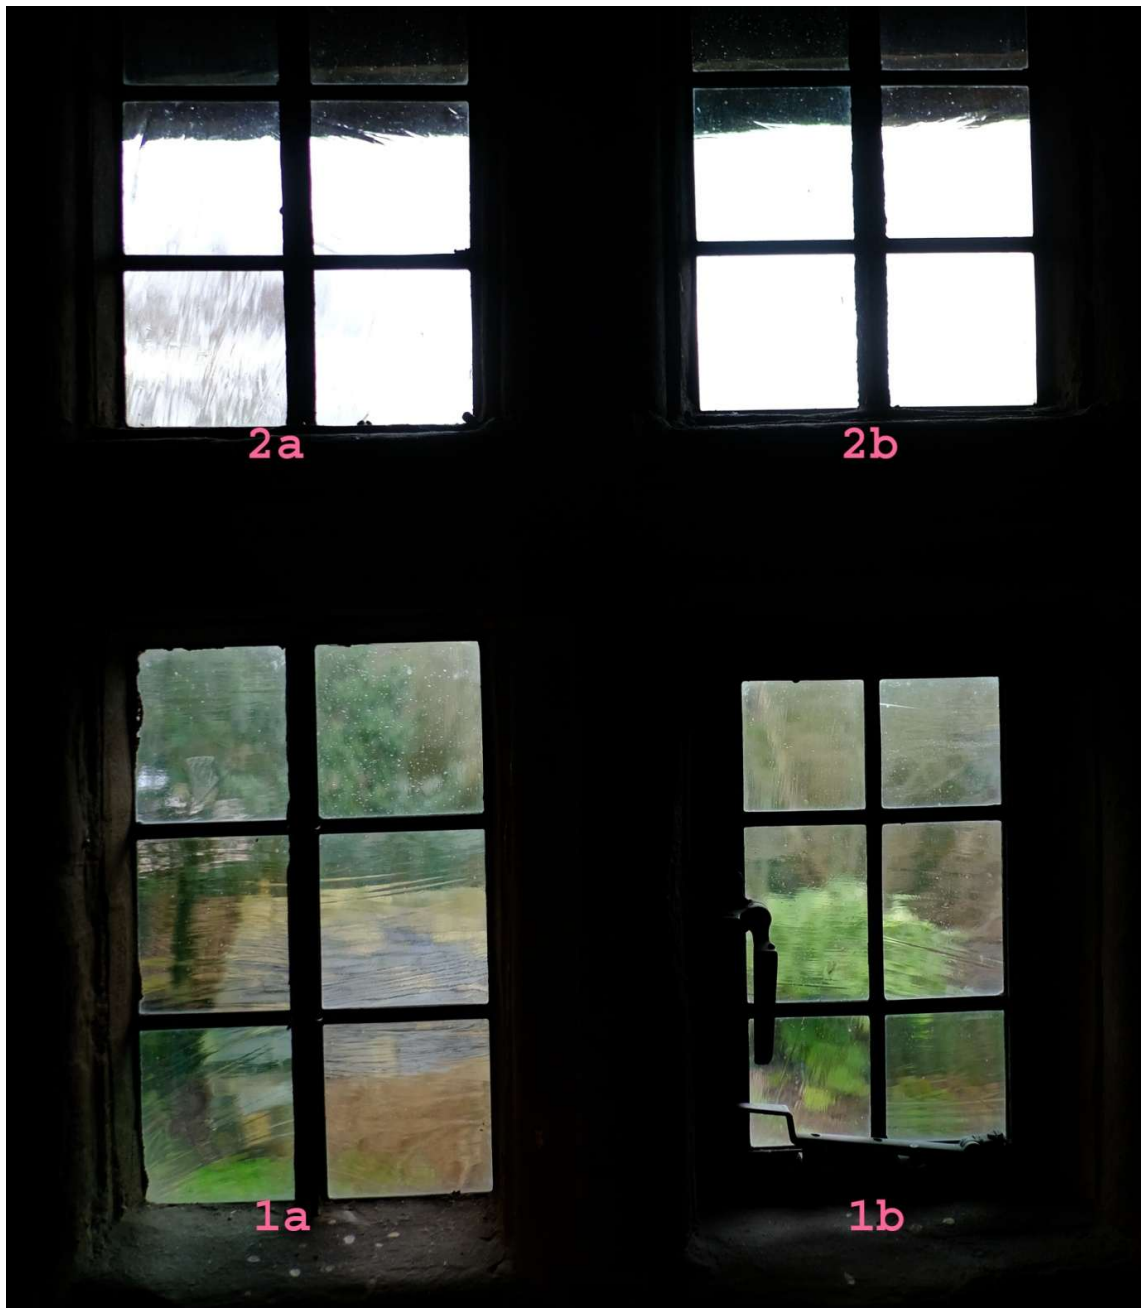
u/w10 ref GAL 105 (S/E facing)

4 light window. Sizes 2 -12"x18" Sizes 2 – 12"x17"

Leaded lights are made up in tinted reamy mouth blown glasses with an opening casement in Light 1b.

All in a good condition with all ties attached.

To facilitate stone repairs, the removal of 1a and 1b, which contains an opening casement. The re-leading of 1a and the re-leading of the opening casement needs no action other than re-sitting into stone apertures.

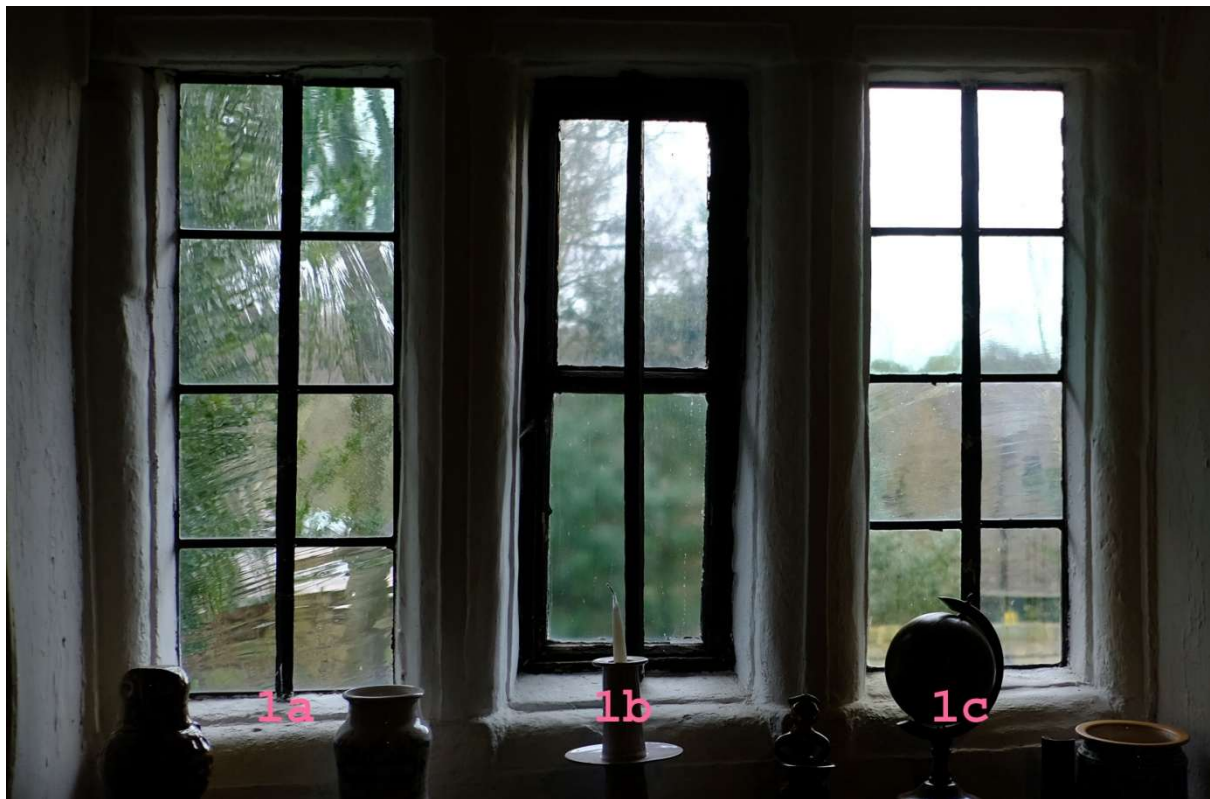
3 light window sizes 12"x23".

Leaded lights are in tinted reamy mouth blown glasses with a wooden casement situated in 1b. Outer light has vert ferramenta. The leaded lights 1a and 1c are in a reasonable condition but the wooden casement is inoperable and in a poor condition. The glass within the leaded light is sheet glass.

To facilitate the stone repairs, the removal of 1b wooden casement and 1c, the re-leading of 1c and the manufacture of a metal casement window and a new leaded light in reamy glasses to match others.

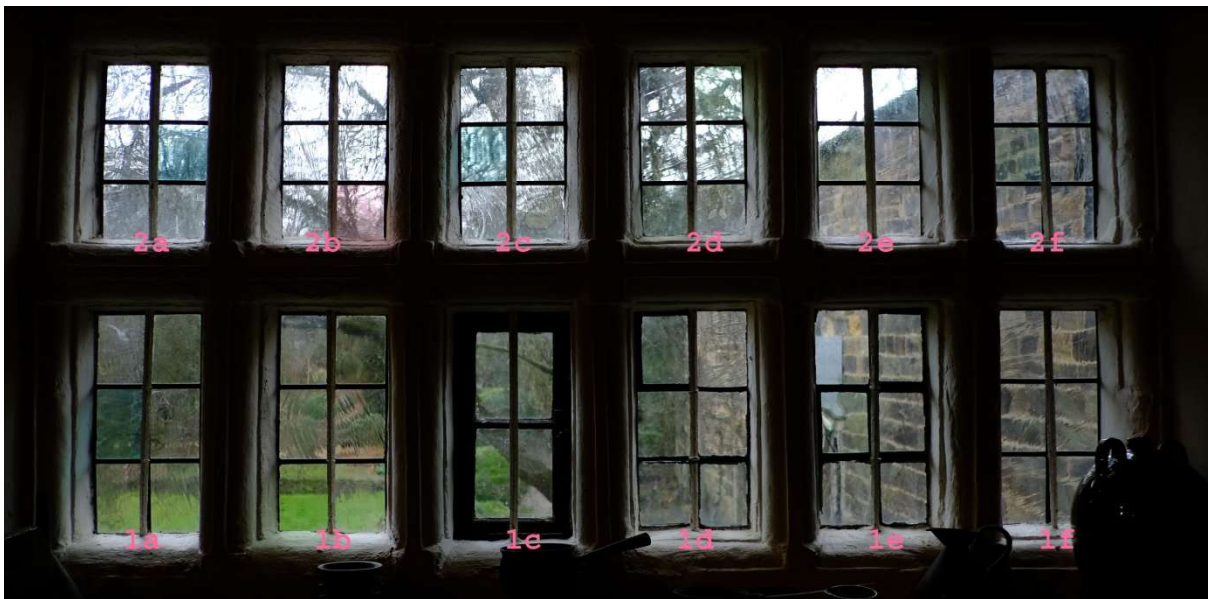
u/w12 ref GAL 102 (N/E facing)

12 light window consisting of 6 main windows (size 12"x27") and 6 transom 12"x24".

Leaded lights are in tinted reamy mouth blown glasses with a wooden casement in 1c. The leaded lights are supported with vertical ferramenta.

All lights are in a fair condition, casement 1c is inoperable and in a poor condition. The ties are all attached. The replacement of opening casement 1c and the glass within replaced with a leaded light in reamy glasses. Panels 1d and 1e are in a poor condition, 1d is especially distorted.

To facilitate stone repairs, nine leaded lights are directly affected. Take out 11 leaded lights and re-lead, the removal of timber casement and manufacture of one leaded light to original specifications. Also, the treatment of the vertical saddlebars.

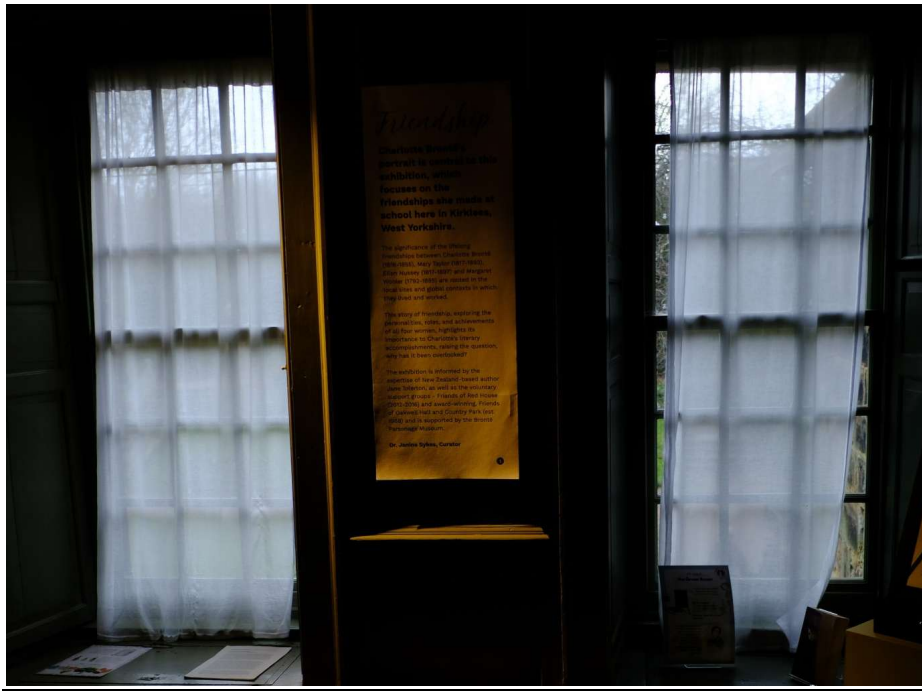
**u/w13- u/w14 ref GAL 107 (N/E facing)**

Georgian style sash windows that are glazed in toughened glass. These require no action.

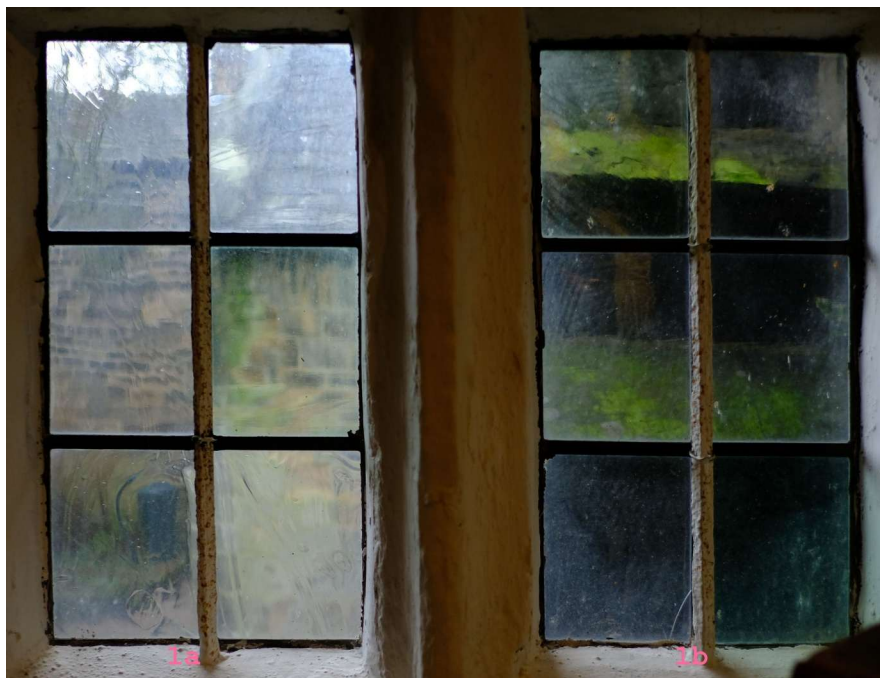
**u/w 15 ref circ 119 (N/E facing)**

2 light (size 12" x 22") block pattern leaded lights in tinted reamy glass with vertical ferramenta. Leaded lights are in a fair condition with all ties attached. There is a minor break in 1b. Recommended to repair the break in situ and treat the ferramenta.

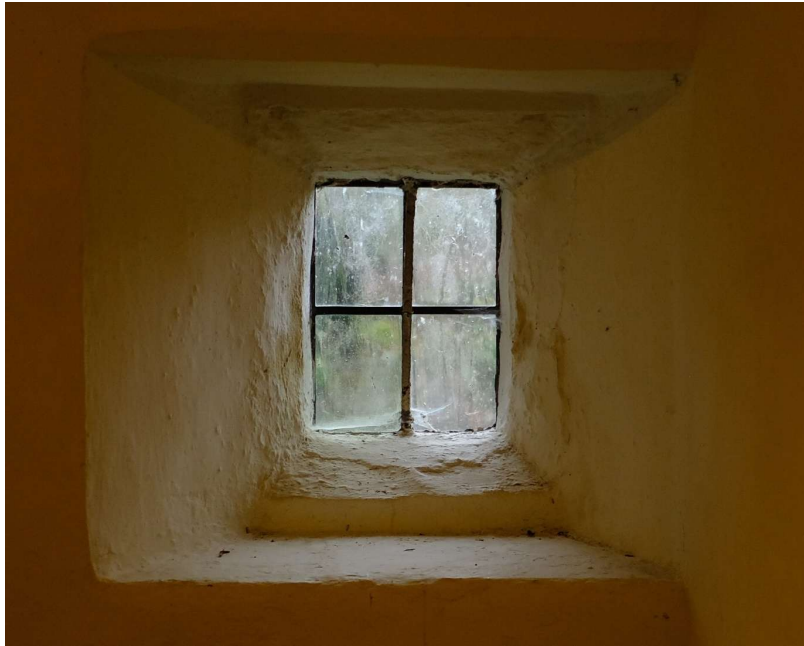
**u/w 16 ref circ 118 (N/E facing)**

Single leaded light size 12"x15".

Light in reamy glasses with vertical ferramenta. Light is in a fair condition. Surface of the glass is covered in verdigris and cobwebs. The central support is showing signs of corrosion.

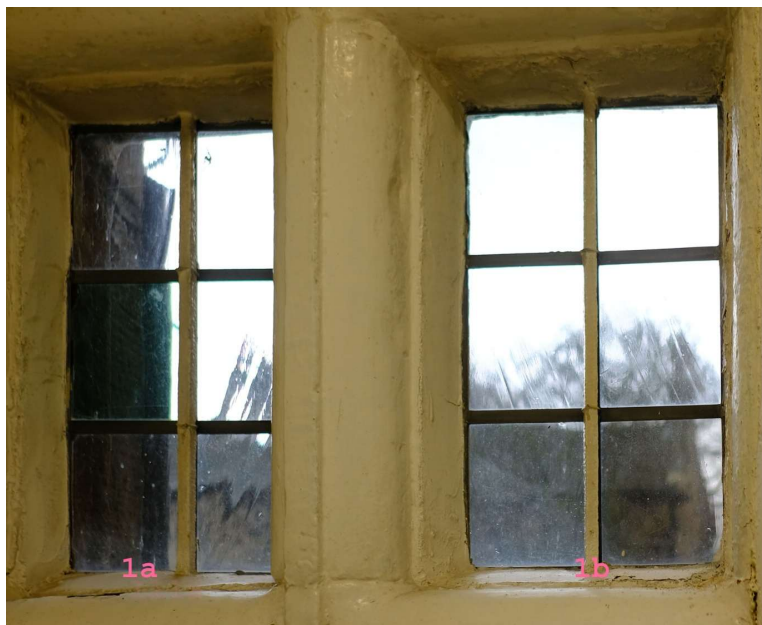
**u/w17 Male Water Closet (S/E facing)**

This is a 4 light window size 12"x17.5". Four leaded lights in a reamy tinted mouth blown glasses with verdigris ferramenta. These lights are in a fair condition. All ties are attached. Only the two upper lights are visible from inside as the lower lights are behind stonework. Lights require cleaning due to build up of verdigris.

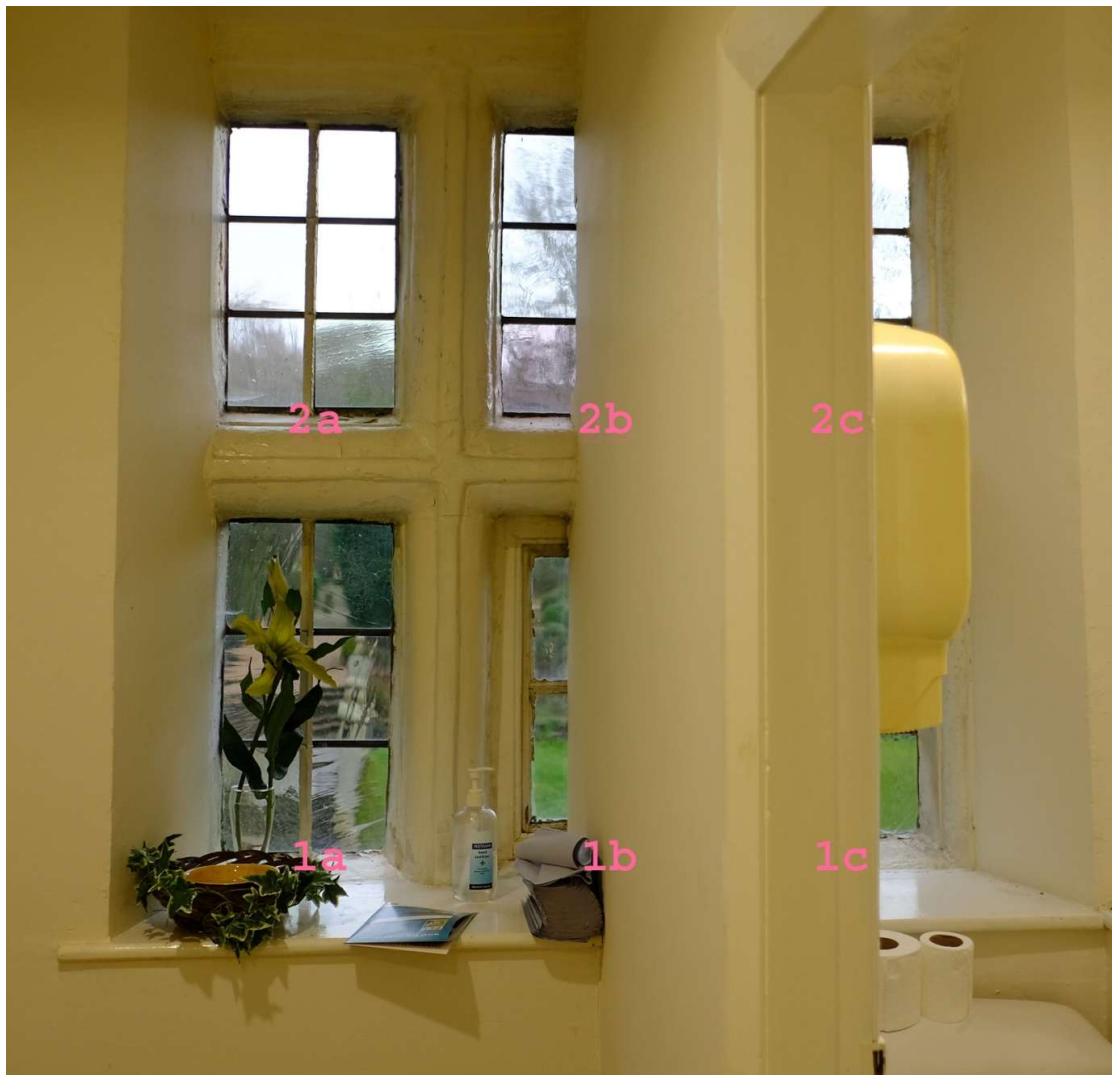
This is a six light window comprising of 3 main lights (size 11.5" x 22.5") and 3 transom lights (size 11.5" x 21")

Block pattern leaded lights in reamy glasses with central vertical ferramenta with a timber casement in 1b.

These leaded lights are in a fair condition with ties attached. However, the wooden opening casement is in a poor condition and inoperative. The glass within the casement is commercial sheet. Some of the bars are misaligned with the leaded light.

It is recommended for the removal of the wooden casement and the manufacture of a metal casement and new leaded light in reamy glasses as specified.

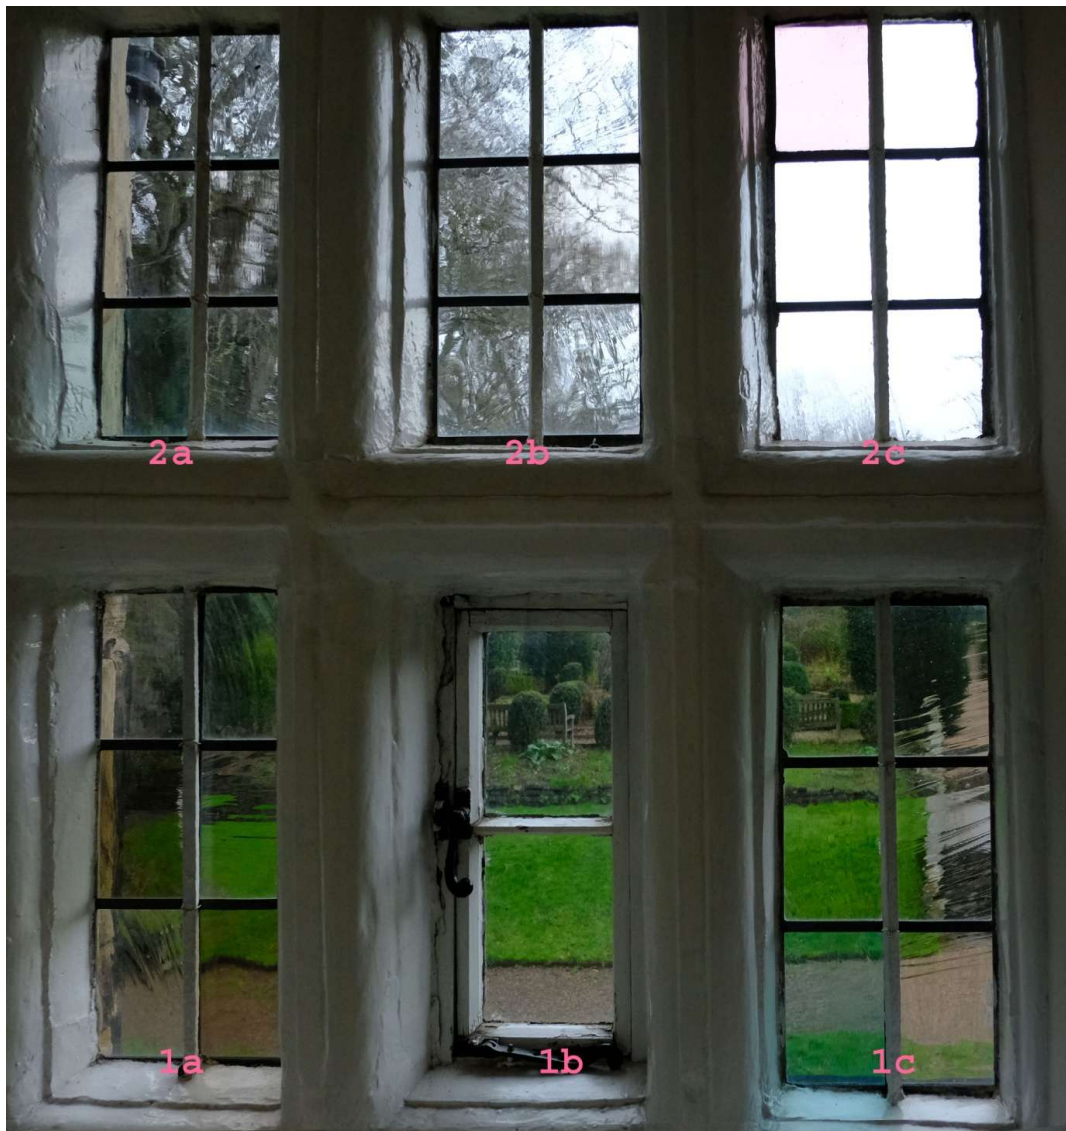
u/w19 ref 119 (N/E facing) womens w/c.

This is a six light window comprising of 3 main lights (size 11.5" x 22.5") and 3 transom lights (size 11.5" x 21")

Block pattern leaded lights in reamy glasses with central vertical ferramenta with a timber casement in 1b.

These leaded lights are in a fair condition with ties attached. However, the wooden opening casement is in a poor condition and inoperative. The glass within the casement is commercial sheet. Some of the bars are misaligned with the leaded light.

It is recommended for the removal of the wooden casement and the manufacture of a metal casement and new leaded light in reamy glasses as specified.

To facilitate the stone repairs, the removal of 2a-2c and the re-leading and treatment of the ferramenta.

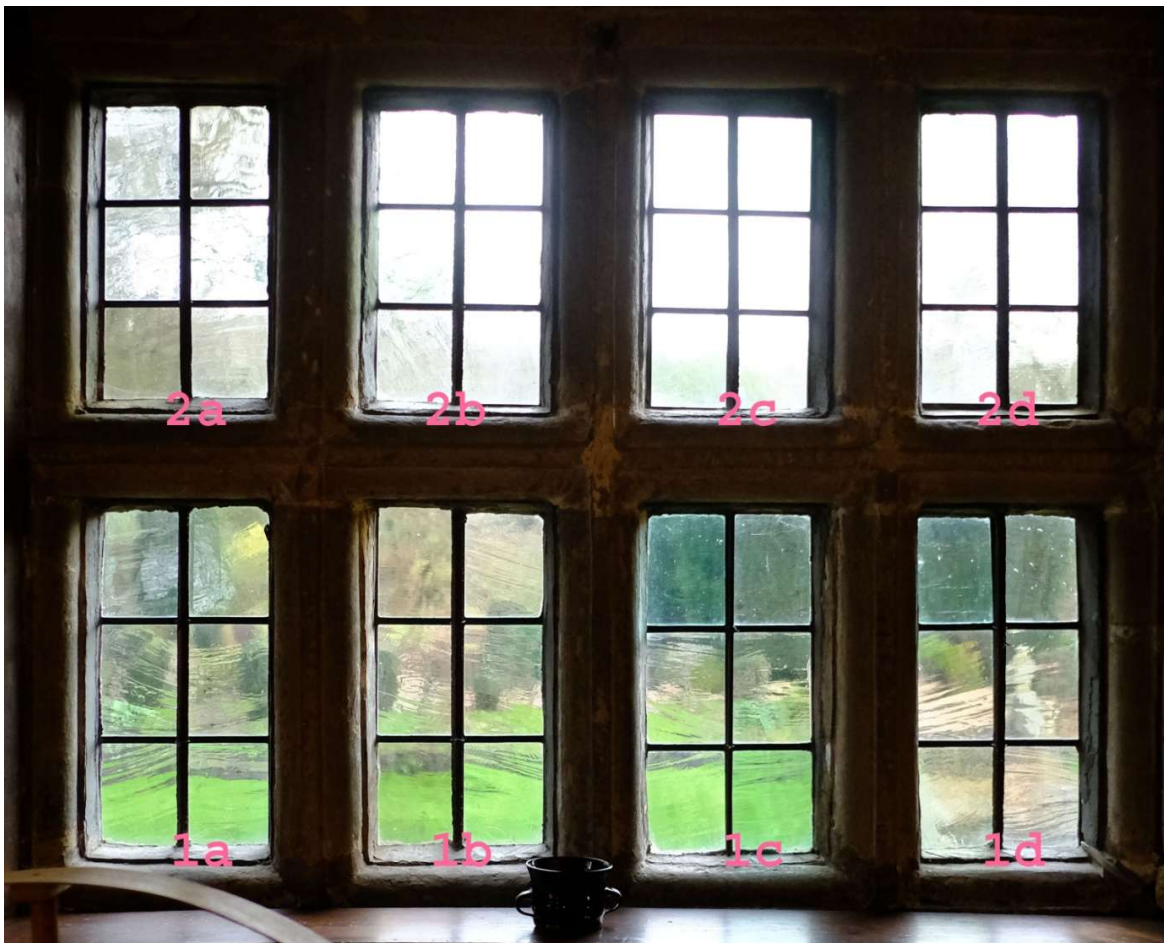
u/w 20 ref Gal 115 (N/E facing)

This is an eight light window, comprising of 4 main lights (size 12"x23") and 4 transom lights (size 12"x21")

Block pattern leaded lights in reamy tinted glasses with vertical ferramenta. All lights in a good condition. However, some of the ferramenta is mis-aligned in 1c and the bar has been replaced with a lighter weight bar. Treatment to ferramenta is required.

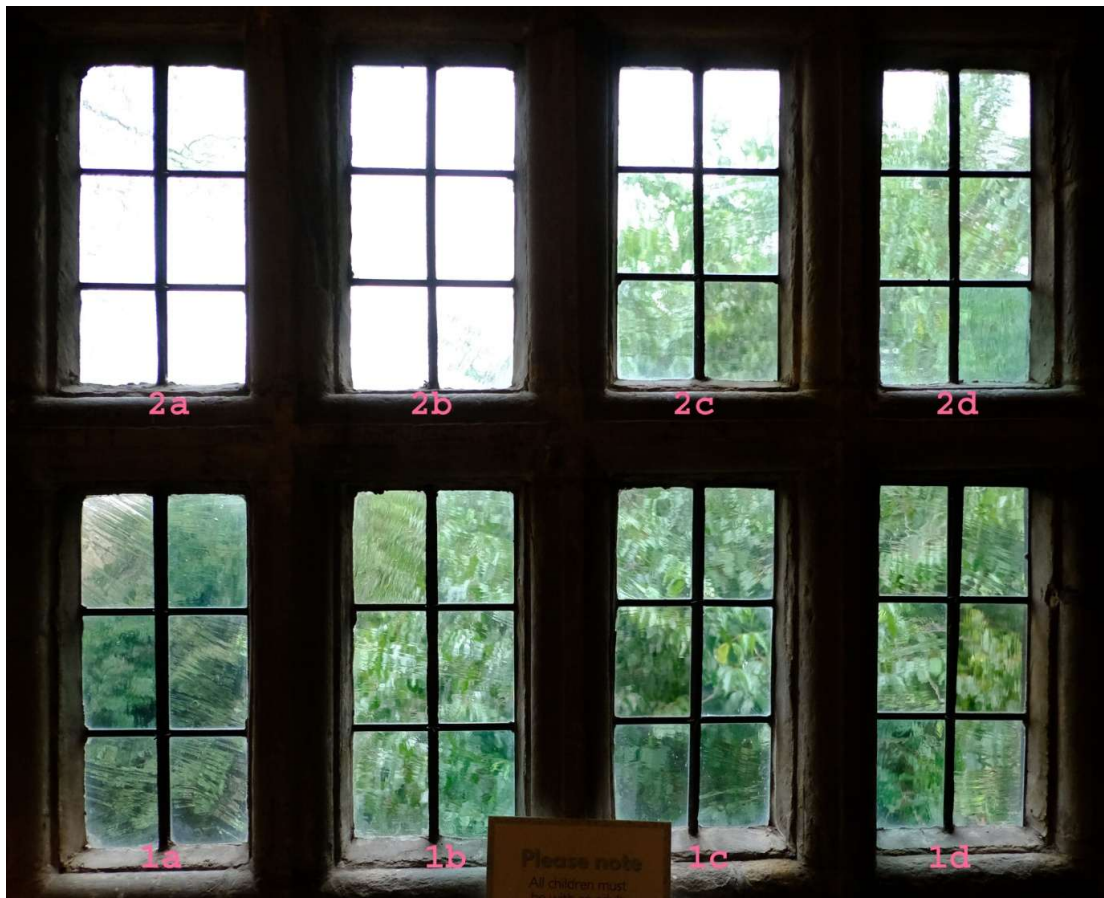
u/w21 ref Gal 115 (N/W facing)

This is a 8 light window comprising of four main lights (size 12"x25") and four transom lights (size 12"x21")

Block pattern leaded lights in tinted reamy glasses with vertical ferramenta. All lights are in a fair condition, but some of the ferramenta is misaligned to the base panels. There is no breakages or tie detachment.

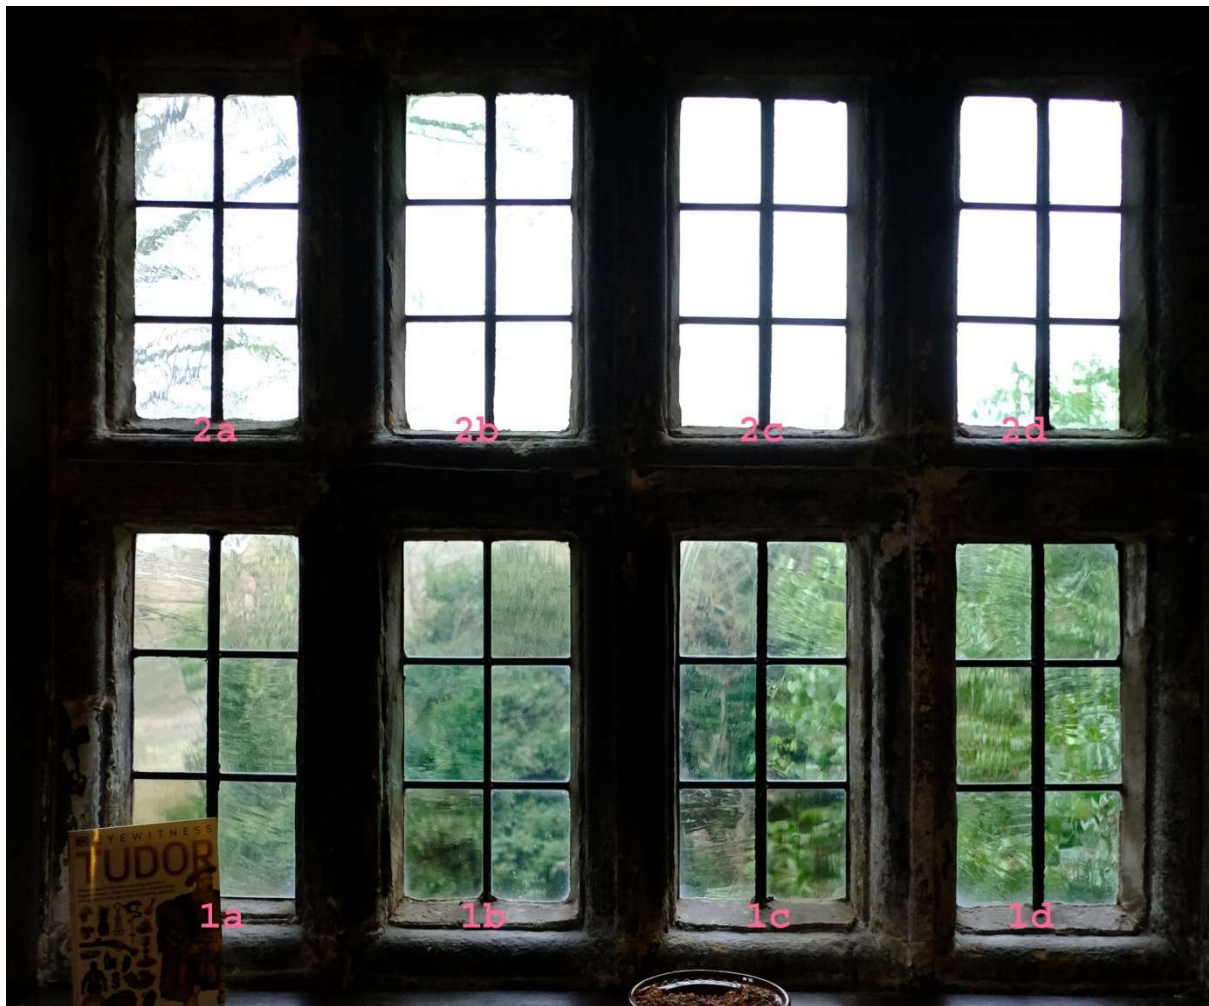
This is an 8 light window comprising of four main lights (size 12"x25") and four transom lights (size 12"x21")

Block pattern leaded lights in tinted reamy glasses with vertical ferramenta. All lights are in a fair condition, but some of the ferramenta is misaligned to the base panels. There is no breakages or tie detachment.
