masonclarkassociates
civil and structural engineering consultants

Client:	Kirklees Council		
Project:	Oakwell Hall		
Title:	Proposed repairs for roof and ceiling structure above 101 CIRC, 104 CIRC, 103 GAL, and 105 GAL		
Drawn:	SM	Checked:	RMP
Date:	13.04.2026		
Scale @ A2:	As noted		
Drawing No.:	22333-Y-SK-010	Rev:	P2

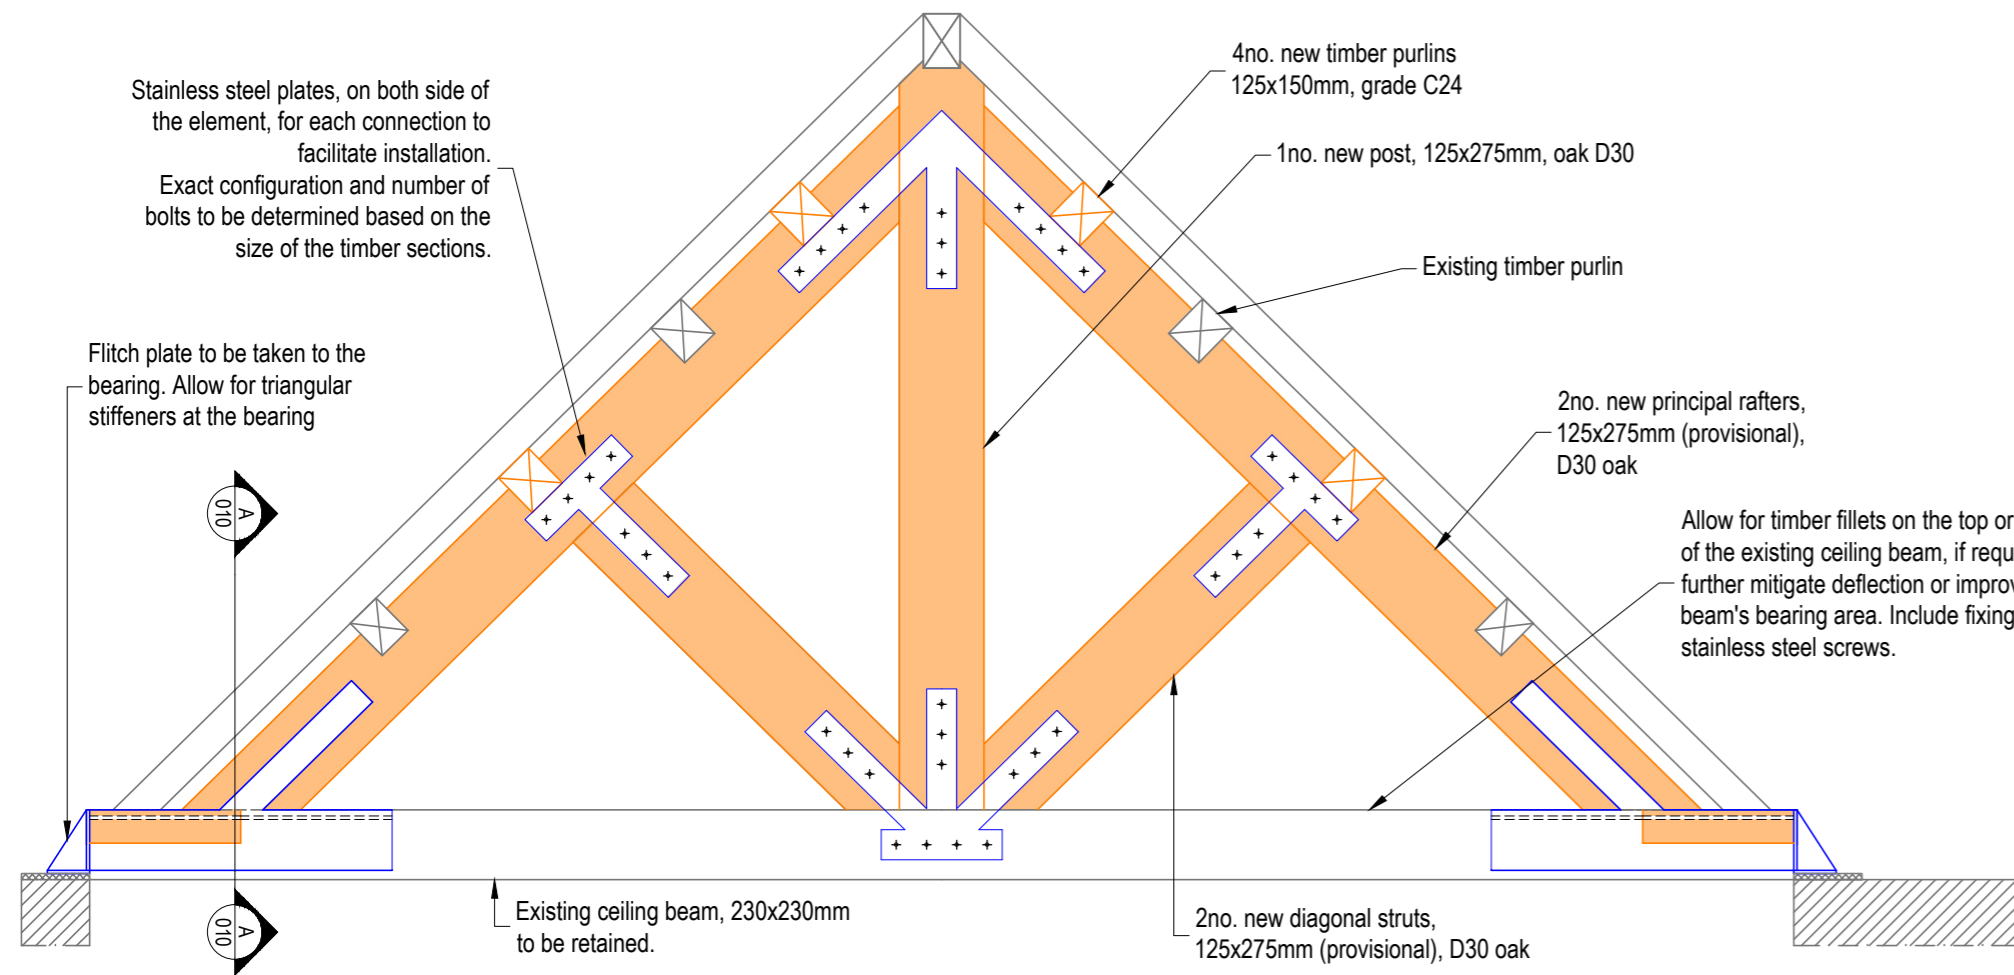
02 Repair 2.2 - Indicative sketch of new truss using the existing ceiling beam (with Option A for ceiling beam bearing repair)
Scale: 1:25

Based on the findings of the inspection, the top section of the ceiling beam near the bearing is decayed and will most likely require repairs. Therefore, Options A and B are proposed for the repair of the bearing.

The proposed intervention in R2.2 is to form a king post truss using the existing ceiling beam as a tie beam, in order to improve the structural performance of the existing purlins and ceiling beam. To facilitate construction, we propose the use of steel plates for the connections, as shown. For further details regarding the design development, refer to 22333-Y-LT-002.

Option A can be considered for both significant and minor decay of the section and is the preferred solution. If half of the section of the ceiling beam can be retained, the repair can be carried out without disturbing the ceiling joists or the lath and plaster, as shown in Detail 3. If most of the section has to be replaced, we will aim to retain the bottom 30 mm of the ceiling beam to avoid directly disturbing the lath and plaster ceiling. However, the tenons of the existing ceiling joists will need to be cut, and the ceiling joists refixed to the new timber section. In this scenario, minor repairs to the ceiling may be required around the bearing (approximately 1 m²).
