P2	Preliminary issue - For LBC	SM	06.05.2026
P1	Preliminary issue - For LBC	SM	05.05.2026
Rev	Details	By	Date
		Hull +44 (0) 1482 345797 Leeds +44 (0) 113 277 9542 York +44 (0) 1904 438005 www.masonclark.co.uk	
Client:		Kirklees Council	
Project:		Oakwell Hall	
Title: Proposed repairs for roof and ceiling structure above the Main Hall			
Drawn: SM	Checked: RMP	Date: 13.04.2026	
Scale @ A2: As noted			
Drawing No: 22333-Y-SK-011		Rev: P2

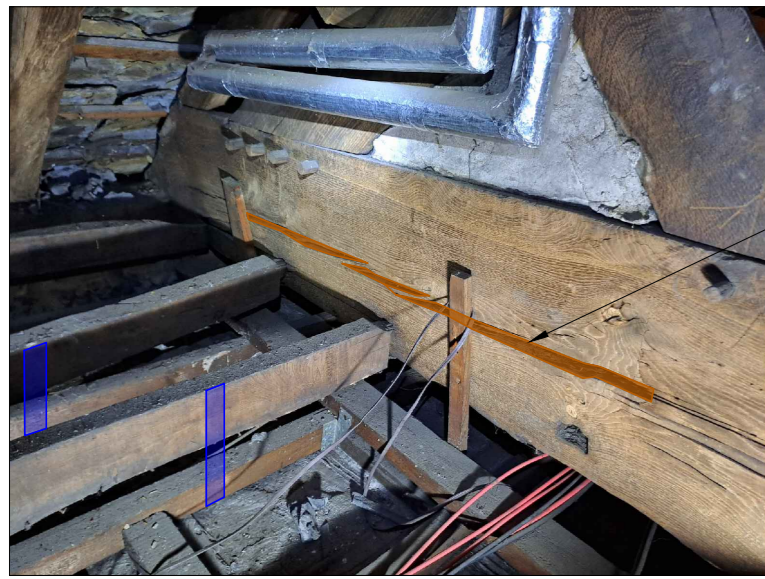
Infill splits and cracks with suitable timber resin the splits along the tie beams of trusses and ceiling beams.

Repair R1.1

- Strapping the redundant timber ceiling joists (upper level) to the newer, lower-level ceiling joists currently supporting the plastered ceiling, using stainless steel straps. Allow for the installation of 120no. stainless-steel flat straps 4x30x300mm, 2no. per joist (assuming 60x110mm ceiling joists at 400mm centres, spanning between trusses and ceiling beams - 3 bays). Include for stainless steel screws to fix the straps and the bearings of the joists to the ceiling beams/trusses.

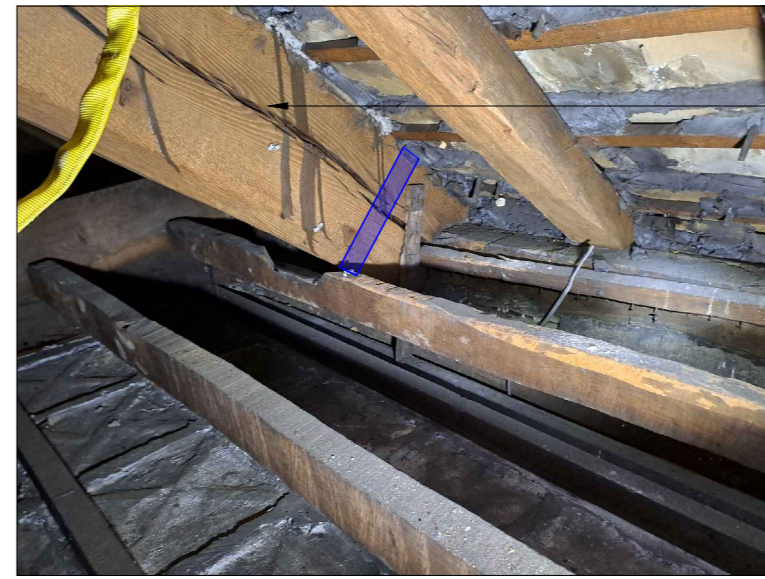
Repair R1.3 - Repair of the end bearings of the principal rafters of the raised truss.

Infill splits and cracks with suitable timber resin the splits along the tie beams of trusses and ceiling beams.

- Allow for the installation of 2no. stainless-steel strap, bent/welded around the section of the principal rafter, 230x400mm. Include for infilling the timber splits with a suitable timber resin.

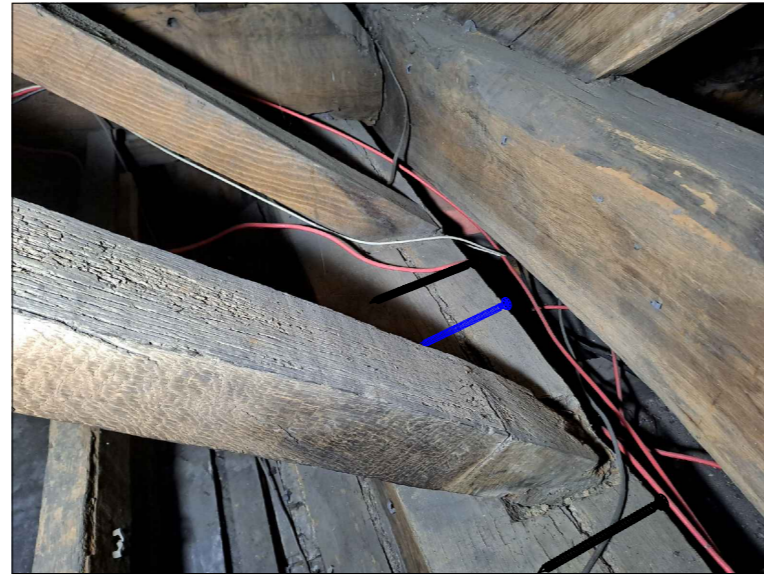
Repair R1.5 - Stitching with stainless-steel screws of timber wall-plate.

Allow for two more locations with similar damage.
