**Gleesons**  
**Cockley Hill Lane, Kirkheaton,**  
**Huddersfield**  
**Pre-Construction Visual Condition Survey**

February 2026

## **PRE-CONSTRUCTION VISUAL CONDITION SURVEY**

Ref: 25-353-001.01

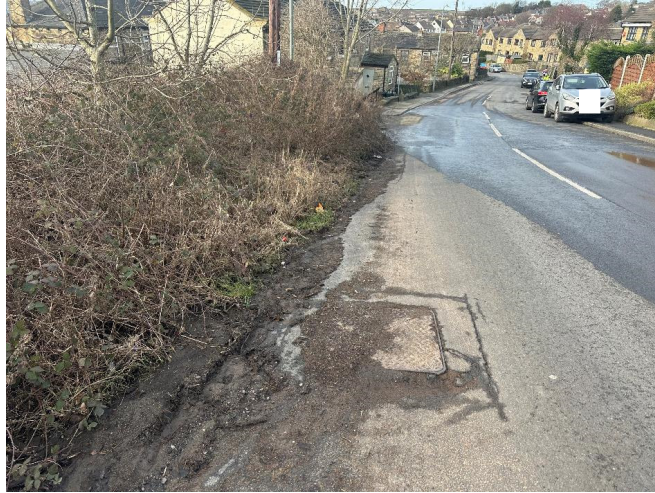
**Photo 1**

Cockley Hill Lane Site Frontage (South)

Carriageway edge deterioration present with associated utility ironwork defect, which shows cracks are present.

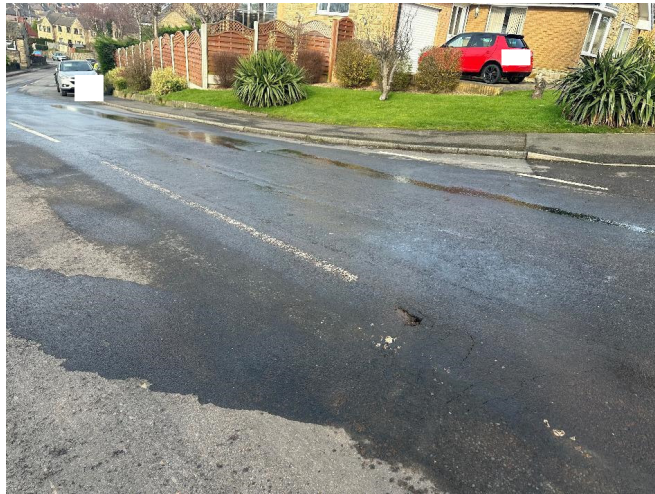
**Photo 2**

Cockley Hill Lane Site Frontage (South)

Deterioration of lining with visible pothole within centre of carriageway.

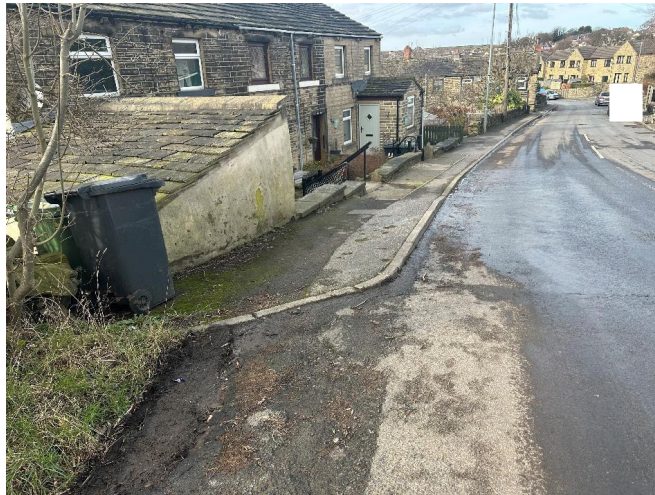
**Photo 4**

Cockley Hill Lane (South)

Intermittent gaps between individual kerb units and cracks.

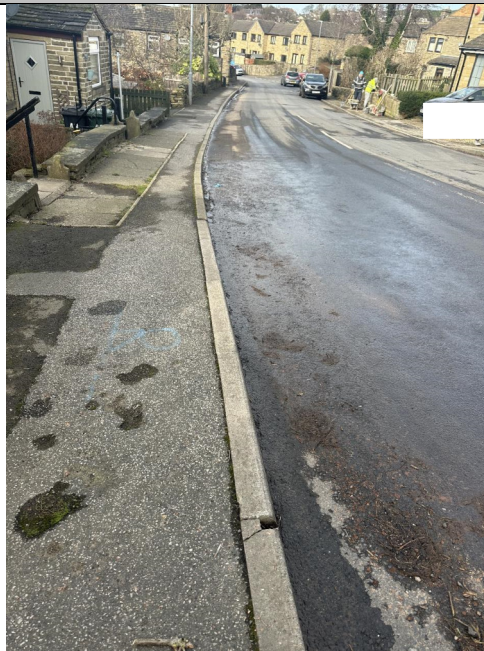
**Photo 5**

Cockley Hill Lane (South)

Intermittent gaps between individual kerb units and cracks.

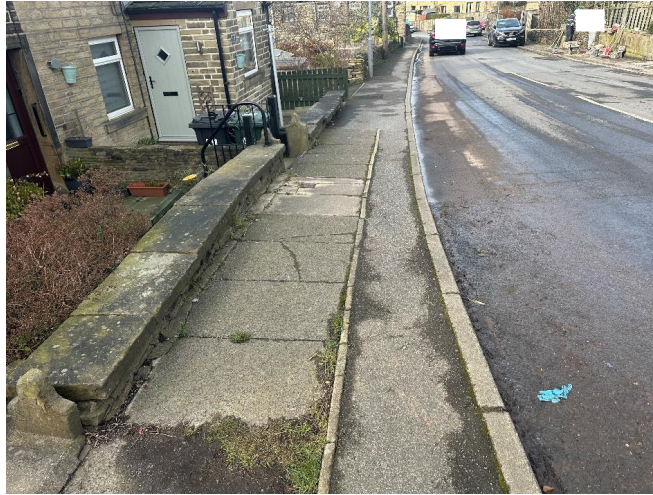
**Photo 6**

Cockley Hill Lane (South)

Multiple slabs show visible cracking with uneven slabs. Surface wear and deterioration present. Vegetation growth in joints between slabs and along edges. Edge deterioration with crumbling and breaking at slab corners and edges.

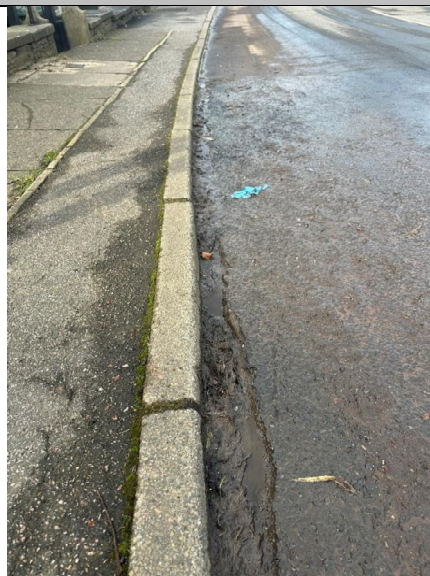
**Photo 7**

Cockley Hill Lane (South)

The road surface shows signs of deterioration adjacent to kerb.

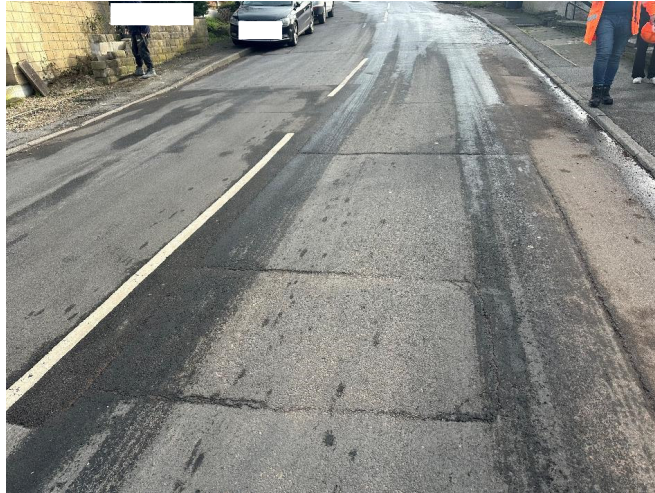
**Photo 8**

Cockley Hill Lane (South)

The carriageway shows reinstatement patch consistent with previous utility trenching, it was commented by Kirklees representative that it could be gas works. Joint failure is visible at the edges of the reinstatement.

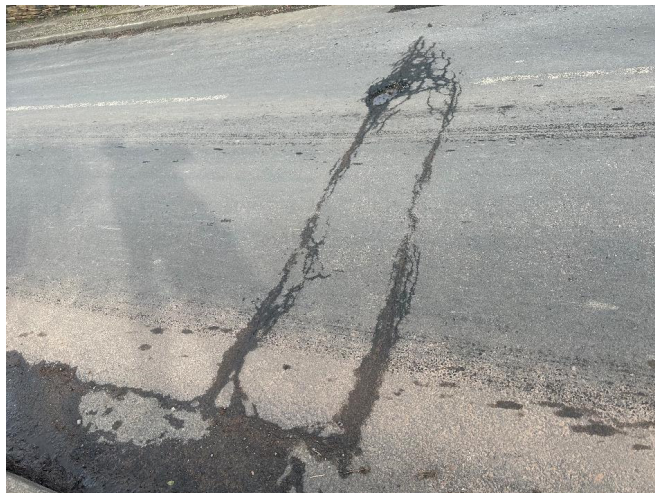
**Photo 9**

Cockley Hill Lane (South)

Joint failure is visible at the edges of the reinstatement, with a pothole in the centre of the carriageway.

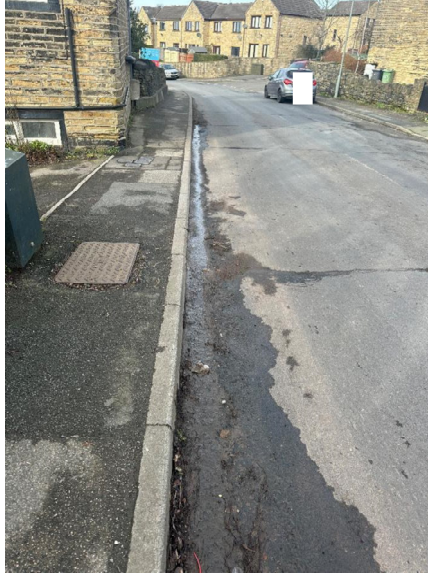
**Photo 10**

Cockley Hill Lane (South)

The road surface shows signs of deterioration on the edges. Surface deterioration also present within the footway.

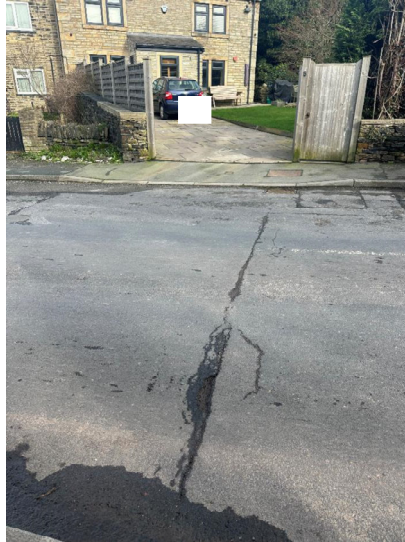
**Photo 11**

Cockley Hill Lane (South)

Joint failure is visible.

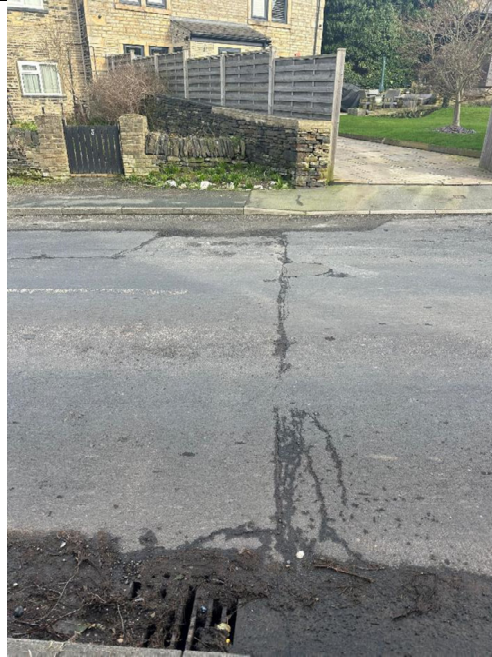
**Photo 12**

Cockley Hill Lane (South)

Joint failure is visible.

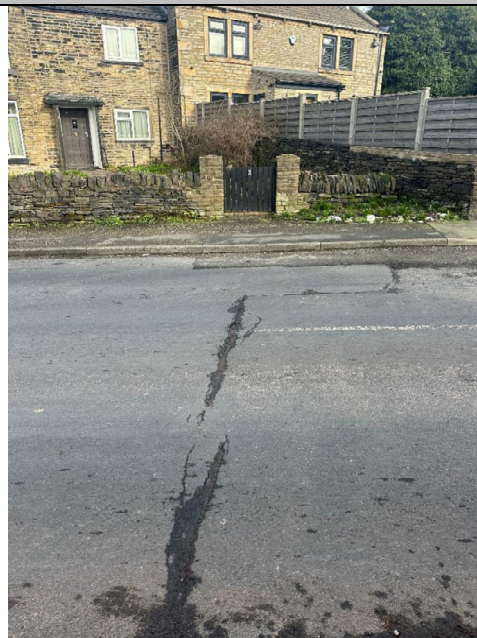
**Photo 13**

Cockley Hill Lane (South)

Joint failure is visible.

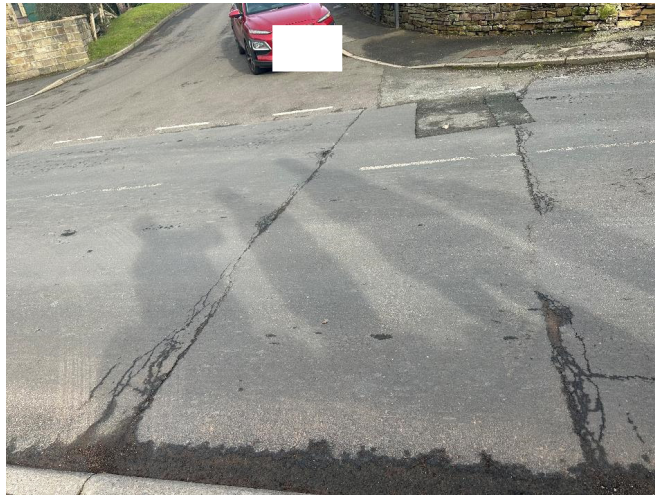
**Photo 14**

Cockley Hill Lane (South)

Joint failure is visible with failure to patchwork on opposite side.

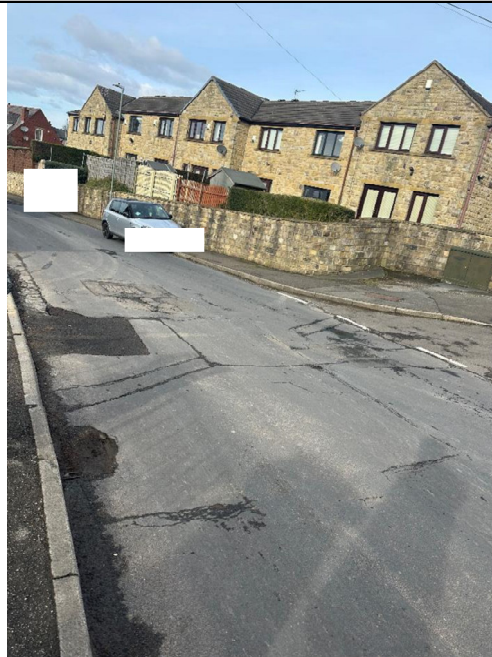
**Photo 15**

Cockley Hill Lane (South)

Joint failure is visible with numerous trench reinstatements present.

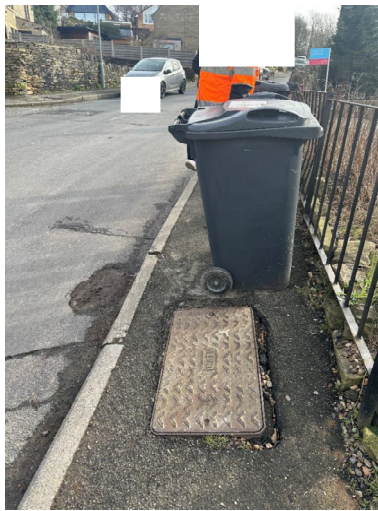
**Photo 16**

Cockley Hill Lane (South)

The utility cover doesn't sit flush with the surrounding pavement. Deterioration of footway surfacing in the vicinity of utility cover.

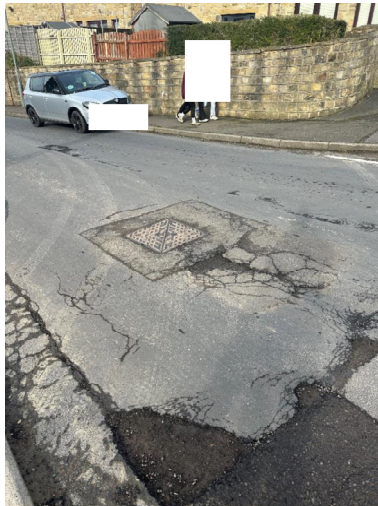
**Photo 17**

Cockley Hill Lane (South)

Carriageway surfacing is cracked in multiple places. Irregular patches where previous repairs were made are present. Manhole surrounding area shows deterioration edges between the cover frame and the road surface.

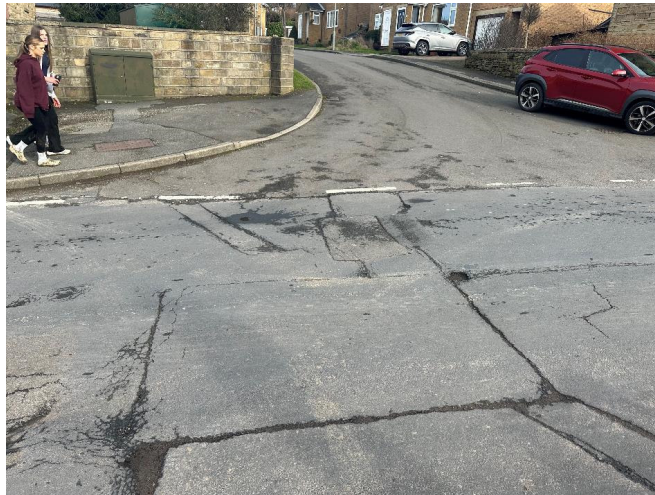
**Photo 18**

Cockley Hill Lane (South)

Numerous joint failures are visible.

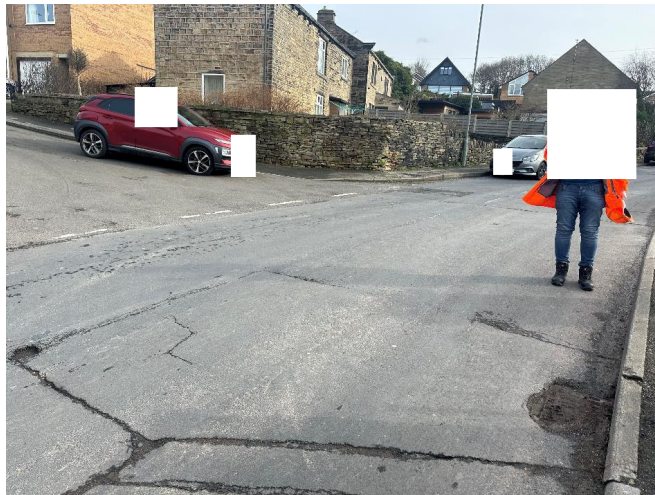
**Photo 19**

Cockley Hill Lane (South)

Numerous joint failure are visible.

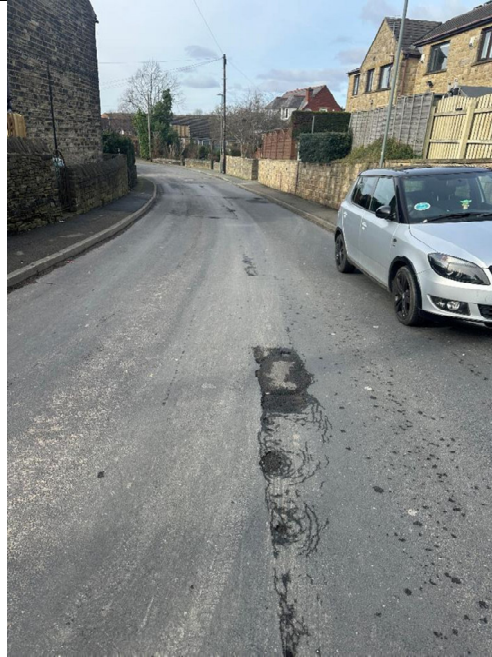
**Photo 20**

Cockley Hill Lane (South)

Carriageway surface cracking down the centre with surface deterioration .

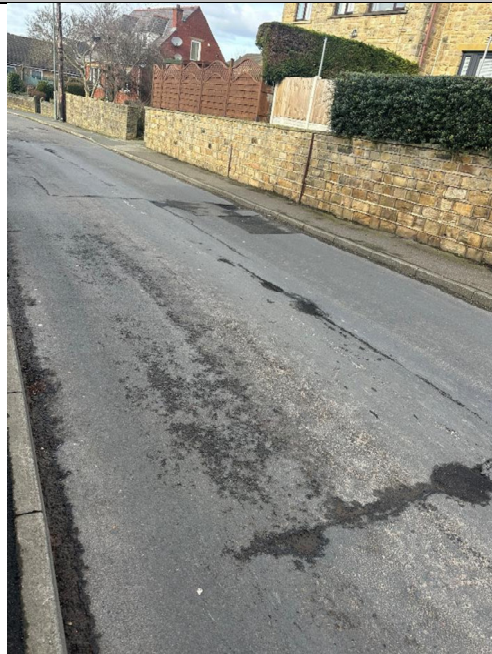
**Photo 21**

Cockley Hill Lane (South)

Joint failure visible.

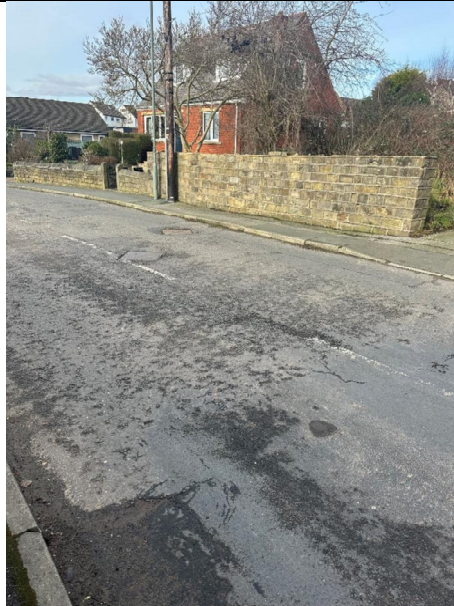
**Photo 22**

Cockley Hill Lane (South)

Multiple cracks visible in carriageway surface, patch repair area present. General surface degradation.

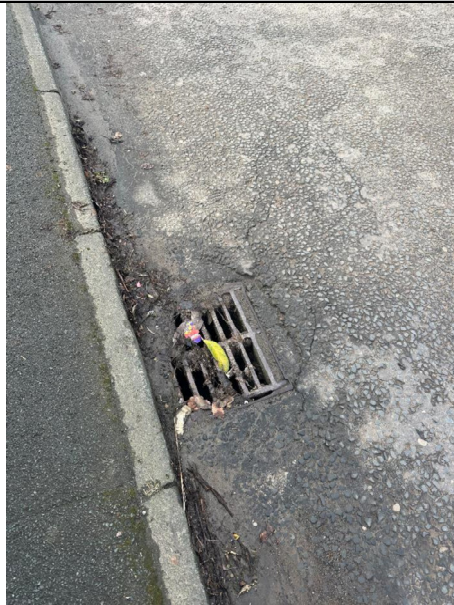
**Photo 23**

Cockley Hill Lane (South)

Gully observation to be full of silt.

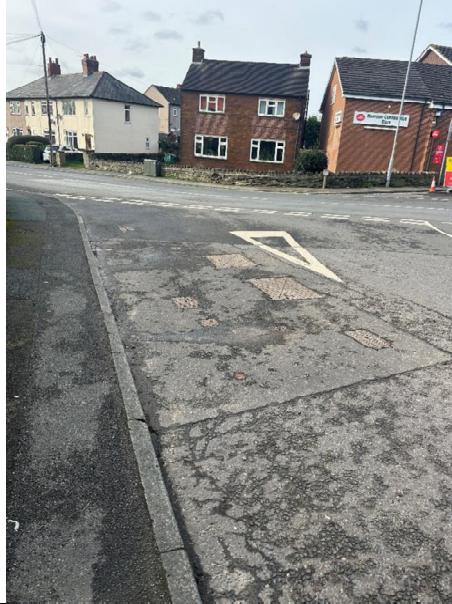
**Photo 24**

Cockley Hill Lane (South)

Multiple cracks observed in carriageway surface.

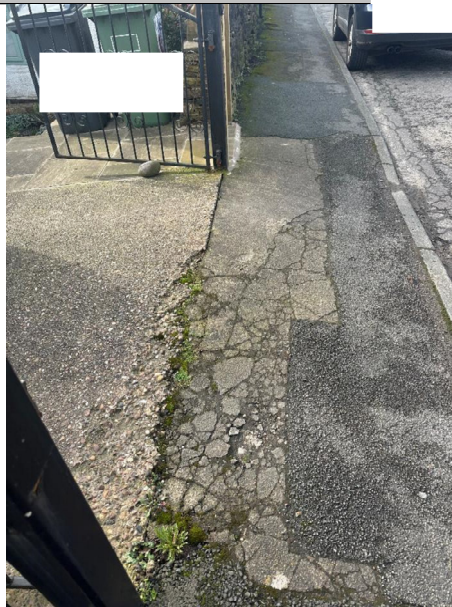
**Photo 25**

Town Road (East)

Multiple cracks present within concrete footway reinstatement.

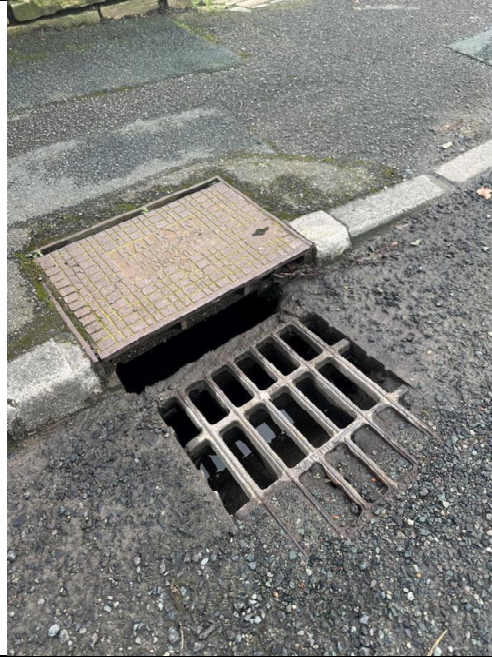
**Photo 26**

Town Road (East)

Gully full of water.

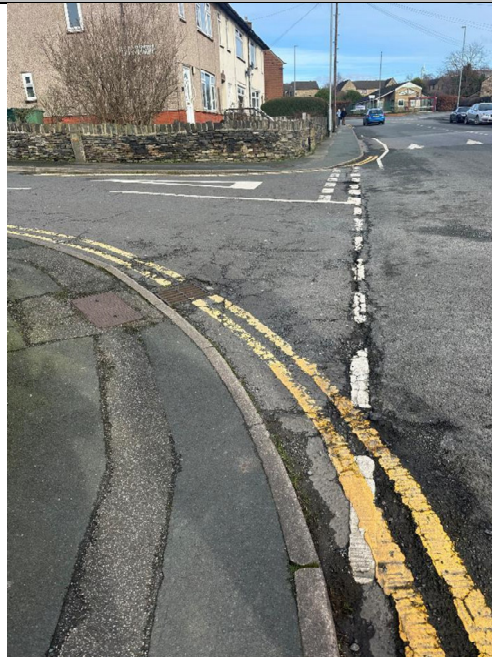
**Photo 27**

Town Road (West)

Visible deterioration of existing carriageway joints junction below existing road markings.  
Carriageway damaged around gully.

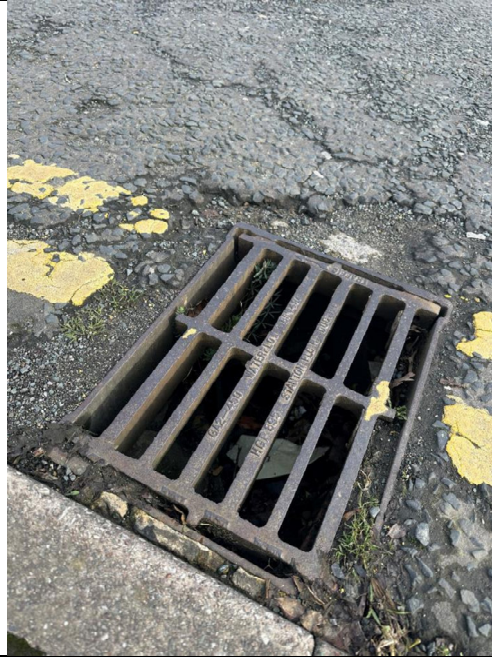
**Photo 28**

Town Road (West)

Gully full of silt with deterioration of surfacing around the gully

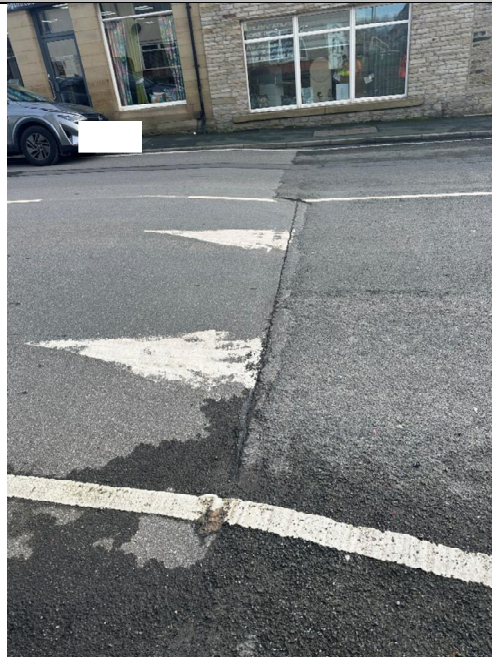
**Photo 29**

Town Road (West)

Cracks and deterioration at hump joint.

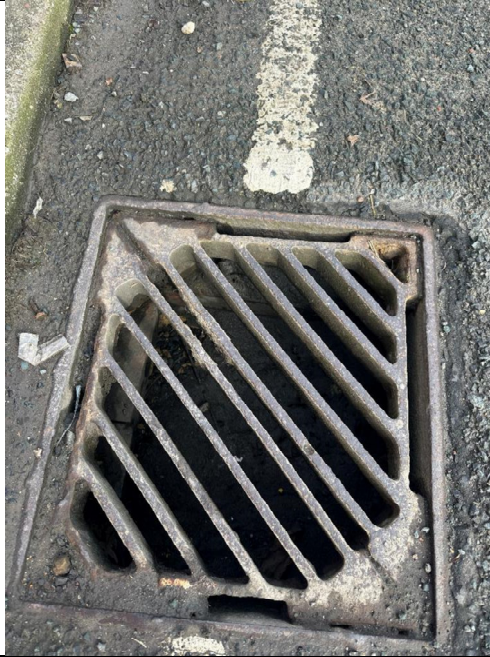
**Photo 30**

Town Road (West)

Gully full of silt.

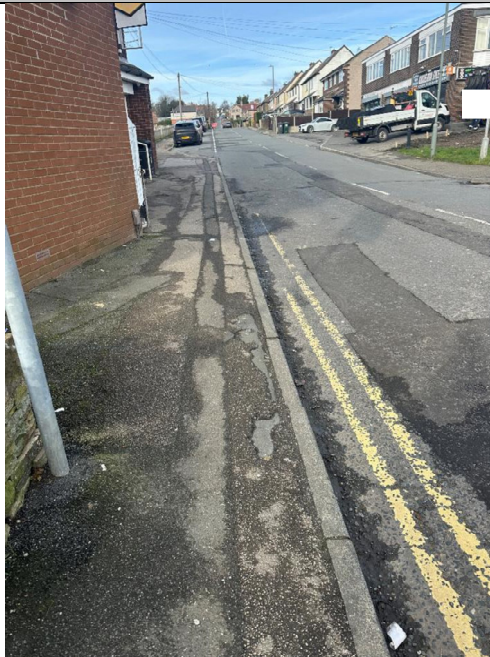
**Photo 31**

Heaton Moor Road (West)

Widespread deterioration of footway surfacing. Existing waiting restrictions in the form of double yellow lines are worn with sections partially missing.

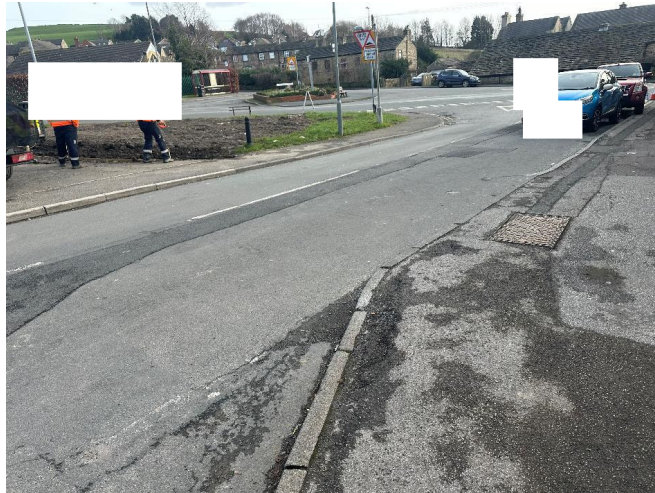
**Photo 32**

Moorside Road (South corner)

Intermittent gaps between individual kerb units and cracks.

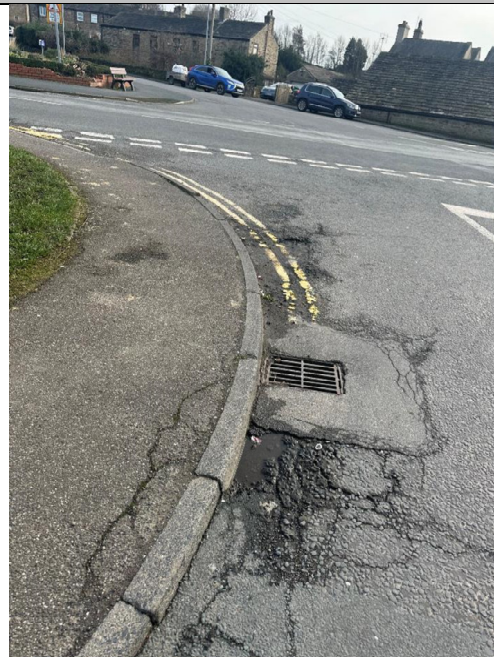
**Photo 33**

Moorside Road (North corner)

Carriageway surfacing around the gully is deteriorating. Existing waiting restrictions in the form of double yellow lines are faded.

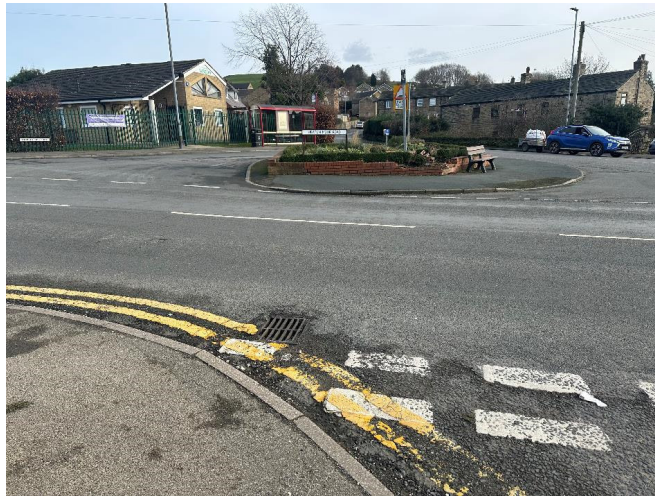
**Photo 34**

Moorside Road (North corner)

Deterioration of carriageway surfacing around gully.

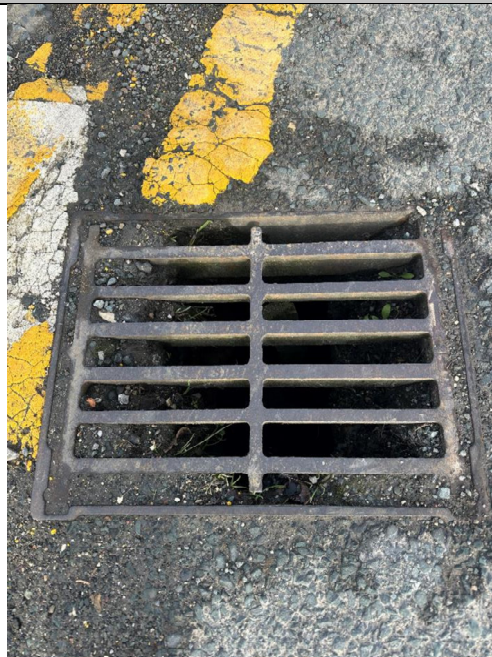
**Photo 35**

Moorside Road (North corner)

Gully full of silt.

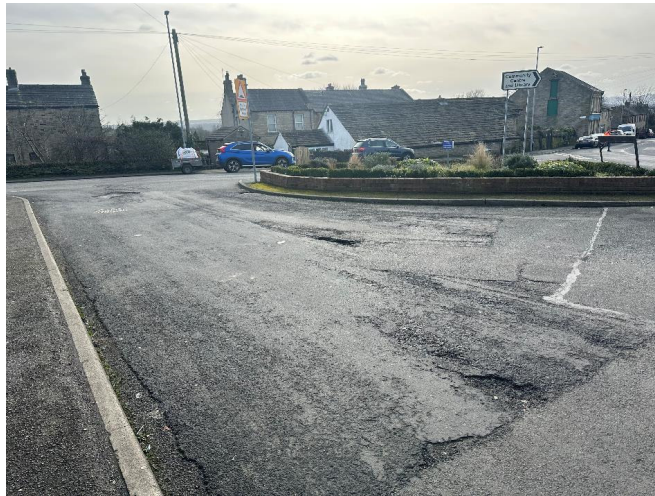
**Photo 36**

Cockley Hill Lane (North of Island at Junction)

Numerous defects within carriageway surfacing

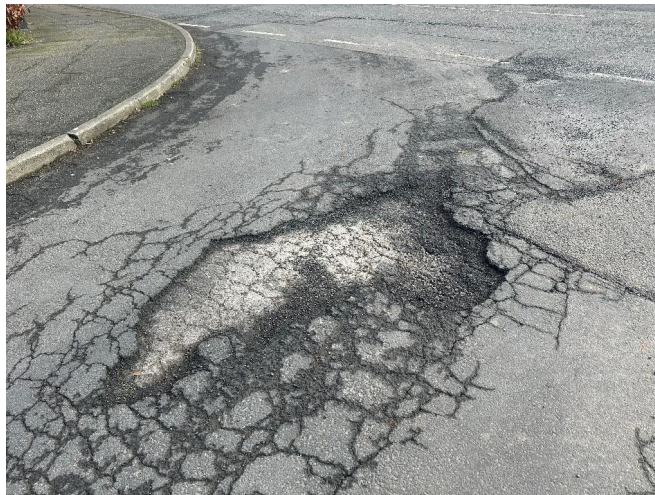
**Photo 37**

Cockley Hill Lane (North of Island at Junction)

Pothole with extensive Alligator / Crazing Cracks within carriageway.

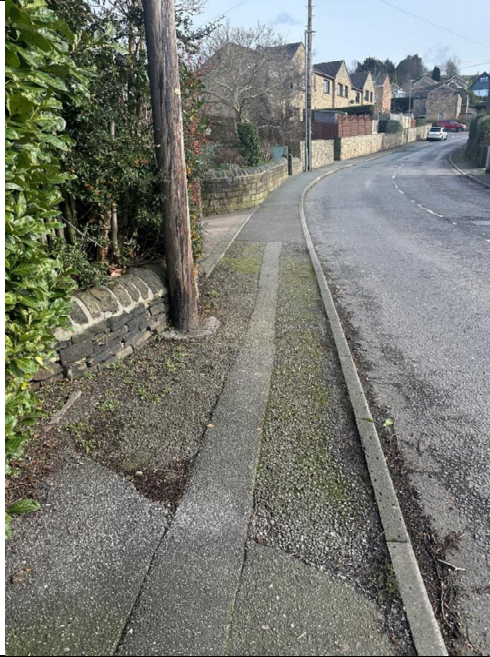
**Photo 38**

Cockley Hill Lane (North)

Footway surface showing signs of deterioration, with uneven texture and weathering.

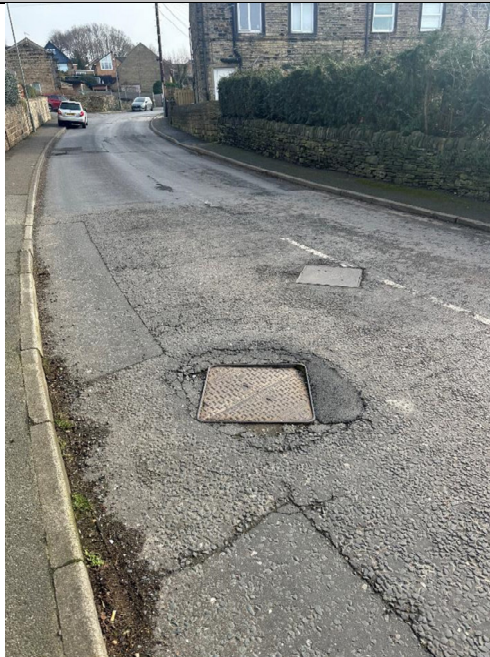
**Photo 39**

Cockley Hill Lane (North)

Existing manhole cover and frame has sunk resulting in carriageway surfacing around the cover and frame showing deterioration. Carriageway surface showing signs of wear and tear.

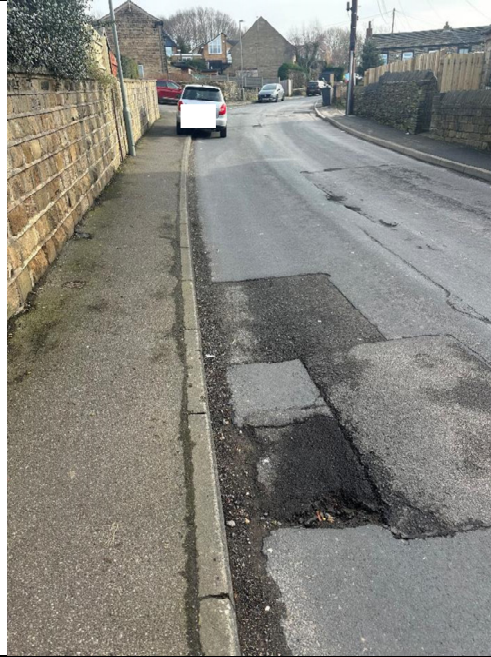
**Photo 40**

Cockley Hill Lane (North)

Existing carriageway has numerous patches with signs of failure

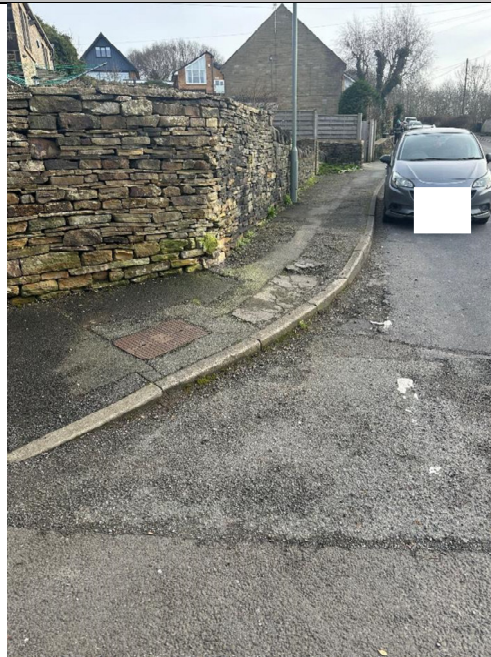
**Photo 41**

Cockley Hill Lane (North)

Carriageway surface shows of wear and tear. Footway shows signs of cracking and failure to surfacing.

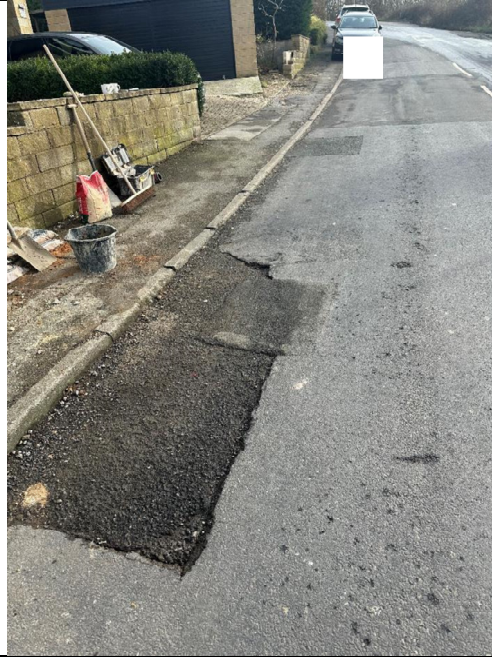
**Photo 42**

Cockley Hill Lane (North)

Existing carriageway reinstatement showing signs of failure.

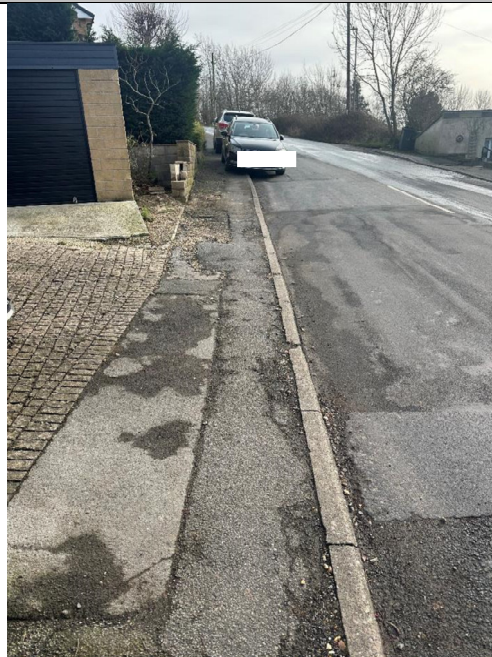
**Photo 43**

Cockley Hill Lane (North)

Footway surface uneven in places with existing reinstatements showing signs of deterioration.
