**ARBORICULTURAL REPORT
AND
ARBORICULTURAL IMPACT ASSESSMENT
to BS 5837:2012
at
49 Cross Bank Road
Batley
Kirklees
West Yorkshire
WF17 8PN**

Client:
DMA Design Management Ltd

JCA Ref:
23700/DP

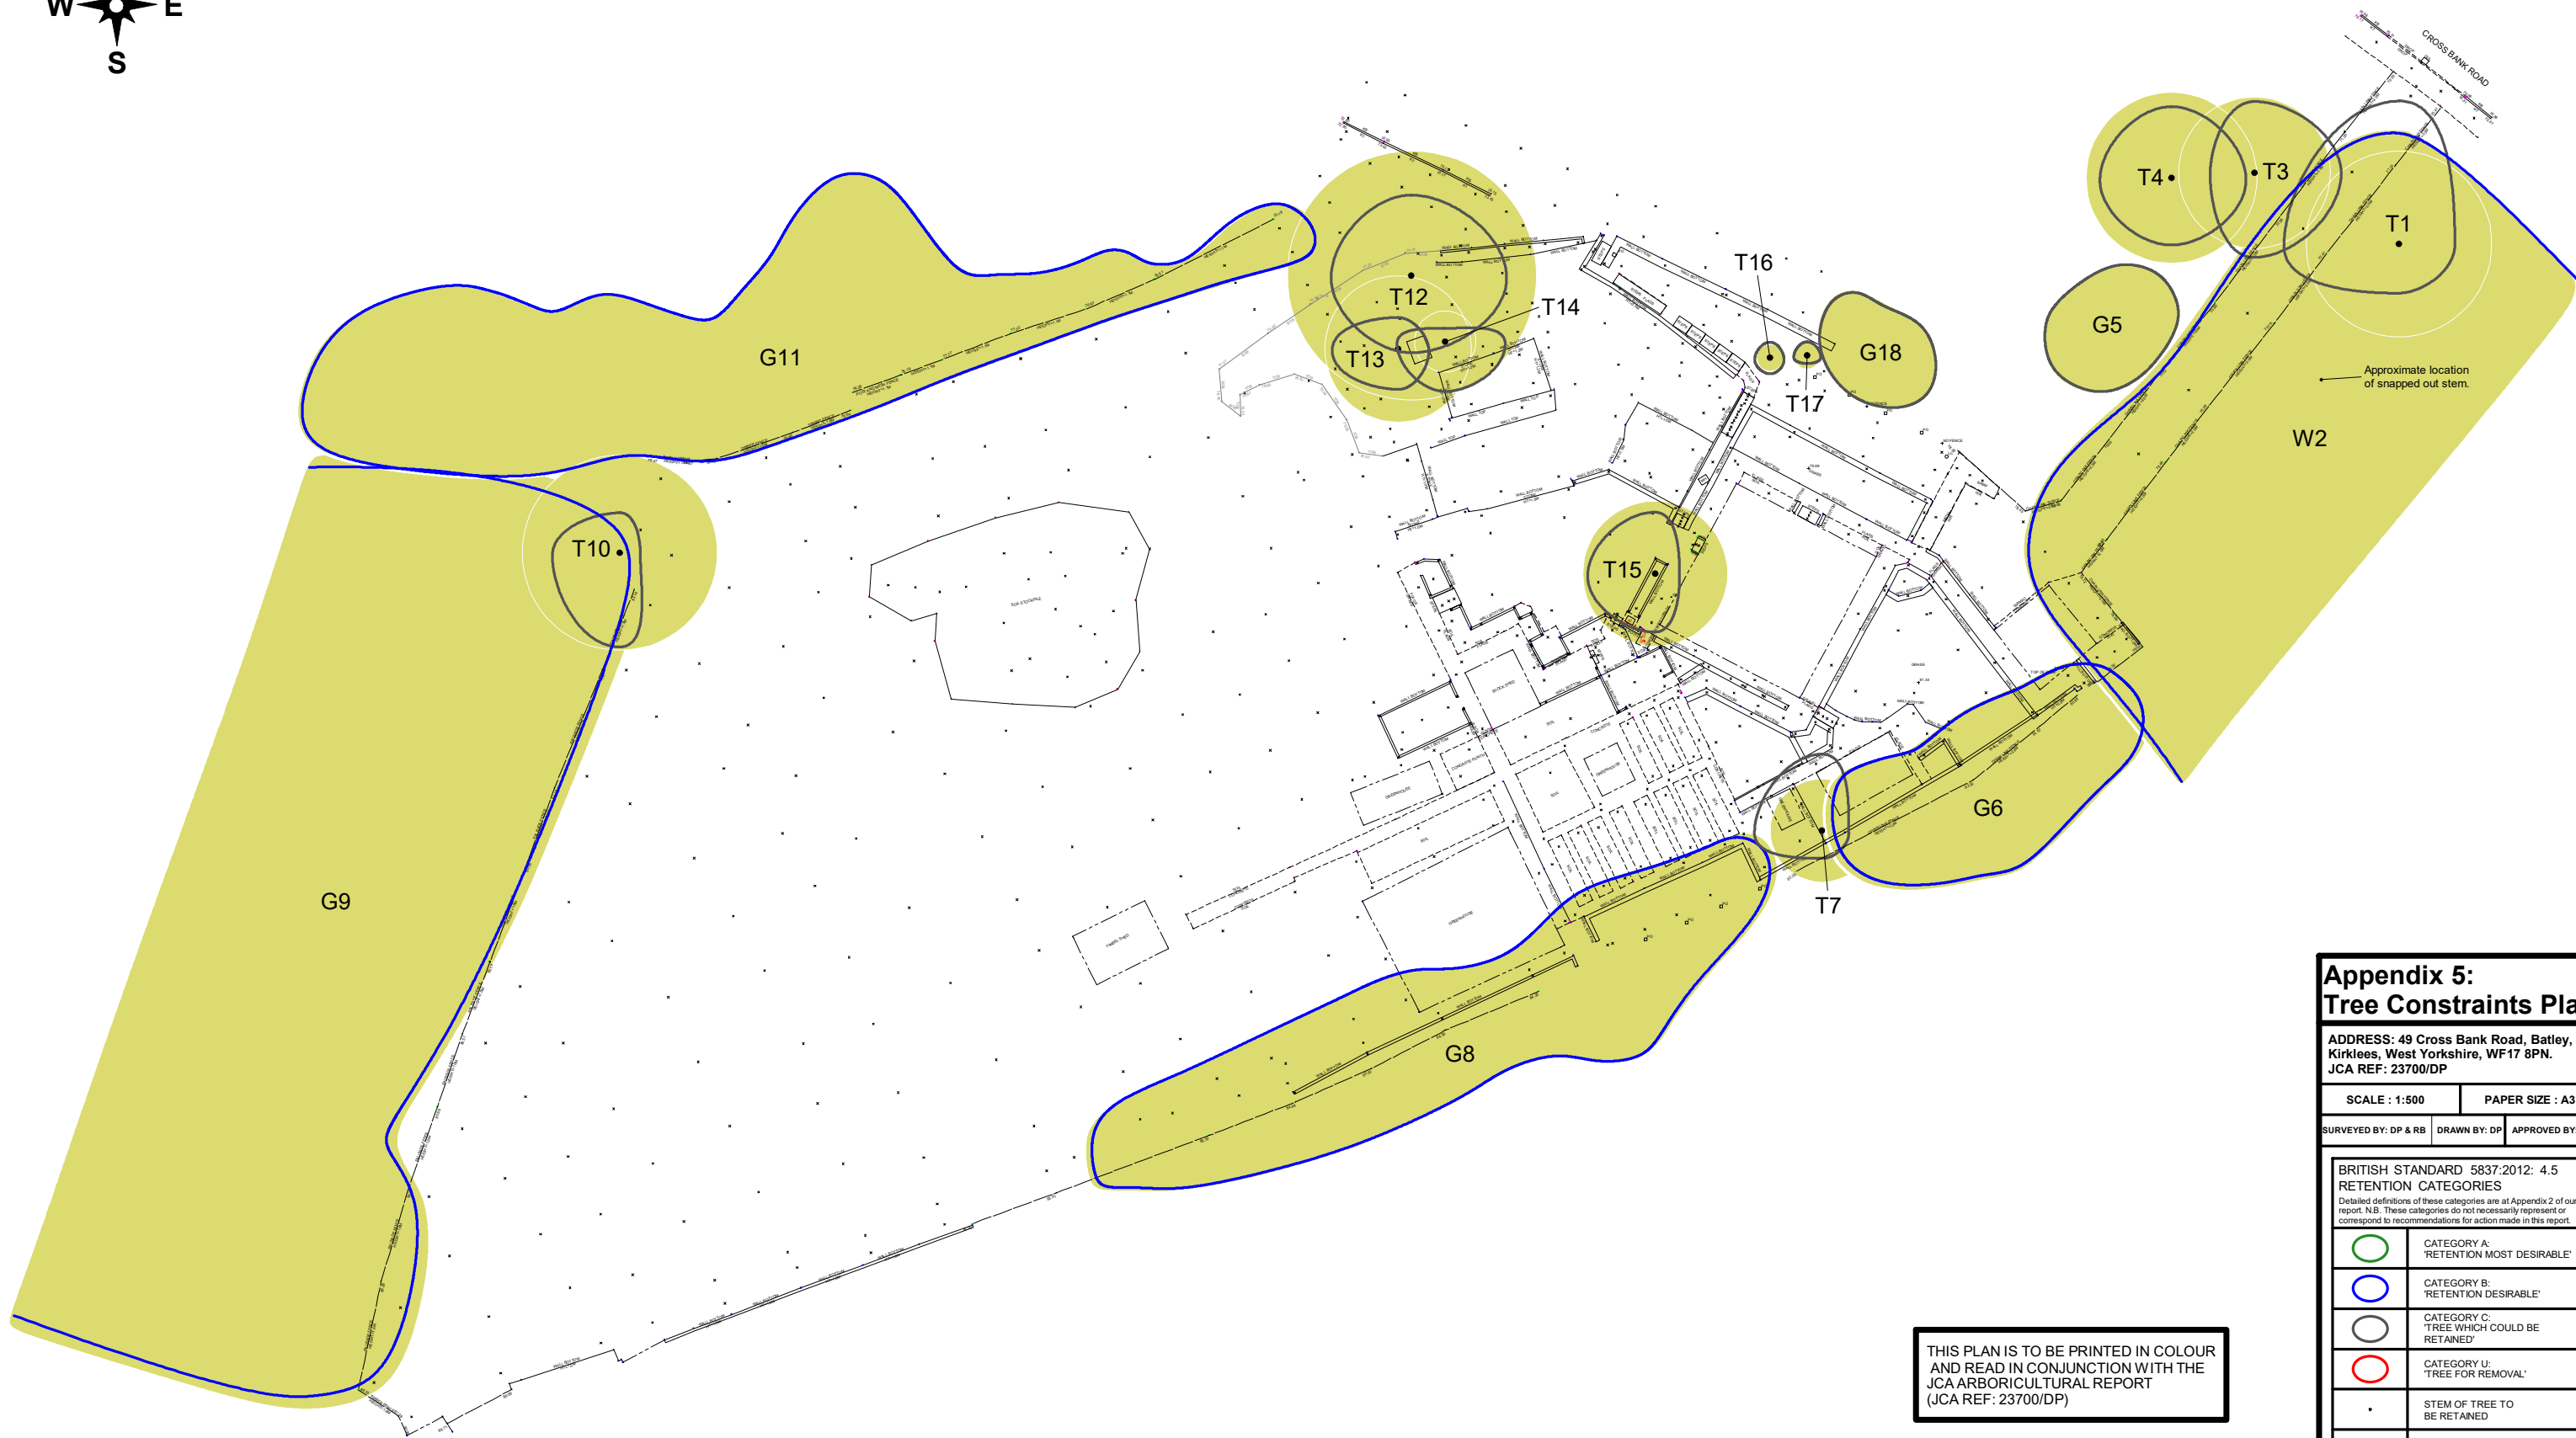
**Appendix 5:
Tree Constraints Plan**

Retention Categories of the Surveyed Vegetation				
Retention Category	Trees	Groups	Woodlands	Totals
A	0	0	0	0
B	0	4	1	5
C	11	2	0	13
U	0	0	0	0
Totals	11	6	1	18

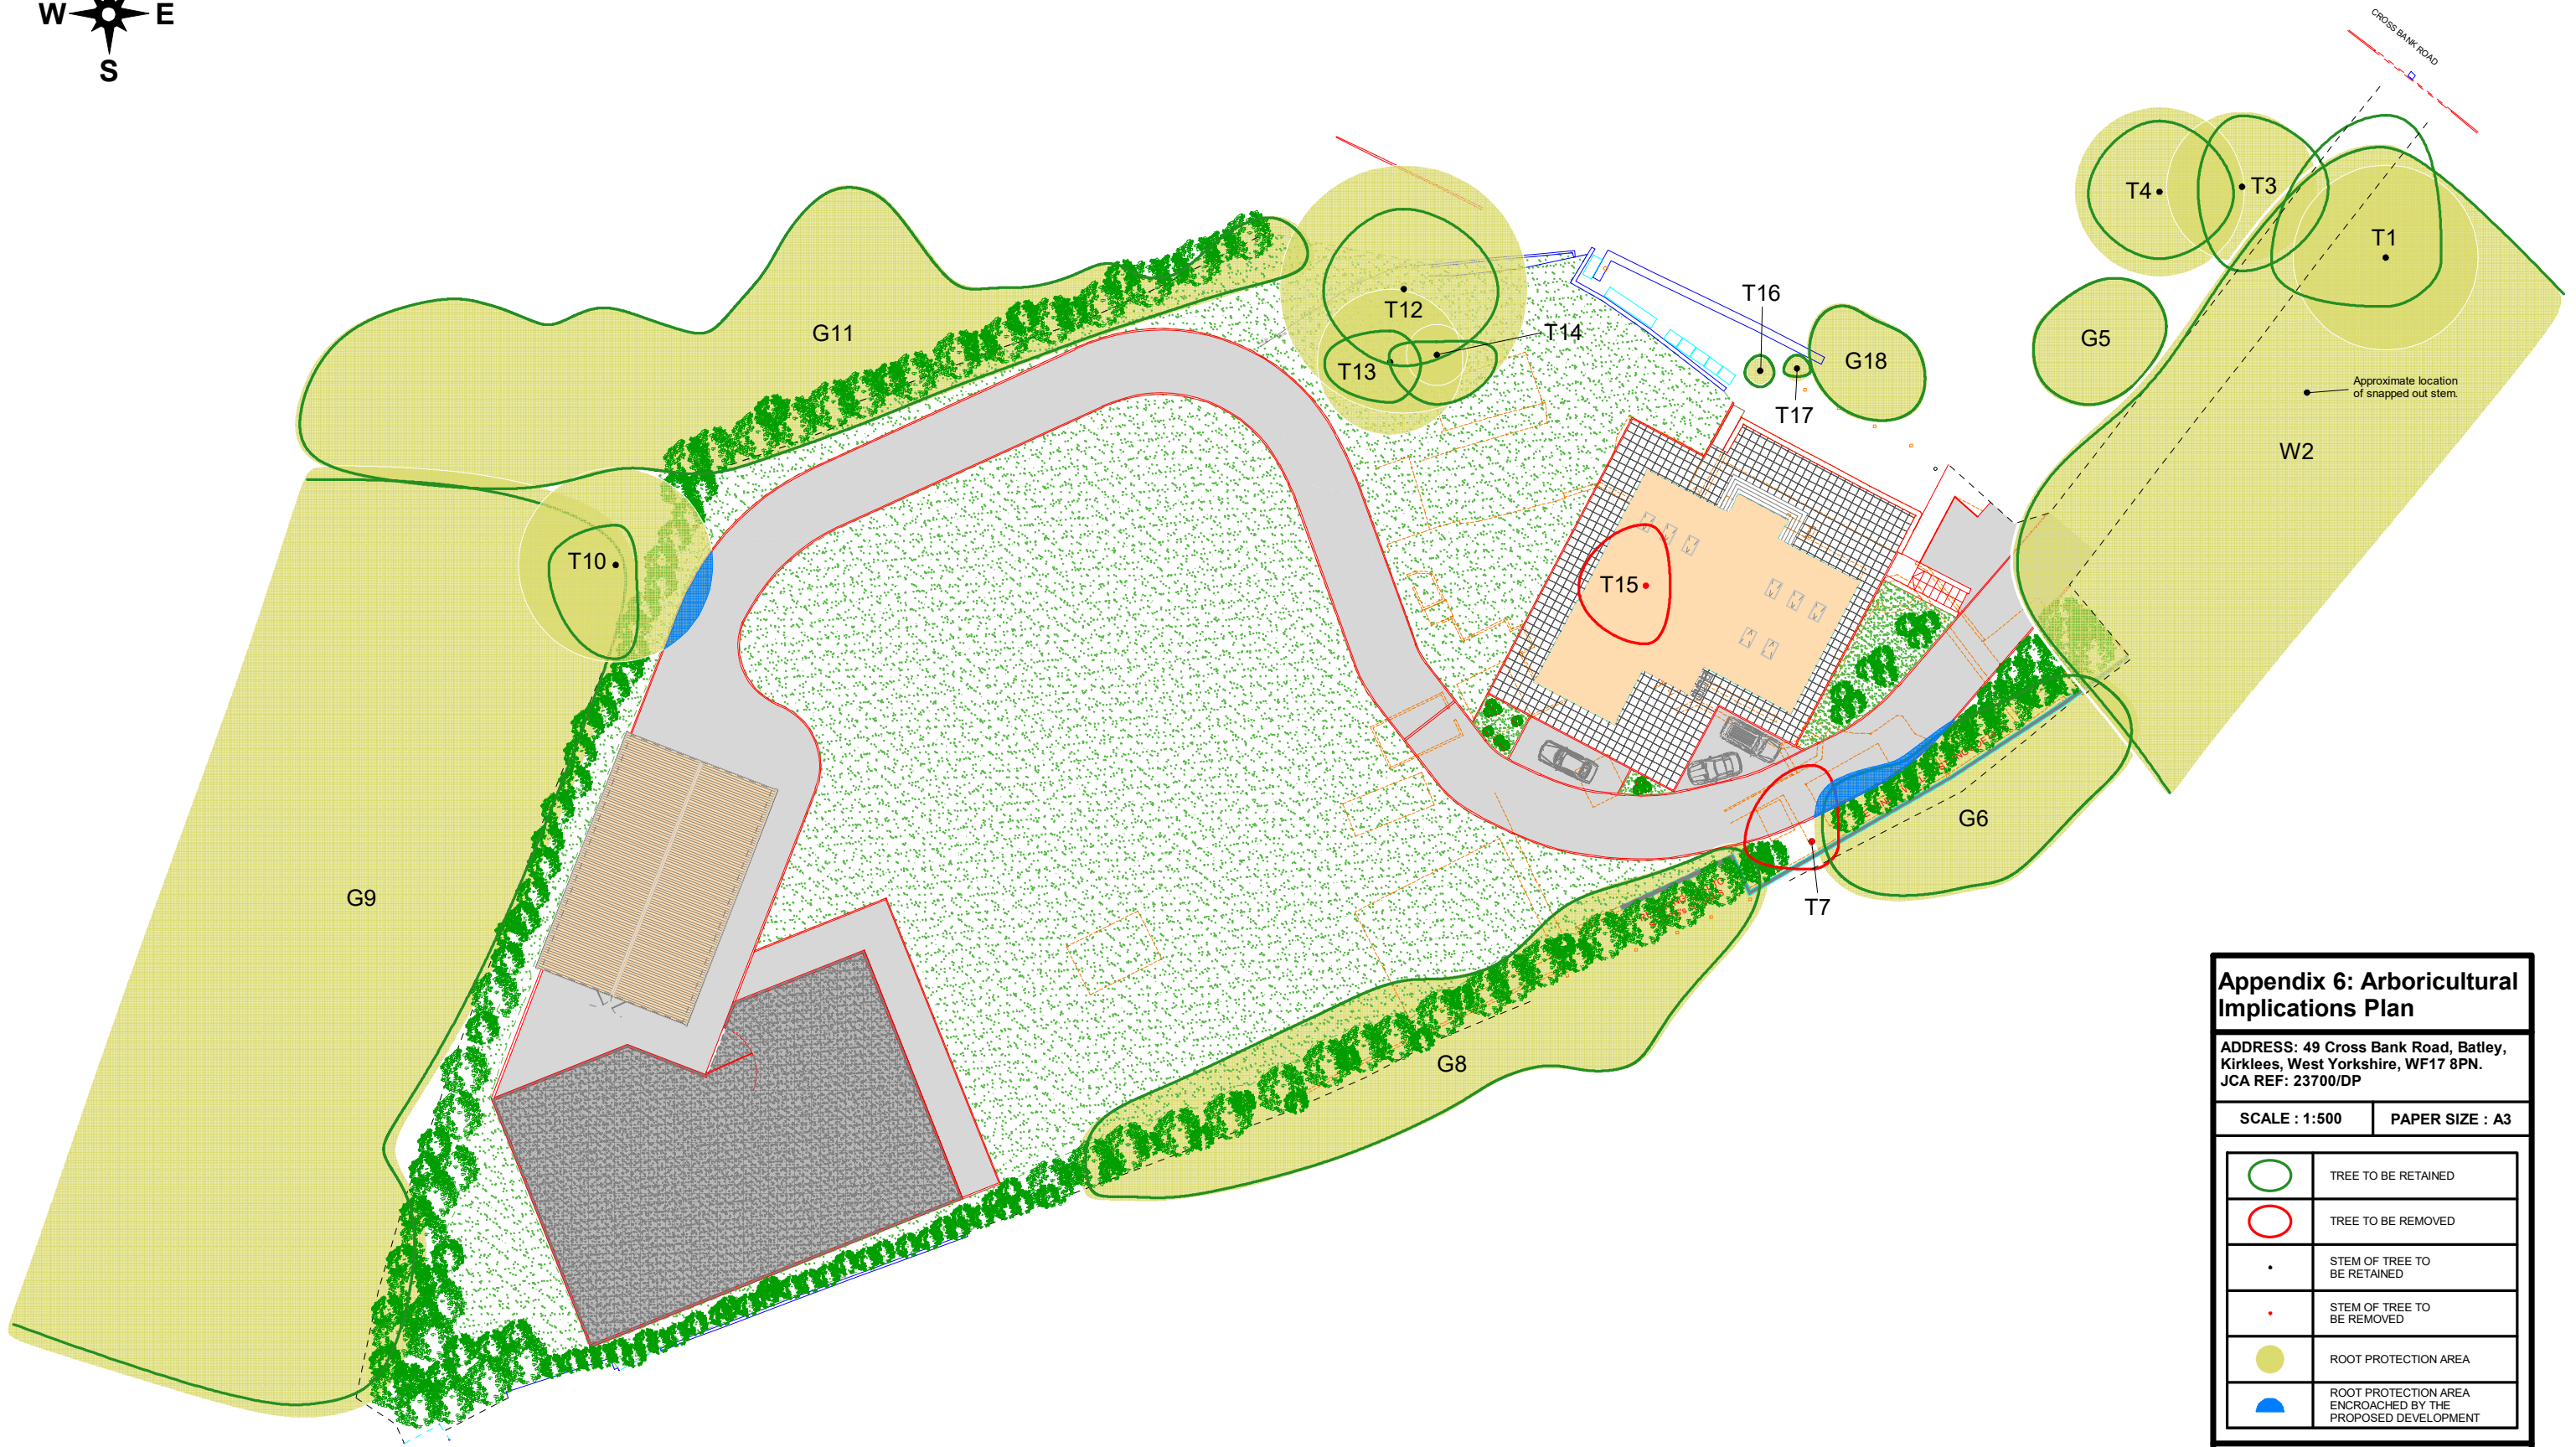
Appendix 6: Arboricultural Implications Plan

- 4.2.1 In order to facilitate the proposed development, **T7** and **T15** will require removal. Both trees are retention category ‘C’ and their removal will not significantly affect the visual amenity of the surrounding area.
- 4.2.2 The removal of trees for development can often be mitigated (either partially or entirely) by the replacement of suitable specimens within a planting scheme. Whilst not always necessary, the planting of trees can improve the aesthetic value of the surrounding area and may be conditioned in the usual manner.

- 4.5.2.1 In order to meet the needs of this proposal, demolition of existing structures is required within the RPA of **W2, G6, G8, T12, T13** and **T14** of the retained trees. Due to this, specialist demolition methods will be required to prevent damage. This may include carefully collapsing structures by hand in a direction away from trees, utilising hand digging methods, working within RPAs etc. Full details on such methods should be included in an Arboricultural Method Statement, including where arboricultural supervision is necessary.

- 4.5.3.2 Proposed hard surfacing is present within the RPA of **T1, T3, W2, G6** and **T10** of the retained trees. In relation to **T1, T3** and **W2** the proposed surfacing is situated within the footprint of existing surfacing. Where this is applicable, the existing surface will be retained in situ to prevent damage to tree roots. If required, it may then be resurfaced as appropriate, providing that the base is retained and no excavation takes place within the RPA.

- 4.5.3.3 New hard surfacing is also proposed within the RPA of retained trees **G6** and **T10**. Due to the limited extent of the incursion, it is not considered necessary to install specialised surfaces. Instead, any excavation required will be carried out with root pruning undertaken under the supervision of an appointed arboriculturist, in order to minimise potential damage to tree roots and avoid ripping damage commonly associated with mechanical excavation.

- 4.6.1 Protective fencing specifications and on-site positioning, along with details of any necessary specialist construction methods, can be provided in an Arboricultural Method Statement (AMS).
