DEMOLITION OF EXISTING DWELLING AND ERECTION OF 4 DWELLINGS

11 WOOD STREET, SKELMANTHORPE HD8 9BN

APP NO: 2024/62/91934/E

Construction Management Plan

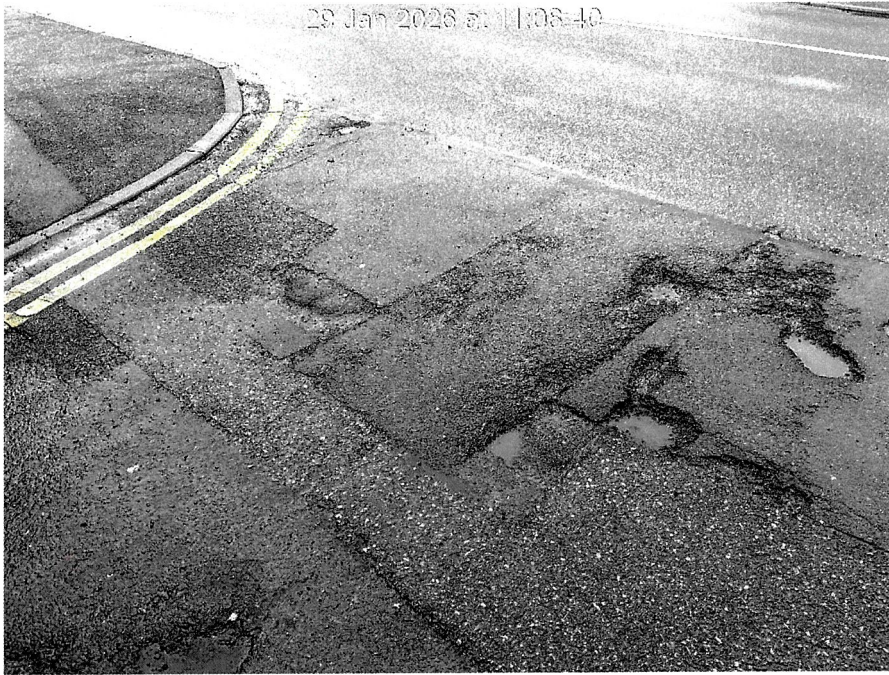
No 1.

Wood Street has general signs of wear along the site boundary and entrance, however it must be noted that at the junction, Wood Street onto Station Road there is a great deal of very heavy wear along with a number of potholes. The footpath is also in a poor state, it appears the top coat as laminated off in places.

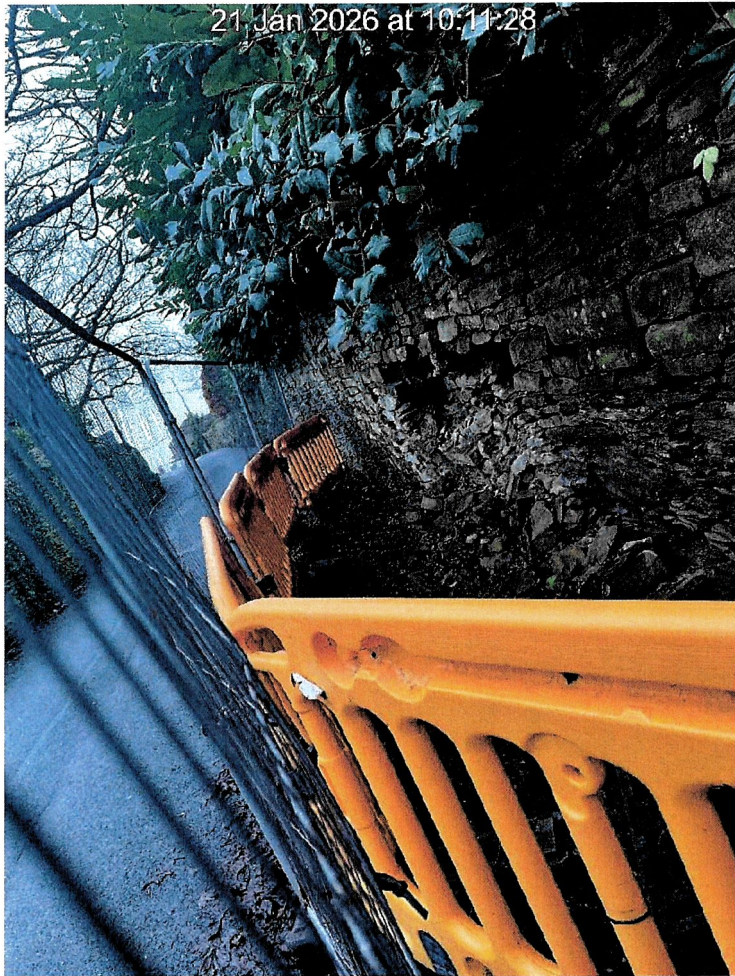
Wall collapse, poor masonry work evident in bonding.

It must be noted that the boundary wall on Wood Street is in a very poor condition. The construction is in a Dry Stone walling method, however the wall has been very poorly constructed in areas, there is a lack of bonding or use of ‘jumpers’ in some areas.

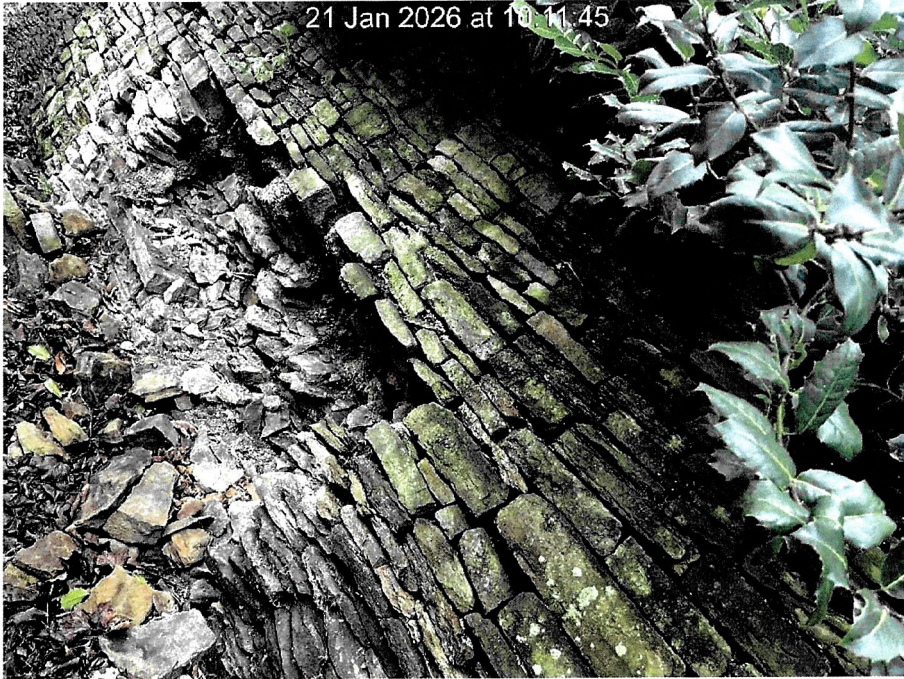
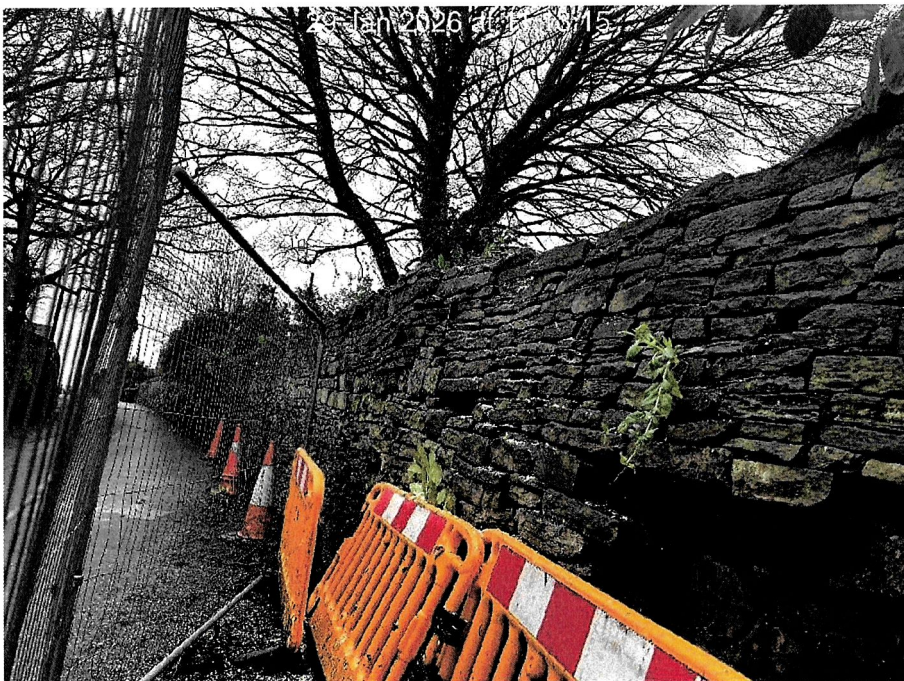
Wall has been pushed out by tree roots.

You can see that the wall has been added onto, rebuilt and generally messed with over the course of its life, the trees have pushed against the wall and caused a major collapse that is currently fenced off.

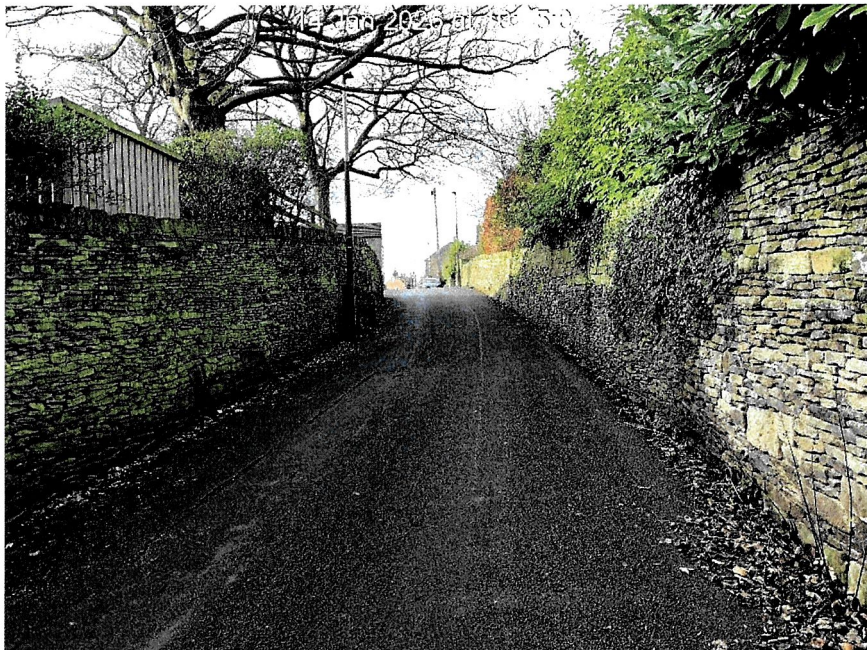
Example of rebuilding.
