# Methodology & Associated Risk - Boundary Wall Works

11 Wood Street,  
Skelmanthorpe, HD8 9BN

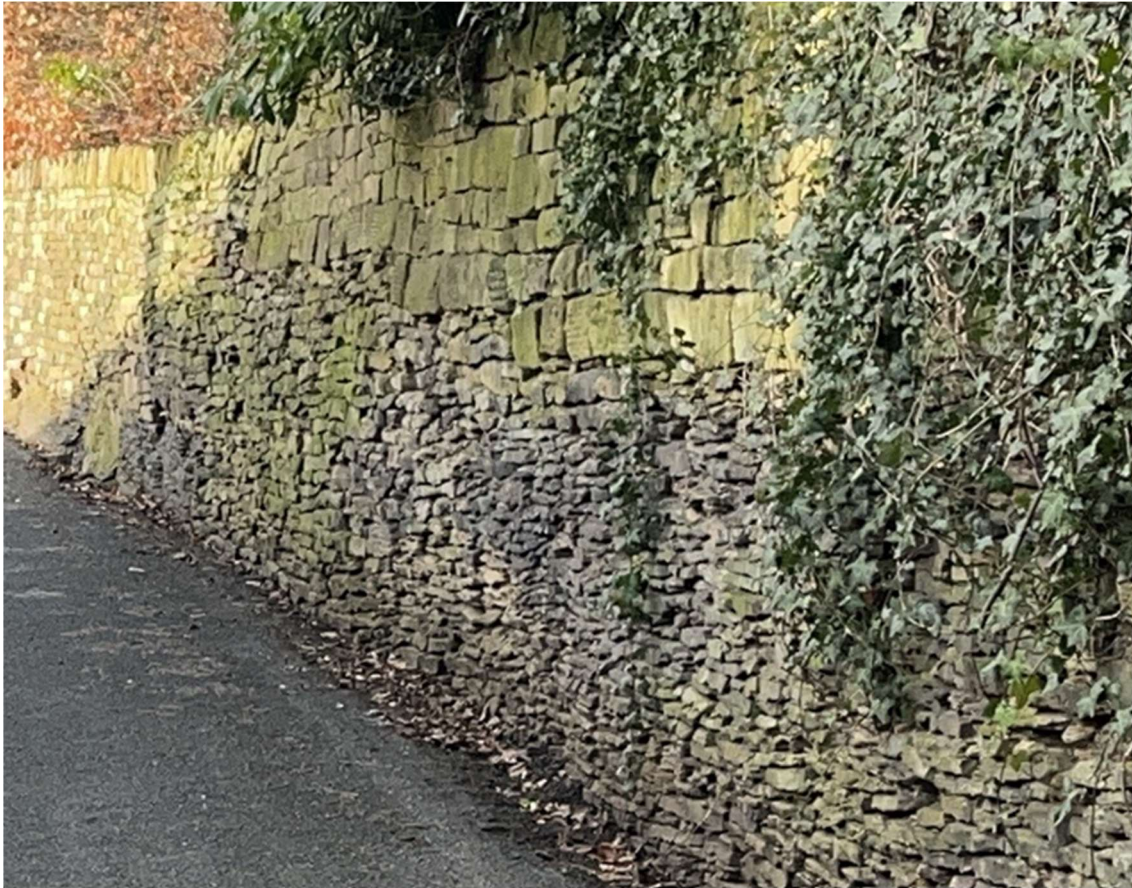
Image 2

As discussed in the engineer's report the existing wall is not of one construction, it appears to have been added onto and repaired quite a number of times. In image 2 (over page), you can clearly see the original shale layer wall, since commencing works onsite, we have been able to determine where the original walling material came from. This type of stone is present in the upper 250mm- 500mm of the ground in the unquarried areas of the site and it understandably has been utilised for the original boundary walls due to the abundance of the material, so much so that it is present on a number of walls local to the site. It must be noted that the shale stone is quite a 'soft' product and is seen as waste by local quarries as it mainly reduces to dust when riddled. The nature of this product is evident in the wall where it has fractured, weathered and formed voids.

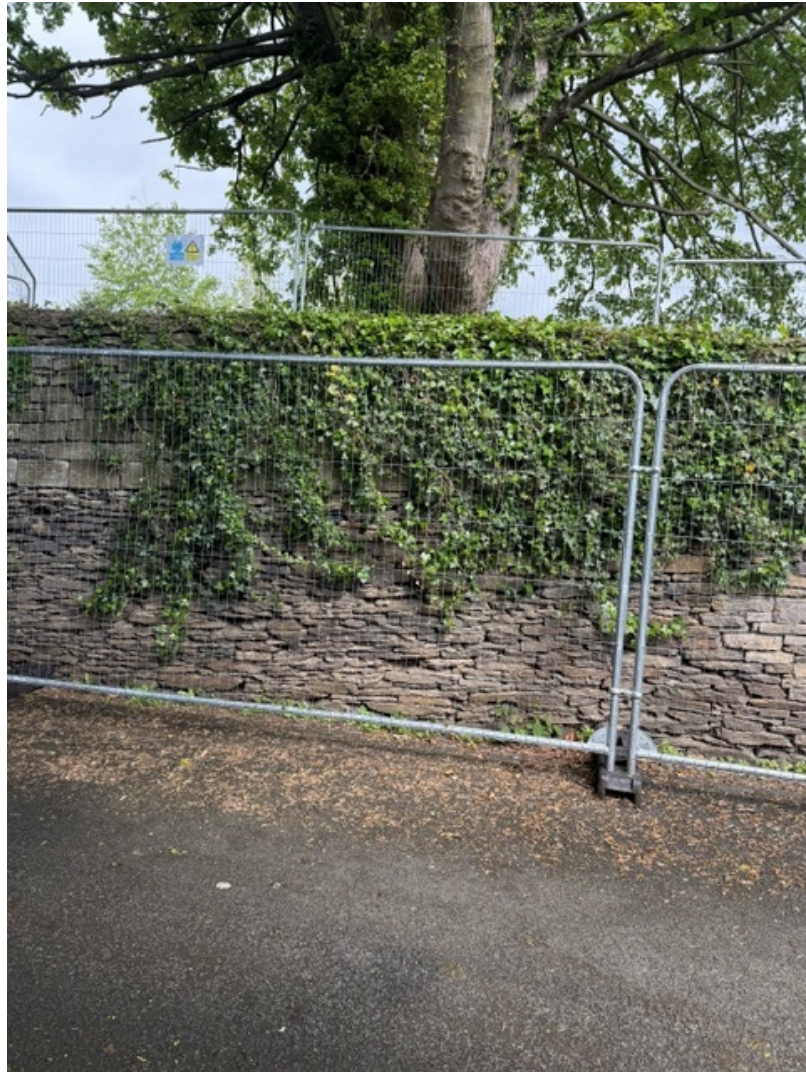
Image 3

In image 3 the shale layer is very prominent with a mixture of 'backings' and random stone above, none of which is bedded on any form of mortar. The shale along the wall length is fragmenting and fracturing is present along the length with pockets forming in the wall.

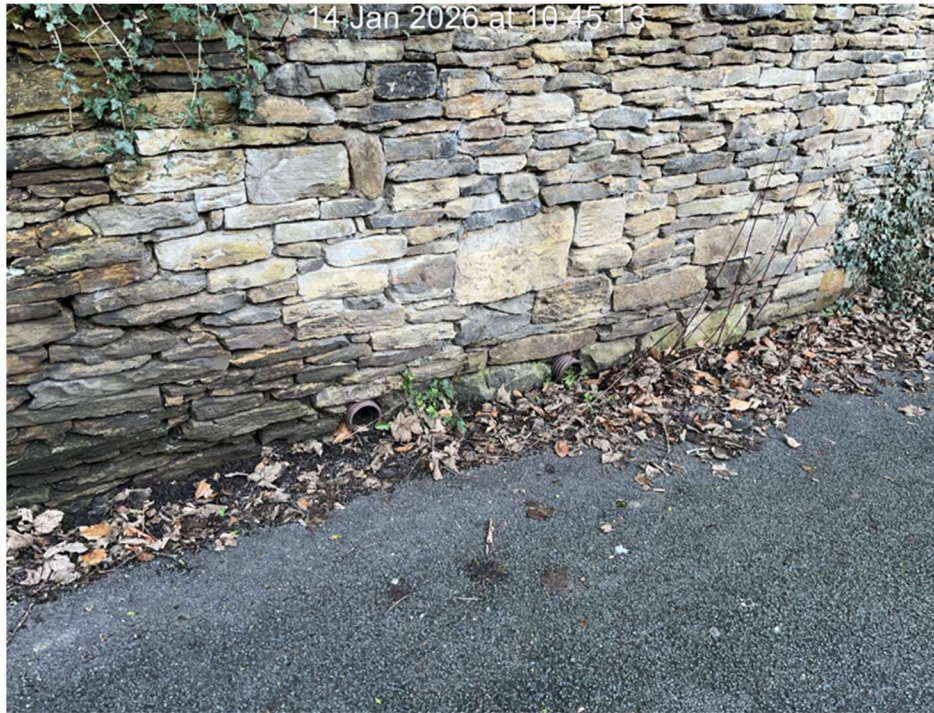
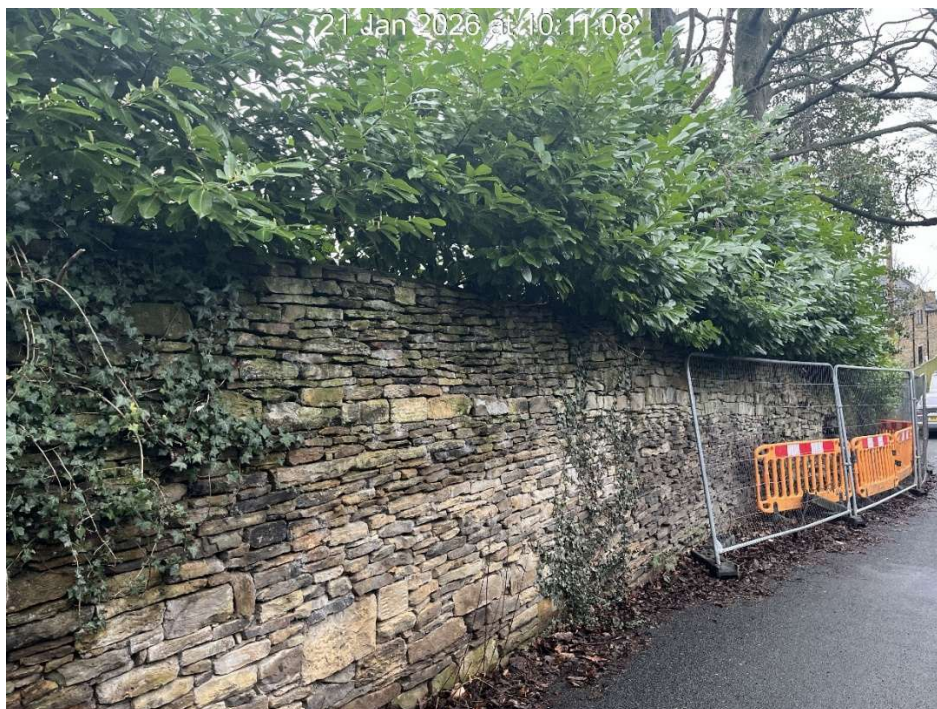
In image 4 & 5 you can see that a section has been repaired to what appears to be a good standard with drainage outlets fitted. Unfortunately, it is only a small area of the wall that has been repaired, however as suggested by the Engineer it is not to an acceptable standard for the Highway.

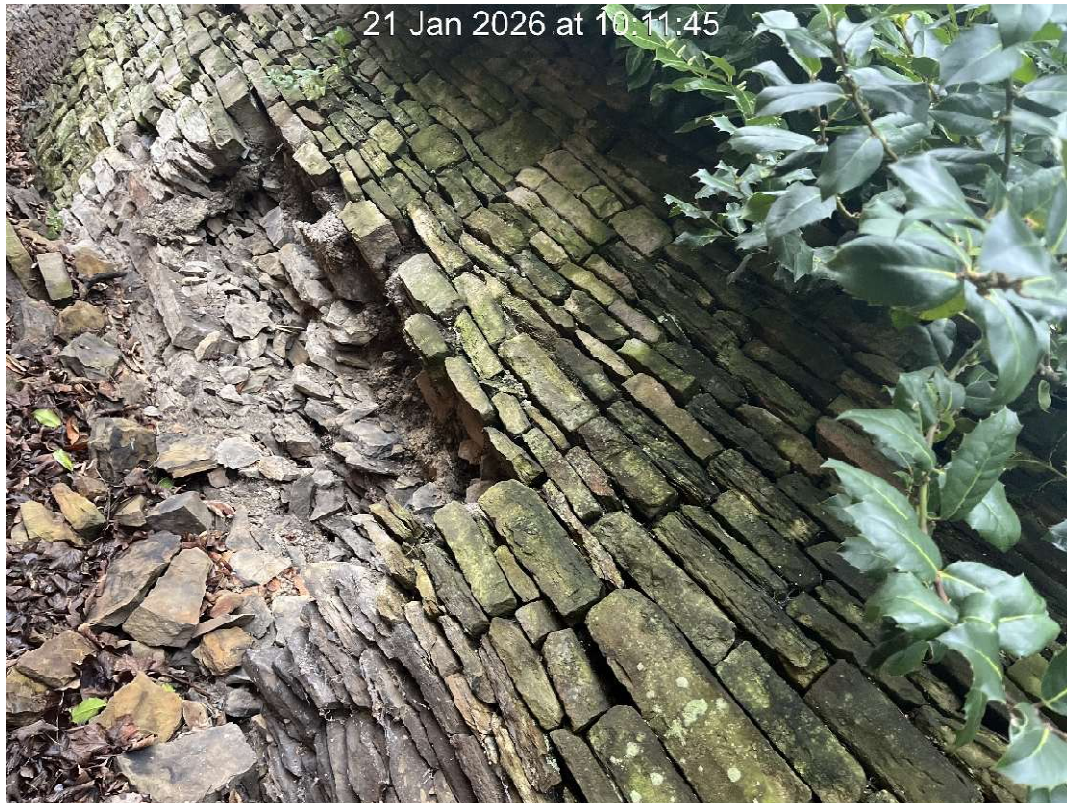
Image 6

'Bellying' has been evident for some time in areas along the length of the wall, this is discussed in the Engineers Report. In January 2026 the area known as Section A in the Engineers Report, partially collapsed leaving a large pocketed area within the wall, see Image 6.

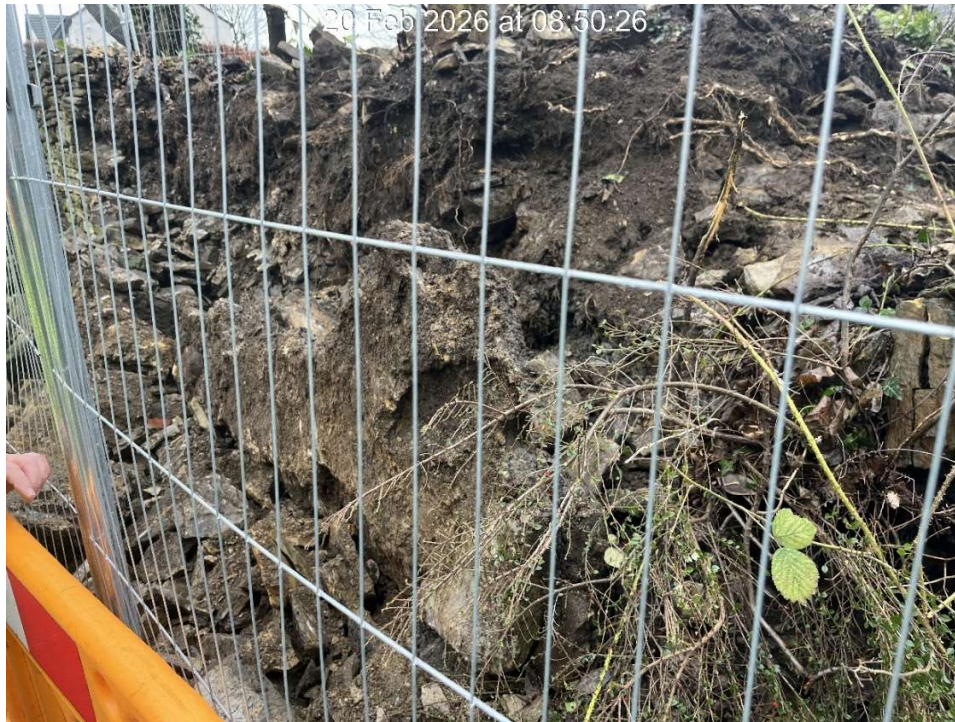
Image 7

This sudden collapse was caused by large amounts of concrete which had been poured down the back of the wall that was unseen, we believe this may have been done to act as a footing for the inner leaf of masonry and/or to stabilise the wall from deteriorating further, See Image 7. We now know that the concrete behind the wall is present in other areas, but can not confirm that it runs the full length of the wall.

Wall Section A – this area has collapsed, the upper section is still piled up against the lower section of wall to prevent further slippage.

The main risk has already occurred in this area, fortunately nobody was injured or property damaged. In this event happening it has demonstrated the potential issues that we will face throughout the task.

The stability of the material behind the wall is unknown, we will assume that it will collapse in the same manner as Section A, see Image 7.

When the collapsed stone is removed from the base, the remaining wall behind may start to shift. To negate this the wall and pile will be reduced at the same time ensuring equal height until fully removed to road level.

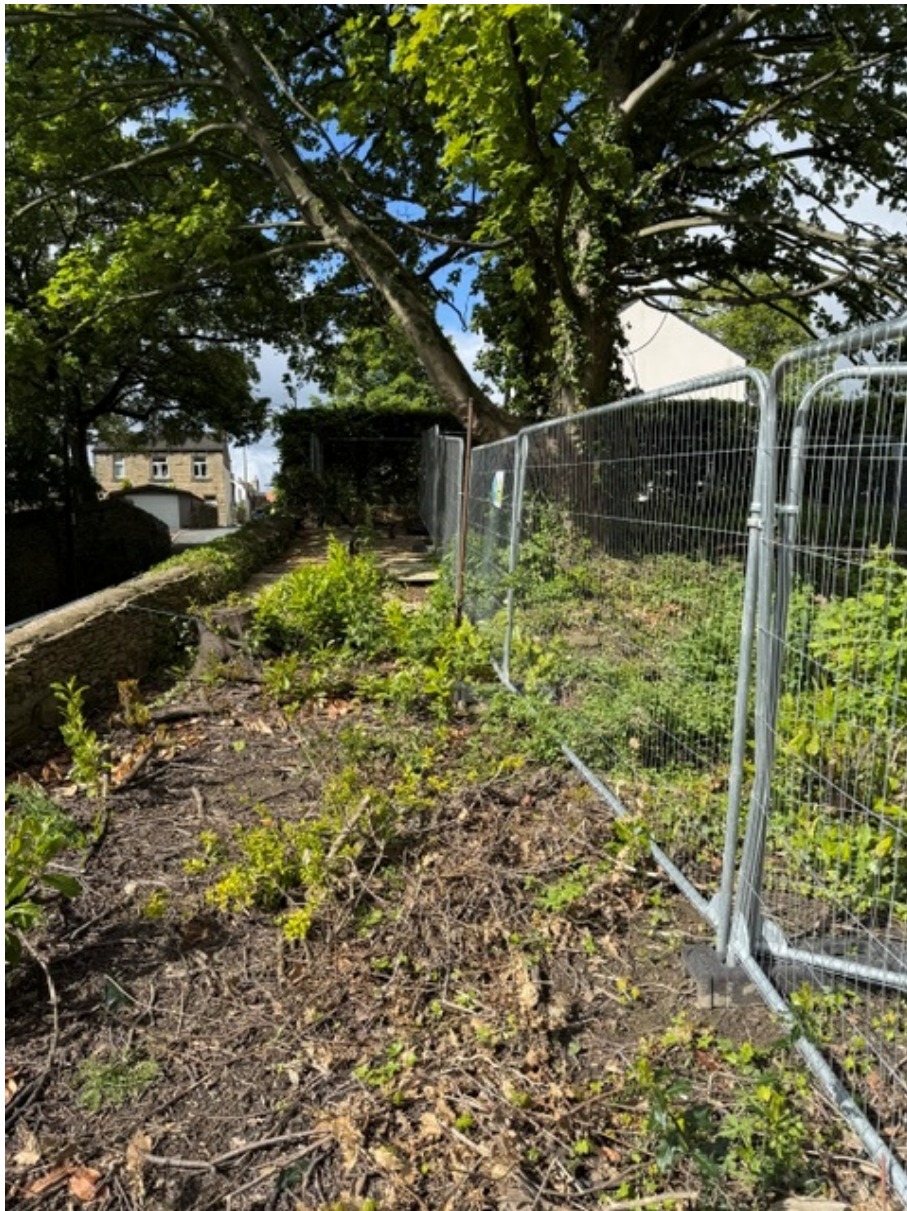
Image 8

At this stage the risk presented by the wall and fill is removed, however the tree T5, as noted in the AMS, will only be circa 2 – 2.5m from the top of the newly formed banking most likely with roots exposed presenting a further risk, see Image 8.
