3 February 2026
Our Ref: MDL – 12562

Structural Inspection of Outbuilding at 61, Leymoor Road, Golcar

Appendix 'A'

Photograph Summary of Structural Defects Noted

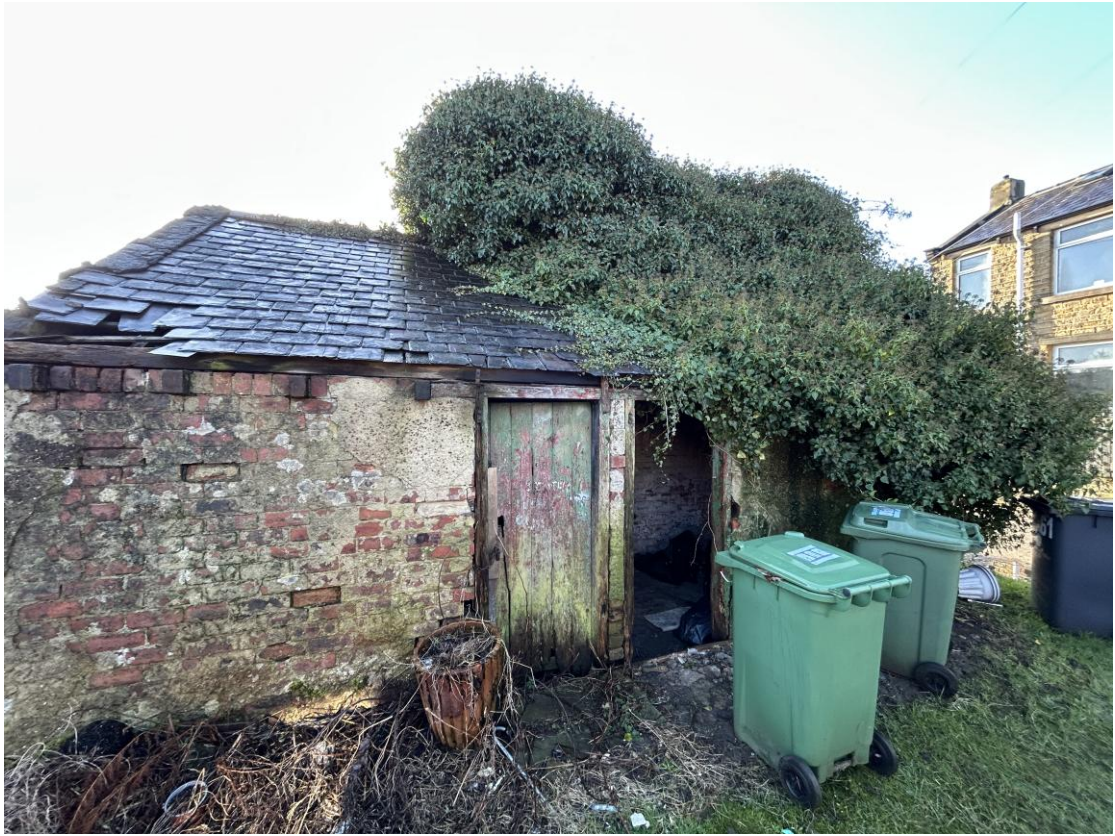
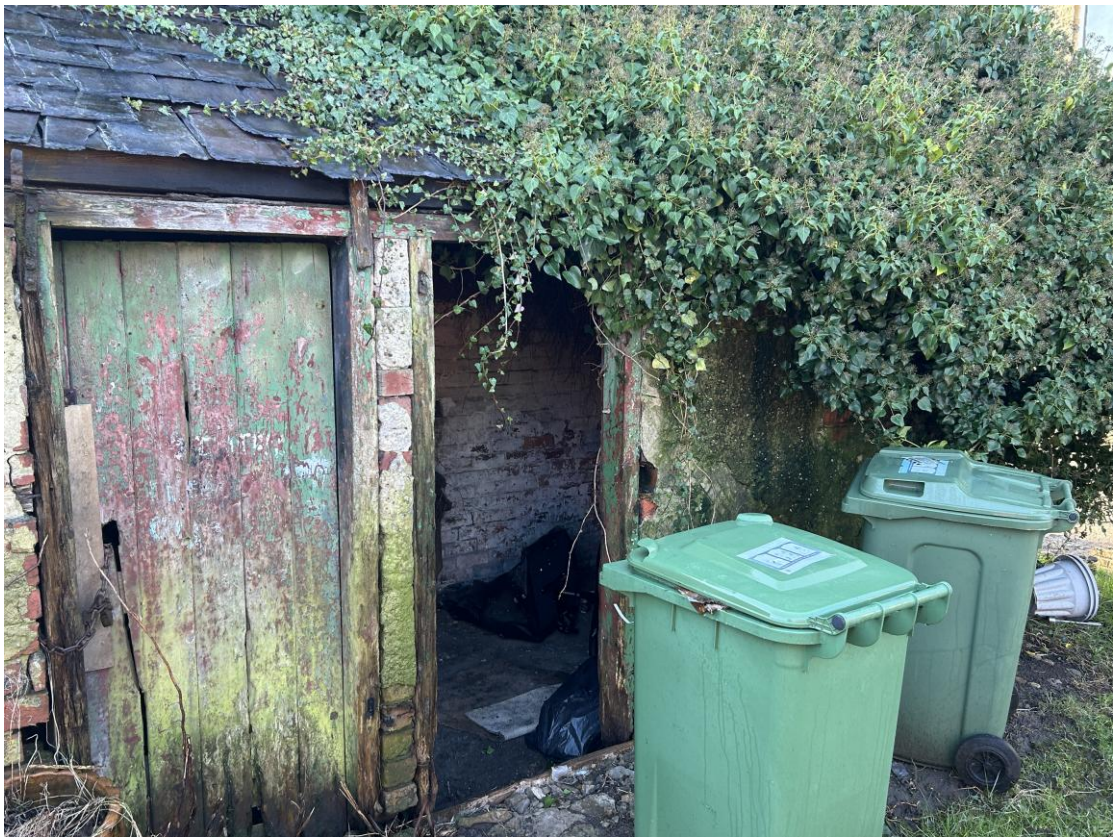
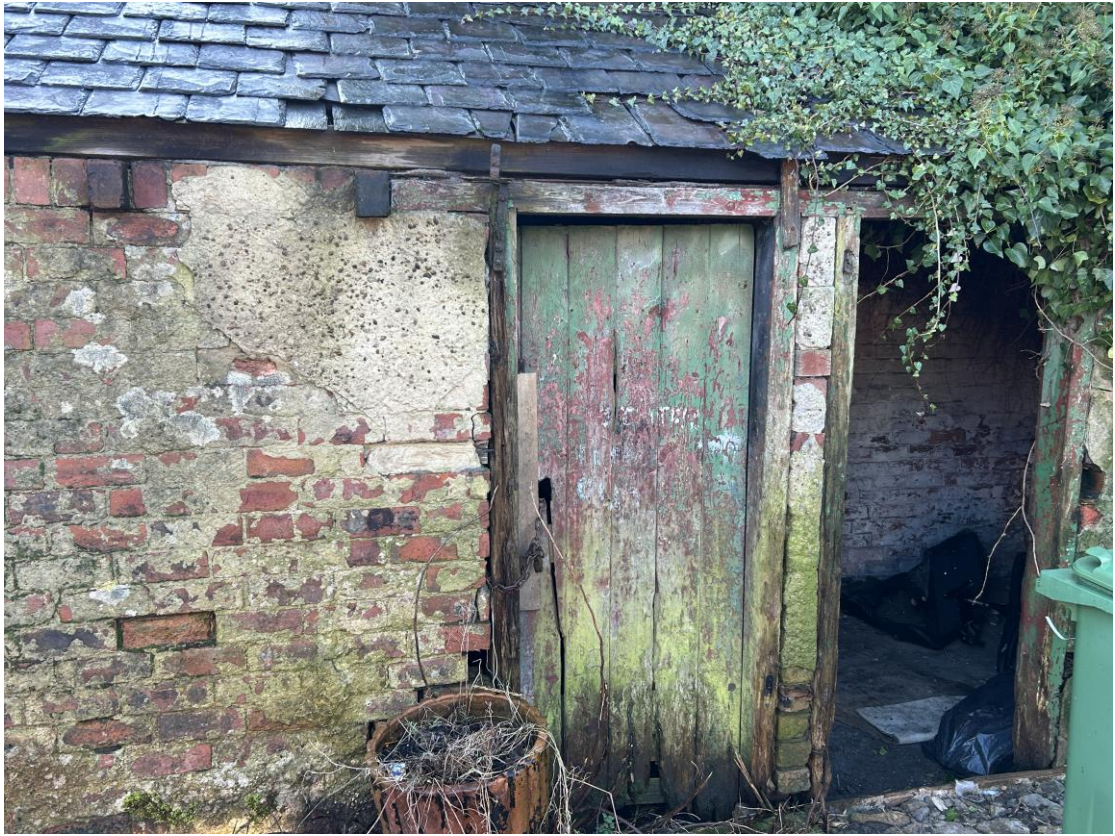
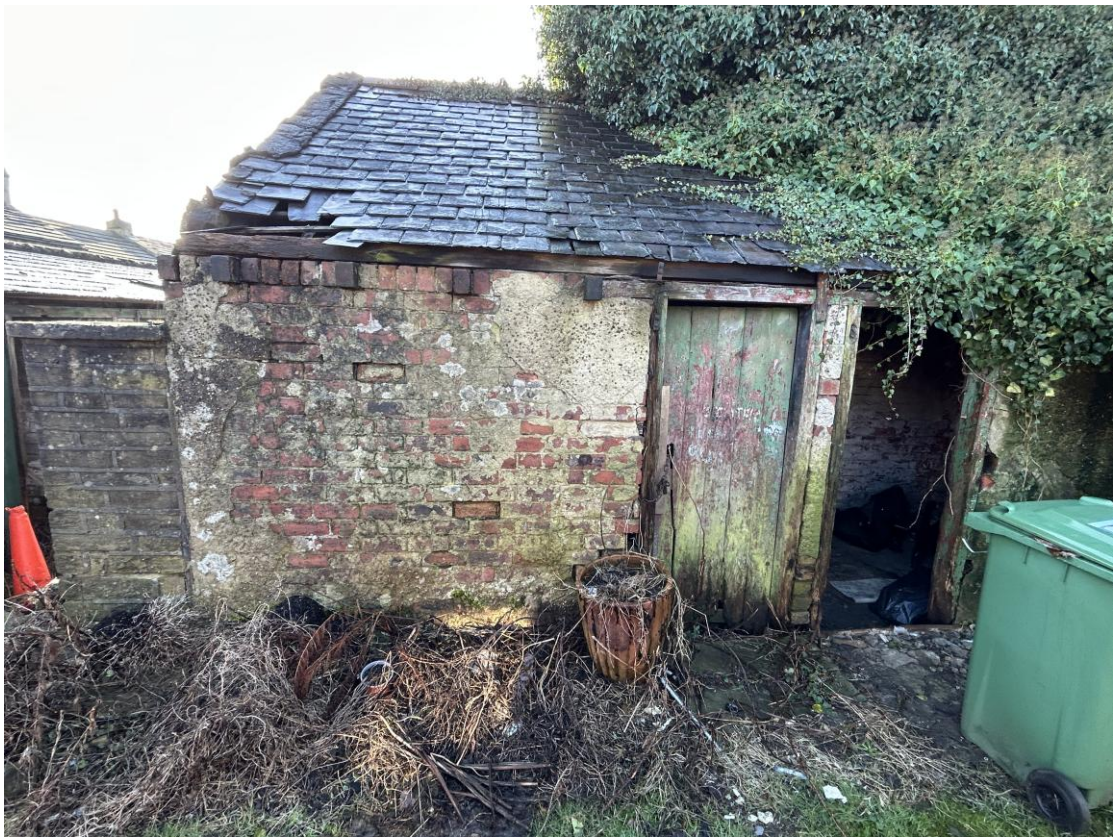
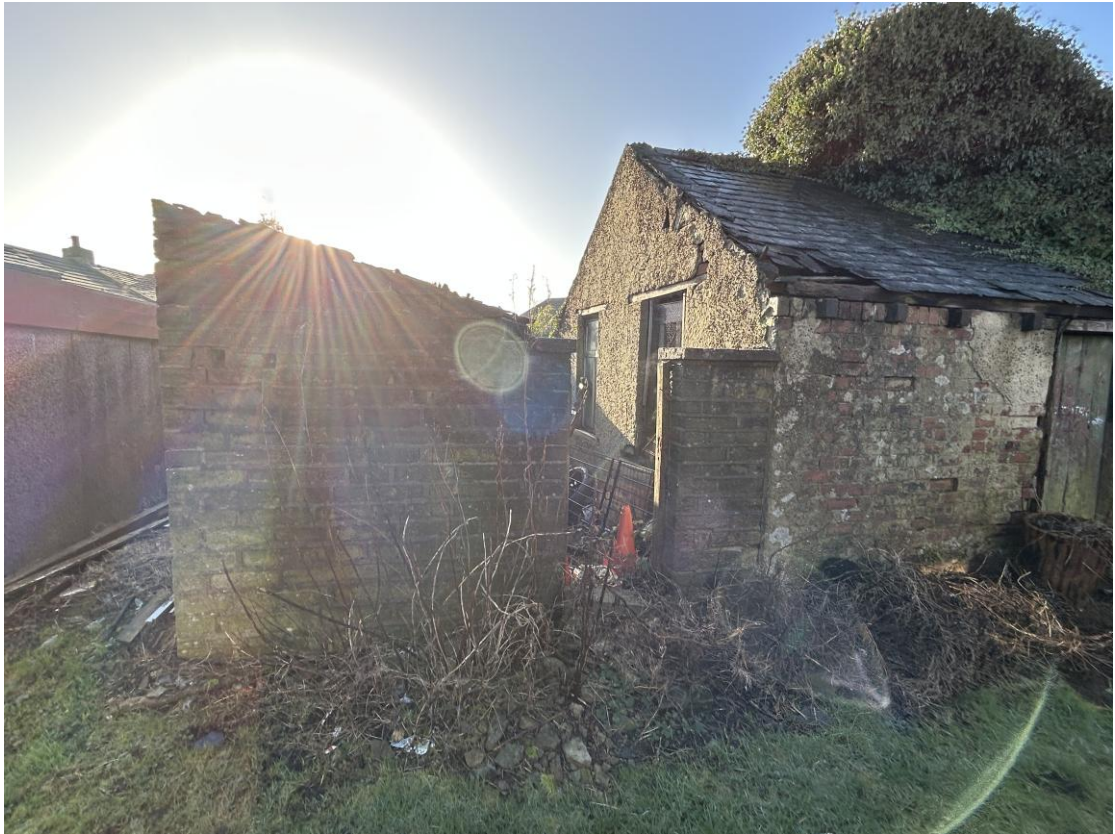
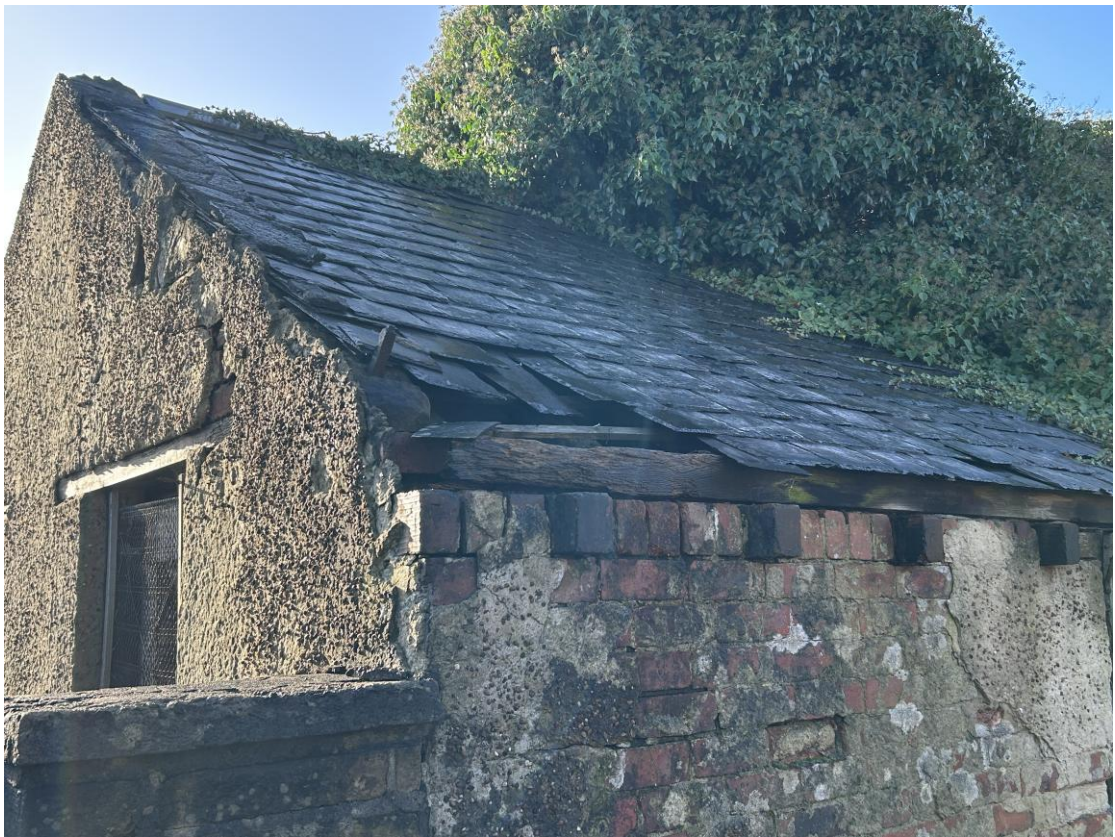
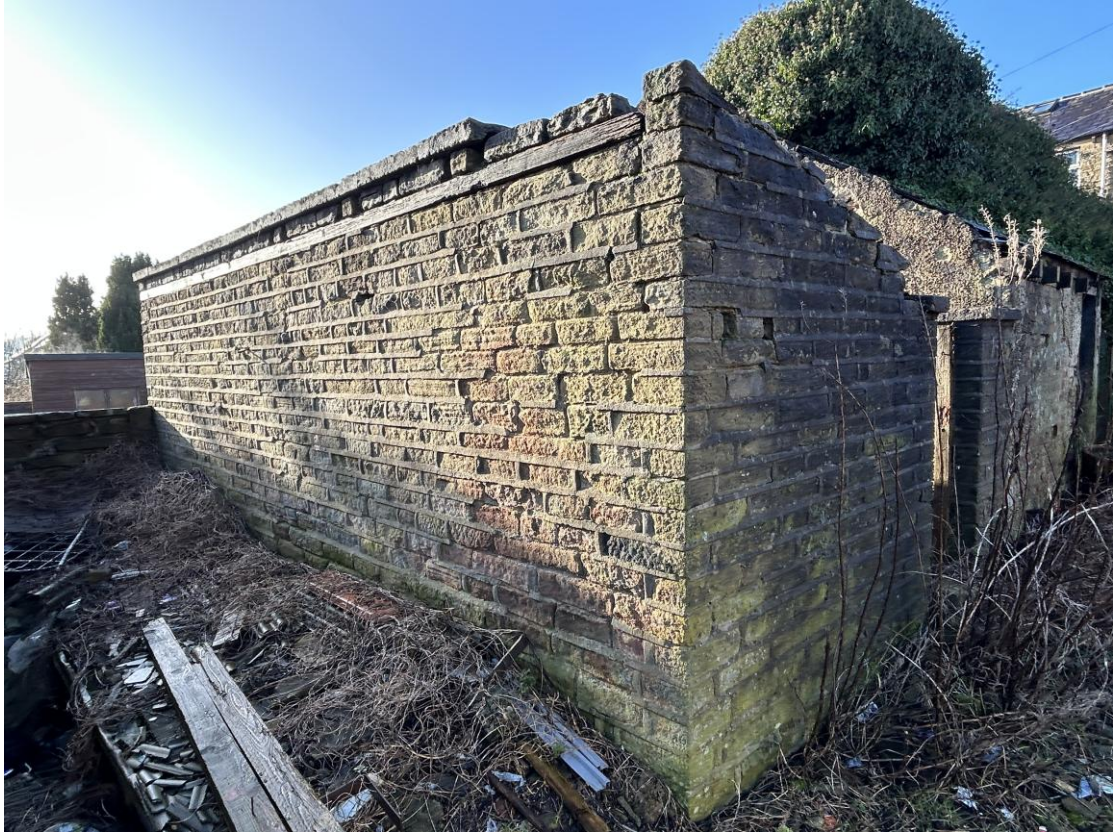
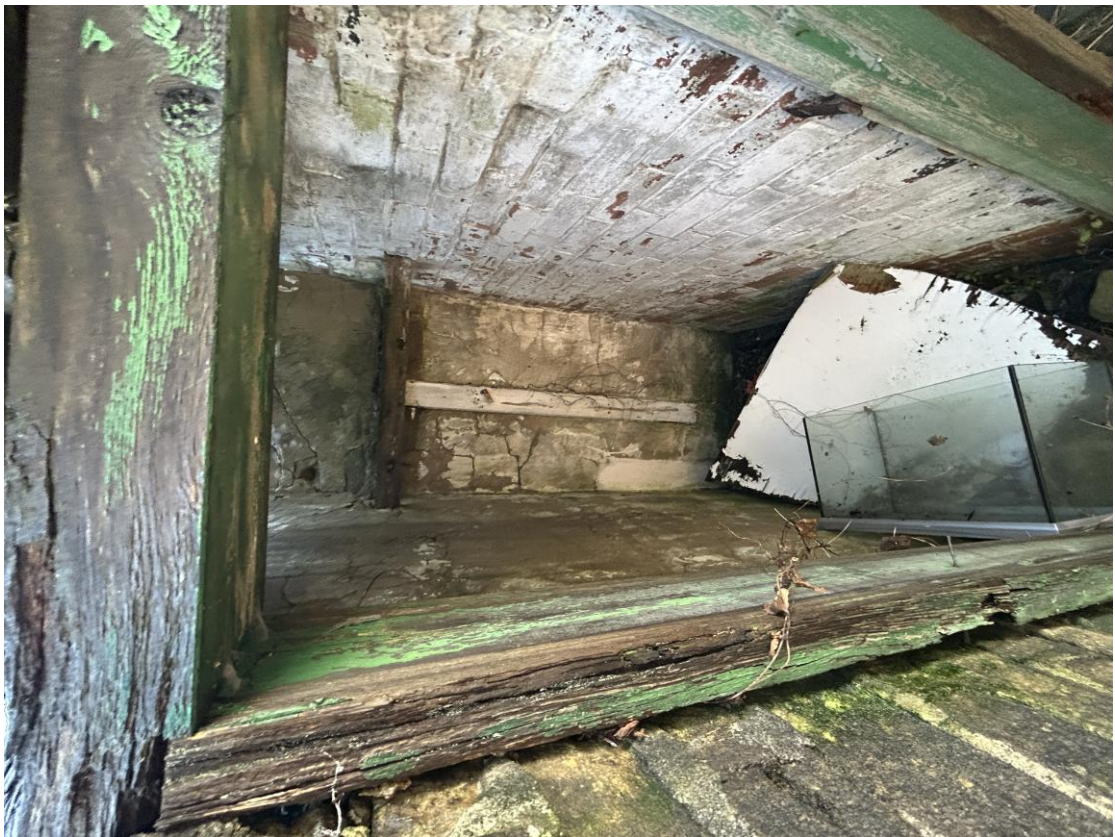
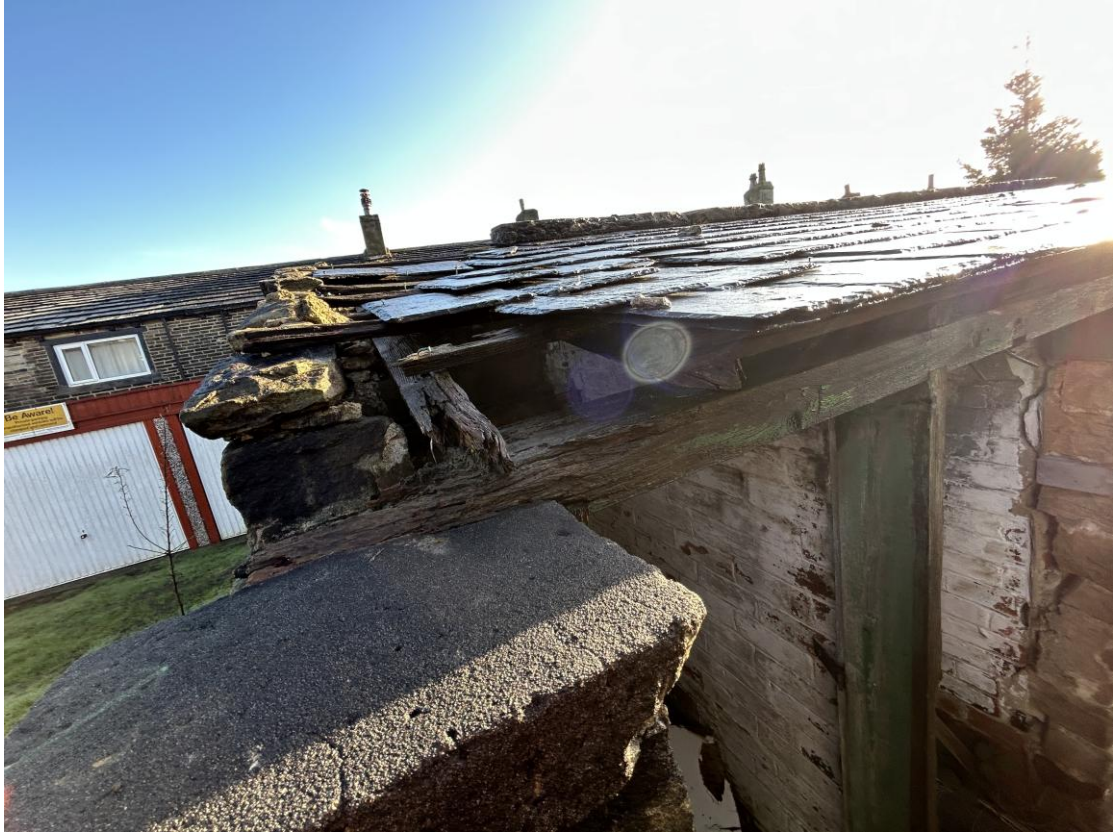
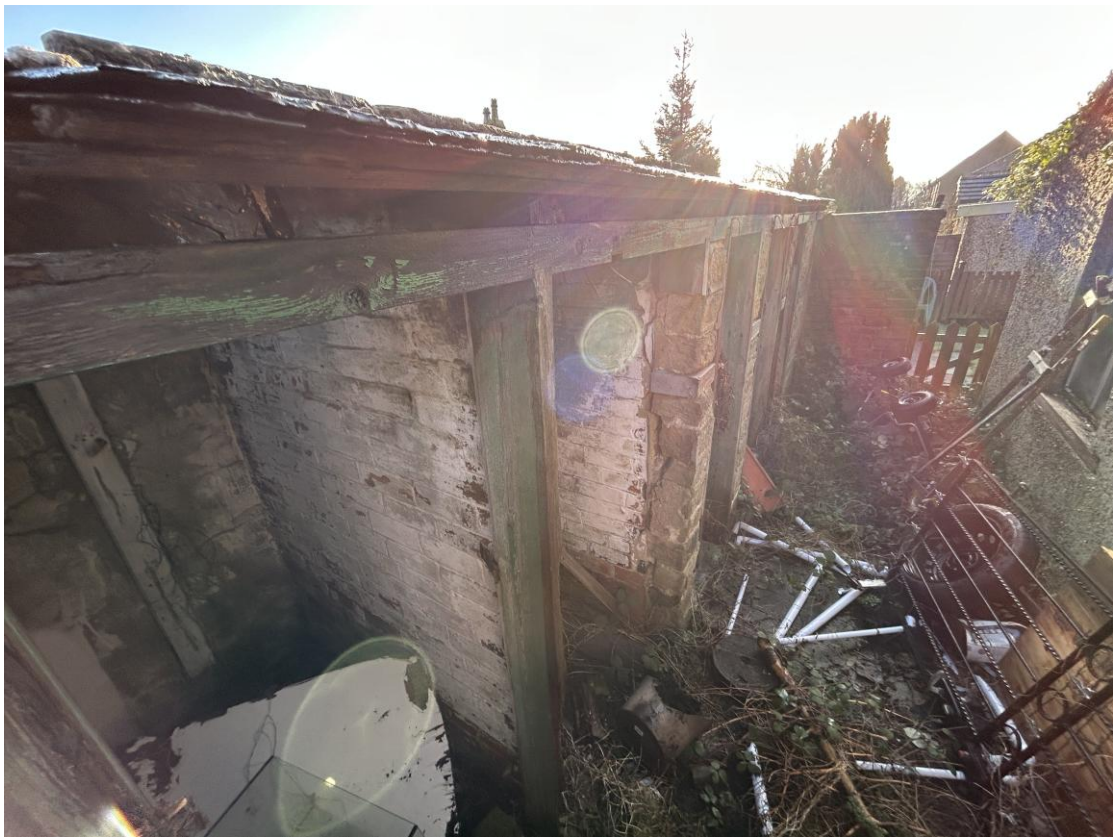
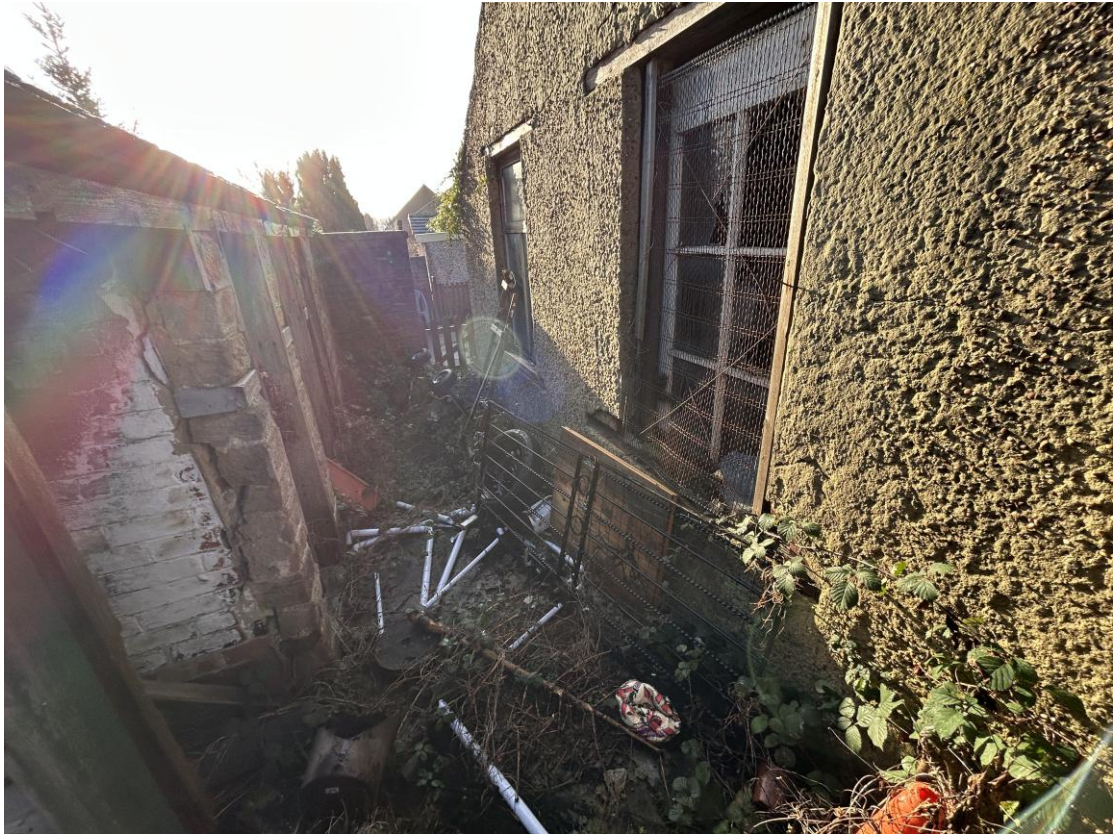
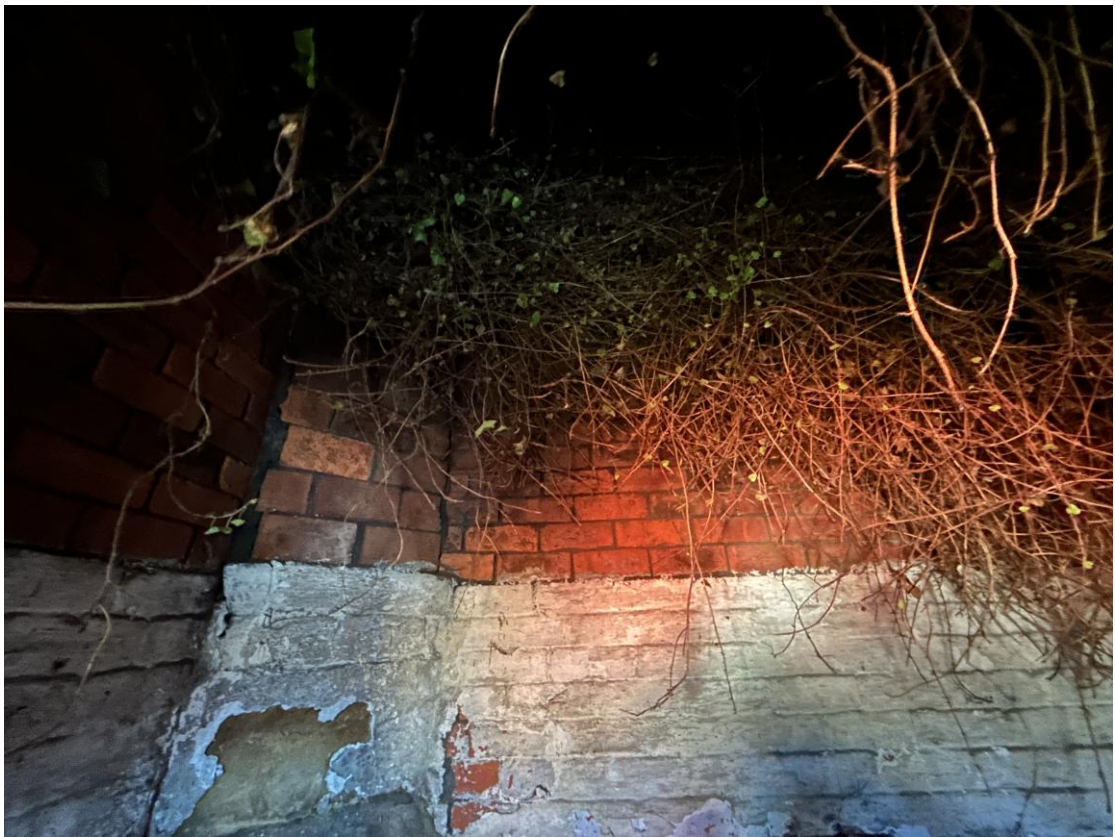
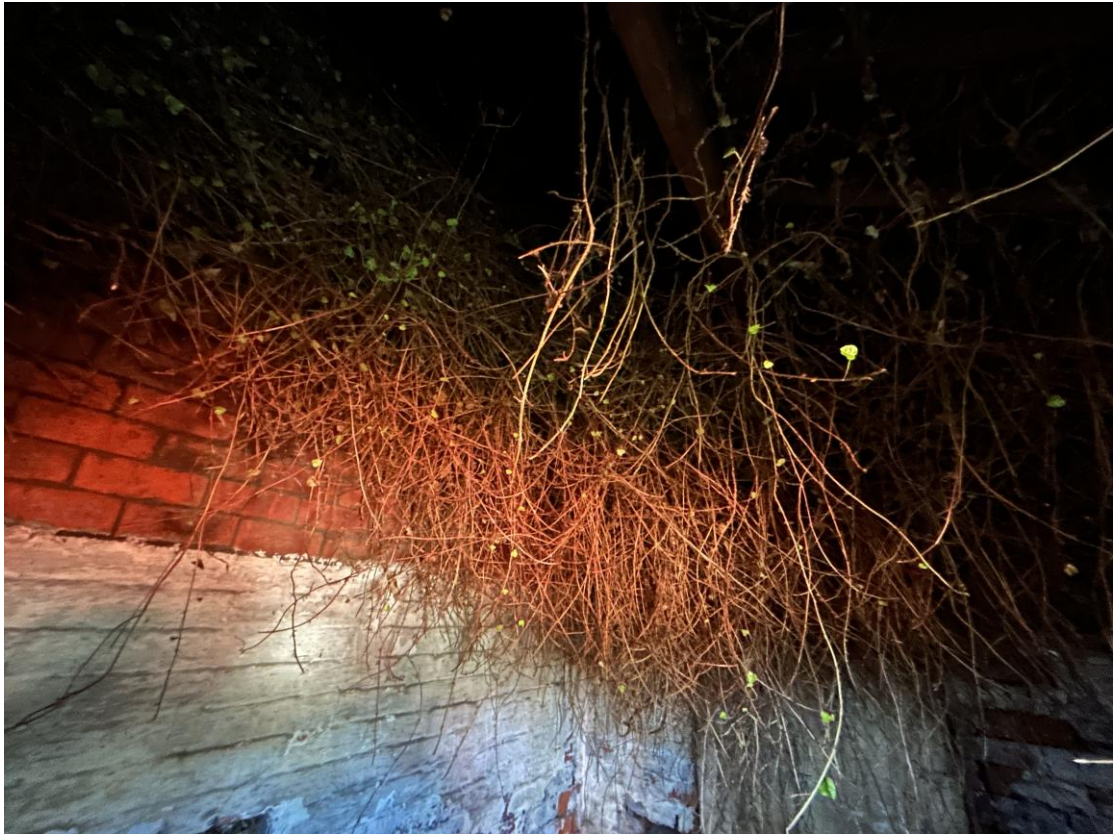
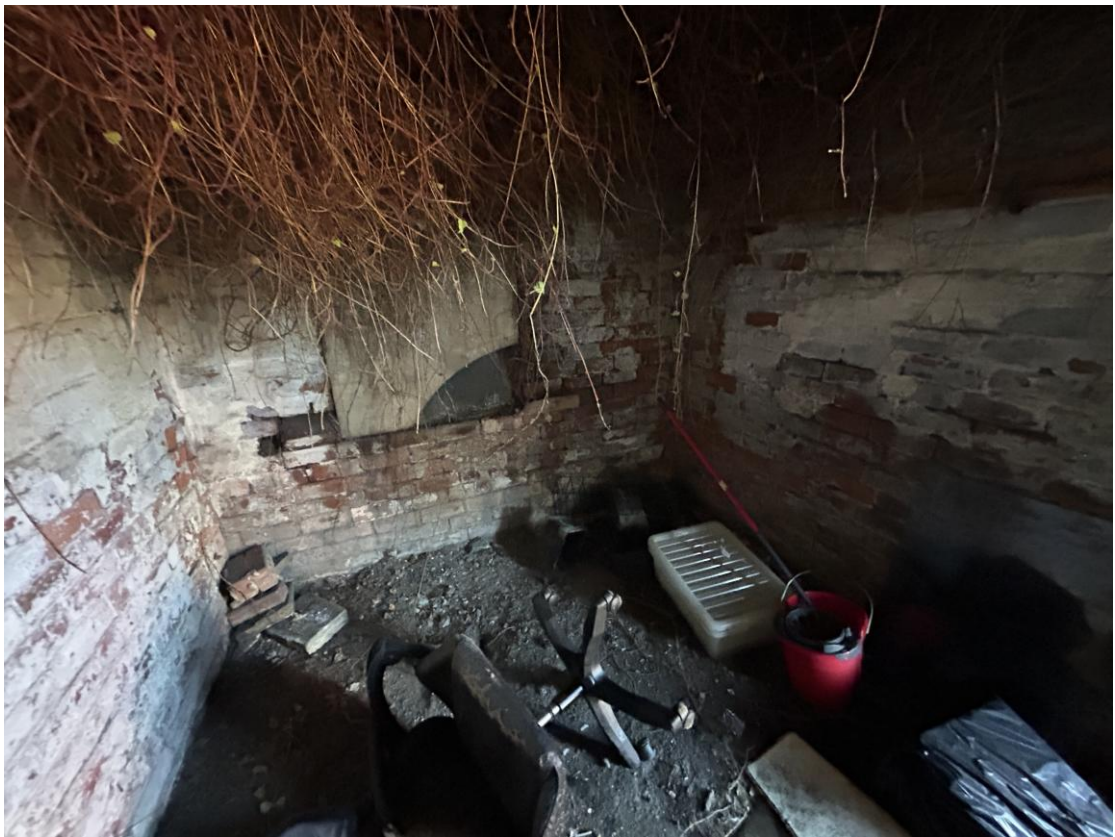
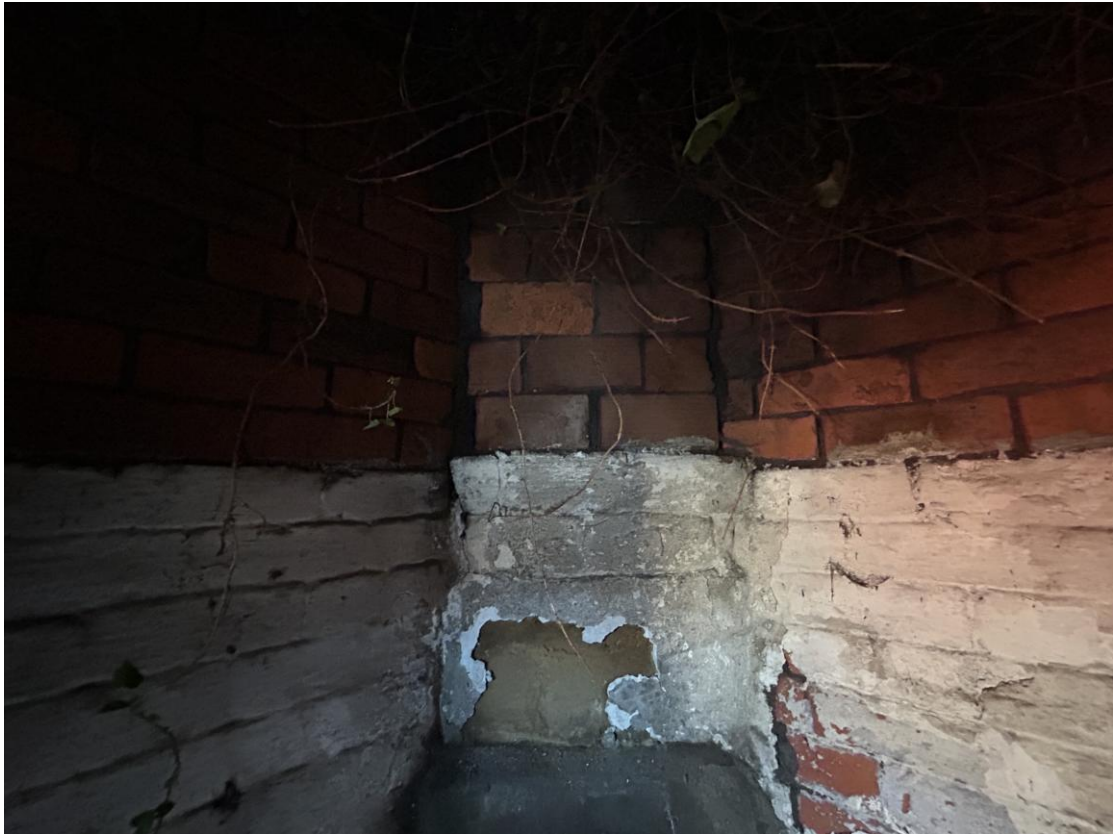
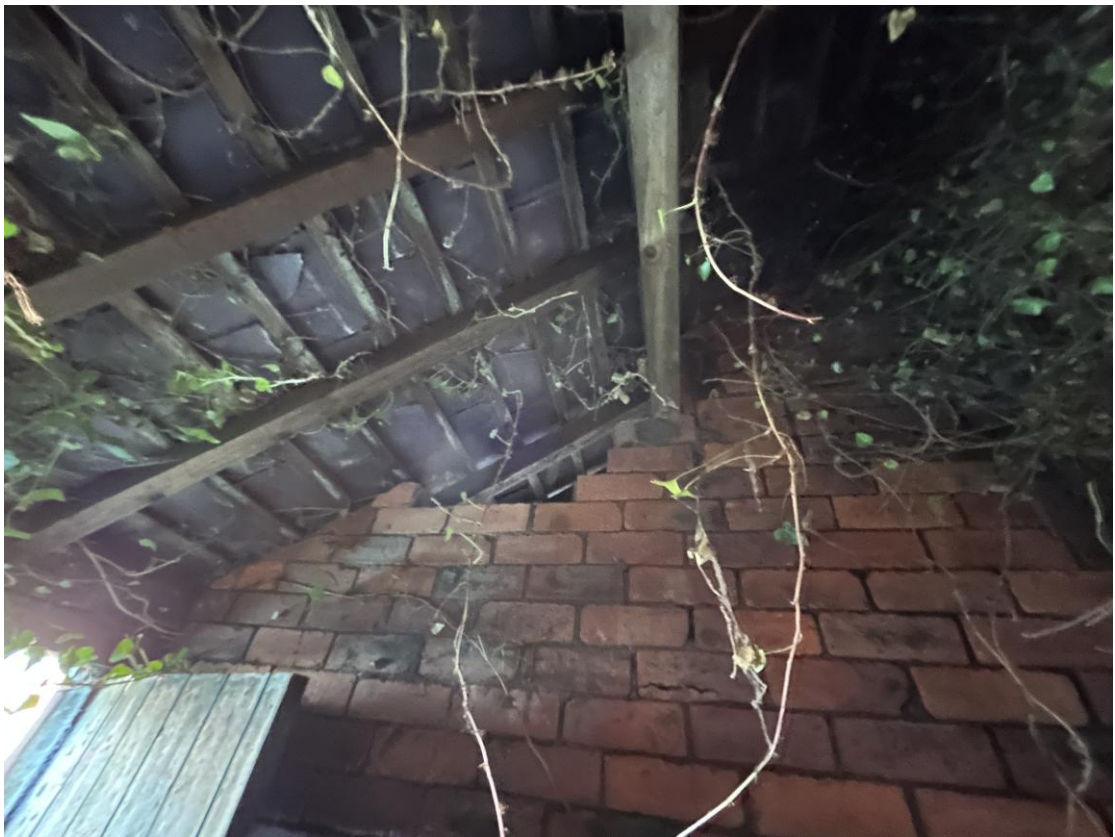
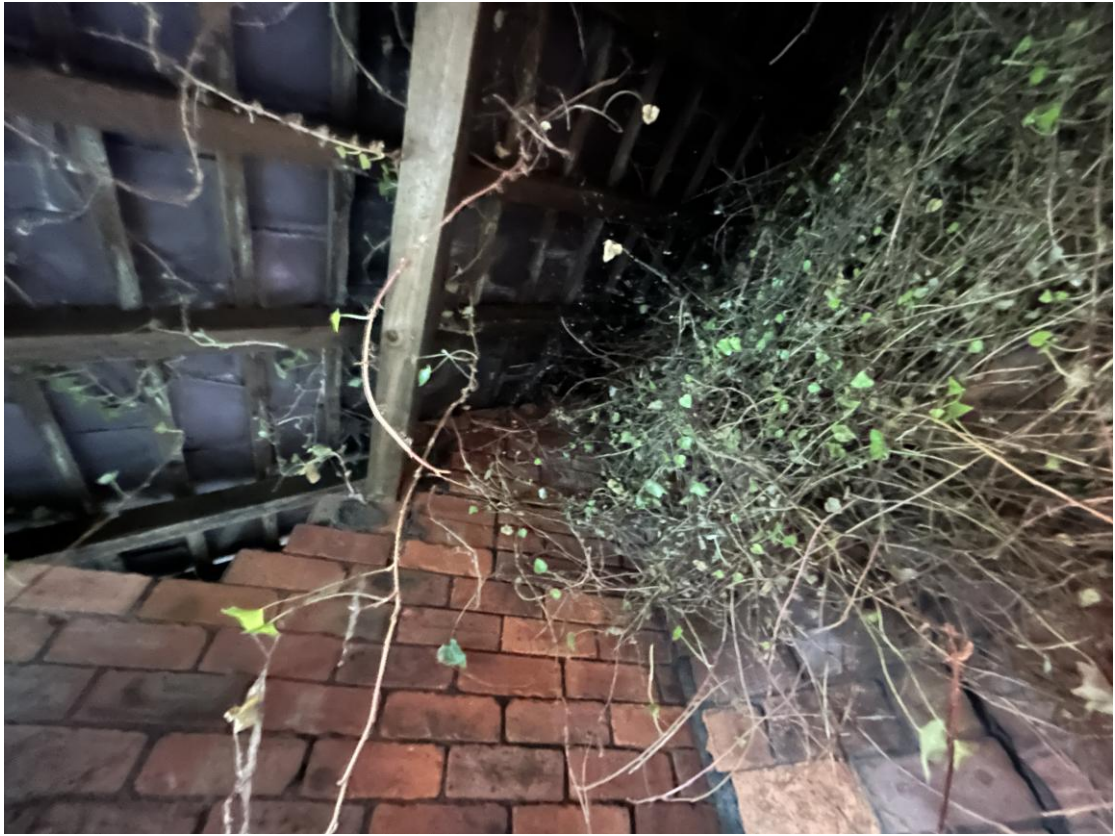
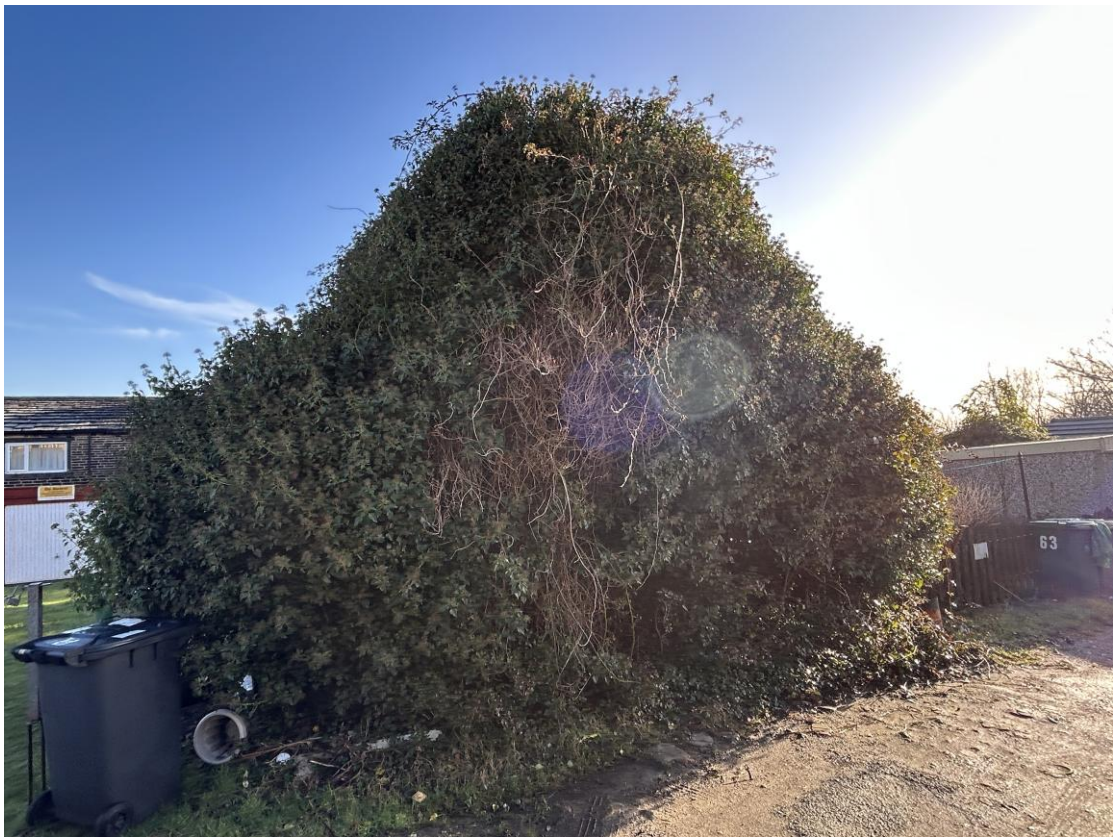
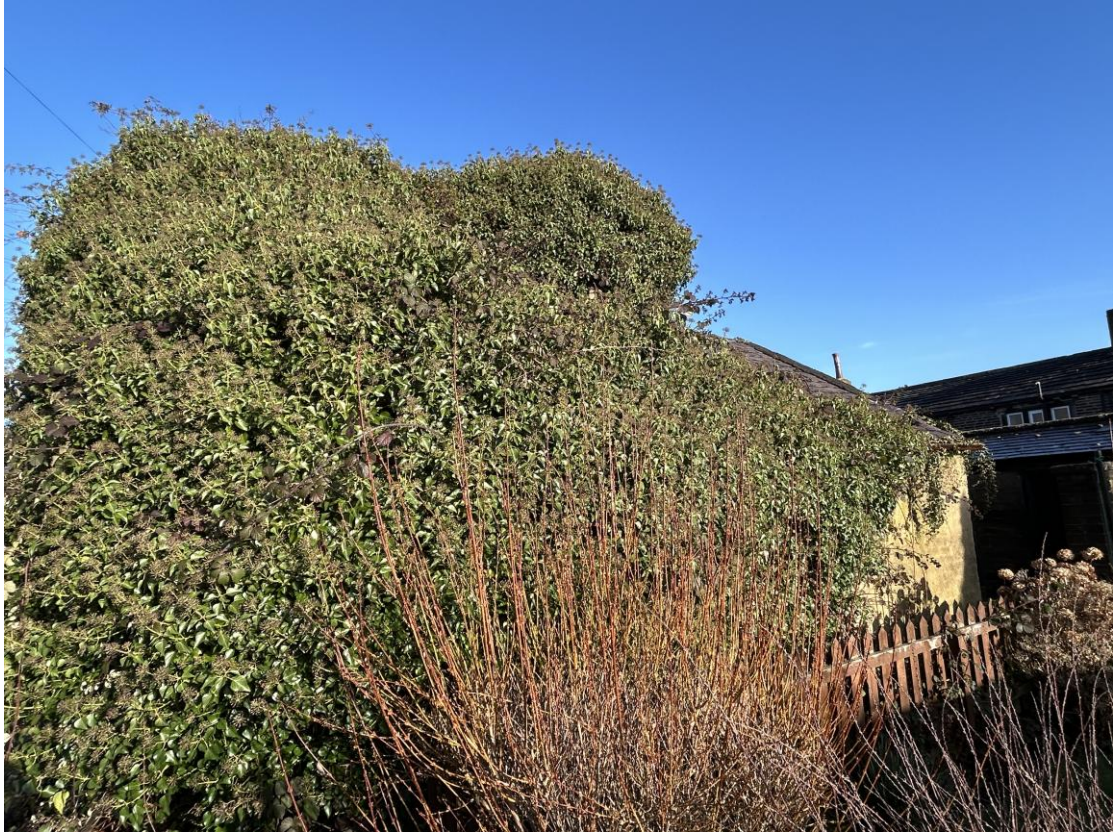
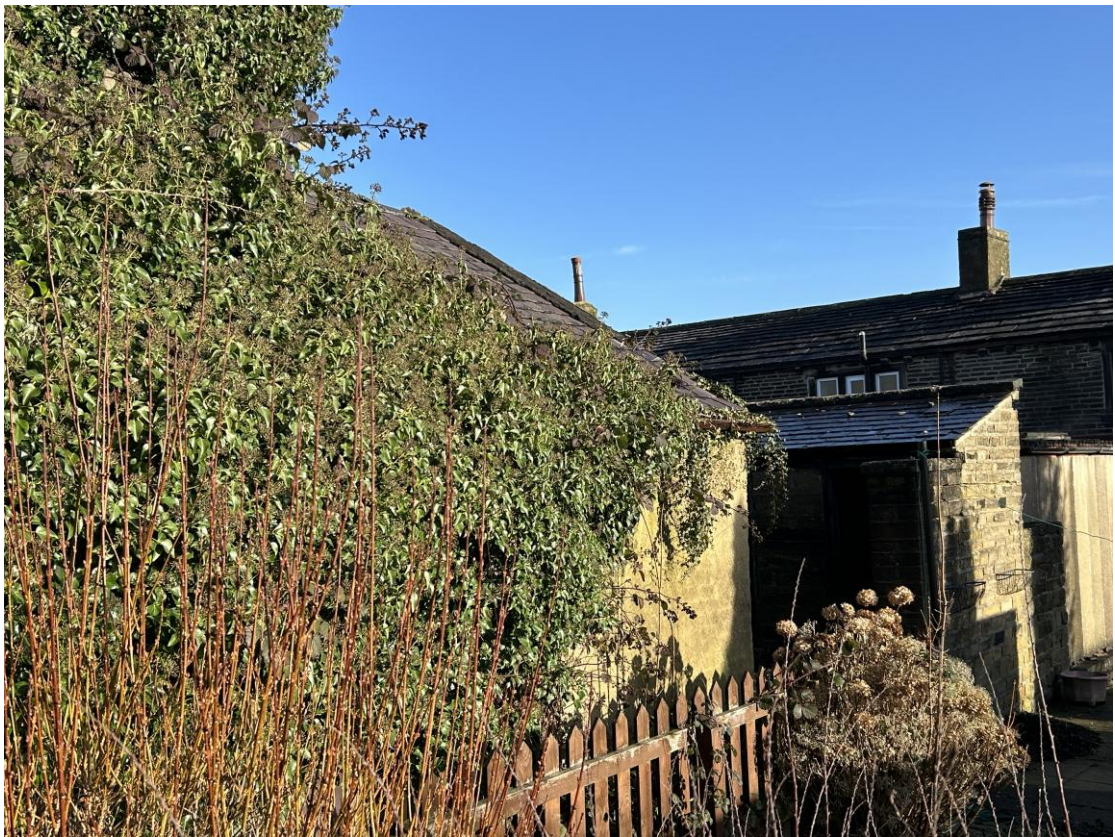
Major structural movement defects, including partial collapse of some structural elements was in evidence, with movement cracking and walls bulging defects noted throughout.

Wet rotting defects and historical infestation was noted to the nearly all the timber elements within the building, timber doors, frames, casing and lintels etc.

Inspection of the roof structure was limited, however, when all the vegetation penetrating through the out fabric of the roof structure is removed, the collapse of blue slate covering is most likely.

The outbuilding is in a very poor state of disrepair, it is derelict and structurally unsafe. It is our advice and recommendation that the building is carefully demolished as soon as possible.

The outbuilding adds no architectural or historical value to the surrounding properties, and it is our opinion that the most cost effective solution, to ensure the safety of the property, would be to carefully demolish the existing structure.
