# SITE OBSERVATIONS

GEORGE HOTEL HUDDERSFIELD

## SITE OBSERVATIONS.

10<sup>th</sup> MARCH 2025 KEY SECTION.

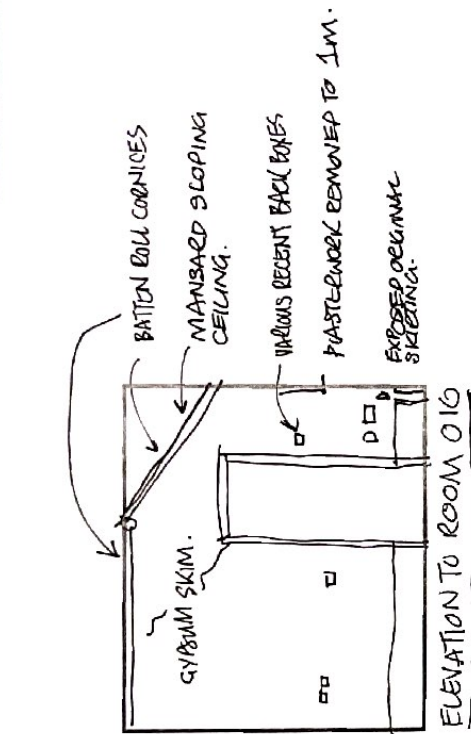
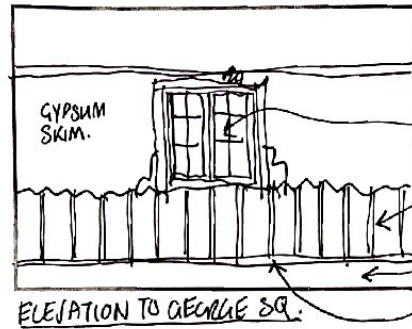
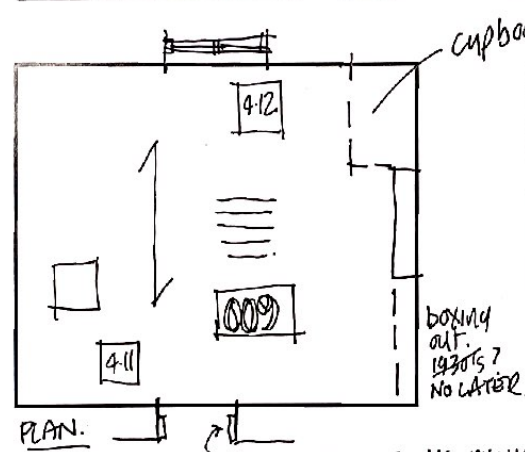
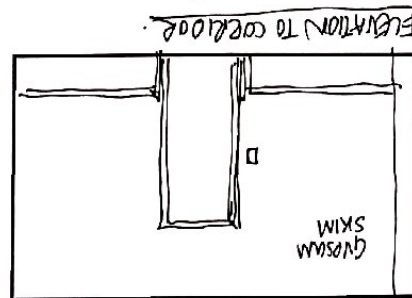
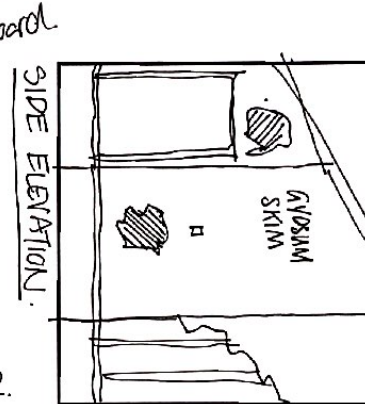
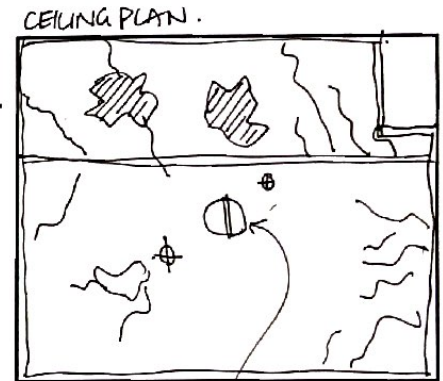
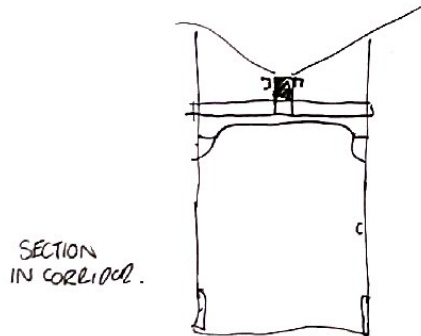
Room Reference - ~~009~~ 183.  
 Floor - 4th.  
 Drawn By - DMC 10.3.24.

BATTEN ROLL CORNICE

WATER DAMAGE

WINDOW SURROUND REMOVED  
STONE REVEALS EXPOSED / TIMBER PUTS RIPPED OUT.

GYP SUM SKIM PLASTER THROUGHOUT.  
SIGNS OF WATER DAMAGE & CRACKING.

1930'S HEATING PIPEWORK  
UNDER SKIRTING EXPOSED?

1930'S BONDING SKIRTING REMOVED AND  
LEFT IN ROOM - ALL SPLIT - MARGINAL IF NO USE.

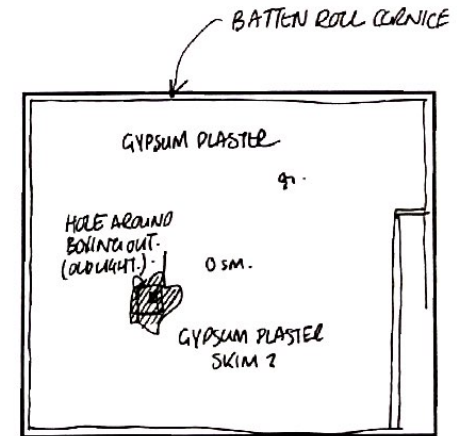
CEILING PLAN.

NOTE: TIMBER WINDOW REVEAL LEFT  
EXTRACTED IN ROOM.  
REASONABLE / SALVAGEABLE.

HARDBOARD FLOORING BACKING MOSTLY REMOVED  
FROM THIS FLOOR. FLOOR BOARDS MORE OR LESS  
INTACT THOUGH WITH A FEW SIGNS OF LIFTING  
FOR SERVICES OVER THE YEARS.  
THERE ARE A MULTITUDE OF NAILS / SCREW PROTRUDING  
UNDER FOOT / EXTENSIVE DE-HEADING OR RE-INSERTION  
REQUIRED. PRESUMED MOST CASES WHERE THERE IS HARDBOARD.

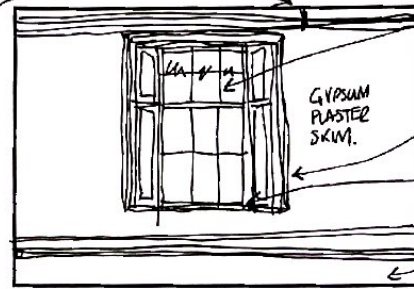
ELEVATION TO ST. GEORGES SQ.

MOULDED CORNICE SMALL CROSS SECTION REMOVED TO REVEAL LATH BUILD UP BEHIND.

NEW WINDOW (IN EXISTING CASEMENT).  
TIMBER WINDOW REVEALS REASONABLE INTACT CONDITION.  
WINDOW REVEAL ARCHITRAVES LEFT INTACT.  
WINDOW BOARD IN POOR CONDITION, HEAVILY SPLIT.  
1930'S HOT WATER.  
SKIRTING INTACT

HIDDEN WINDOW VISIBLE THROUGH WALL CONNECTION

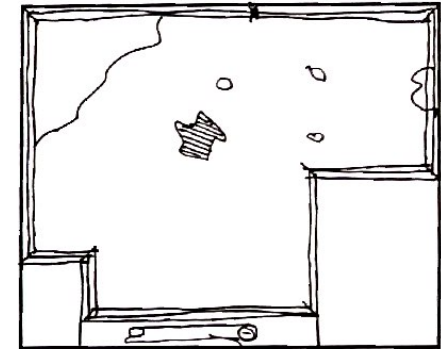
CEILING PLAN. SVP.

WATER DAMAGE  
VARIOUS PATCHES

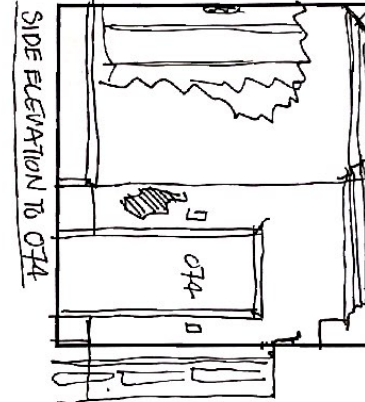
SIDE ELEVATION TO 074

HARDBOARD REMOVED TO 50% OF FLOOR  
NAILS PROTRUDING.  
RELATIVELY POOR CONDITION OVERALL
