**LYONS CMC  
COAL MINING & GEOTECHNICAL  
CONSULTANCY**

Date: 13<sup>th</sup> June 2025  
Your ref: (HD2 1YF)  
My Ref: SI 00324

**COAL MINING RISK INTERPRETATION REPORT – FOLLOWING THE SITE  
INVESTIGATION FOR PROPOSED NEW STORAGE UNIT AT LAND AT RED DOLES LANE,  
LEEDS ROAD, HUDDERSFIELD HD2 1YF**

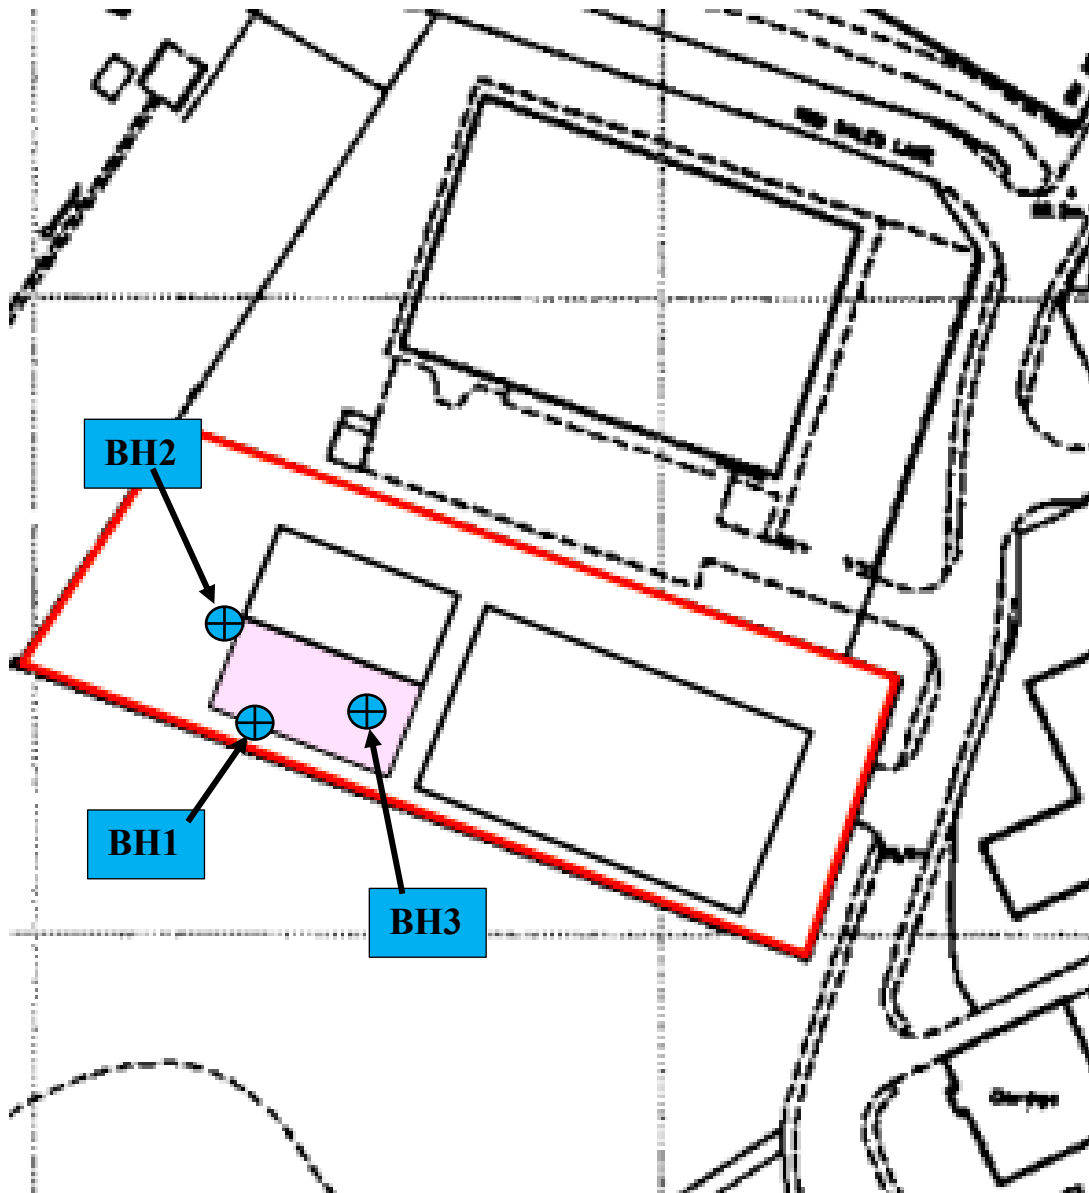
5.2 Borehole Location Plan No. 00372/B

Planning permission has been granted for a new industrial unit at the above location, subject to the mining legacy risks been fully realised and mitigated from on site, if necessary. Cape Site Services has now undertaken this work via an intrusive site investigation of 3 boreholes, the location of which is outlined on plan no. 00372/B – as attached and illustrated in appendix 5.2. The site is centred at OS NGR: 415339E / 418137N. of which is outlined on plan no. 00372B – as attached and illustrated in appendix 5.2.

Prior to the intrusive site investigation, a search for utilities was undertaken both via online data providers and physically on site using a Cable Avoidance Tool (CAT). Boreholes were marked out with tape measure from boundary lines as illustrated on plan no. 00372/B outlined in appendix 5.2.
