**JCA Ref: 22667f/ChC**

**Planning Ref: 2026/90702**

**Date: 30<sup>th</sup> July 2026**

### **Arboricultural Supporting Document relating to T11 at Fieldhead, Snelsins Road, Cleckheaton, West Yorkshire, BD19 3UE.**

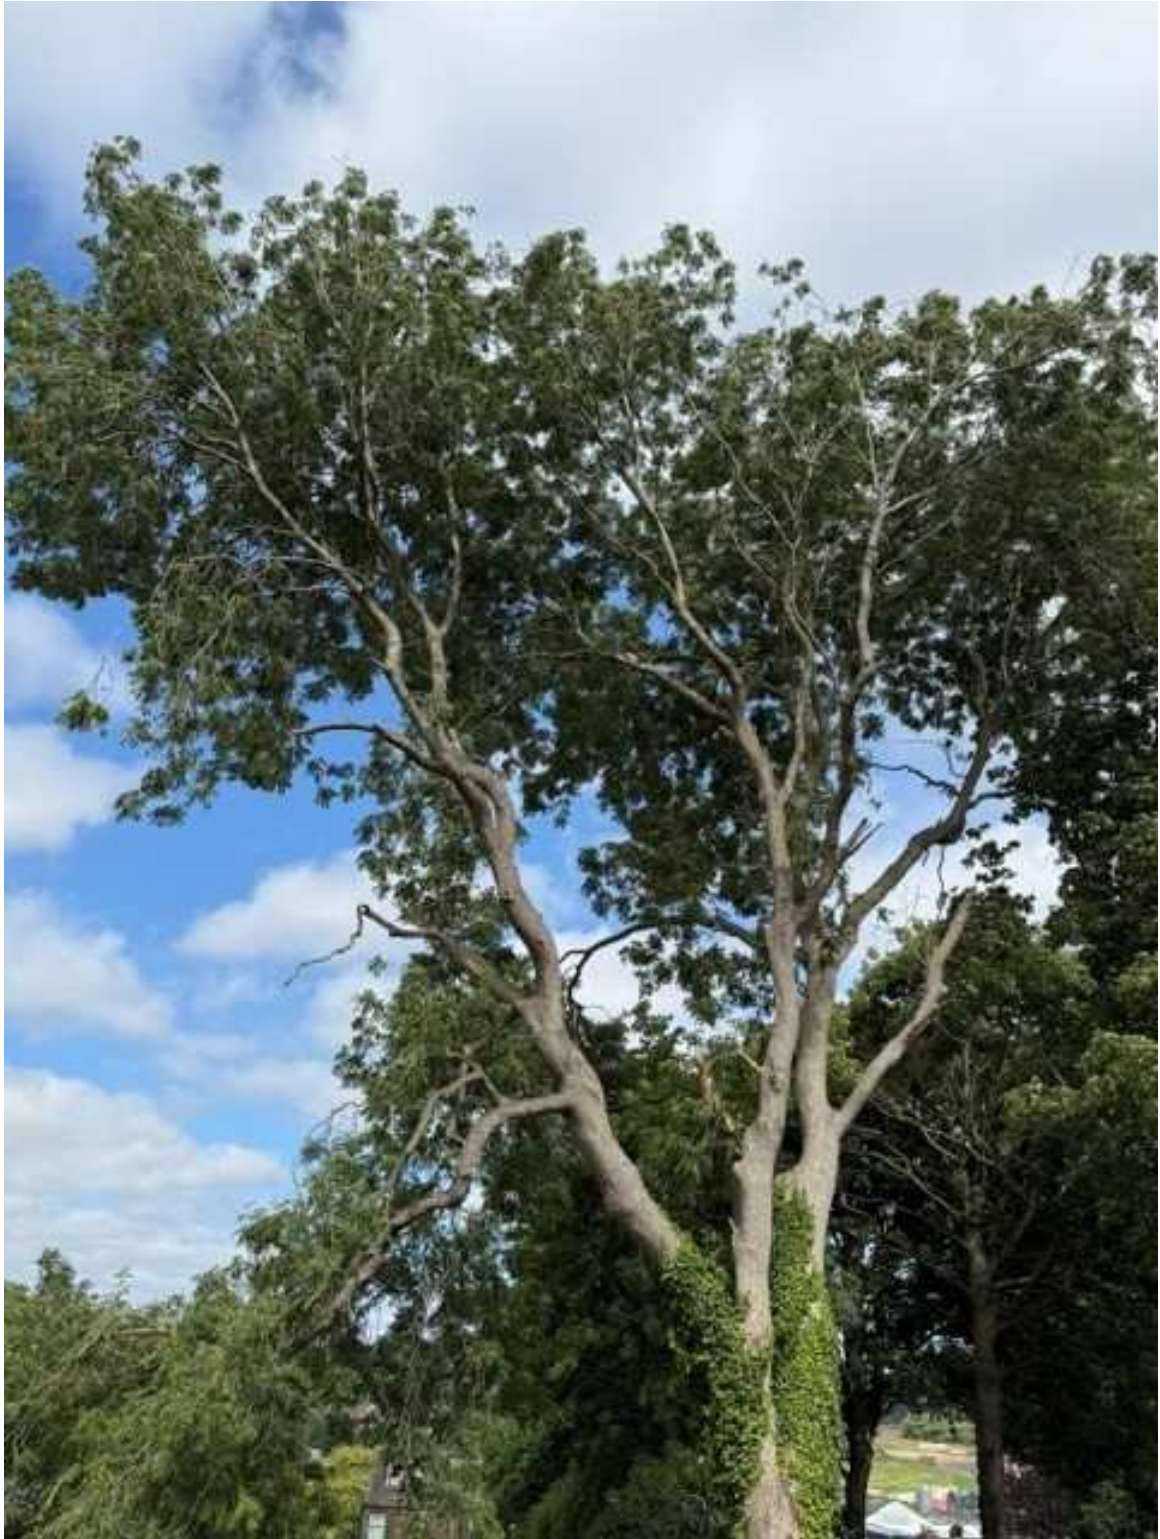
- 1.2.1 The tree in question is an over-mature Ash, identified as **T11** in our reports, which is protected by an individual Tree Preservation Order (TPO).
- 1.2.2 Since we surveyed this tree back in February 2025, its health and condition has deteriorated significantly. In recent weeks, the tree has shed multiple very large branches (which could have caused major injury or even death) and this is unacceptable for a rear garden location which is frequently used by the occupiers.
- 1.2.3 In addition, there are now multiple *Inonotus hispidus* brackets on one of the main stems, indicating internal decay and the potential for further limb loss in the near future. Given the recent limb failure and presence of this fungi, future limb failures are foreseeable and given the owners duty of care, requires urgent attention to deal with the associated risks.

**Photo 1:** A general view of T11 (an over-mature Ash tree, the subject of this report).

- 1.3.1 Given that this tree is clearly in decline, shedding large limbs within a garden location and the presence of a wood rotting fungi, we have made the decision to downgrade the Retention Category of this tree to 'U' in accordance with BS5837: 2012, essentially meaning that it should be removed irrespective of any proposals for development on site.

- 1.3.2 We therefore recommend that this tree is removed now and suitably replaced. Whilst removal of a protected mature tree is always considered a last resort, in this case we consider it to be the only proportionate means of managing the foreseeable risk of further significant limb failure. Delaying intervention would unnecessarily increase the likelihood of structural damage or serious injury.

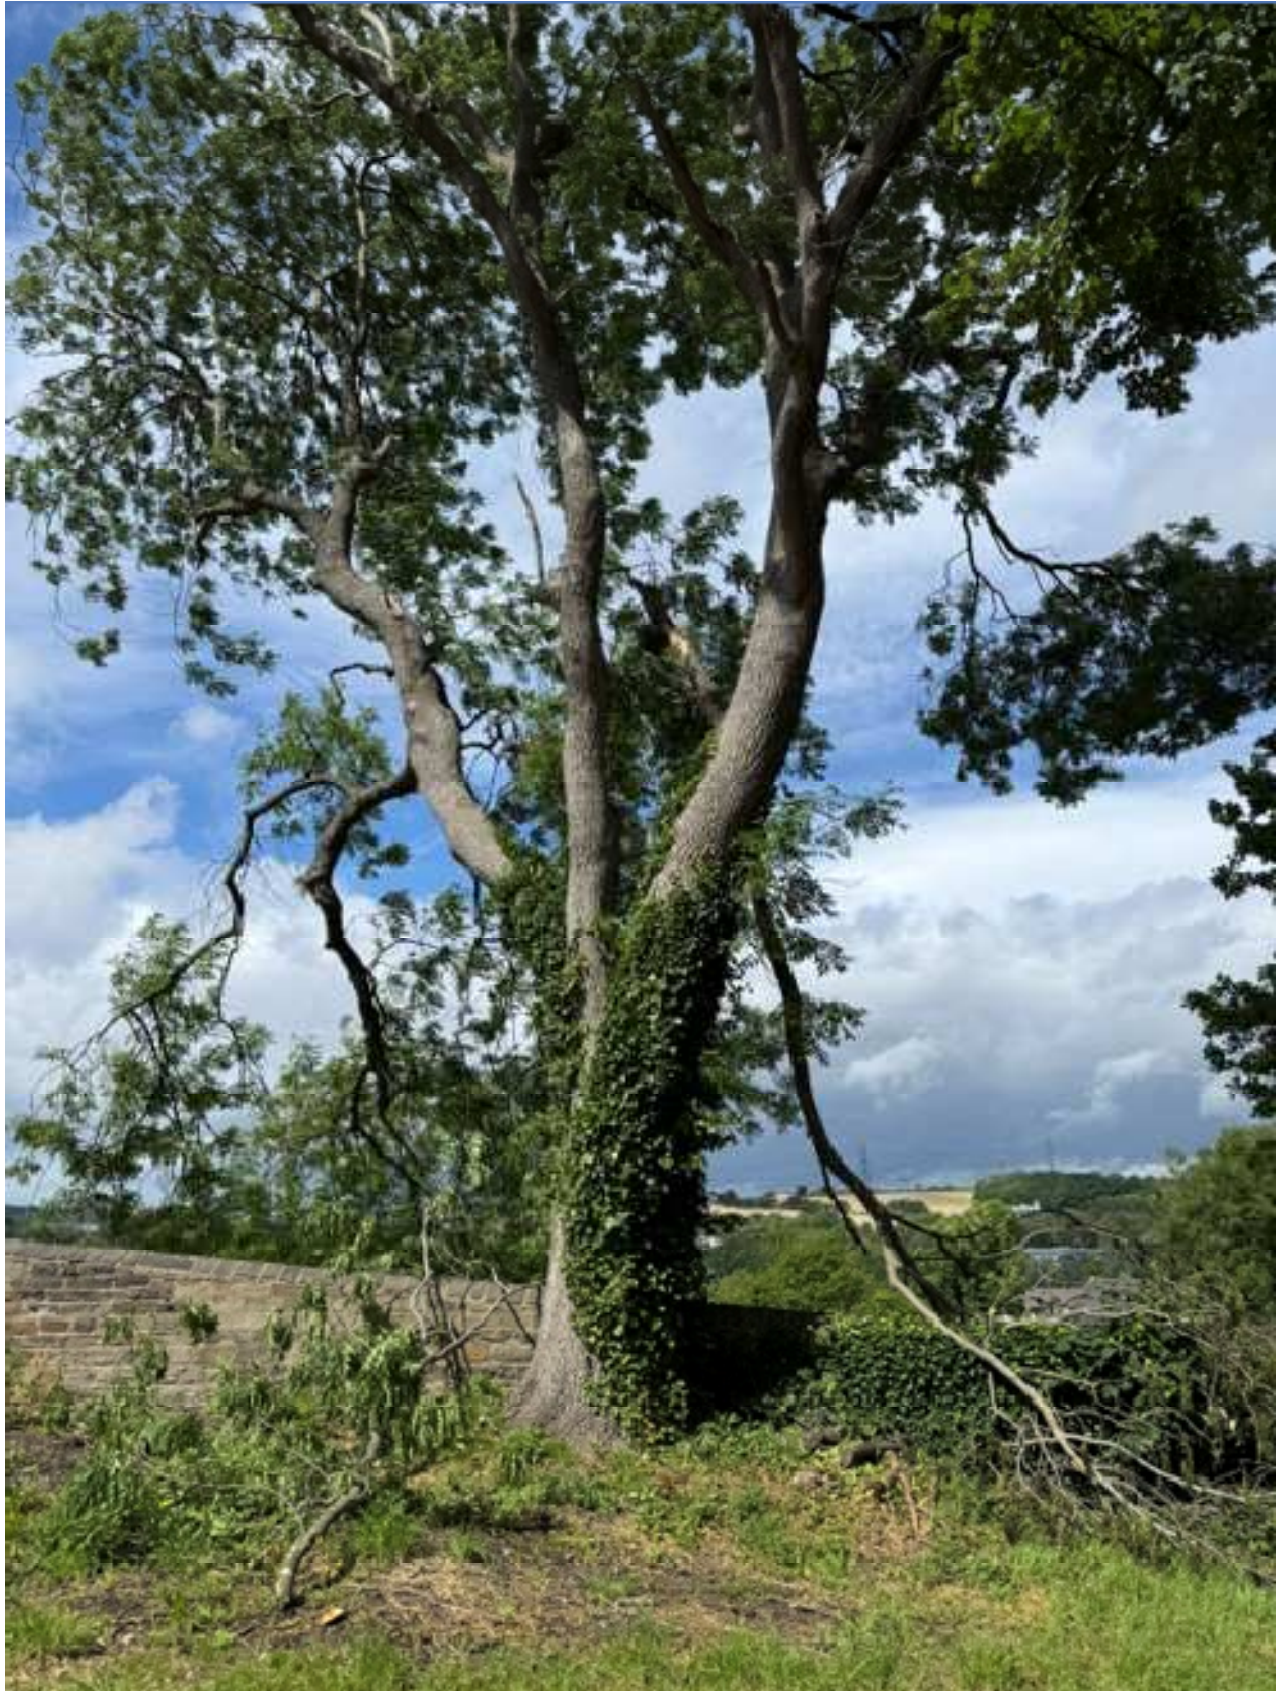
***Photo 2:*** Showing evidence of recent branch failure.

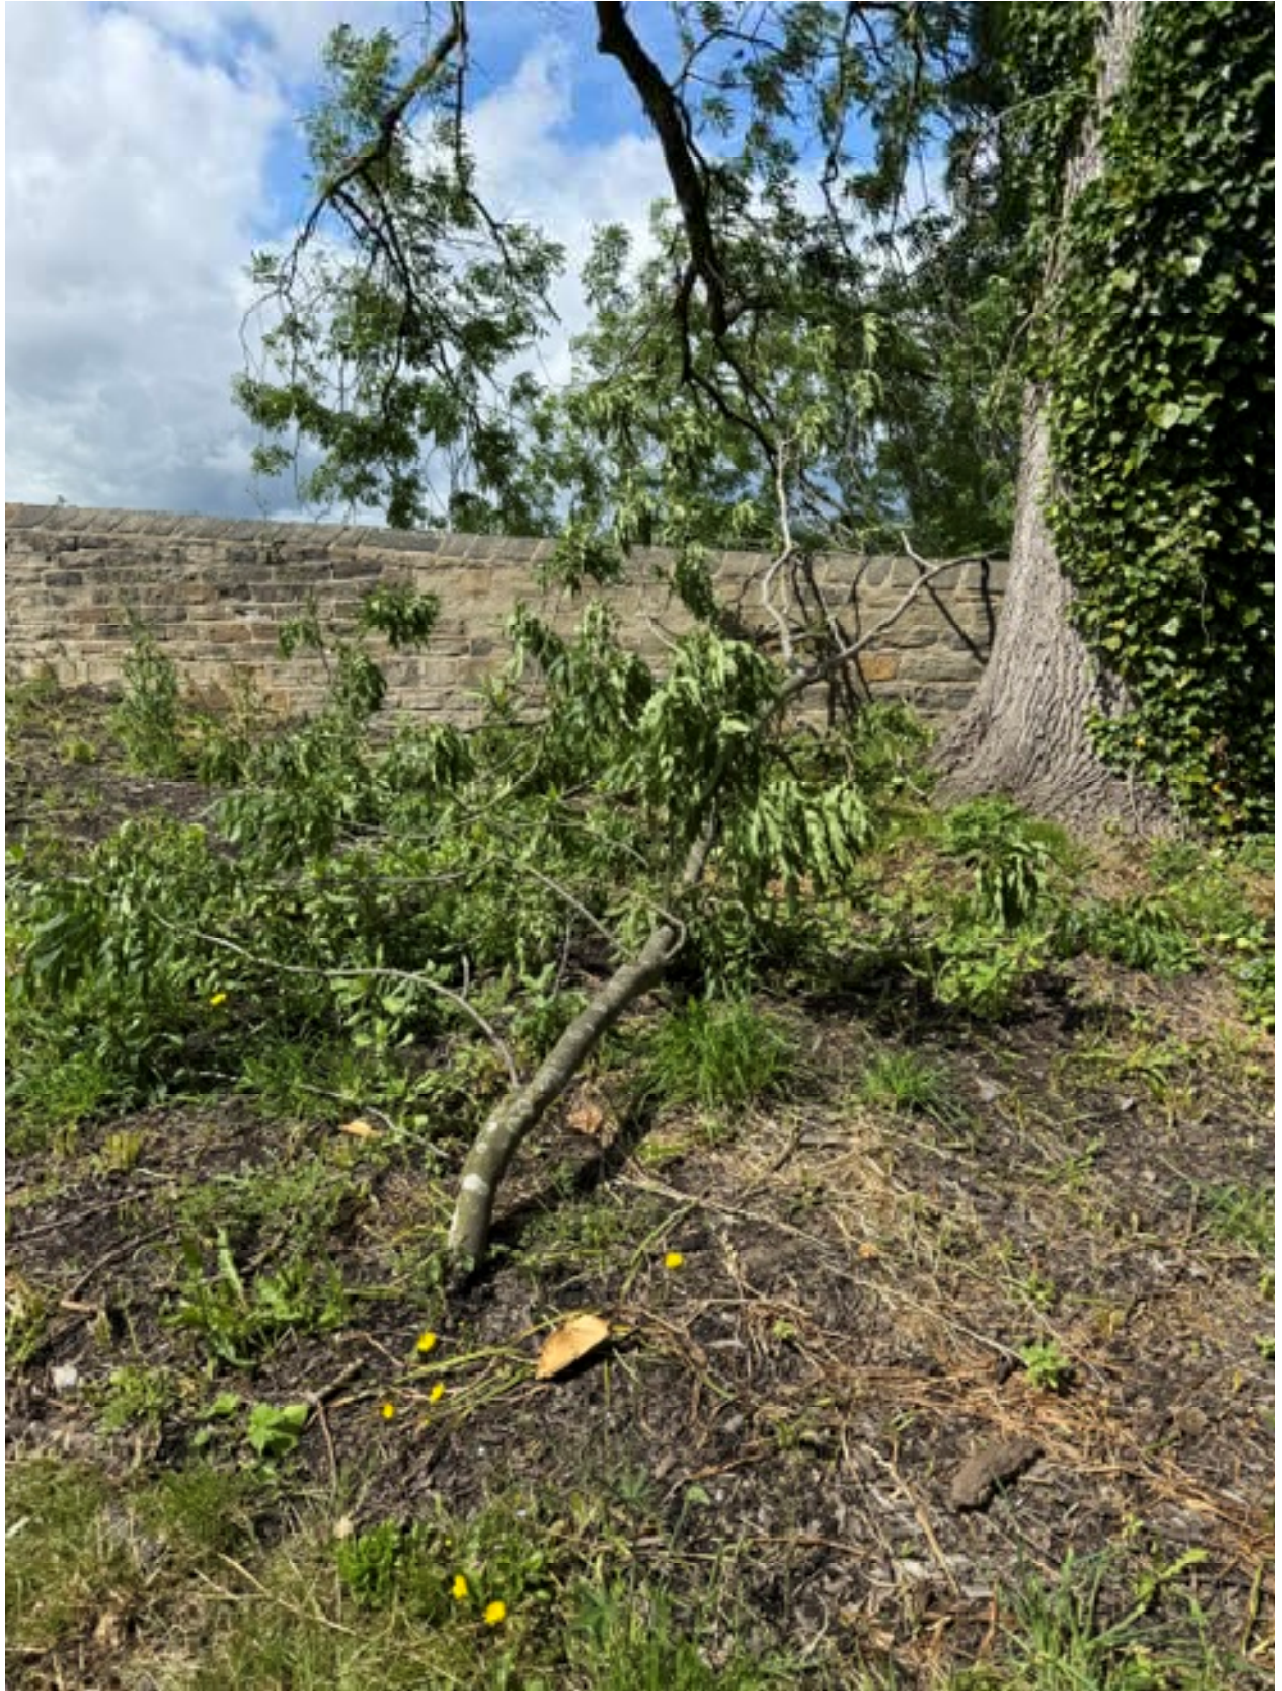
**Photo 3:** Showing evidence of recent branch failure.

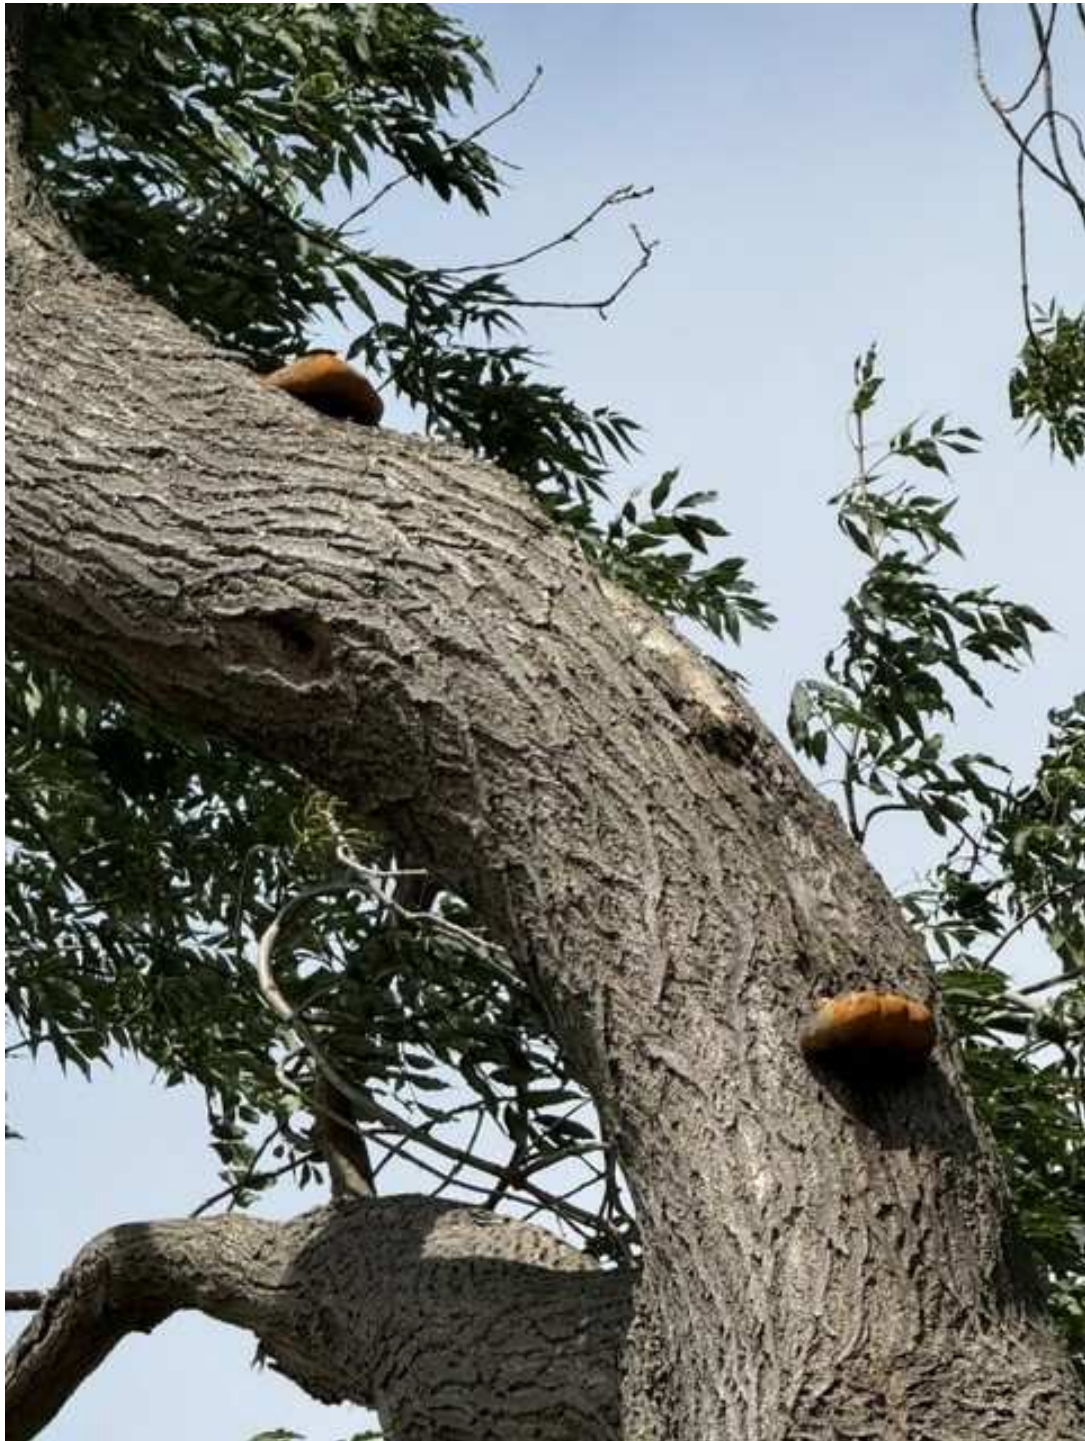
**Photo 4:** Showing *Inonotus hispidus* bracket fungi on one of the main stems.
