PROJECT  
Kirklees Cultural Heart, Phase 2

DRAWING TITLE  
Envelope Repairs - East Elevation

PROJECT NUMBER	ORIGINATOR	ZONE	LEVEL	TYPE	ROLE	NUMBER	REVISION
IR430300	CTA	ZZ	XX	DR	A	072161	PO2

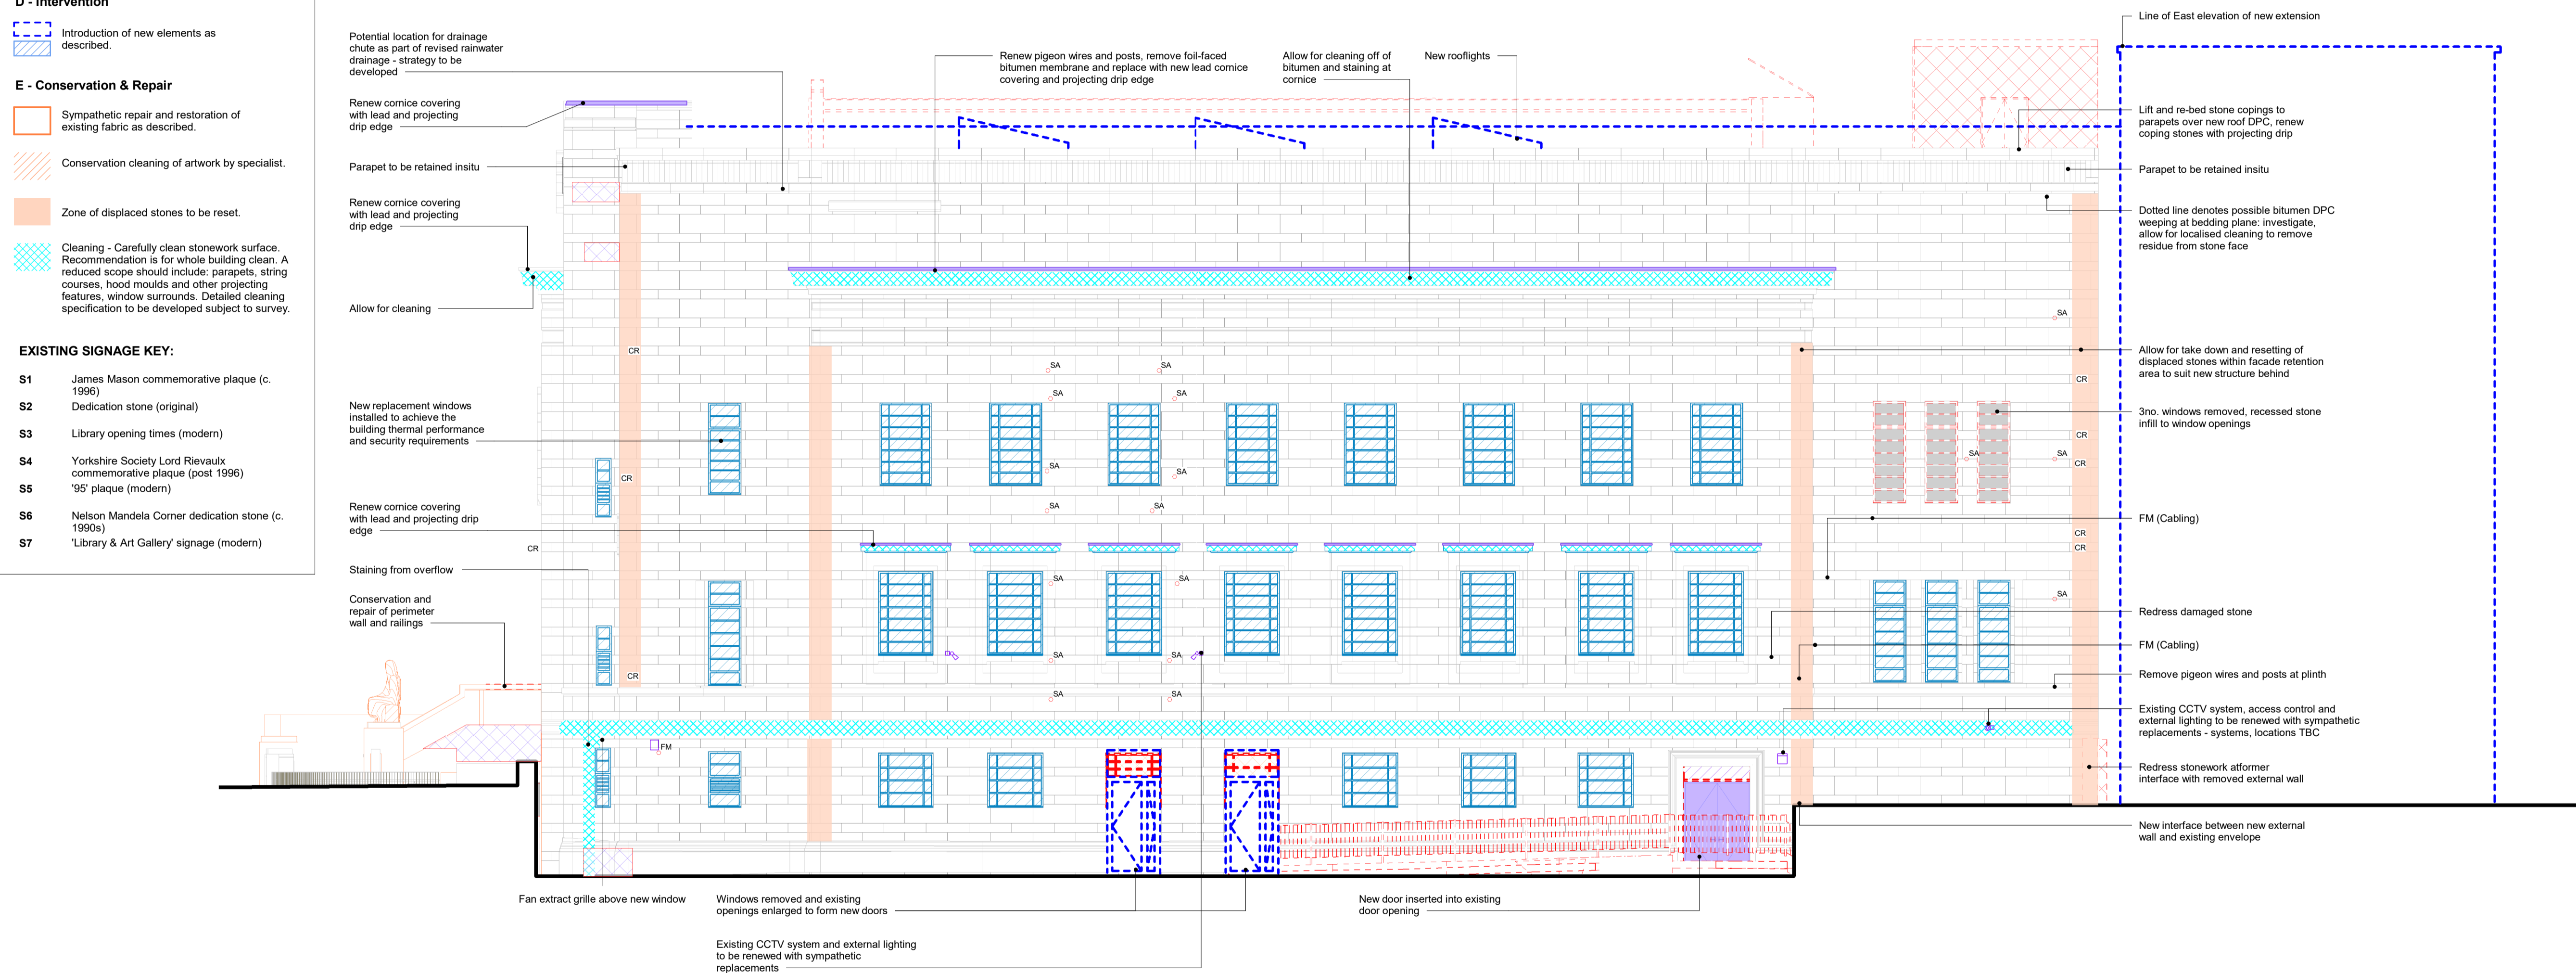
**E Envelope Repairs - East Elevation**  
1 : 100

**SA** ○ Putlog scaffold anchor - remove and make good.

**CR** | Crack / open joint - investigate / remediate.

**FM** ○ Ferrous material - remove

Zone of displaced stones to be reset.

Descaling - Where the surface is powdery and friable, remove loose stone and prepare the exposed face with a stiff brush / scotch chisel. With ashlar use a carborundum block.

Redressing - Where the surface damage is superficial, or loose friable stone needs removing back to a sound base. Stone is to be dressed back to a sound free draining surface with tooling and carborundum blocks as appropriate.

Cleaning - Carefully clean stonework surface. Recommendation is for whole building clean. A reduced scope should include: parapets, string courses, hood moulds and other projecting features, window surrounds. Detailed cleaning specification to be developed subject to survey.
