Tree condition survey

7 Vineyard Leymoor Road, Golcar, Huddersfield, HD7 4RN

Date of site visit: 23<sup>rd</sup> March 2026

Report Date: 24th March 2026

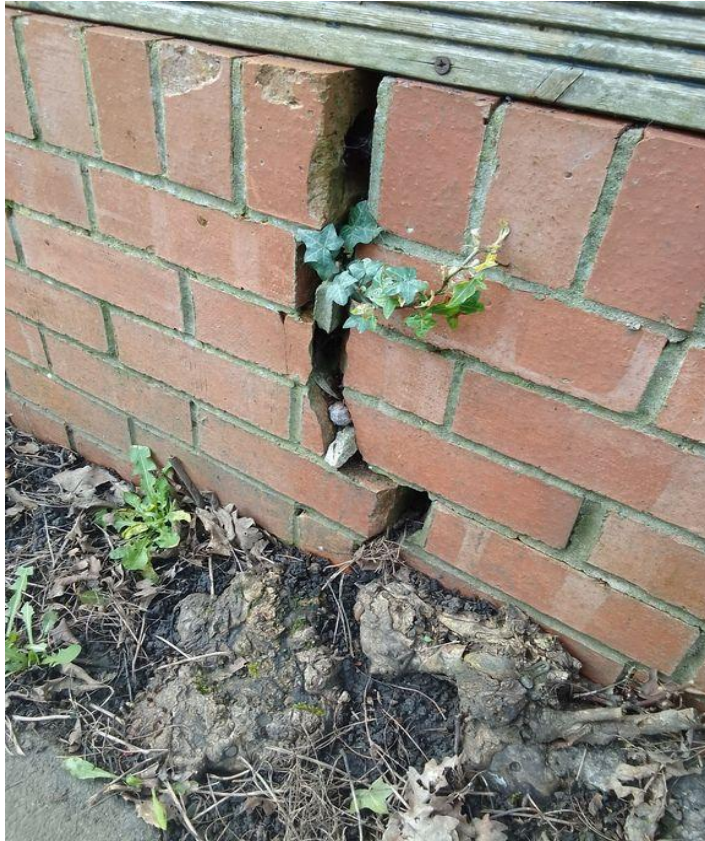
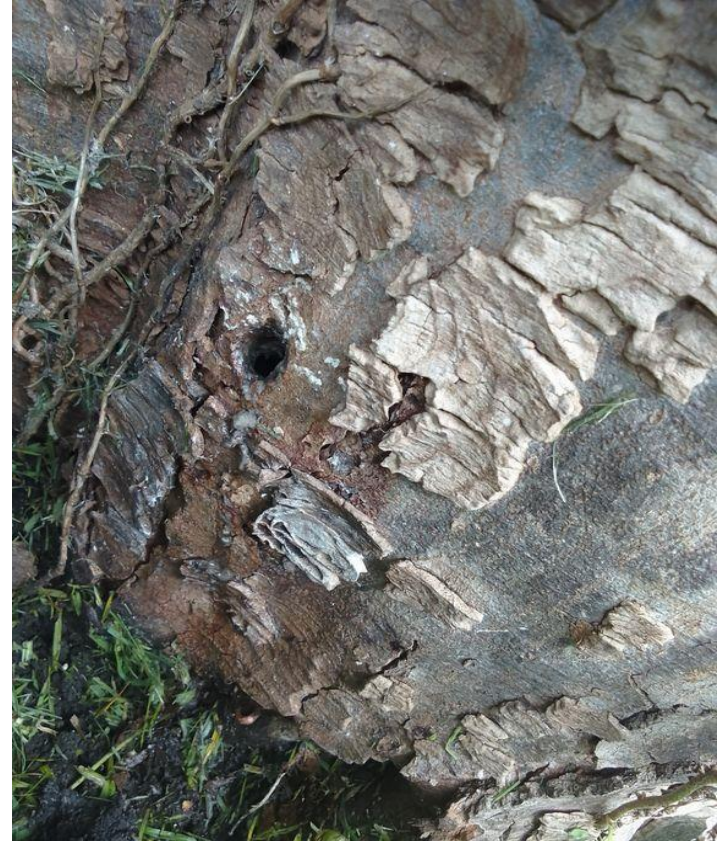
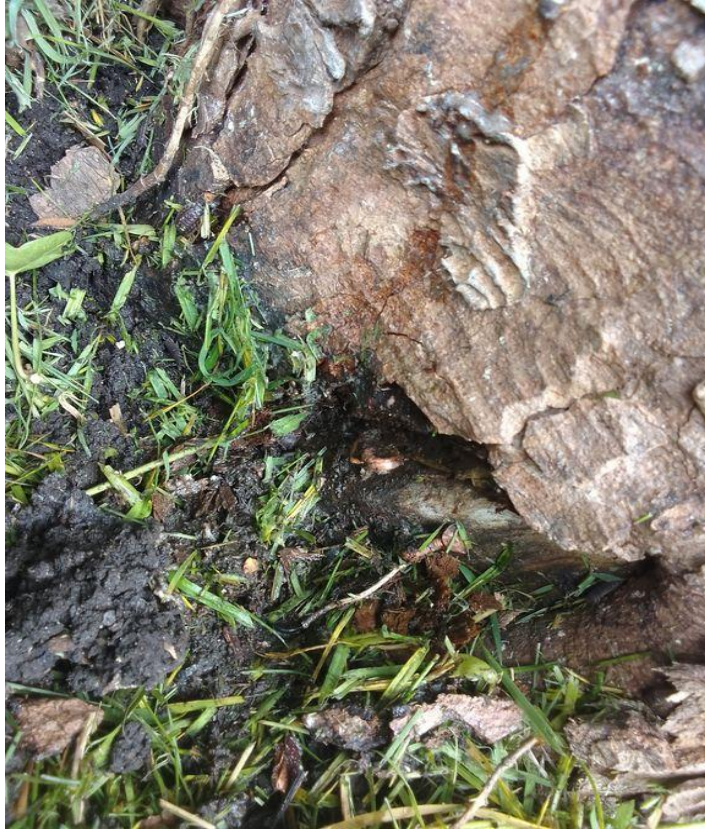
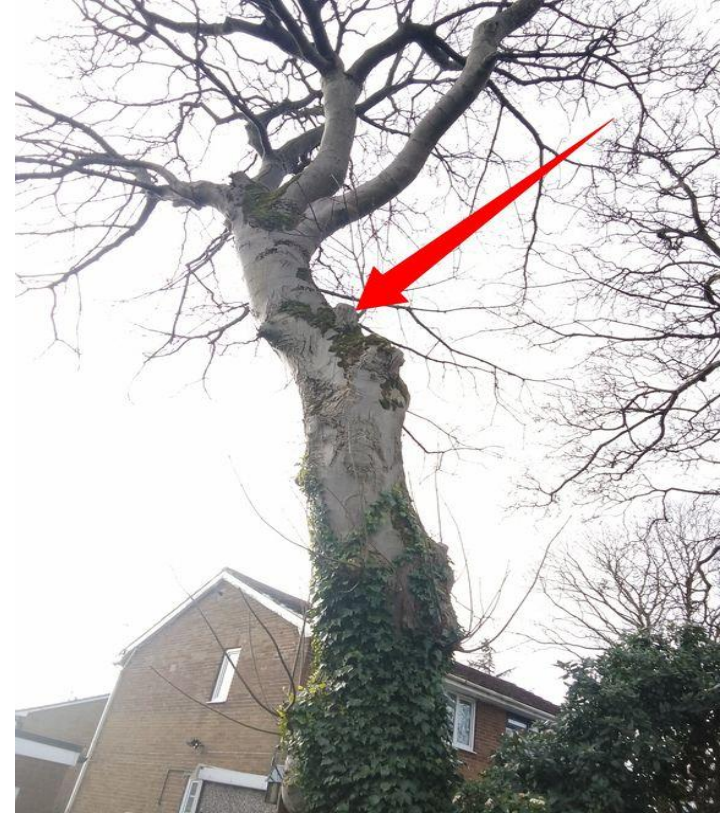
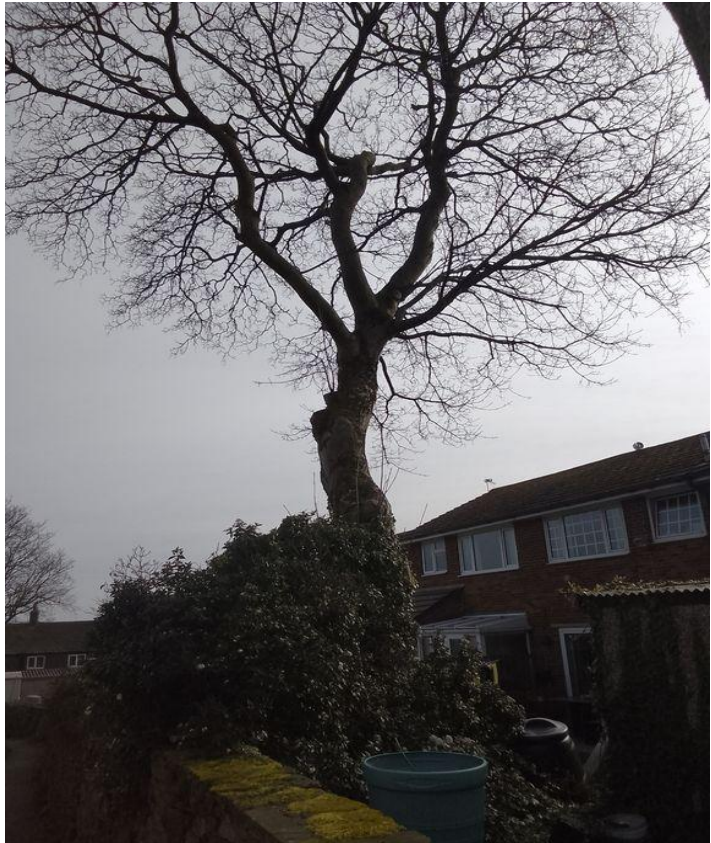
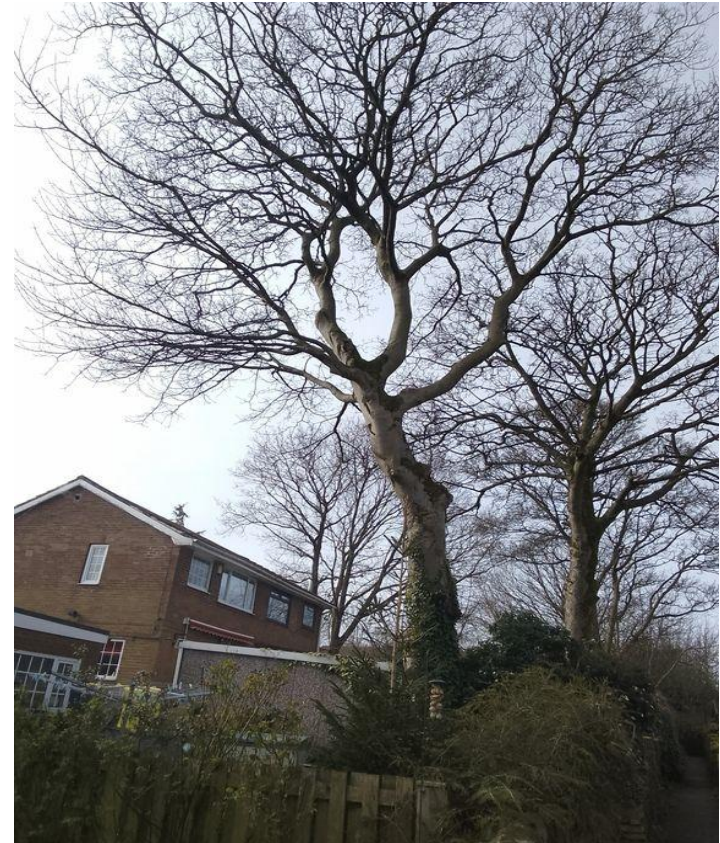
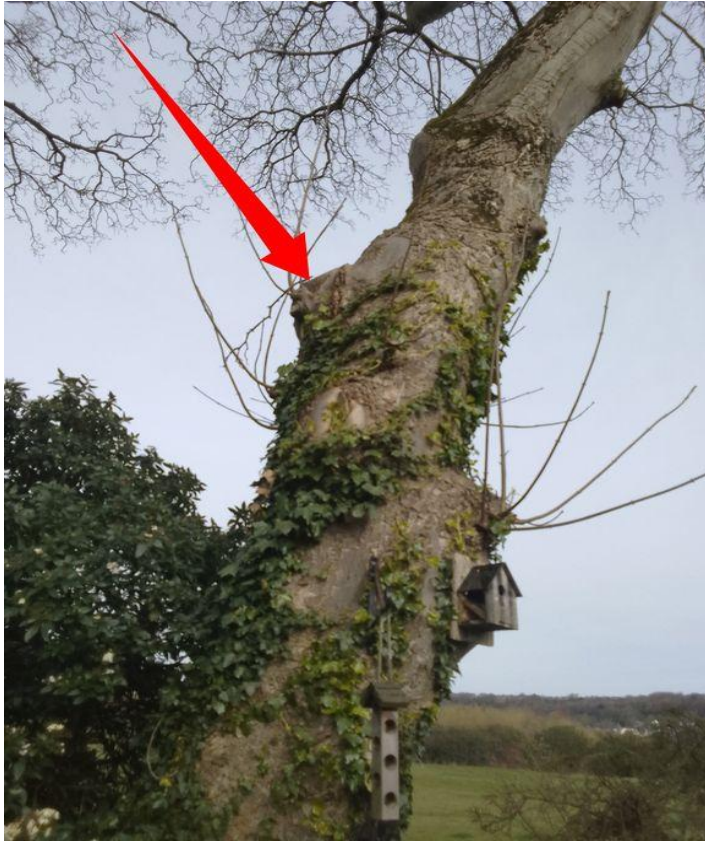
The tree shows a range of defects and indicators of dysfunction concentrated at the base and lower stem. The rooting environment is significantly restricted by a surrounding wall on three sides

for approximately 270 degrees of the lower root plate, with the wall standing close to the trunk at between approximately 0.4m and 1.4m. There is significant displacement of the garden wall, recorded as BRE Category 5 damage, indicating substantial and prolonged root pressure within a confined rooting environment.

At the base of the tree there is visible stress response growth, suggesting adaptive growth in response to mechanical stress and/or dysfunction. Several wounds are present around the basal stem, some of which are not fully occluded, although partial occlusion is occurring. Probe testing at the base penetrated to approximately 300mm and was accompanied by the release of discoloured sap, which is consistent with dysfunctional or decayed internal tissue. Acoustic sounding produced a hollow resonance, indicating likely internal voiding and/or loss of sound wood within the lower stem.

Additional observations include woodlice at the base, two embedded copper nails within one wound area, and several historic pruning wounds, including two that remain unoccluded and exhibit signs of associated decay adjacent to the main stem. The trunk exhibits a lean toward the south-east, and the crown is asymmetrically weighted toward the dwelling. Ivy is present on the stem and partially obscures the bark surface, although it is not the principal defect. A bird's nest was also noted within the crown.

There is a credible likelihood of failure associated with the base and lower stem given the combination of restricted rooting, pronounced wall displacement, stress response growth, basal wounds, probable internal decay, hollow acoustic response, lean, and asymmetric loading toward the principal target. While the observations do not on their own quantify the precise residual wall thickness, they do establish a reasonable arboricultural basis for concern regarding the structural integrity of the lower stem and root buttress region.

Recommended management: remove T001.

The tree should be scheduled for removal within 6 months. This timeframe is appropriate to the current observed condition and risk context, provided no further deterioration becomes evident before works are undertaken.

Pending removal, the tree should be kept under observation for any signs of progression, including fresh cracking, soil or root plate movement, increased lean, bark separation, or sudden deterioration in crown condition. Should such symptoms arise, the urgency of works should be reviewed immediately.
