LIMITED STRUCTURAL REPORT

Project	Liley Hall Farm, Liley Lane, Mirfield, WF14 8EG
Project Number	2024/086
Date	30 April 2024

**Limited Structural Conditional Report on
Liley Hall Farm buildings, Liley Lane, Mirfield, WF14 8EG
for the Purposes of Conversion into Domestic Dwellings**

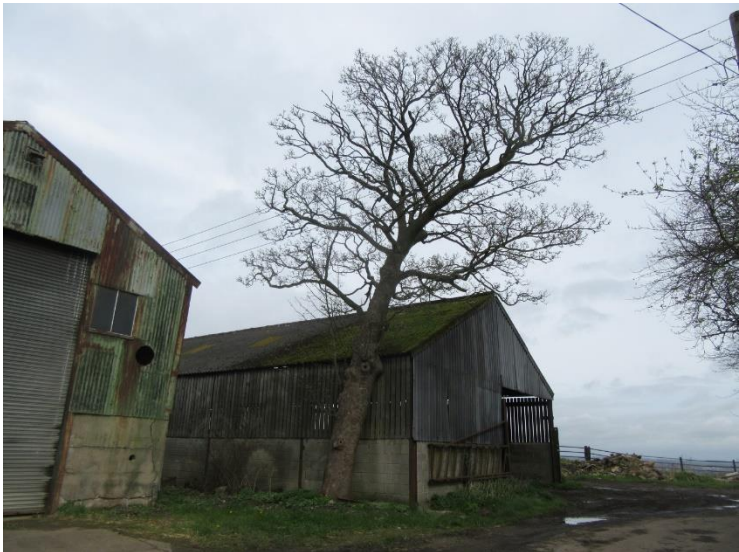
Ref.	Building 1 - Photo	Notes
P101

<p>Description - Steel trusses comprising of single steel angle top chord, bottom chord and web members. Trusses sat on cap plates on steel columns. Steel angle roof bracing. No side wall bracing. Steel gable posts. Steel angle purlins & side rails. Goods door to Right-hand side.</p> <p>Cladding – Blockwork dado panels full perimeter. Steel sheeting to left & right gables. Open timber boards front and rear elevation up to eaves. Asbestos cement roof panels.</p> <p>Size - 22.8m long internally x 10.46m wide. 3.93m floor (earth) to sheeting at eaves & 6.4m floor to sheeting U/S at ridge pad foundation seen internally. Measured as 600x300mm projection. Seen where earth floor has been scraped away. Strip footings have 100mm projection.</p> <p>Defects – 13m high sycamore 650mm diameter only 350mm from blockwork face and 1.4m from front right corner of the building. Cracking to blockwork of Building 1 and also adjacent Building 4. Side block panels are generally in good condition.</p> <p>Inspection of the front elevation reveals immediately the self-seeded mature sycamore tree seen to front left corner which was seen touching the building</p>

Ref.	<u>Building 1 - Conclusion</u>	<u>Building 1 - Recommendations</u>
<p>P101 - 106</p>	<ol style="list-style-type: none"> 1. The 13m high self-seeded mature sycamore tree has caused damage to building 1 and possibly building 4. This should be removed. 2. Side block panels are generally in good condition despite the footings being of minimal size and voids seen below. 3. The pad foundations to the steel frame were very minimalistic. 4. The steel trusses frame can readily be checked for adequacy to meet Building Regulations calculation requirements. 	<ol style="list-style-type: none"> 1. The sycamore tree should be removed, and roots grubbed up. 2. The ground conditions need to be explored and footings underpinned to achieve deeper foundations bearing on stable ground. 3. Once ground conditions are confirmed the minimal pad footings can be underpinned with larger pads. 4. Wood Associates Architectural drawing 22026D-20-R01 shows the proposed house layout with glazed link corridor to the garage annex Building 4. The double columns shown in the garage annex and first floor lounge can be omitted as the 5 Tonne independent Crane can be removed. 5. The steel trusses can readily be strengthened by bolting new on supplementary members alongside the existing.

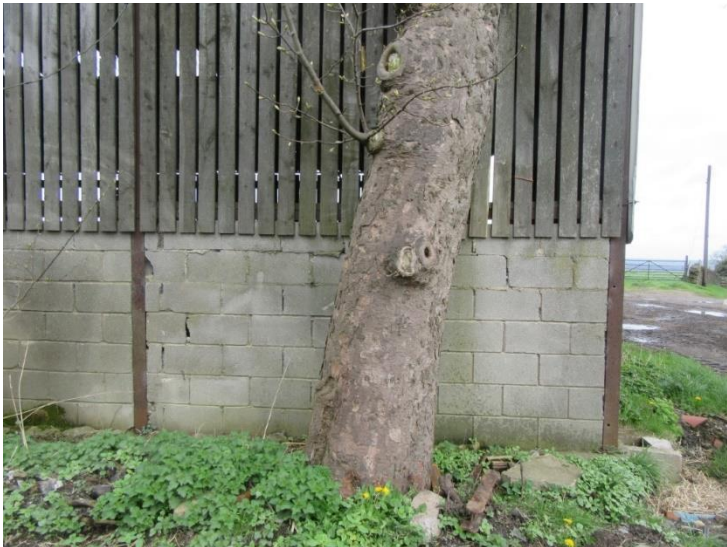
P102

<p>Left-hand side – Front left panel of blockwork has cracking, most likely caused by the sycamore tree.</p>

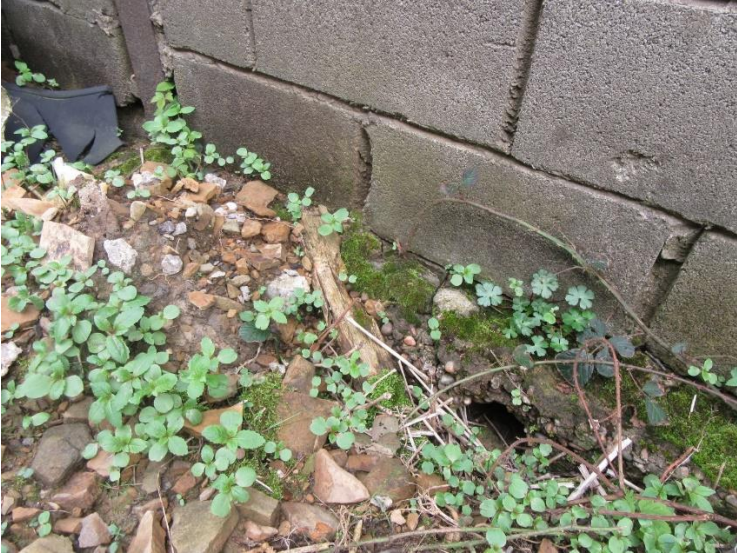
Ref.	Building 1 - Photo	Notes
P103

Left-hand foundation – Very shallow footings seen to side walls. There were voids seen below the footings.
P104

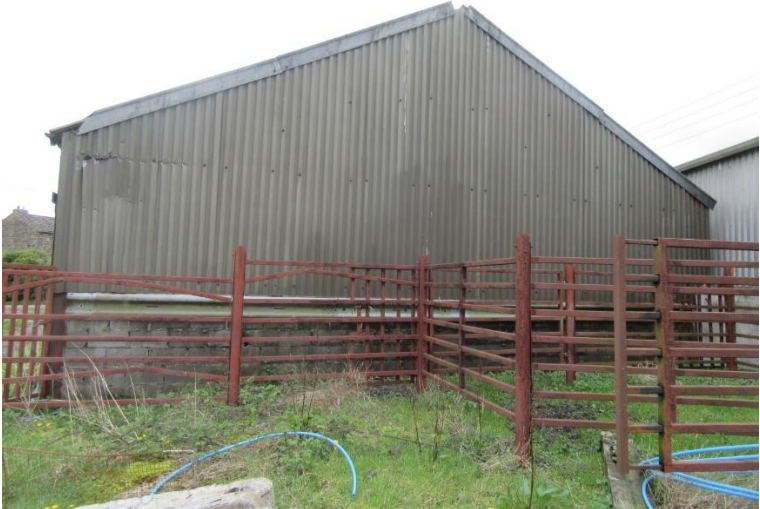
Rear Elevation –Modern vertical metal cladding was noted over the dado height of the blockwork perimeter wall.

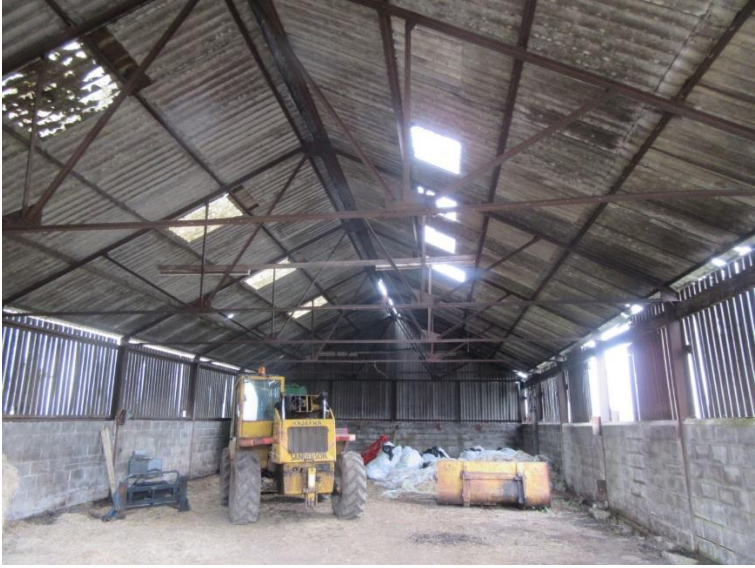
Ref.	Building 1 - Photo	Notes
P105

<p>General Internal View showing steel trussed roof structure – Steel angle purlins were seen supporting the asbestos cement roof panels. Open timber vertical side cladding boards are supported on timber cladding rails above the blockwork dado height panels.</p>
P106

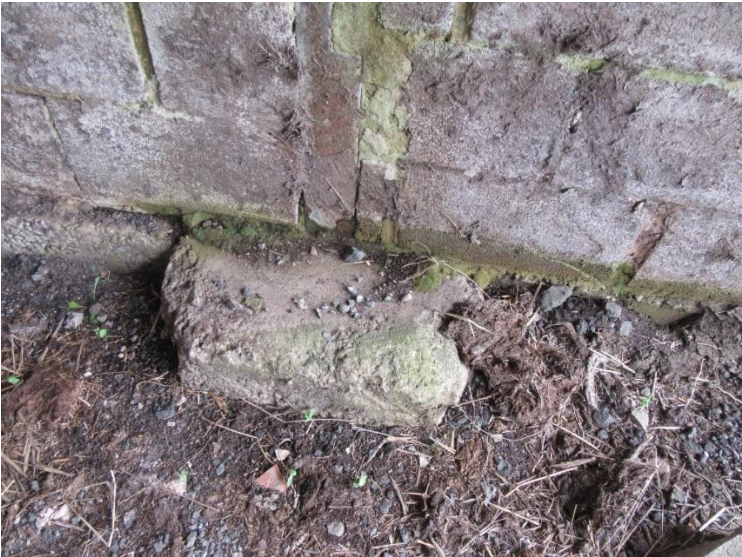
<p>Column Base Pad Foundation – Minimal concrete pad foundations were seen internally together with undermined strip footings to the rear right-hand side perimeter walls.</p>

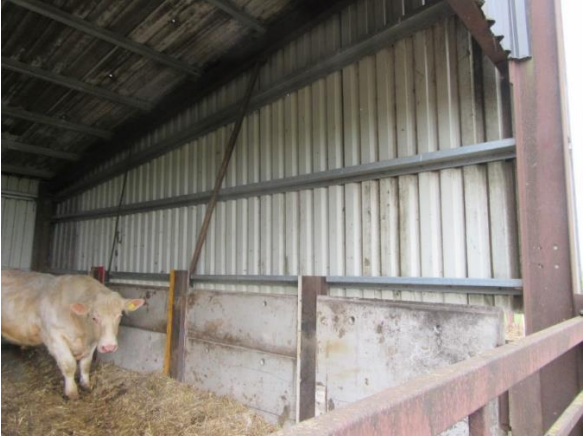
<p>Internal View of Right-hand Elevation – Steel columns support precast concrete dado height panels. Cold rolled sheeting rails spanning from corner stanchions onto inadequate diagonal steel angle gable posts. No diagonal wall bracing.</p>

Ref.	Building 2 – Conclusion	Building 2 - Recommendations	
<p>P201 - 206</p>	<ol style="list-style-type: none"> 1. Two mature trees in close proximity of the rear wall. Both are of significant diameter and age. 2. There is no central rafter hence the purlins are over spanned for their size. Causing the deflection seen. 3. There is a lack of roof bracing and side braced for long term frame stability. 	<ol style="list-style-type: none"> 1. The trees should be removed. 2. A central rafter should be added into the frame system. 3. Diagonal roof bracing can readily be bolted into the rafters running between the frames and rafters. 4. Purlin restraint struts should be added in. 5. Wood Associates Architectural drawing 22026D-20-R02 shows the proposed Annex building layout integral with part of the adjoining Building 3. We confirm that this open aspect layout can readily be achieved with the existing structure.

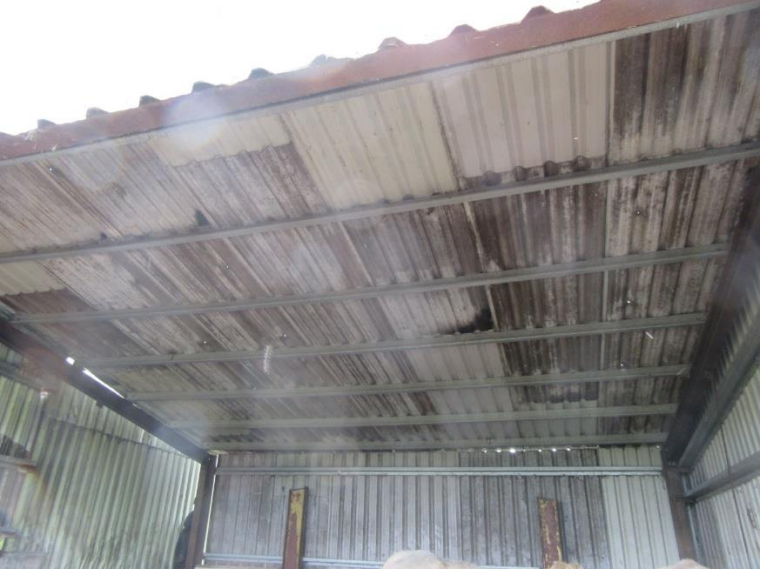
Ref.	Building 2 - Photo	Notes
P203

<p>Internal view of Roof Structure – Steel roof sheeting supported by undersized cold rolled purlins with no tube spacer or diagonal wire restraint system. No diagonal roof bracing.</p>
P204

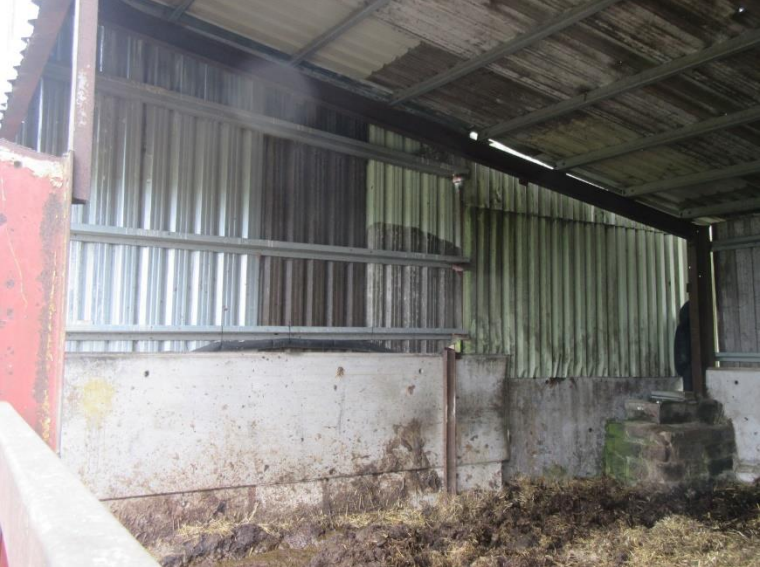
<p>Internal view of left-hand Gable Structure – Part sheeting rails seen. Inadequate support to precast concrete dado side panels.</p>

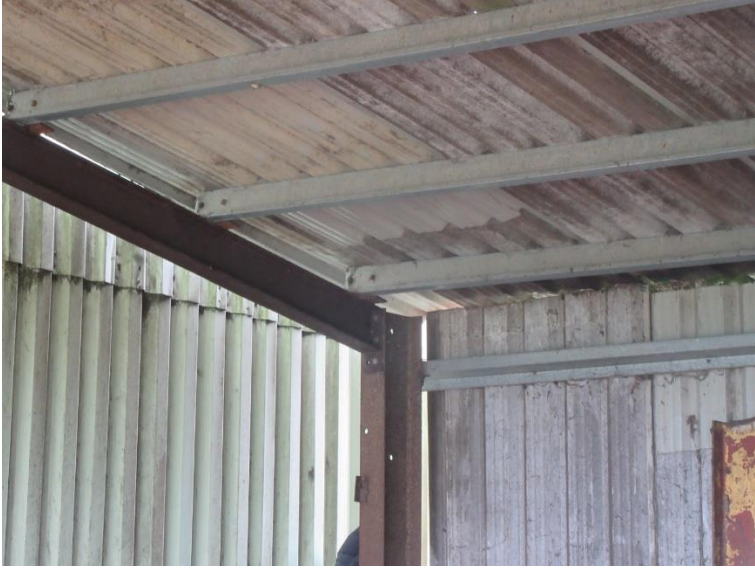
Ref.	Building 2 - Photo	Notes
P205

<p>Internal View on rafter to column connection – This connection should be strengthened to cater for the bending forces when converted.</p>
P206

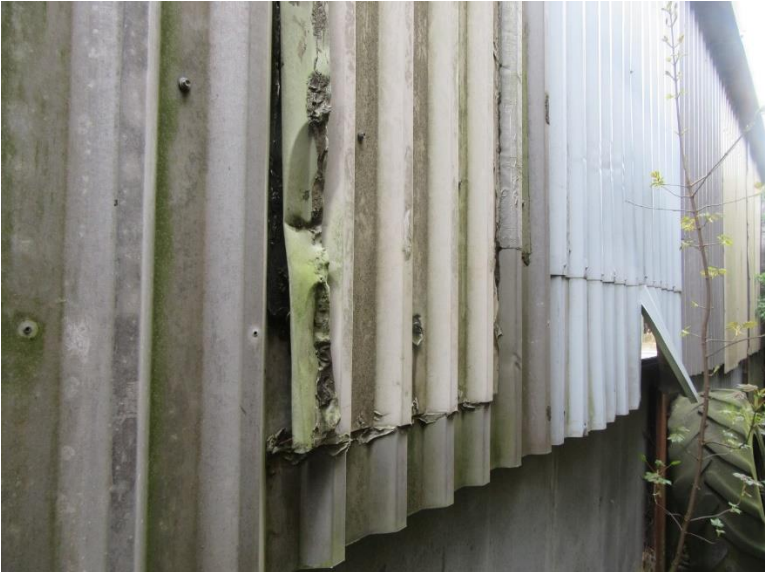
<p>Rear elevation Cladding – Cladding in poor condition in its present state.</p>

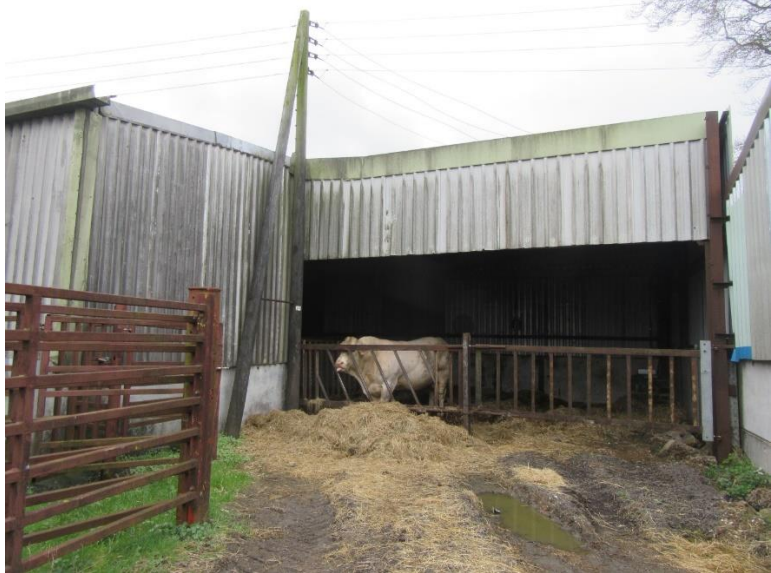
Ref.	Building 3 - Photo	Notes
P301

<ul style="list-style-type: none"> • No internal access due to Bull present. <p>Description – 'L'-shaped building so part mono-pitch steel frame and part duo-pitch usual portal frame. Tubular steel roof bracing to both ends of shed. No vertical bracing to front elevation.</p> <p>Size – Mono-pitch area measures 704m front to rear. Duo-pitch portal measures 11.9m approx. front to rear. Whole shed measured 22.1m long. Notch out mono-pitch was 6.8m wide left to right.</p> <p>Cladding – Cold rolled Zed purlins on steel rafters. Steel angle cladding rails to front elevation, Precast concrete up to dado height. Mid-strut and third span struts present to roof. None to walling sheeting rails.</p> <p>Front Elevation of building 3 - Open aspect for the Bull.</p>
P302

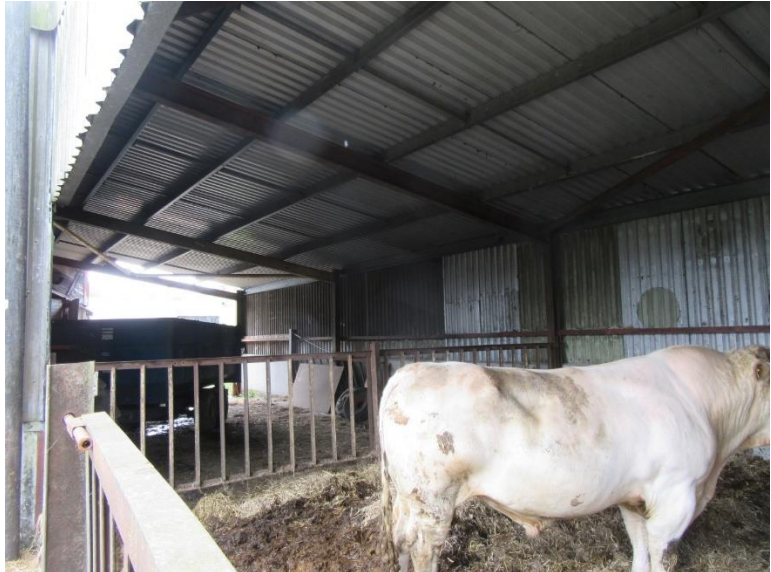
<p>Internal view of mono-pitch roof profile – Steel sheeting on cold rolled purlins with restraint system present and diagonal roof bracing. Rear sheeting spanning vertically onto rail system.</p>

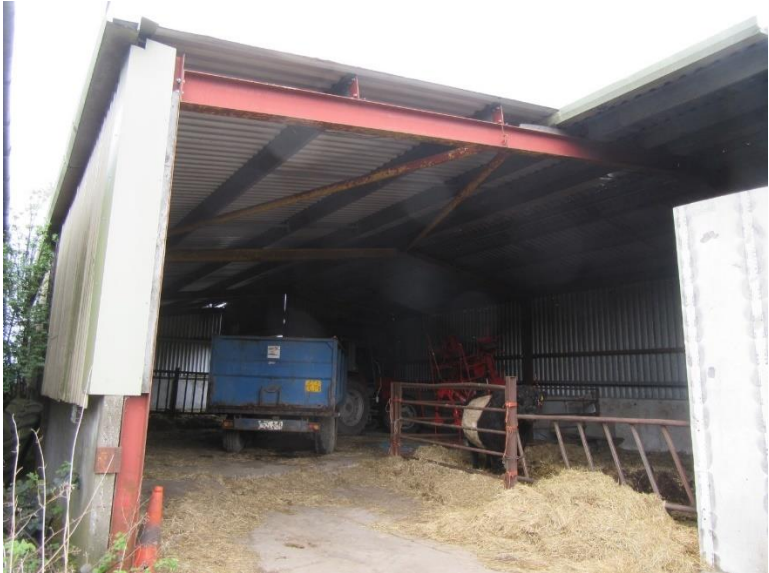
Ref.	Building 3 - Photo	Notes
P303

Left-hand External view – A symmetric roof profile seen of steel frame. Substantial roof purlins seen.
P304	 	Internal view of Left-hand end of the shed – Roof structure in good condition.

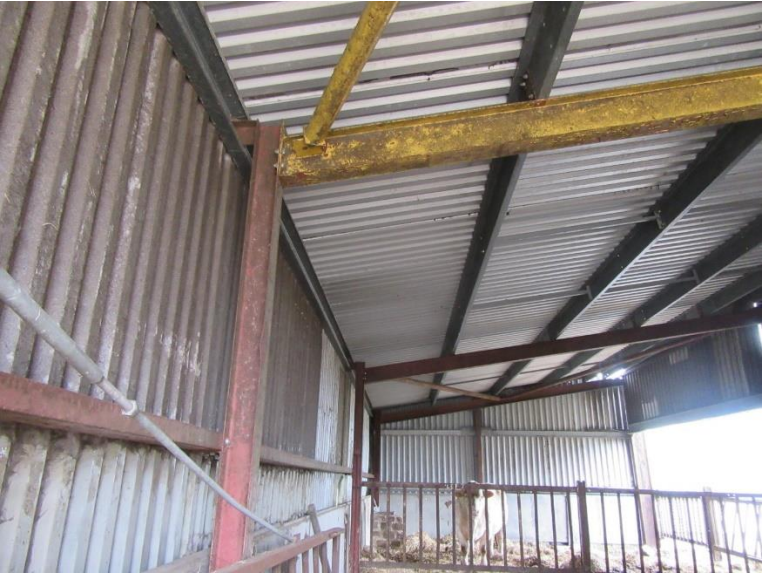
Ref.	Building 3 - Photo	Notes
P305

<p>Steel Frame connection – Rafter to column connection appears to be inadequate and will require strengthening.</p>
P306

Ref.	Building 3 – Conclusion	Building 3 - Recommendations
<p>P301 - 306</p>	<ol style="list-style-type: none"> 1. There was an electric mast was very close to front of building. This will need relocating in order to convert the property into domestic as shown on Wood Architectural Drawings. 2. Main frame appears to be in good condition with purlins of sufficient size and centres and some diagonal bracing present. 3. Connections look a little undersized and would need proving by calculation. 	<ol style="list-style-type: none"> 1. The steel frame sizes would need checking by calculation and connections strengthening. 2. Cladding rails and purlins would also need checking out for their sizes. 3. All the existing structural frame sizes and frame layout lends itself to the development shown on Wood Associates and Architects drawings 22026D

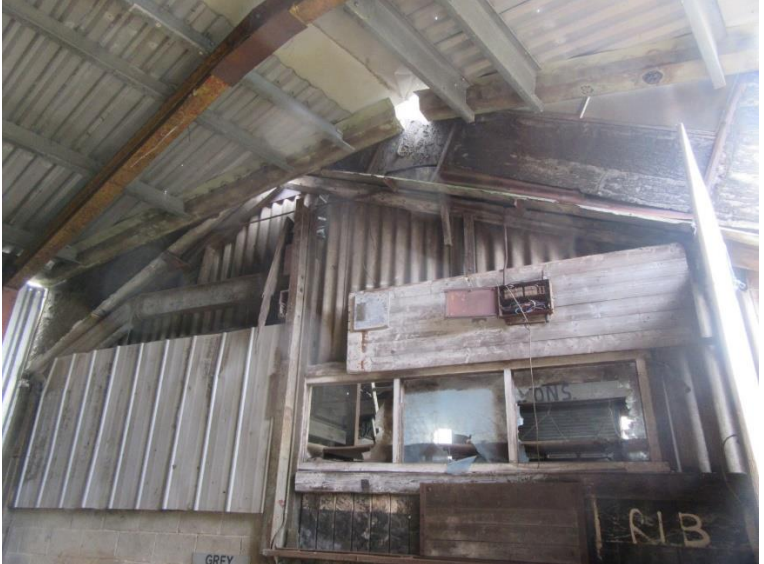
<p>Left-hand End Wall – This sheeting is part building 4 and part building 3. This needs substantial work.</p>

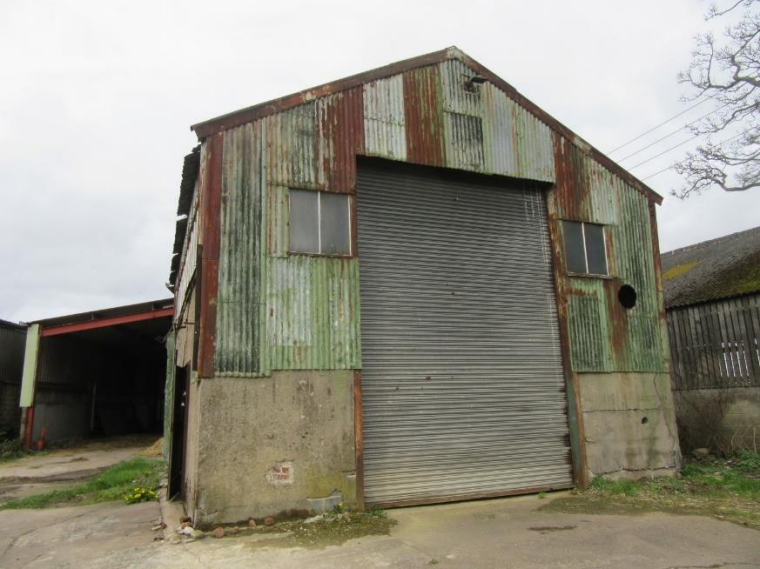
Ref.	Building 4 - Photo	Notes
<p>P401</p>

<p>Description – Formerly an engineering workshop. Steel trusses at 2.43m centre comprising tubular members to top, bottom and web members. Cap plates onto steel RSJ columns build of a finished concrete slab which could possibly be a raft foundation. Steel angle roof purlins. Small steel channel side sheeting rails. RSJ steel gable posts and RHS goods door posts retro spectively fitted independent 5 tonne SWL crane track & rails.</p> <p>Size – Measures 9.15m Left to right x 7.38m Front to rear. 5.25m floor slab to sheeting U/S at eaves and 7.5m slab to ridge sheeting underside.</p> <p>Cladding – Asbestos cement roof panels. Blockwork dado walls up to 1.83m high (six foot). Front panels are approx. 2.1m high with a band of Clear Light glazing over up to eaves level. Left hand gable is poor – mixture of asbestos cement sheeting, plus glass, plus unknown flat panels. All in poor condition.</p> <p>Front elevation of Building 4</p>

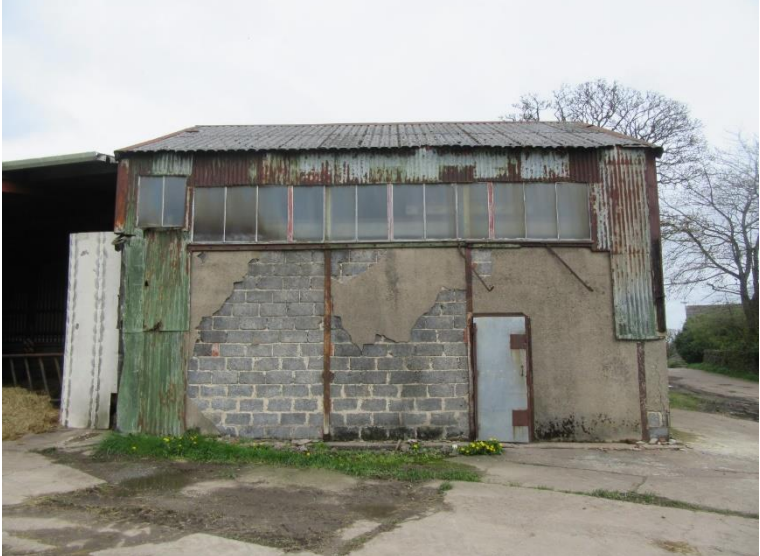
<p>P402</p>

<p>Left-hand side wall with Personnel Door – This elevation has been extended front and rear with an additional window and timber panelling.</p>

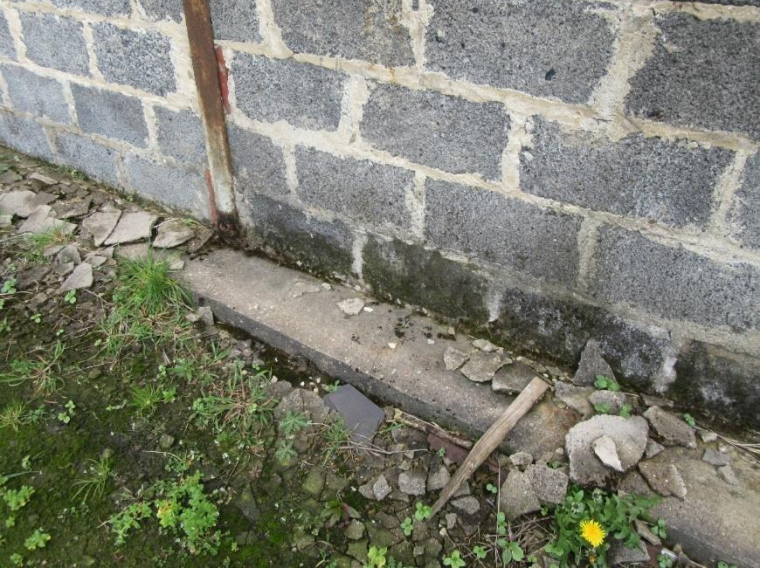
Ref.	Building 4 - Photo	Notes
P403

<p>Edge of Concrete Slab Seen Externally – Concrete slab appears to be in good condition. Render has fallen off the external face of the blockwork.</p>
P404

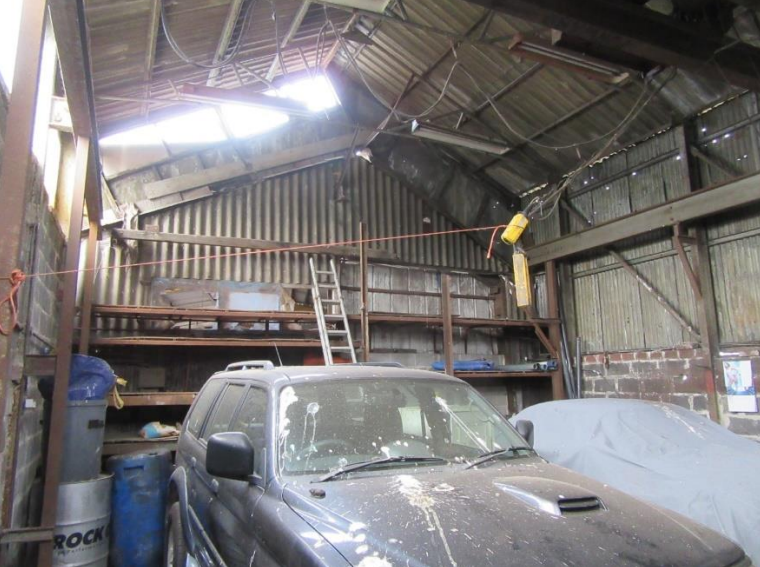
<p>Internal view of Building No.4 – Purlins span onto tubular trusses supported by braced steel columns.</p>

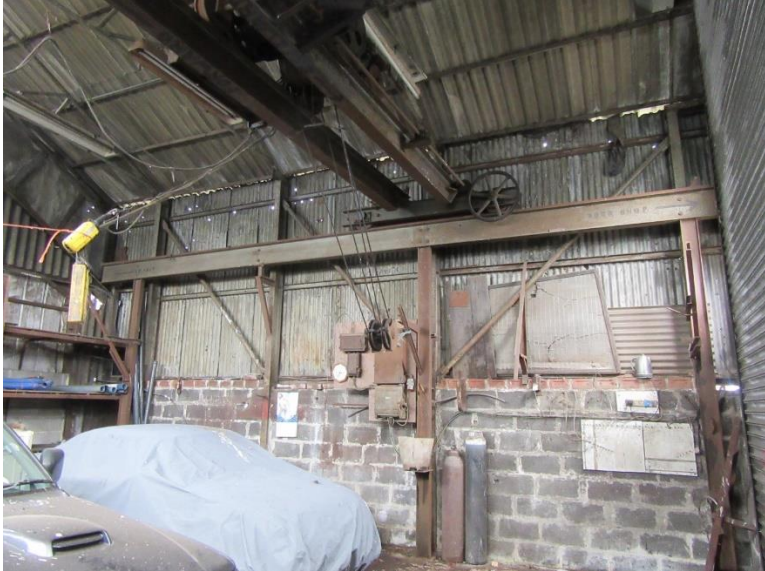
Ref.	Building 4 - Photo	Notes
P405

<p>Retrospective 5 Tonne Crane – This later addition has independent bracing and can be stripped out without compromising the integrity of the original structure.</p>
P406

Ref.	Building 4 Conclusion	Building 4 Recommendations
<p>P401 - 406</p>	<ol style="list-style-type: none"> 1. Rear right corner cracking possibly caused by Sycamore tree. 2. The 5-tonne crane can readily be removed as this was a retrospective addition to the main frames of the original building. 3. The ground floor ground bearing concrete slab has previously been used as an Engineering Workshop and would have likely been subject to high applied loads. 	<ol style="list-style-type: none"> 1. It is recommended to remove the self-seeded sycamore tree. 2. Wood Associates Architectural drawing 22026D-20-R01 shows the proposed house layout with glazed link corridor to the garage annex Building 4. The double columns shown in the garage annex and first floor lounge can be omitted as the 5 Tonne independent Crane can be removed. 3. The steel trusses can readily be adapted strengthened by bolting new on supplementary rafter members alongside the existing truss top chords and removing the bottom section of the trusses to create the double height garage with living accommodation above. 4. The ground floor ground bearing concrete slab can readily be used as a domestic car garage.

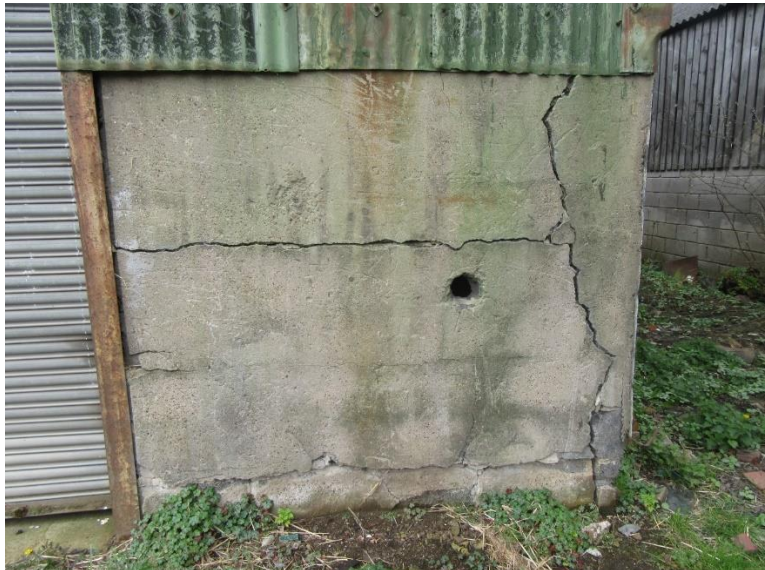
<p>Cracking to front right masonry panel – On close inspection, this cracking has been caused by internal impact cracking the render.</p>

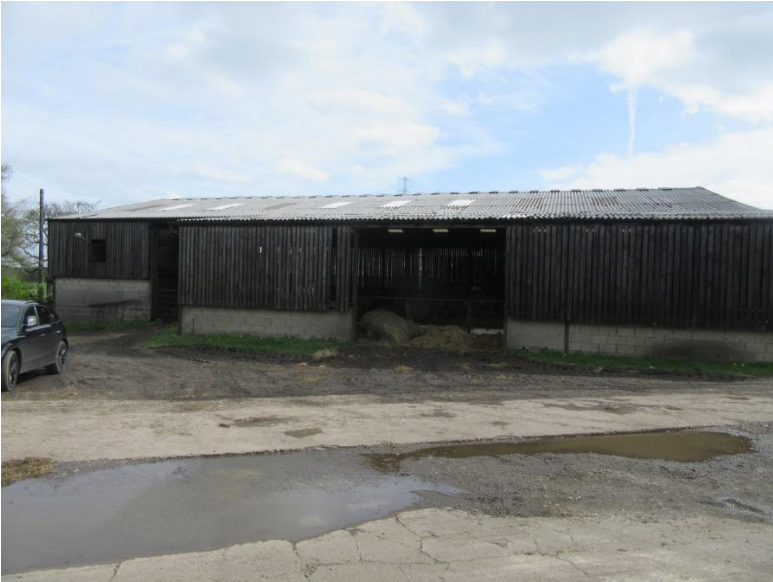
Ref.	Building 5 - Photo	Notes
P501

<p>*Limited access due to cattle and no access into RHS Yard*</p> <p>Description – Steel portal frame with cat slide roof profile. Asymmetric roof profile supporting timber purlins and ‘Big six’ asbestos cement roof panels. Diagonal roof bracing to one central bay. No wall bracing present. No intermittent rails to the vertical timber boards to left and right elevations. No sheeting to rear left elevation.</p> <p>Free standing internal columns between main RHS shed and Lefthand lean to cat-slide shed.</p> <p>Size – ‘L’- shaped on plan measuring 18mx6.1m left hand area of the ‘L’- shape. Larger right hand side measures 16.8m x 10m. Height of left-hand annex was measured as being 3.8m from slab to underside of the roofing panels.</p> <p>Cladding – ‘Big Six’ asbestos cement roof panels with translucent roof panel area left and right, plastisol coated steel to front elevation down to dado concrete blockwork wall. Left & Right sides are open vertical timber boards spanning full height eaves down to the 1.2m high blockwork dado wall. Rear was plastisol coated sheeting to upper gable 7 blockwork to layer 2.7m</p> <p>Front Elevation of Building 5 – Open vertical timber boarding present above the dado height concrete blockwork wall.</p>

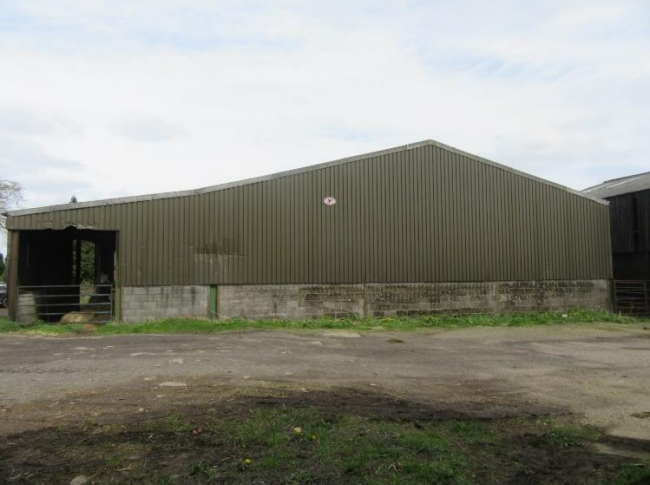
<p>P502</p>

<p>Right-hand Elevation – This profile shows the Asymmetric profile of the roof. Minor impact damage to the steel sheeting noted.</p>
<p>P503</p>

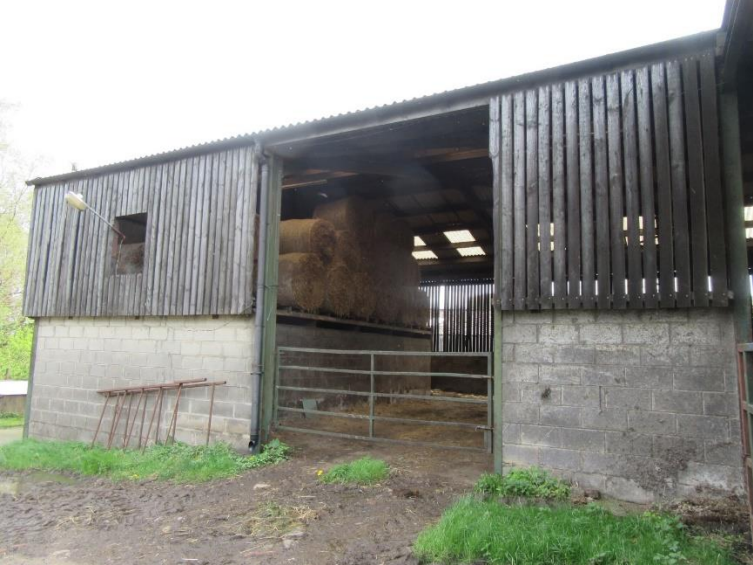
<p>Left-hand set back portion of Building 4 – Higher blockwork dado wall panels due to slope of ground roof sheeting on timber purlins on braced steel frame.</p>

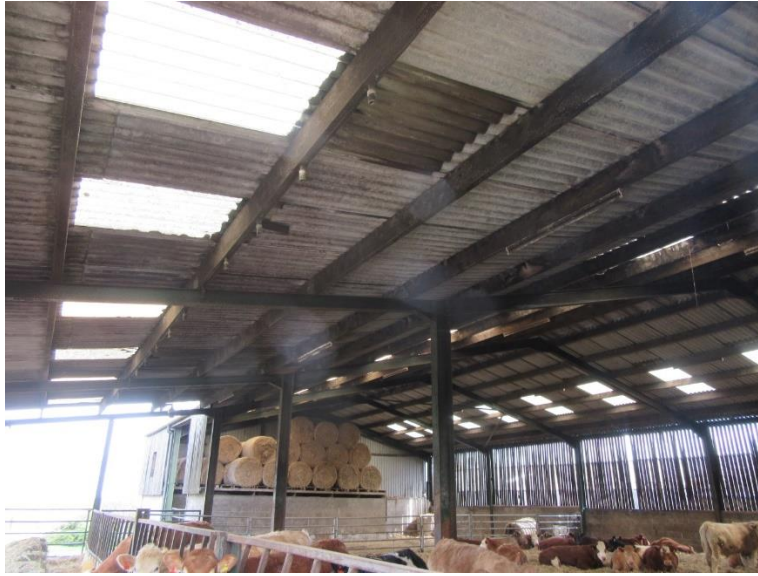
P504

Internal View on Main Shed – Asbestos sheeting spans onto timber purlins, onto steel portal rafters and columns. All in adequate condition. Concrete slab present.

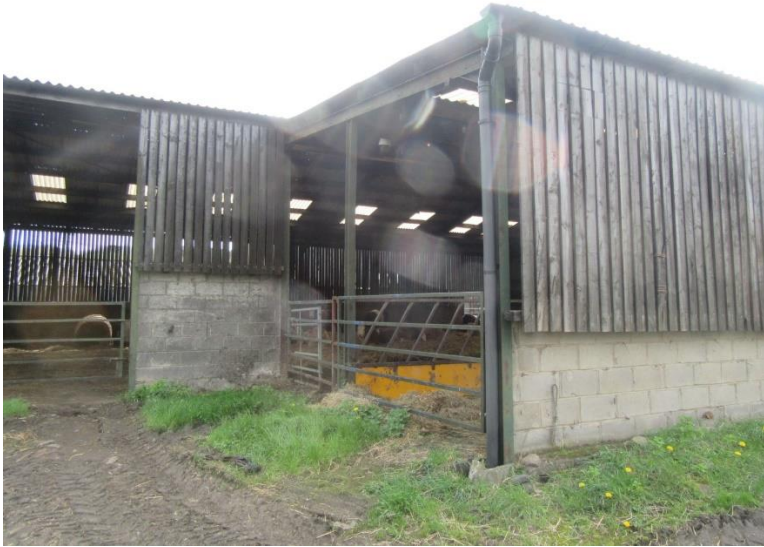
Ref.	Building 5 - Photo	Notes
P505

A photograph showing the left-hand open side of a large main shed. The structure features a concrete base and vertical corrugated metal siding. Steel columns and gable posts are visible, supporting the roof. The interior shows a dirt floor and some equipment.	Left-hand Open side of Main Shed – Set back portion of the main shed seen to the left. Steel columns and gable posts.
P506

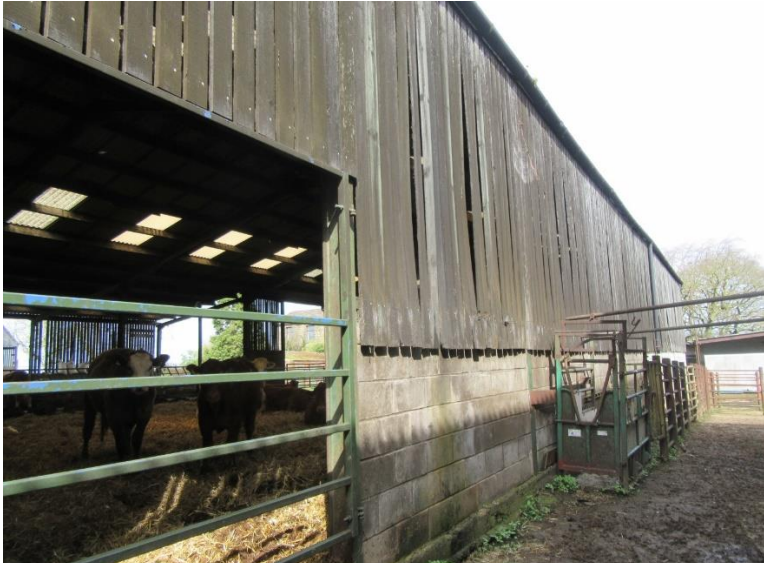
A photograph showing the rear elevation of a building with vertical timber boarding. The boarding appears weathered, with some sections that have shrunk and twisted. A metal railing is visible in the foreground, and the interior of the building shows some equipment and a dirt floor.	Rear Elevation of Building 6 – Timber vertical boarding has shrunk and twisted.

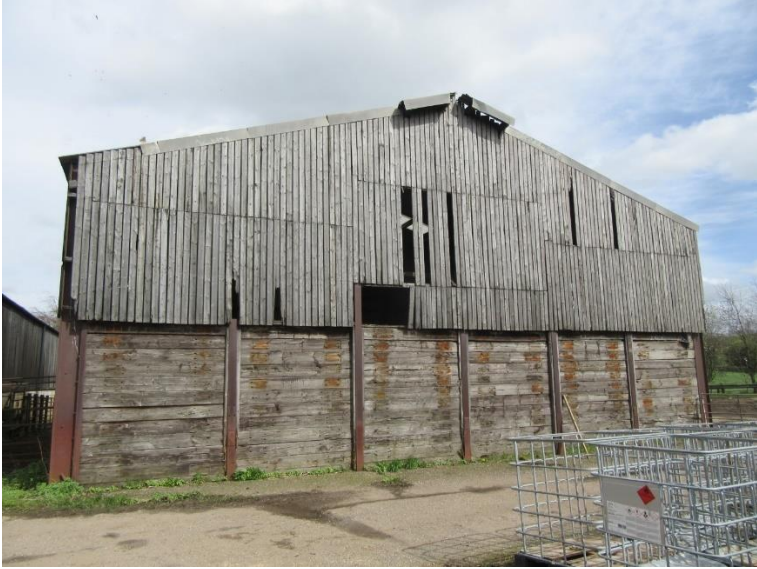
Ref.	Building 6 - Photo	Notes
P601

<ul style="list-style-type: none"> • No access inside due to presence of cattle <p>Description – Timber roof purlins on two steel portal frames with steel gable frames to front and rear ends.</p> <p>Size – Width Left to right = 16.5m. Measured internally. 6.4m eaves height.</p> <p>Cladding – Plastisol coated steel to rear elevation on timber side rails. Front, left and right are all vertical open boards on horizontal timber rails above horizontal sleepers sat between vertical steels. Approx 2.8m high sleeper walls</p> <p>Front elevation of Building 6 – Open vertical timber cladding spans onto timber sheeting rails. Heavy sleeper planks have been used to span below the steel gable posts.</p>
P602

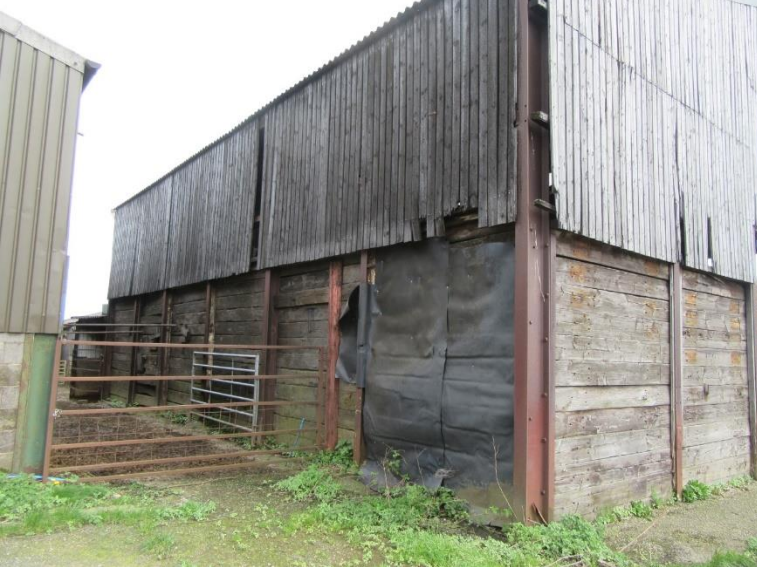
<p>Left Side Wall – Similar construction to that seen with the front elevation.</p>

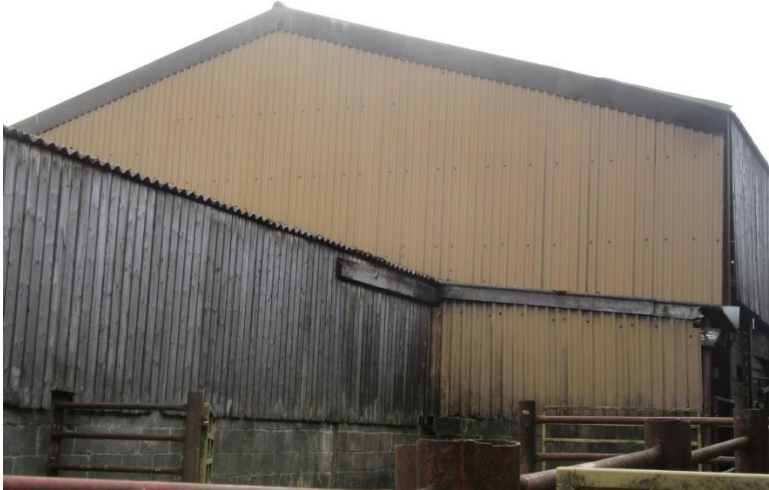
Ref.	Building 6 Photo	Notes
P603

Right Side Wall – Right side wall abuts the higher Building 7, seen to the rear.
P604

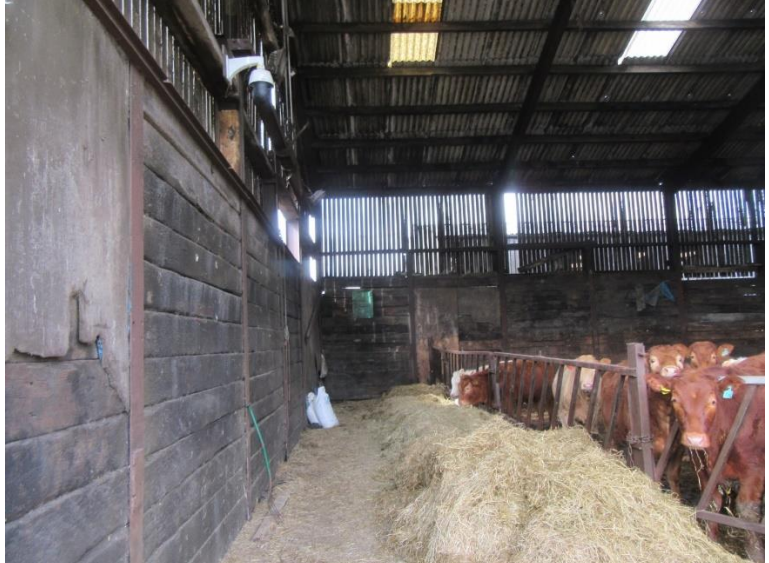
Internal View of Building 6 – Asbestos cement roof sheeting supported on timber purlins spanning from front gable frame onto internal steel portal frame.

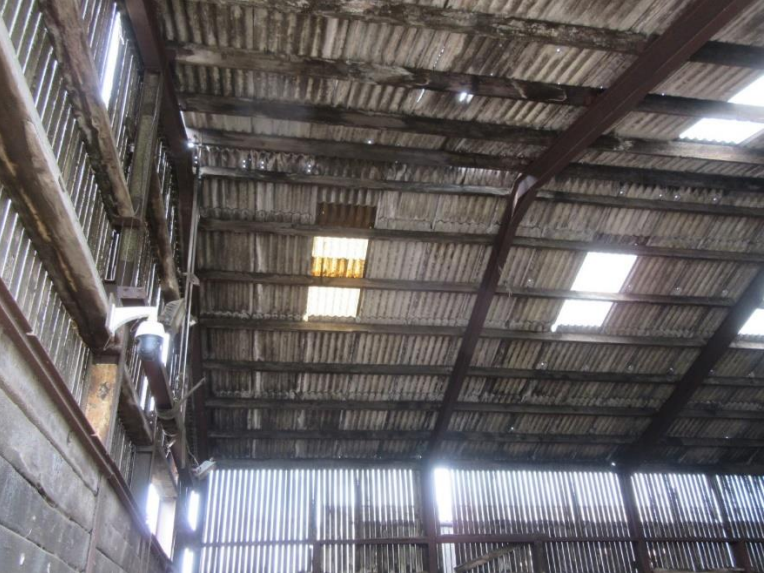
Ref.	Building 6 - Photo	Notes
P605

<p>Roof Structure – Adequate steel ridge connection seen. Lack of roof bracing noted, but can be added in.</p>
P606

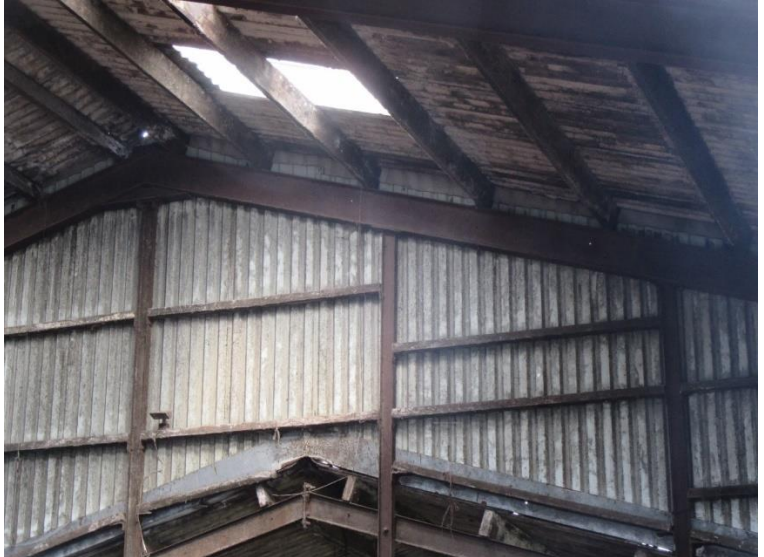
<p>Rear gable where the wall abuts the lower Building 7 – vertical modern sheeting seen spanning onto timber rails supported by steel gable posts.</p>

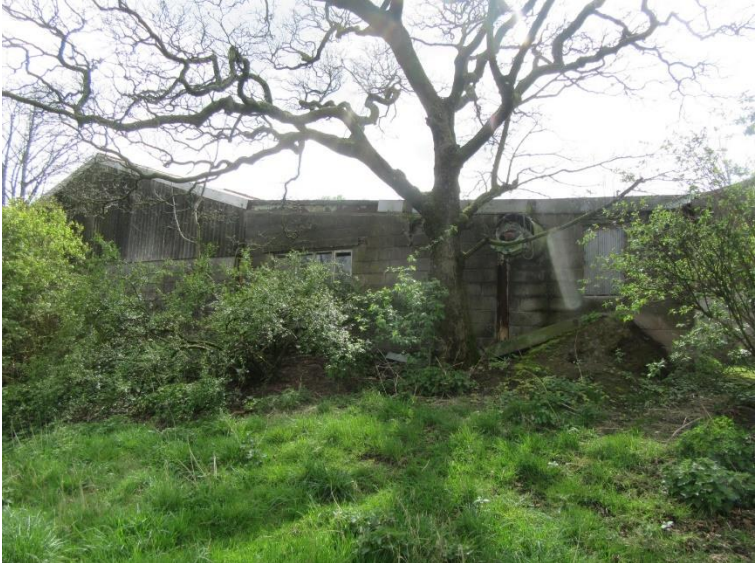
Ref.	Building 7 Photo	Notes
P703

Rear right area of Right-hand gable – Further older tree seen here.
P704

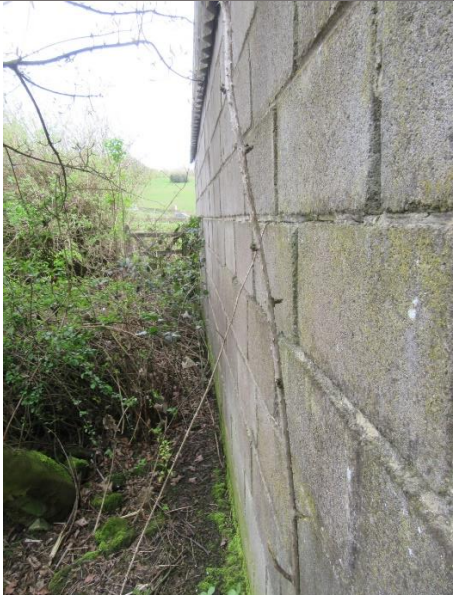
Right-hand blockwork – Significant outward bowing was seen to the blockwork wall which was likely caused by presence of the tree.

8. The mature tree near the front left corner of Barn 1 should be completely removed, as should the two at the rear of Barn number 2.
9. Building 7 with the outward lean of the blockwork will simply need new deeper footings installing to sound ground prior to re-building the right-hand gable wall.

Ref.	Building 7 Conclusion	Building 7 Recommendations
<p>P701 - 706</p>	<ol style="list-style-type: none"> 1. Significant outward bowing was seen to the right-hand side gable blockwork wall caused by presence of the adjacent trees. The trees will have caused the foundations to have settled and rotate which as caused the blockwork to push out. 2. Inadequate substrata were seen below the concrete slab edge causing the edge slab to have settled causing cracking of the blockwork panels above and the concrete edge slab. 	<ol style="list-style-type: none"> 1. The two trees adjacent the right-hand gable wall should be removed, and roots grubbed up. 2. The ground conditions need to be explored and footings underpinned to achieve deeper to provide foundations to bear onto stable ground. 3. Once ground conditions are confirmed the minimal pad footings can be underpinned with larger pads. 4. Wood Associates Architectural drawings 22026D-26-R01 and 22026D – 27-R02 show the proposed house layout for the tree properties. 5. The steel portal frames can readily be strengthened if needed by bolting new on supplementary members on.

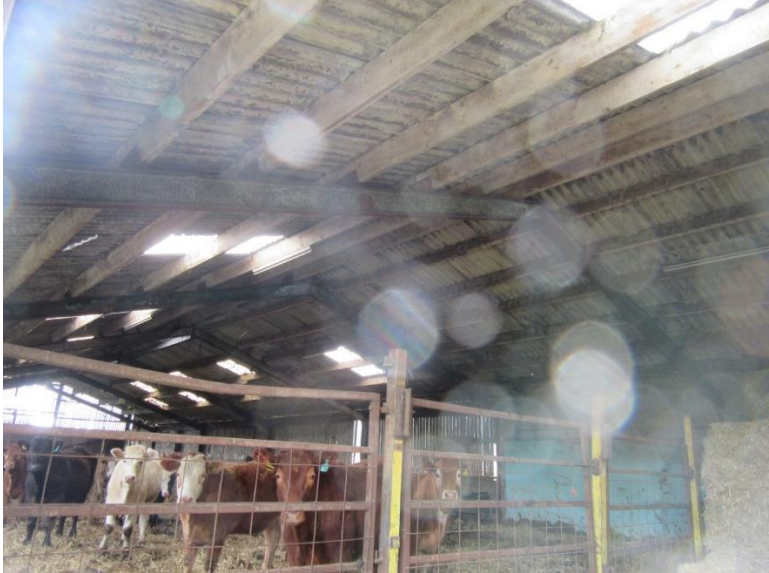
Ref.	Building 7 Photo	Notes
P705

<p>General Internal View of Shed 7– Again, asbestos sheeting on timber purlins on steel portal frame with inadequate connections.</p>
P706

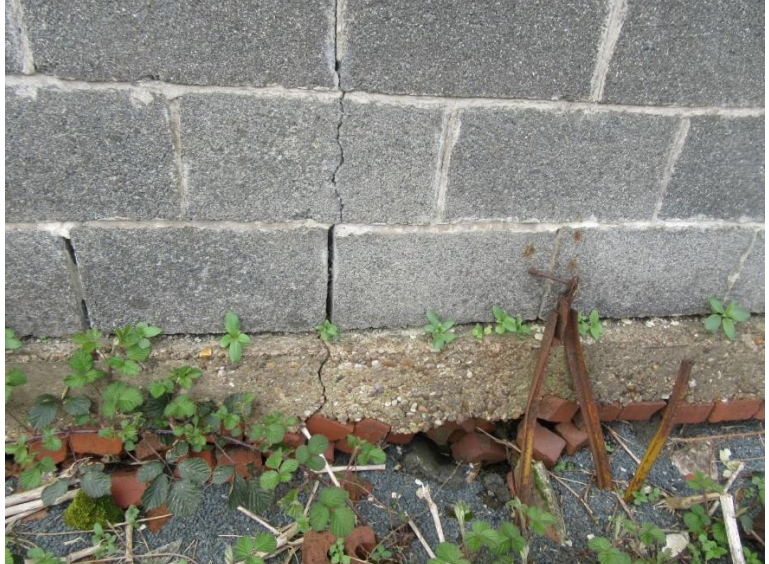
<p>Cracking to blockwork wall panels and concrete slab edge – Inadequate substrata seen below the concrete slab edge has caused settlement and cracking. This can easily be underpinned to the edge.</p>

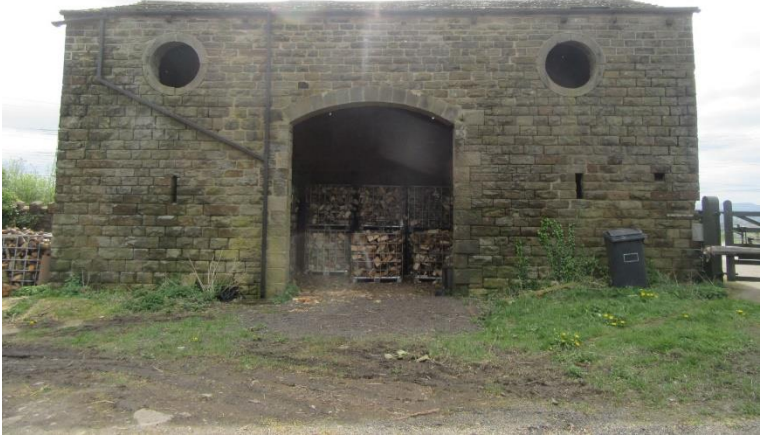
Ref.	Building 8 Photo	Notes
P801

Front elevation of Building 8 in good condition– Natural stone barn building with two circular windows and feature arch. Heavy natural stone roof finishes present.
P802

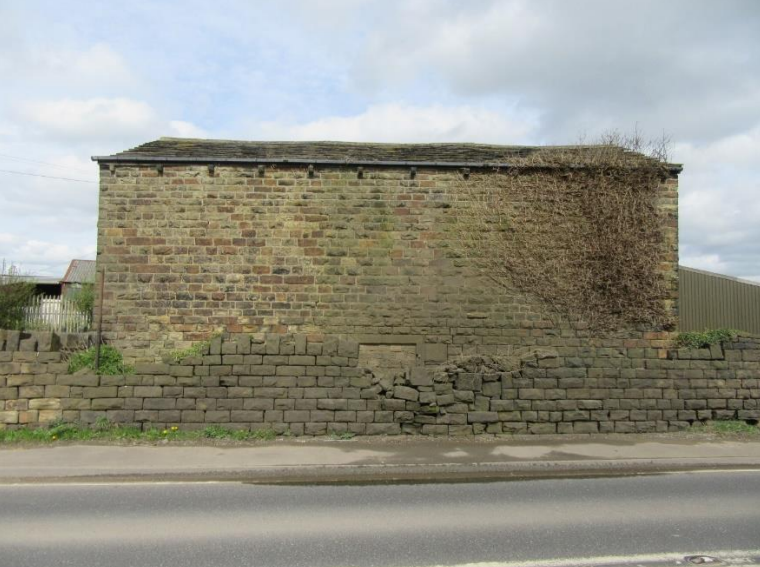
Rear Elevation – Rear elevation of barn in good condition.

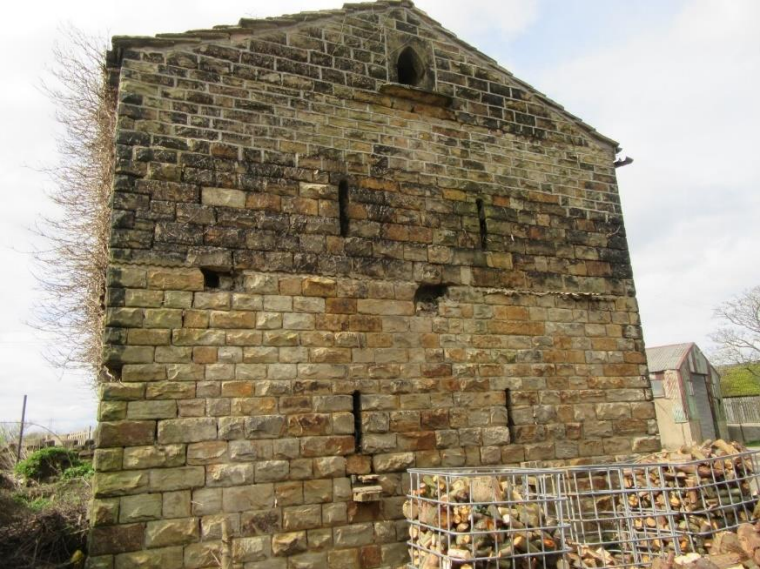
Ref.	Building 8 Photo	Notes	
P803

<p>Left-hand Gable – Evidence of previous lean-to building seen. Holes noted in stonework where previous structure would have sat.</p>	
P804

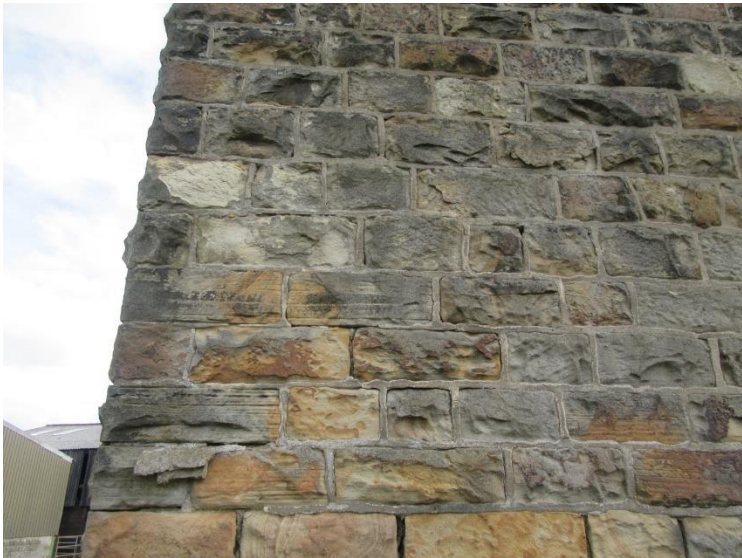
<p>Part right-hand gable – Cracking noted to gable and front elevation indicative of localised settlement of this front, right corner.</p>

10. Building 8 simply needs some minor localised underpinning to the front right corner in order to stabilise the current footing stones.
11. Existing timber lintels should be strengthened by bolting new timbers alongside. Again sizes can be determined after completing of structural calculations necessary for Building Regulations.
