LIMITED STRUCTURAL REPORT

Project	Liley Hall Farm, Liley Lane, Mirfield, WF14 8EG
Project Number	2024/086
Date	30 April 2024

**Limited Structural Conditional Report on
Liley Hall Farm buildings, Liley Lane, Mirfield, WF14 8EG
for the Purposes of Conversion into Domestic Dwellings**

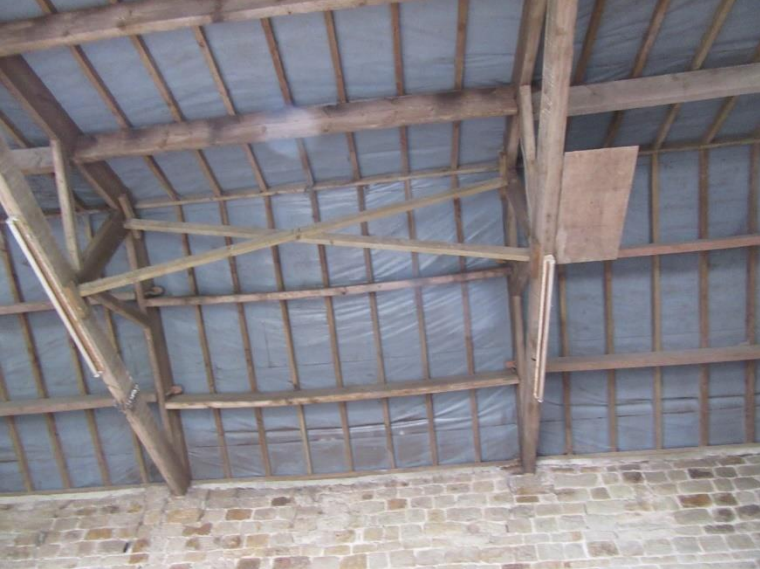
Ref.	Building 8 Photo	Notes
P805

<p>Internal View – The queen post trusses were noted to have ‘lozenged’ over towards the left. The later cross bracing seen here will have undoubtedly helped reduce the movement.</p>
P806

Ref.	Building 8 - Conclusion	Building 8 - Recommendations
P801 - 806	<ol style="list-style-type: none">1. Building 8 is intended to become the Service building for the development as shown on Wood Associates Architects Drawing 22026D-38-R012. There was minor settlement seen to the front right corner of the building.3. The building is in very good condition with little structural defects.4. The roof structure has a slight lean with the trusses having lozenged over.	<ol style="list-style-type: none">1. Ground conditions should be explored by the front right corner and possibly an underpinning scheme drawn up in order to site the footing stones to a deeper depth.2. The roof structure should have a designed bracing system installed in order to prevent further twisting and leaning of the trusses.

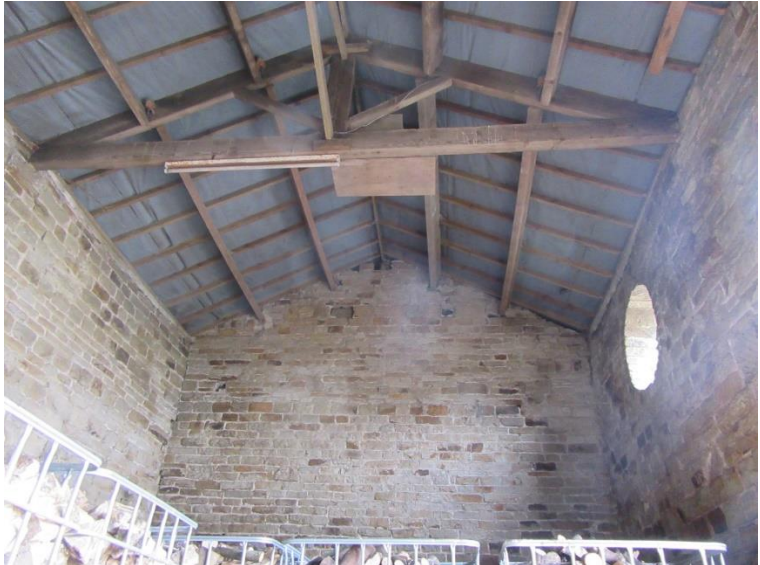
<p>Internal View of right-hand end Panel – Purlins were seen to have a slight curve due to the very heavy weight of the natural stone roof finishes. These purlins can readily be strengthened by bolting additional timbers alongside.</p>
