Tree condition survey

9 Church Lane south, Crosland, Netherton, HD47DB

Date of site visit: 18<sup>th</sup> March 2026

Jason Isherwood HND, M Arbor A, PTI, TRAQ, Bond Solon Expert Witness.

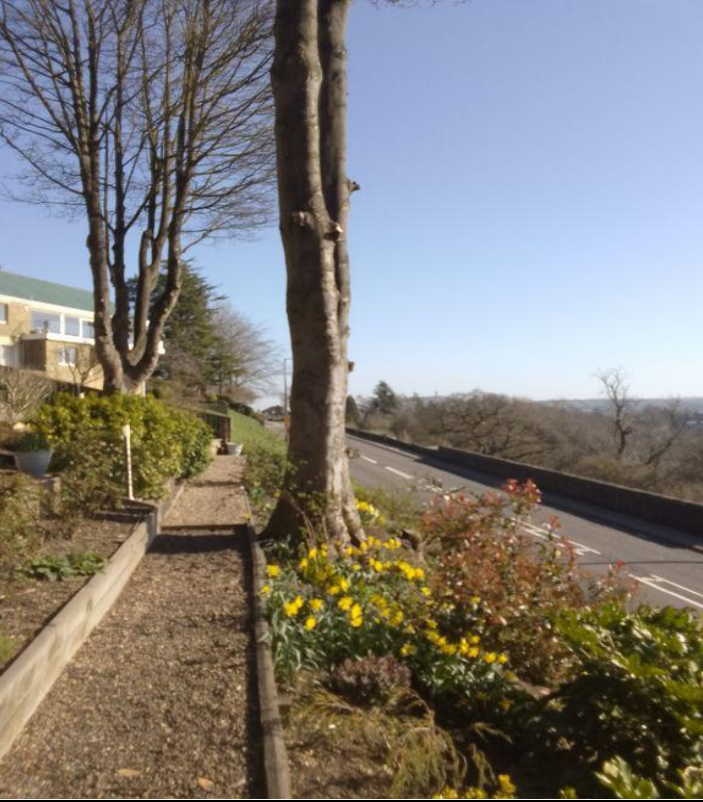
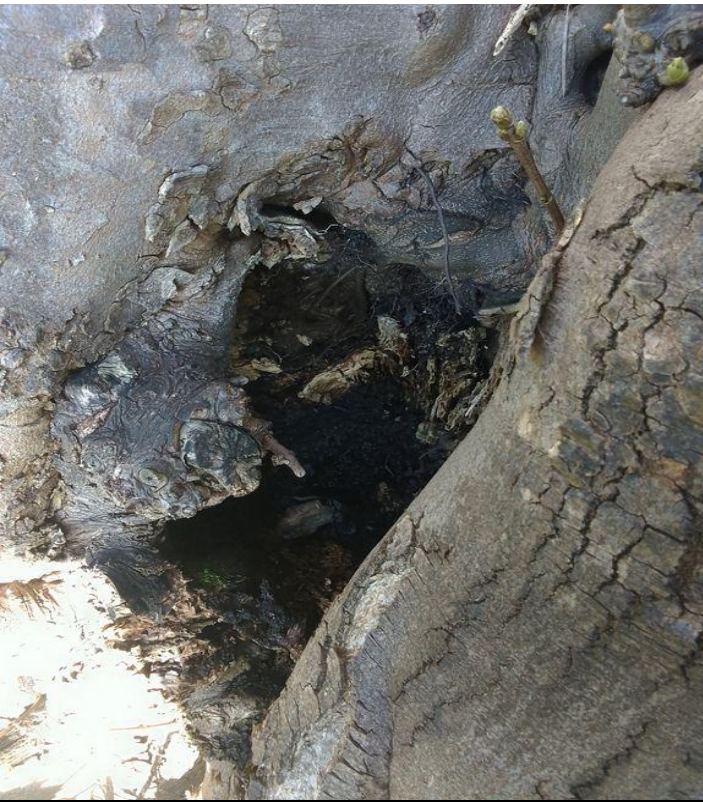
| Ref. | Species | Photo | Photo |
|---|---|---|---|
| T001 | Sycamore<br>( <i>Acer pseudoplatanus</i> ) | | |

The tree is in poor physiological and structural condition. Of principal concern is the presence of significant basal dysfunction and decay, evidenced by a combination of an open wound at the stem base, extensive internal rot, deep probe penetration, and hollow acoustic response. In my

opinion, the most important defect is not in the outer crown but at the lower stem / basal region, where loss of structural integrity has the greatest bearing on the risk of stem base or whole-tree failure.

- The report records an open wound on the roadside aspect of the trunk.
- Rot within that wound is described as extensive.
- This is a significant structural defect because decay at the base affects the tree's primary load-bearing zone.

- A probe test penetrated 24cm into the trunk.
- This suggests a substantial area of softened, decayed or compromised woody tissue rather than a superficial surface defect.

- An acoustic test revealed hollow resonance in parts of the trunk.
- While not a full decay mapping exercise, this finding is consistent with internal dysfunction and corroborates the probe test and visible wound/rot observations.

- The tree is described as having two trunks dividing at less than 1 metre from the base.
- This growth form can increase loading and stress concentration at the lower stem, particularly where decay is already present.

The report's assigned rating of High risk is, in my opinion, justified by:

The recommendation recorded in the survey report is to remove the tree, and on the information provided I consider that recommendation to be reasonable, proportionate and arboriculturally justified.

- Removal of T001
- Works to be carried out by a competent arboricultural contractor
- Operations to be undertaken with appropriate traffic/pedestrian management if required
- Stump treatment or retention to be determined by site objectives and any replanting proposal
- Replacement planting should be considered, if appropriate to the site and subject to any statutory requirements
