## Huddersfield Station

Roof A - Truss Pre-emptive Interventions Proposals Sketchbook

151667-TSA-30-MVL3-SK-S-007 Rev P03

06 October 2023

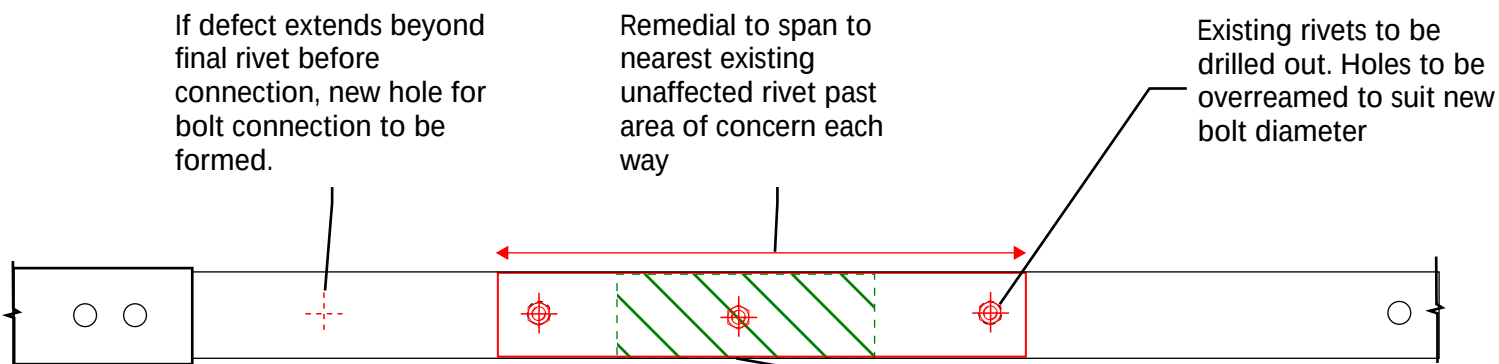
Scenario A - Proposal

The sections appear to be in generally reasonable condition with the exception of a small number of locations where water has penetrated between the riveted sections causing corrosion between the plates forcing them apart, commonly referred to as birds mouting. Away from these isolated details, it is anticipated that the likelihood of excessive corrosion or other defects including cracking is low.

Should remedial works be identified as required during the works a notional deterioration scenario is shown opposite, conservatively assuming full plate section loss.

The proposal is to remediate in a similar manner to the existing compound section of flat plates. This will be done by drilled through existing rivets and fixing an additional flat side plate of matching depth to the affected lengths.

Bolts to be fixed through existing rivet holes. Plate thickness and bolt sizing to suit extent of defect.

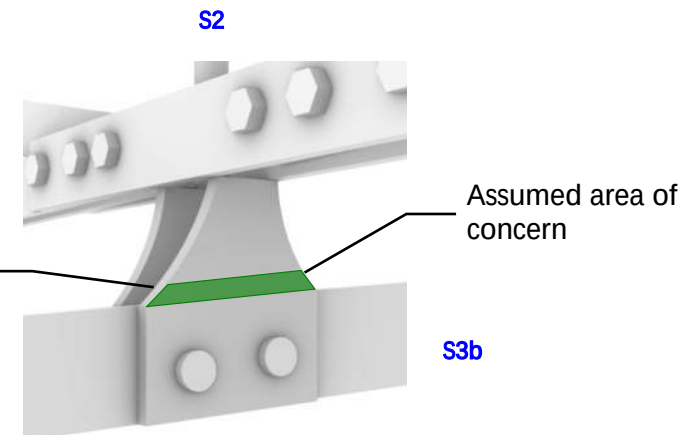
## Scenario A: Outer connection plates deteriorated

Outer connection plates only deteriorated

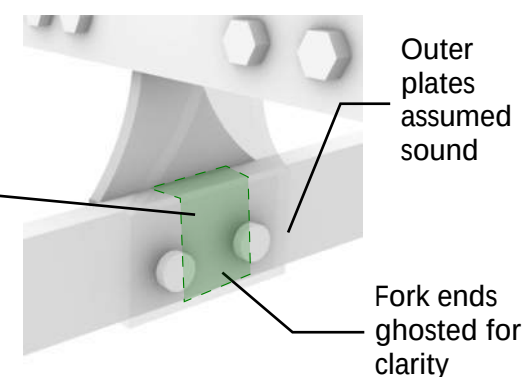
## Scenario B: Inner connection plates deteriorated

Assumed area of concern

Internal bolts - through over-reamed existing rivets - transfer S2 loads into new side plates

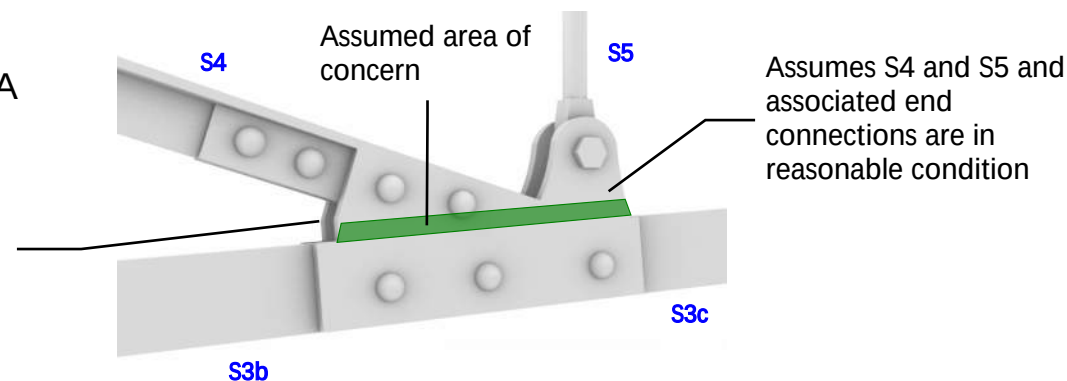
## Scenario A

Outer connection plates only deteriorated

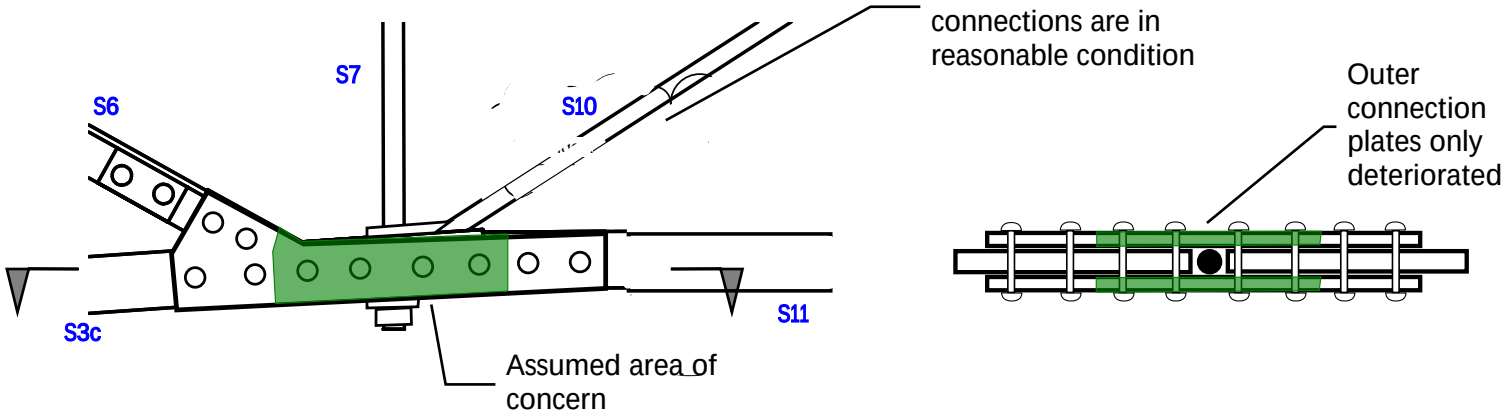
Scenario A

C7 has been identified as having corrosion present which appears to have progressed between the initial survey in 2019 and the latest in 2023. The corrosion appears most significant in the bolts and connection plates around the base of the diagonal members and particularly on the central side of the truss (towards member S11). It unclear from the photos to what extent the corrosion and water ingress has penetrated to the inner plates of the connection and what condition they may be in. The vertical tie rod S7 and associated washers and bolts appear generally to be in good condition as do the incoming diagonal angle S6 and its associated bolts.

Any intervention will need to be considerate of the part of the connection which is identified as deteriorated. Given the current condition, the most likely elements to be identified as understrength is the central section of the outer connection plates and the associated inner plates of the corresponding connecting elements. Scenarios are presented to account for increasing deterioration.

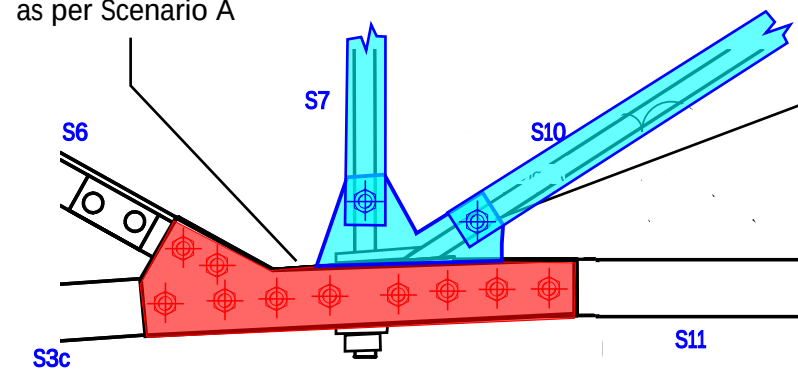
### Scenario B: Outer connection plates deteriorated + S7 / S10 ends deteriorated

- Low likelihood of requirement due to generally good condition of S7 and S10 connection elements
- Requires full strengthening / capacity matching of elements S7, S10 which in turn requires interaction detail with central rose.
- Detail assumes some capacity of existing tie rod and connections subject to wider design checks. Proposal C may be more suitable to allow for complete redundancy of existing connection elements.

Extension to bridging plate to accommodate S7 and S10 tie rod strengthening.

Existing S7 and S10 tie rods retained throughout

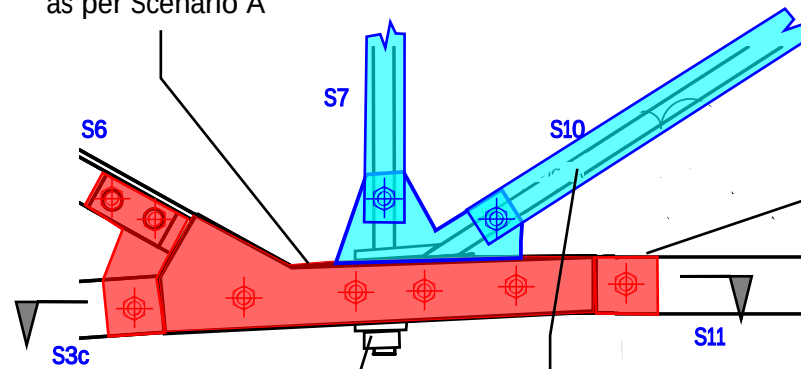
### Scenario C: Outer connection plates deteriorated + S7 / S10 ends deteriorated + S6 / S3c / S11 ends deteriorated

- Detail to be designed to make existing connection redundant.
- Requires full strengthening of elements S7, S10 which in turn required the full extent of central rose and associated tie rod strengthening. See associated element replacement page.
- Detail assumes some capacity of existing tie rod and connections subject to wider design checks. Proposal C may be more suitable to allow for complete redundancy of existing connection elements.

Bridging plate extended past existing connection with additional bolts through new holes into sound existing elements

No new washer required

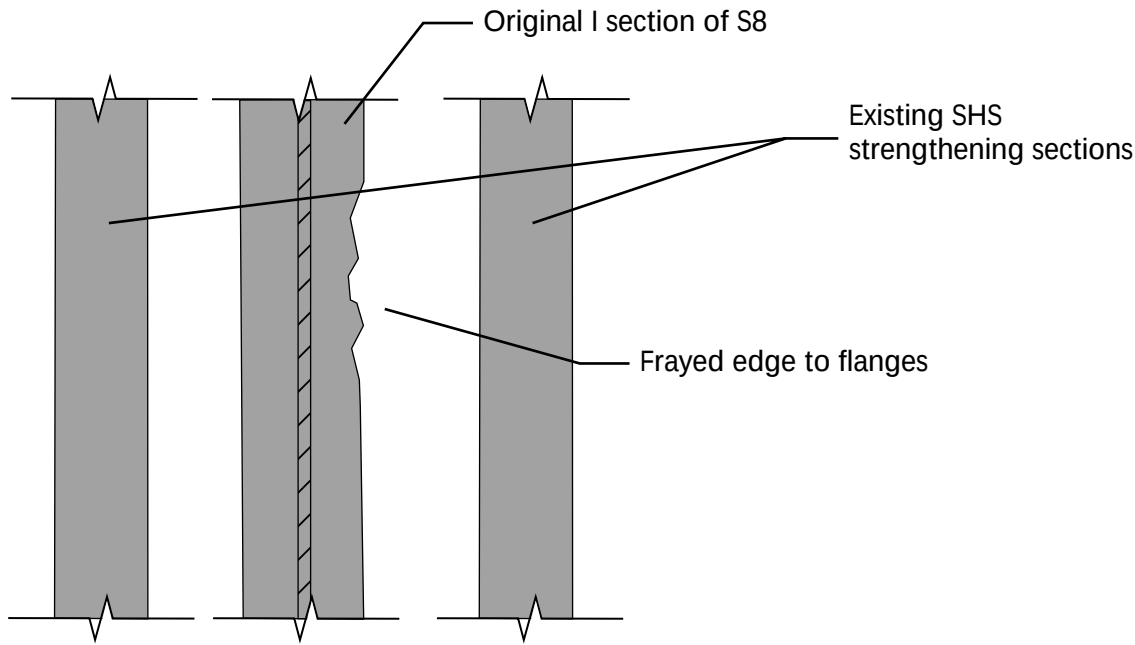
Scenario A

Whilst the corrosion protection system of the elements appears in a generally poor condition, the nature of the closed box sections, their more recent installation in modern materials and their original design capacity means that the risk of interventions being required is very low. In the unlikely event of intervention being required, the strengthening elements are proposed to be replaced like for like.

The remedial opposite assumes a known deterioration scenario where the edges of the I section are ragged and frayed due to corrosion. The flanges are to be ground back to a minimum thickness in line with Network Rail Guidance NR/L3/CIV/040 (Specification for the Use of Protective Coating Systems) and should be ground back to a consistent line where possible to reduce the visual impact of the section loss when viewed from platform level.

Works are to be undertaken to restore the corrosion protection of both the original and strengthened sections as per the rest of the structure.
