Dismantling Methodology – Record of elements to be replaced

The following schedule updates the indicative schedule noted in the Arup Methodology Document Ref: 151667-TSA-30-MVL3-REP-A-AR-012001 (HUDDERSFIELD STATION - Methodology for deconstructing, storing and reconstructing the Tea Rooms. Item 4.5 Items to be Replaced. (Issue 03 – 21/01/26).

Record of Items to be Replaced

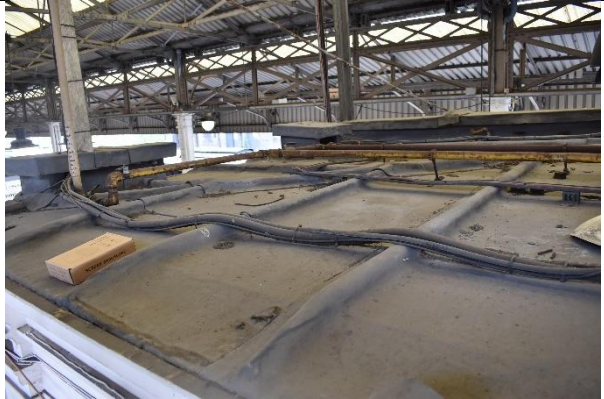
Roof		
Ref	Item Description	Photograph
01	<p>Lead sheet roofing – to be replaced with zinc roofing. This is to include the raised cable entry points and service supports.</p> <p>Note: The lead roofing is not original to the construction of the Tea Rooms it is believed to have been a later replacement of the original zinc roof which was replaced in the 1980’s.</p>

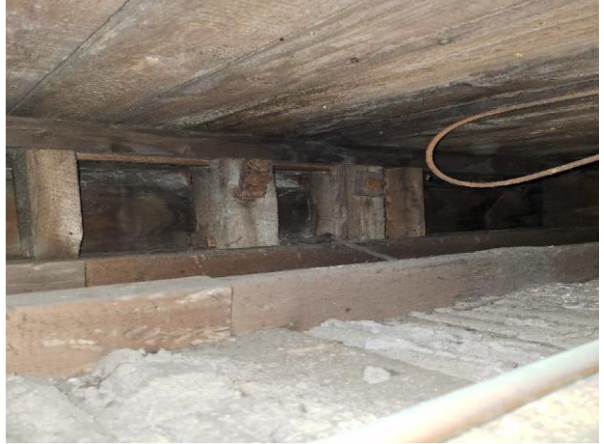
02	<p>Sarking Boards – The existing sarking boards were salvaged from the building for possible re-use. Unfortunately, the timber cannot achieve the strength requirements of the proposed roof construction. All sarking boards are to be replaced with a structural plywood material which will provide the required rigidity to the Tea Rooms structure.</p>

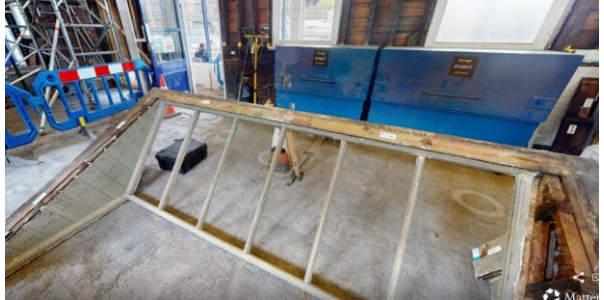
03	<p>Roof lantern – the glazing bars of the roof light are in poor condition and were damaged as a result of an earlier re-glazing. These are to be replaced with replica mouldings.</p> <p>All other elements of the timber rooflight have been salvaged and will be reused.</p> <p>The glass to the rooflight will also be replaced to provide a clear glass appearance rather than the modern “wired” glass that was present.</p>

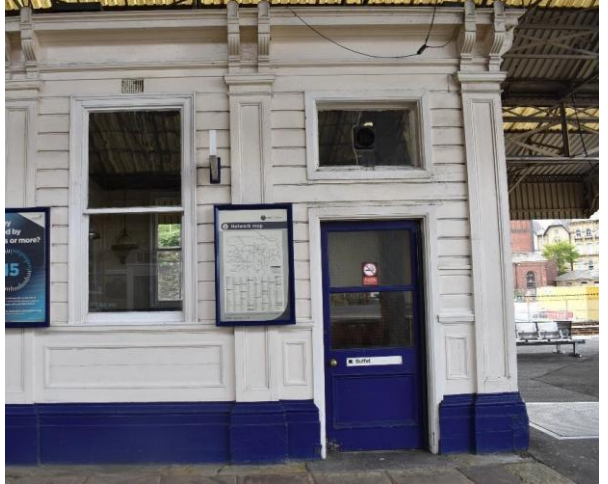
Ref	Item Description	Photograph
04	<p>External Doors – The existing external doors were salvaged from the building for possible re-use. The doors have been identified as being a later adaption of the building (possibly in 2005) and do not follow the original historic appearance. Due to steeper slope of new platform, the doors will need to vary in height in order that the level thresholds match the new platform levels. All doors are to be replaced with new door sets that match the original appearance of the historic doors – glass to be fitted in the upper panel sections to meet Building Control requirements. This will include new ironmongery, hinges and where necessary, actuators.</p>

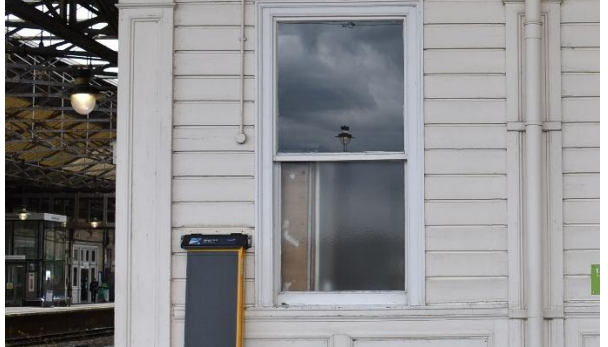
05	<p>Window glazing – The glazing to the sash, pivot and external doors will be replaced with a new laminated glass to meet Building Regulation approval.</p> <p>Internal sash vents and ironmongery will also be replaced.</p>

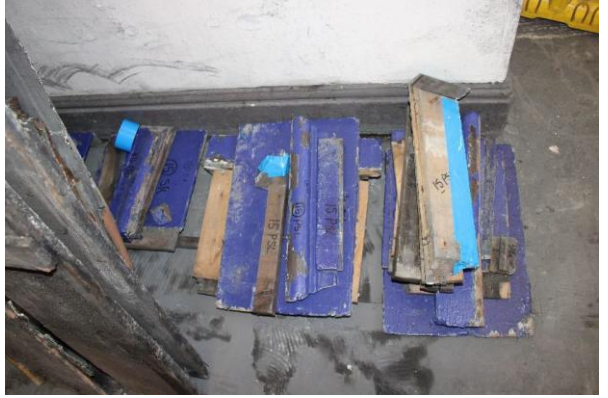
06	<p>The external skirting (Plinth Cladding) - This was fully salvaged from the building for possible re-use. However, the re-orientation of the building and the proposed gradient of the platform will require a variable plinth depth. It is proposed that the lower timber element of the plinth is replaced whilst the upper elements are re-used. This will allow the maximum amount of original material to be retained.</p>

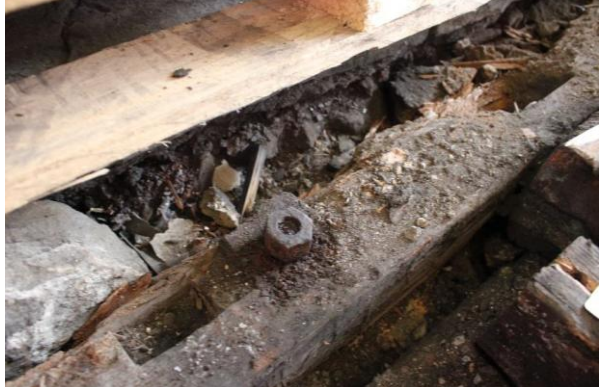
07	<p>Timber Sole Plate – the severely degraded sole plate will be replaced in new timber to match existing.</p> <p>Holding down bolts also to be replaced with modern fixings to Engineers details.</p>

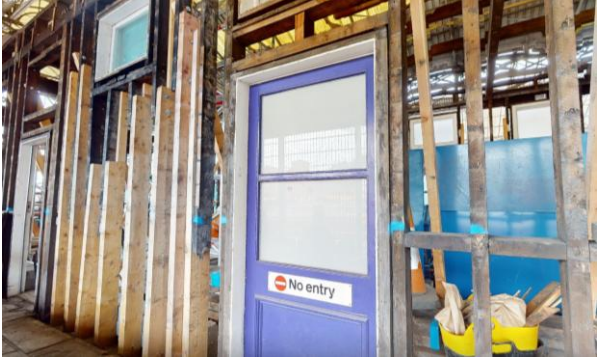
<p>08</p>	<p>Studwork – Later and poorly repaired studwork will be replaced with new timberwork to match existing.</p>

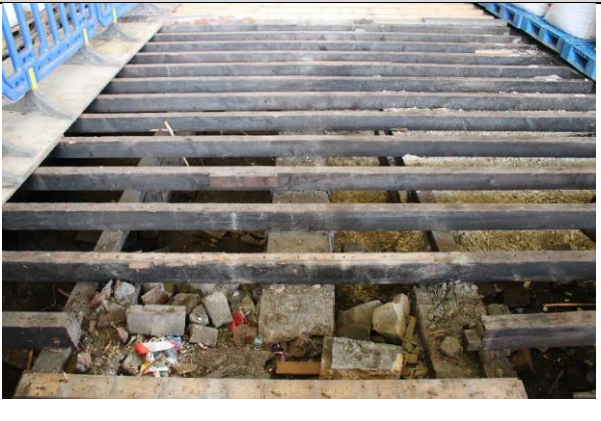
<p>Internal Structure</p>		
<p>Ref</p>	<p>Item Description</p>	<p>Photograph</p>
<p>09</p>	<p>Floor joists – to be replaced with new. (The retained original floor joists to be re-purposed for timber floor battens within new floor construction).</p> <p>Note: The photograph opposite shows the only area of original joists that were discovered in the building. (Approx 20% of the total building footprint).</p>

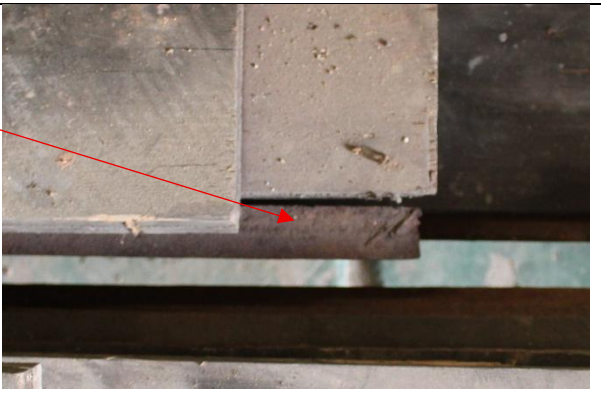
<p>10</p>	<p>Corroded metal tongues to timber floor boards – The original timber floor boards have been salvaged for re-use. However, it is not possible to retain the ferrous tongues to the boards as these have corroded.</p> <p>The floor boards will be re-used in the café with replacement steel tongues.</p>

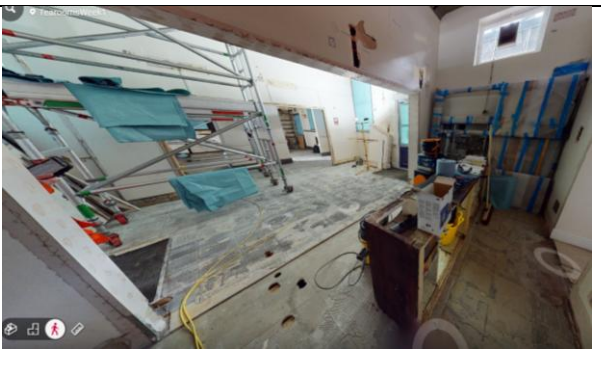
<p>11</p>	<p>Floor – The plywood and chipboard boarding together with existing finishes will be replaced with new.</p>

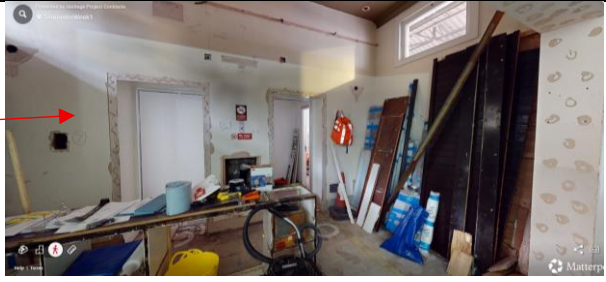
<p>12</p>	<p>Internal partitions – All internal partitions were found to be modern and most likely installed as part of the 2005 refurbishment. These will be replaced.</p> <p>Note: This includes modern skirting boards, architraves, internal doors and door frames.</p>

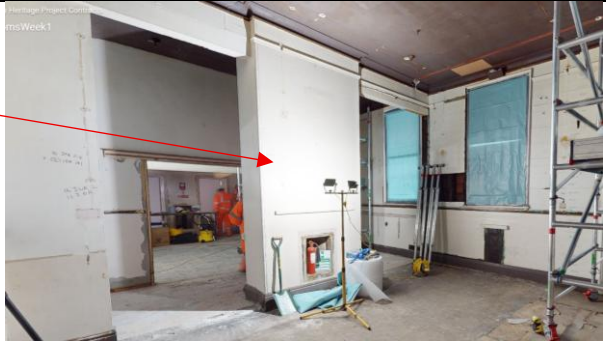
<p>13</p>	<p>Internal masonry wall – All masonry walls including chimney breasts will be replaced.</p>

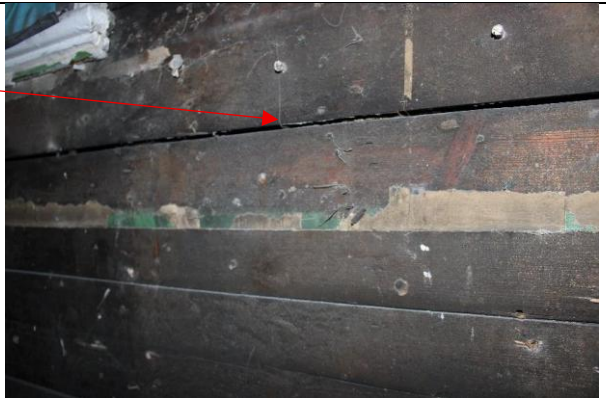
<p>14</p>	<p>Plain butt-jointed cladding boards – The boarding removed from the interior of external walls will be replaced with new boarding.</p> <p>Note: The boarding is in a poor condition with much loss through adaption of the building interiors.</p>

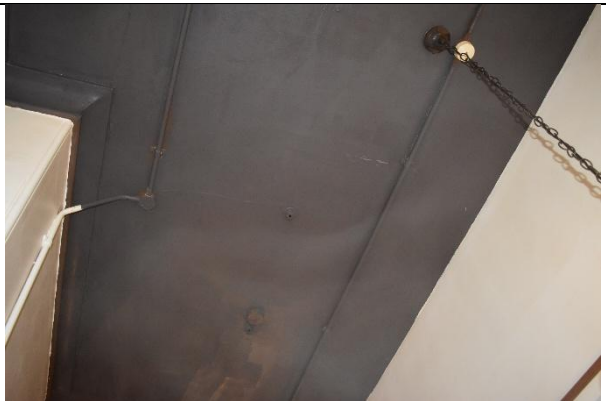
<p>15</p>	<p>Plaster Ceiling – The original lath and plaster ceiling will be replaced with a plasterboard ceiling construction which can incorporate access hatches for the services above.</p> <p>The original cornice profile will be replicated in a fibrous plaster.</p>

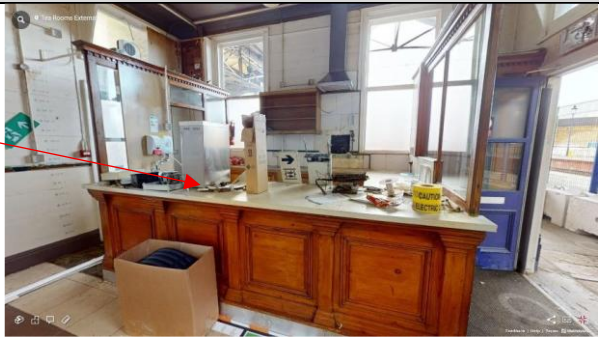
Ref	Item Description	Photograph
16	Buffet Counter – the buffet counter was a modern chipboard work surface marked “2005” and will be replaced.

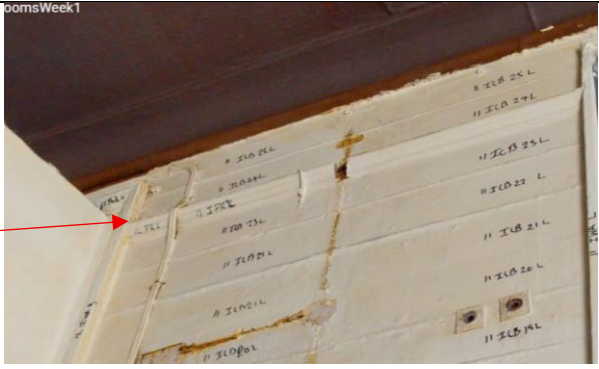
17	Timber Mouldings – Picture Rail Sections of the original picture rails were present in the café area. These will be used to replicate additional timber section to replace sections where missing. Original Picture Rail

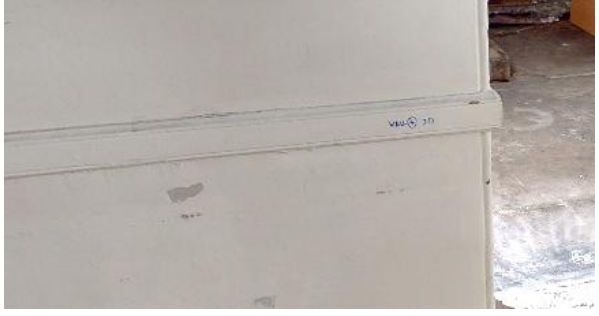
18	Timber Mouldings – Dado Rail Sections of the original dado rails were present in the café area together with later replacement sections. The original section profiles will be used to replicate the original dado rails where missing. Note: Original dado section discovered to the rear of the chimney breast.

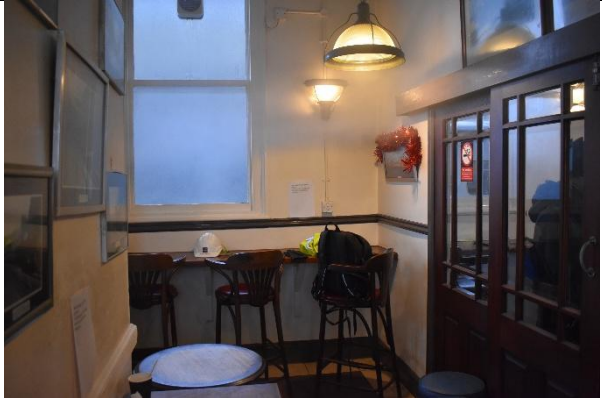
Ref	Item Description	Photograph
20	<p>All internal finishes will be replaced.</p> <p>This includes:</p> <ul style="list-style-type: none"> • Painted wall, floor and ceiling finishes. • Ceramic Tiles • Matt wells • Vinyl floor tiles <p>Note: None of the original finishes with the exception of paint finishes were discovered in the building. For details of the original paint finishes please see details of the Paint Analysis which is included within the Site Findings Report.</p>
