Dismantling Methodology – Part 2a / 2b Item 4.4 – Record of external and internal elements that are not to be retained.

The following schedule updates the indicative schedule noted in the Arup Methodology Document Ref: 151667-TSA-30-MVL3-REP-A-AR-012001 (HUDDERSFIELD STATION - Methodology for deconstructing, storing and reconstructing the Tea Rooms. (Issue 03 – 21/01/26).

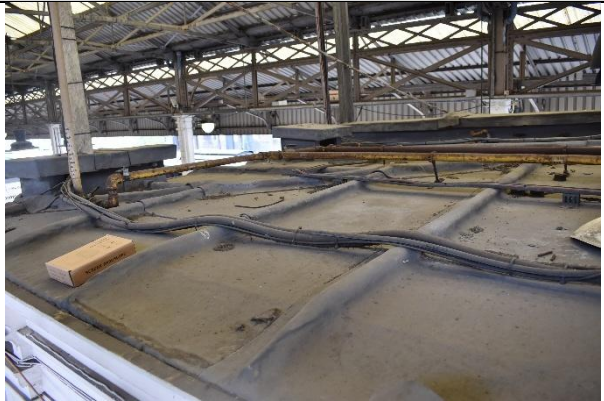
Building External		
Ref	Description	Photograph
Roof – 01	<p>Lead sheet roofing – not to be retained. To be replaced with zinc roofing. This is to include the raised cable entry points and service supports.</p> <p>Note: The lead roofing is not original to the construction of the Tea Rooms it is believed to have been a later replacement of the original zinc roof which was replaced in the 1980’s.</p>

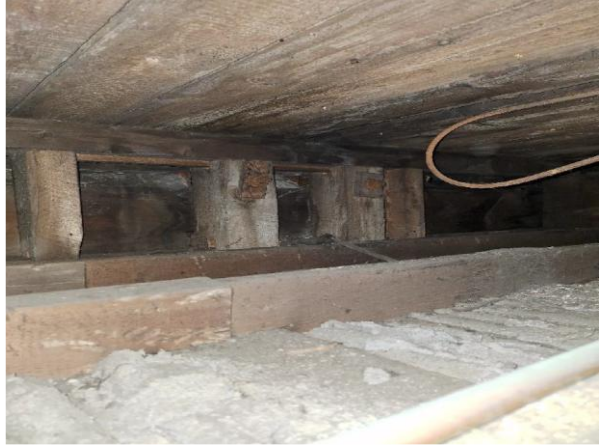
Roof – 02	<p>Sarking Boards – not to be retained. The existing sarking boards were salvaged from the building for possible re-use. Unfortunately, the timber cannot achieve the strength requirements of the proposed roof construction. All sarking boards are to be replaced with a structural plywood material which will provide the required rigidity to the Tea Rooms structure.</p>

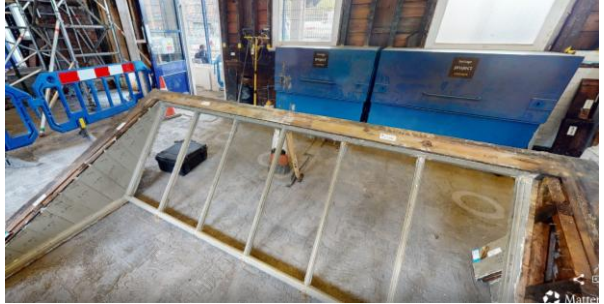
Roof – 03	<p>Roof lantern Glazing Bars – not to be retained. The glazing bars of the roof light are in poor condition and were damaged as a result of an earlier re-glazing. These are to be replaced with replica mouldings.</p> <p>All other elements of the timber rooflight have been salvaged and will be reused.</p> <p>The glass to the rooflight will also be replaced to provide a clear glass appearance rather than the modern “wired” glass that was present.</p>

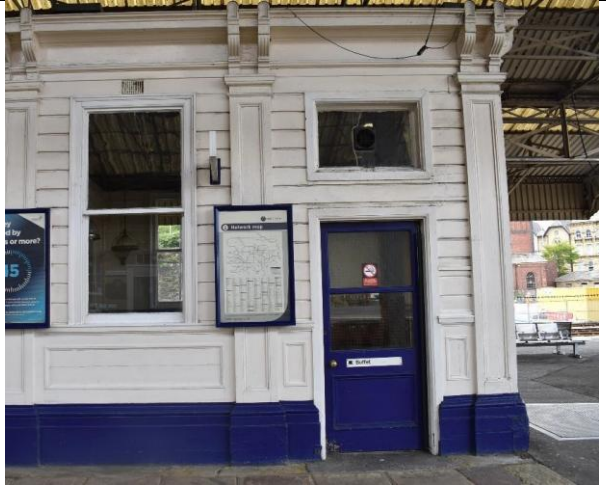
Ref	Description	Photograph
External – 04	<p>External Doors – not retained. The existing external doors were salvaged from the building for possible re-use. However, the doors have been identified as being a later adaption of the building (possibly in 2005) and do not follow the original historic appearance. Due to steeper slope of new platform, the doors will need to vary in height in order that the level thresholds match the new platform levels. All doors are to be replaced with new door sets that match the original appearance of the historic doors – glass to be fitted in the upper panel sections to meet Building Control requirements. This will include new ironmongery, hinges and where necessary, actuators.</p>

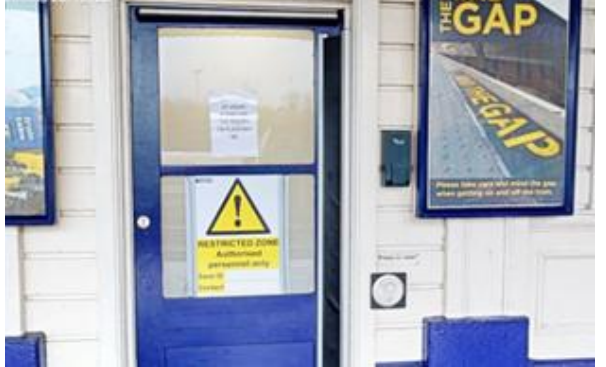
External – 05	<p>Door ironmongery – not retained.</p> <p>Push buttons, hinge guards, modern ironmongery and Radar locks are not to be retained.</p> <p>Modern signage will also not be retained.</p>

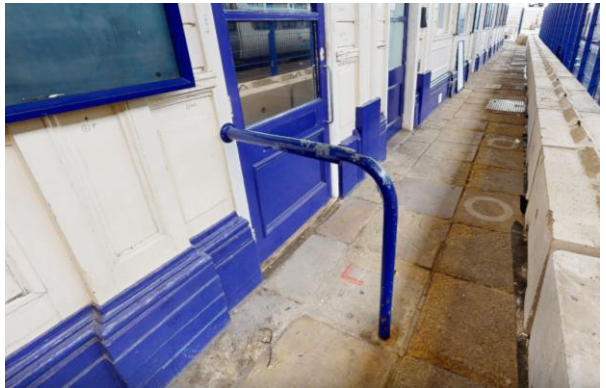
External – 06	<p>Handrail – not retained.</p> <p>Modern galvanized steel handrail fitted to the door architrave. Not to be retained.</p>

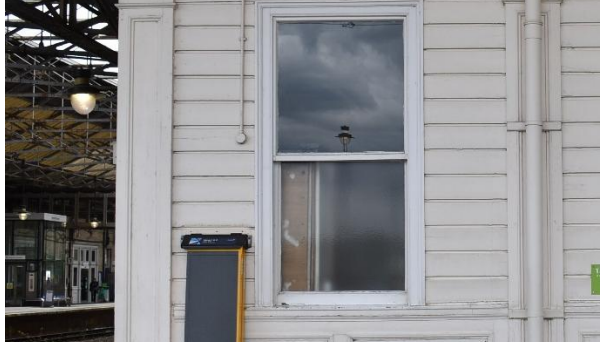
External – 07	<p>Glazing to windows and doors – not retained. The glazing to the sash, pivot and external doors will be replaced with a new laminated glass to meet Building Regulation approval.</p> <p>Internal sash vents and ironmongery will also be replaced.</p>

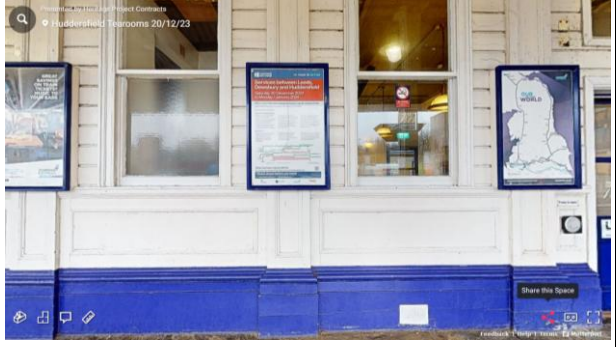
<p>External – 08</p>	<p>Poster board frames – not to be retained. The frames are a modern display system and will not be retained.</p> <p>A number of historic posters were discovered behind these frames which have been retained.</p>

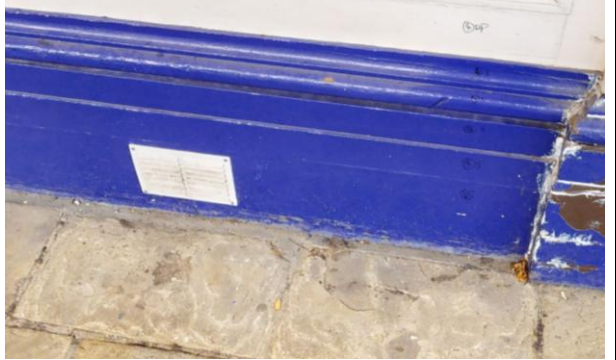
<p>External – 09</p>	<p>Plastic vent grilles – not retained.</p> <p>The plastic vent grilles are a modern item possibly replacing an earlier grille (not present). As the floor construction will be a raft rather than suspended timber ventilation will not be required and all holes will be infilled.</p>

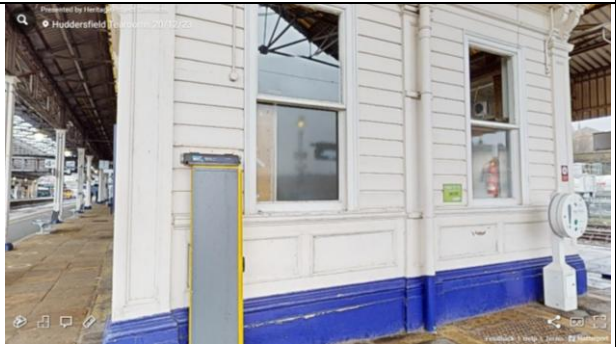
<p>External – 10</p>	<p>Conduits and cables – not retained.</p> <p>Ramp – not retained.</p> <p>SVP – not retained.</p> <p>Call point – repositioned by BAM.</p>

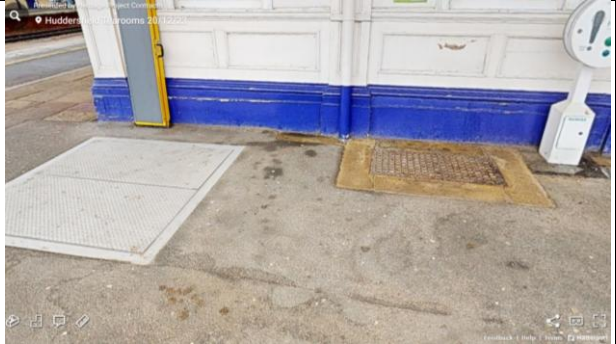
<p>External – 11</p>	<p>Beer cellar doors – not retained.</p> <p>Note: The Pavement Light has been salvaged for possible re-use.</p>

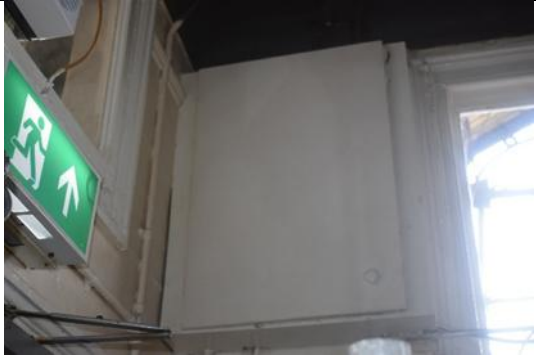
Ref	Description	Photograph
Café – 12	<p>Electrical boxing (modern) - Not retained.</p> <p>Modern electrical boxing (plywood construction) incorporating fuse box. New boxing to be provided to fit with new café layout.</p>

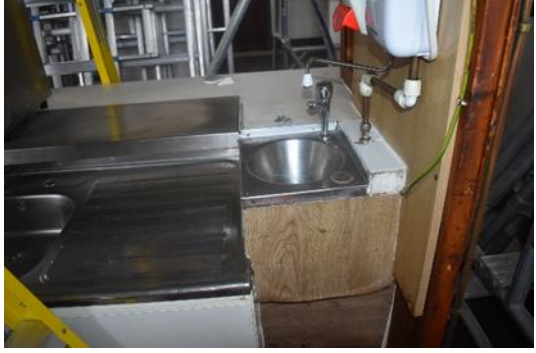
Café – 13	<p>Counter sink inc handwash (modern) – not retained.</p> <p>Modern counter top – not retained.</p> <p>Modern cupboards behind counter – not retained.</p> <p>All items are modern fittings and will not be retained.</p>

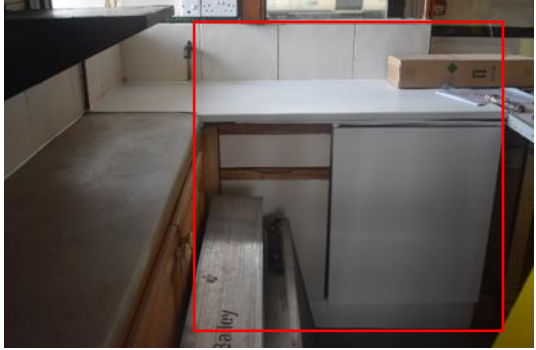
Café – 14	<p>Kitchen units (modern) – not retained.</p> <p>Note: to include the ceramic tile upstand.</p>

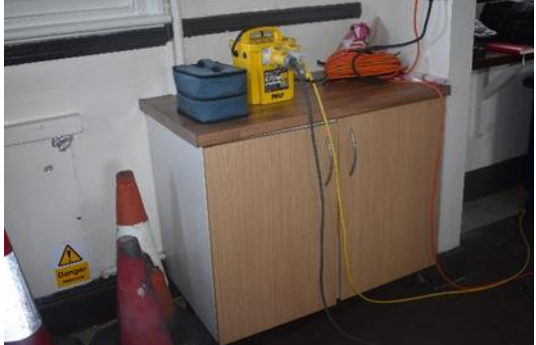
Café – 15	<p>Cupboard (modern) – not retained.</p>

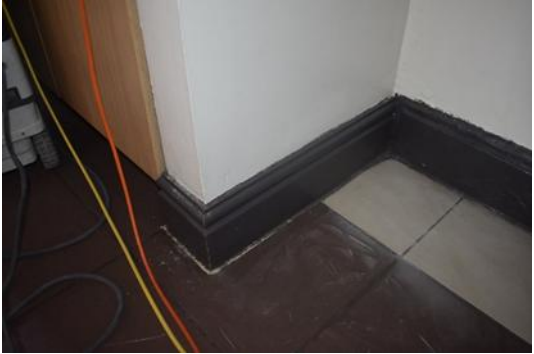
<p>Café – 16</p>	<p>Modern skirting boards to partitions – not retained.</p> <p>Skirting is similar but slightly smaller than original profile.</p> <p>Note: Sample of all modern skirtings to be retained for record purposes.</p>

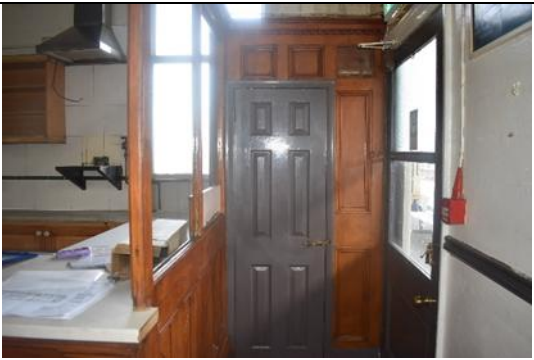
<p>Café – 17</p>	<p>Modern door to cupboard – not retained.</p> <p>Note: Door is a modern replacement. Screen to be retained for future use.</p>

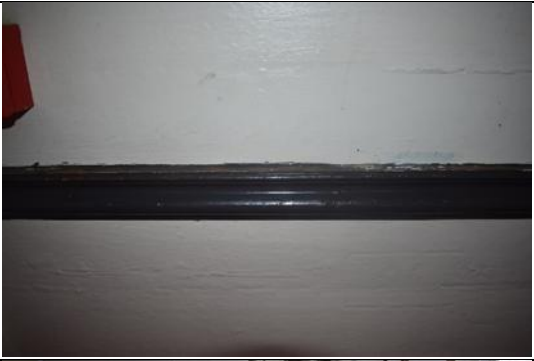
<p>Café – 18</p>	<p>Modern timber dado fitted to partitions and internal wall areas – not retained.</p> <p>Note: Sample to be taken from each of the modern dado rails for future reference.</p>

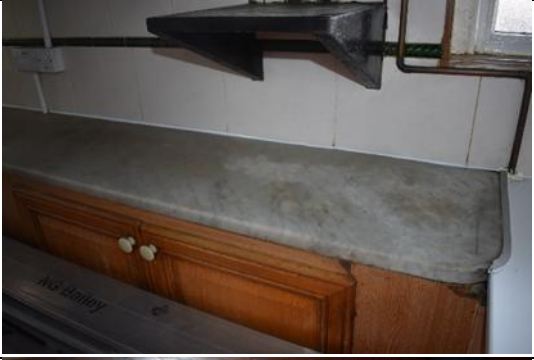
<p>Café – 19</p>	<p>Modern doors to rear cabinets – not retained.</p> <p>Note: Marble counter top and shelving behind are to be retained.</p>

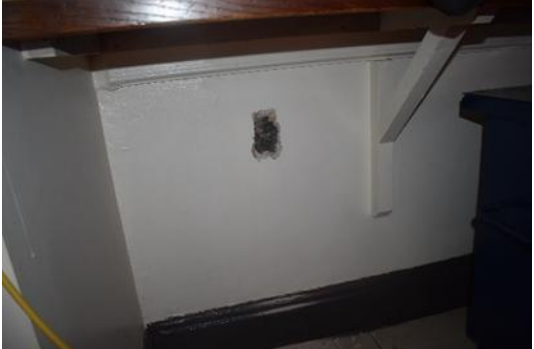
<p>All Areas - 20</p>	<p>Modern plasterboard / plywood linings to wall areas – not retained.</p> <p>Plywood and plasterboard has been fitted to line out the interior wall areas. Most of this is believed to have been fitted as part of the 2005 refurbishment.</p>

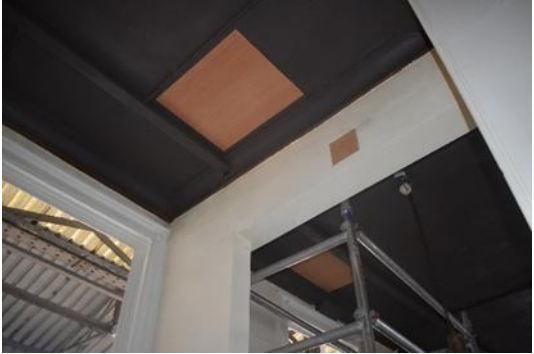
<p>All Areas – 21</p>	<p>Modern boxings (false beam) – not retained.</p>

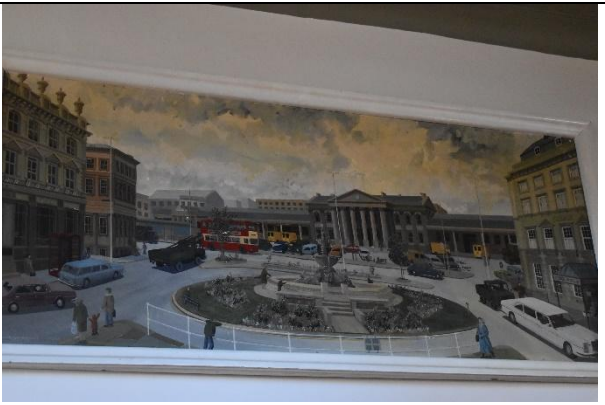
<p>All Areas – 22</p>	<p>Modern Painting – not retained. Removed by Network Rail in advance of the project works.</p>

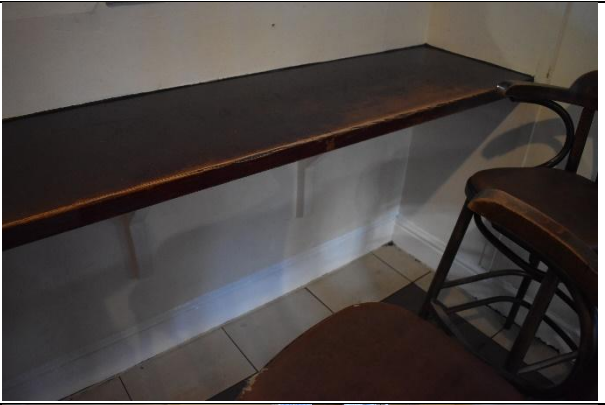
<p>All Areas – 23</p>	<p>Modern wooden counter – not retained. Counters are modern elements fitted as part of the 2005 building refurbishment.</p>

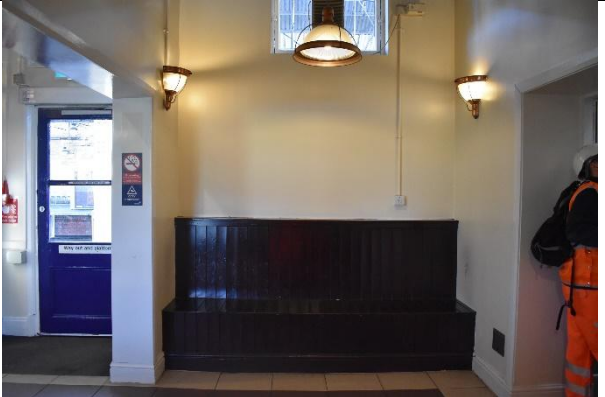
<p>All Areas – 24</p>	<p>Modern wall cladding – not retained. Plasterboard cladding to wall areas fitted as part of the 2005 building refurbishment. Note: Seating to be dismantled into sections / components for possible re-use.</p>

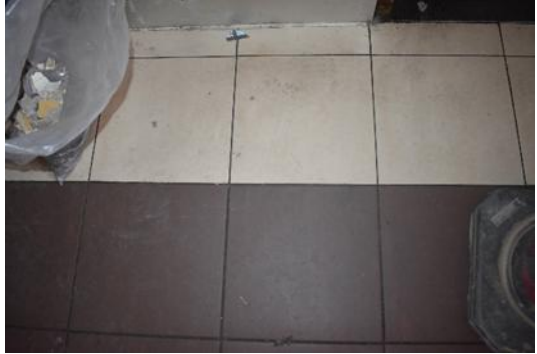
<p>All Areas - 29</p>	<p>Ceramic tiles (Except for samples for record purposes as noted in 4.6 – not retained.</p>

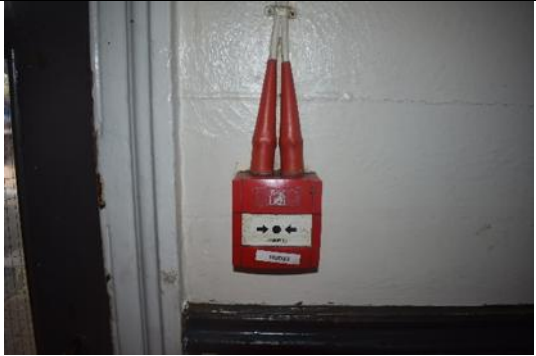
Mechanical and Electrical Systems		
Ref	Description	Photograph
All Areas – 33	<p>Modern fire prevention systems – not retained.</p> <p>All Fire Systems will be new to meet current standards.</p>

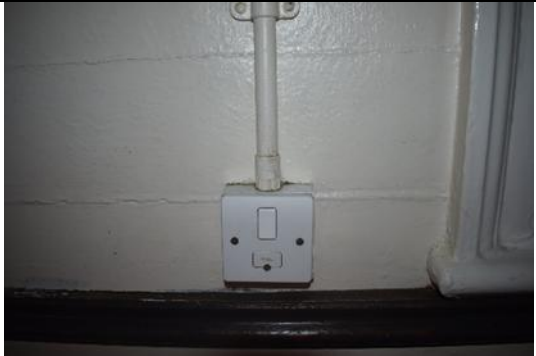
All Areas – 34	<p>Modern electrical distribution systems – not retained.</p> <p>Note: Screws to be unscrewed from all areas of face finished timber cladding where possible.</p> <p>All electrical systems will be new to meet current standards. With cable routes hidden where possible</p>

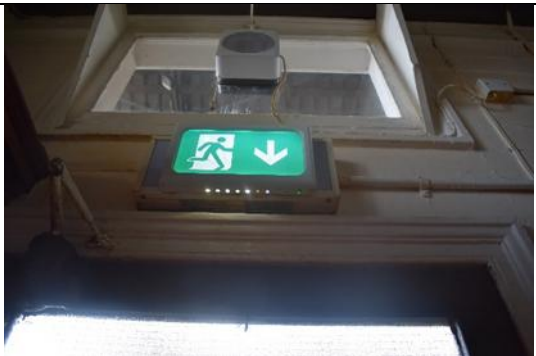
All Areas - 35	<p>Modern emergency lighting / escape signage – not retained.</p> <p>All to be replaced with new systems to meet station requirements.</p>

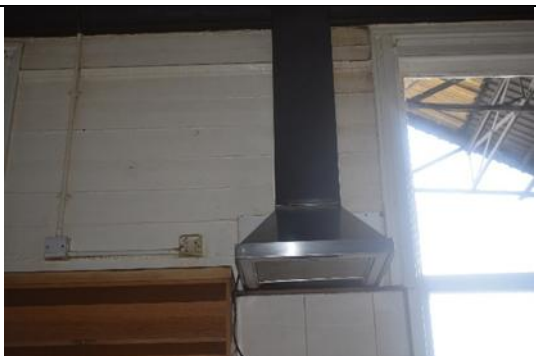
Cafe – 36	<p>Modern kitchen extract – not retained.</p> <p>New extract systems to be provided to meet café requirements.</p>

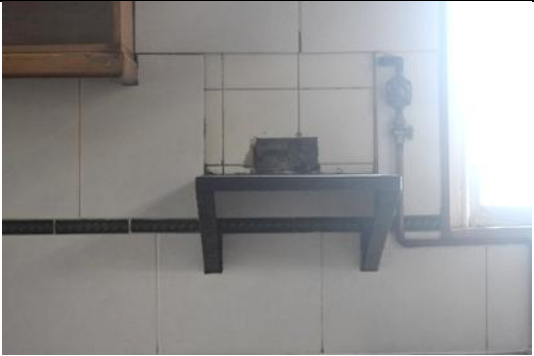
<p>Cafe – 37</p>	<p>Modern stand for grille and gas pipe connection – not retained.</p> <p>New café equipment to be provided to meet café requirements.</p>

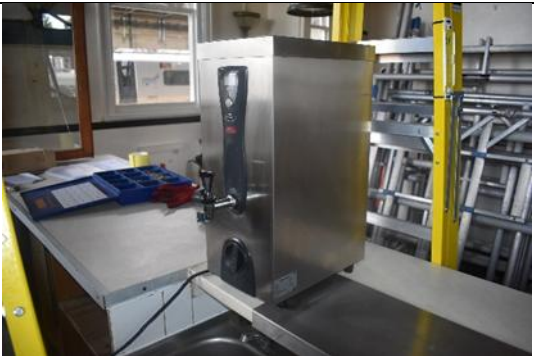
<p>Café – 38</p>	<p>Modern water boiler – not retained.</p> <p>Removed by Network Rail ahead of the project works.</p>

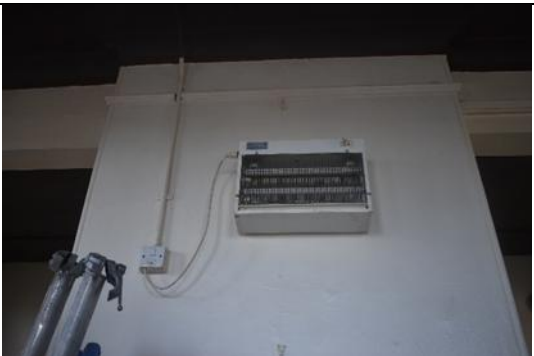
<p>Café – 39</p>	<p>Modern insect killer – not retained.</p>

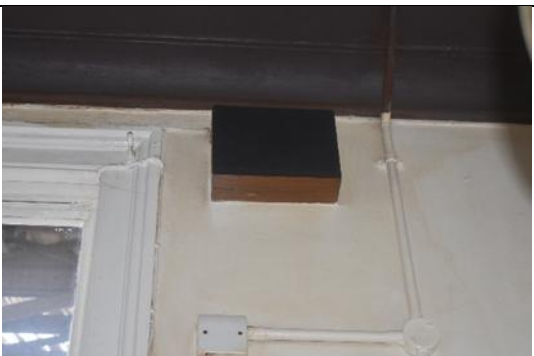
<p>All Areas - 40</p>	<p>Modern PA speakers – not retained.</p>

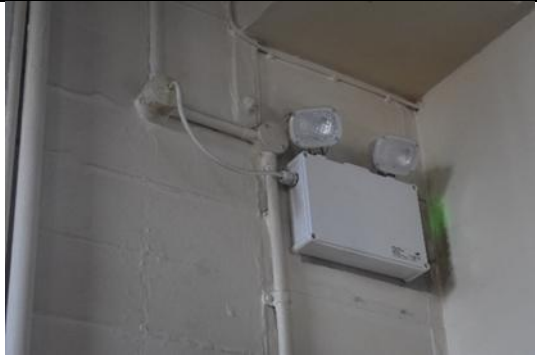
<p>All Areas – 41</p>	<p>Modern emergency lighting inc cabling and conduits – not retained.</p>

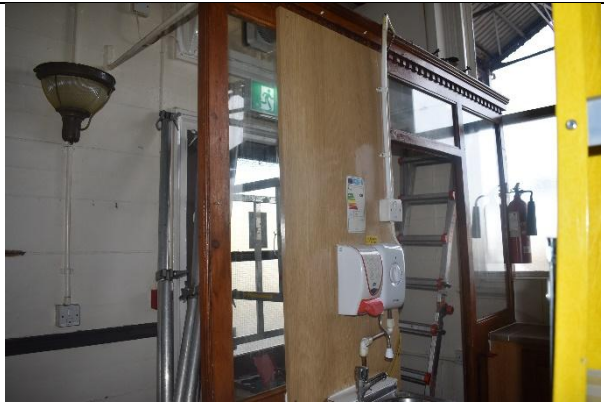
<p>Café – 42</p>	<p>Modern services and timber panel fixed to heritage screen element – not retained.</p> <p>Note: Care required to remove all services and timber boarding adjacent to the heritage screen and glazing.</p>

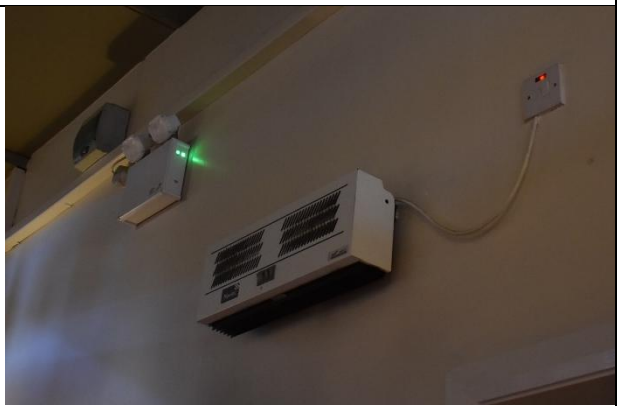
<p>All Areas – 43</p>	<p>Modern heaters – not retained.</p> <p>New heating systems will be provided to meet the café / waiting room requirements.</p>

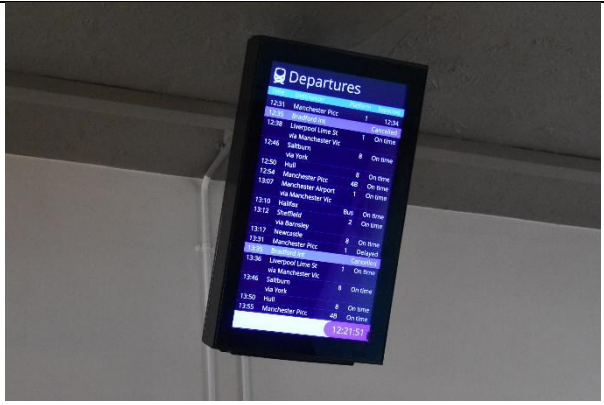
<p>All Areas - 44</p>	<p>Modern train departure screen – not retained</p> <p>Removed by Network Rail ahead of the project works. New information systems to be provided to meet waiting room requirements.</p>

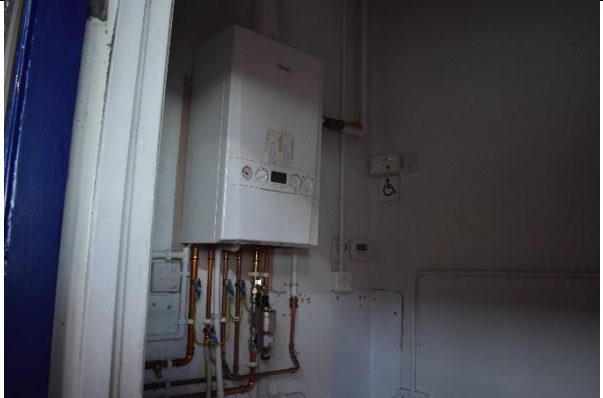
<p>All Areas – 45</p>	<p>Information point – not retained.</p> <p>Removed by Network Rail ahead of the project works.</p>	 
<p>All Areas – 46</p>	<p>Modern sink, tap, and soap dispenser – not retained.</p> <p>Modern tiles on wall – not retained.</p> <p>Modern w/c's including partitions – not retained.</p>	 
<p>Boiler Room – 47</p>	<p>Modern boiler – not retained.</p> <p>New heating systems will be provided which are electrically powered.</p>

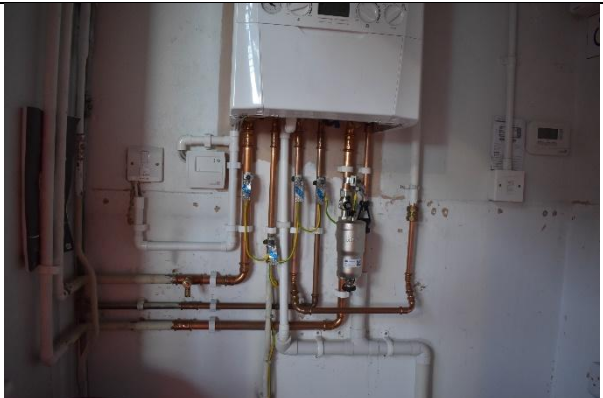
<p>Boiler Room – 48</p>	<p>Copper pipes for boiler – not retained.</p> <p>Ditto.</p>

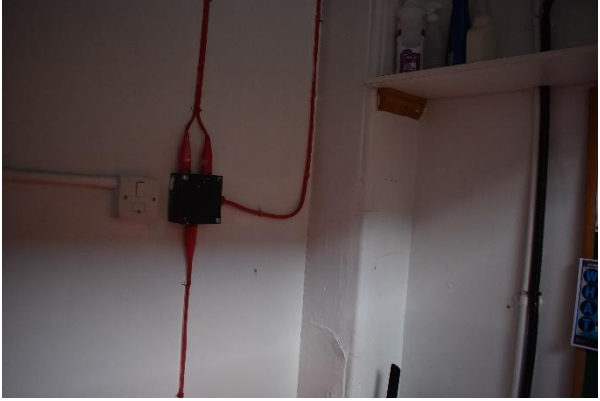
<p>Boiler Room – 49</p>	<p>Modern services within the boiler room – not retained.</p> <p>New services to be provided to meet the waiting room and café requirements.</p>

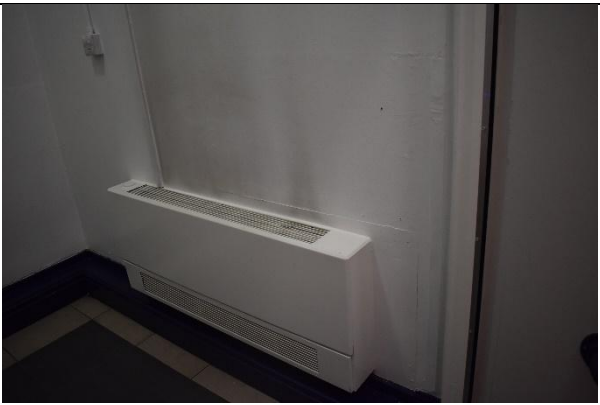
<p>All Areas – 50</p>	<p>Modern radiator inside disabled toilets – not retained.</p> <p>New heating systems will be electrically powered radiators.</p>
