## GOMERSAL ST MARYS PRIMARY SCHOOL

### Sustainable Drainage Strategy

Hexa ref: SRP1134-HEX-XX-XX-T-C-0001

Revision: P02

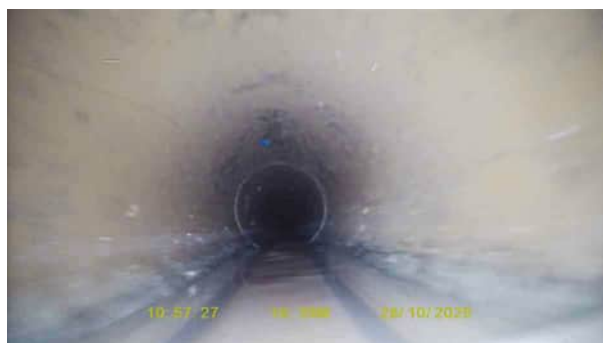
FW3X\_ee52754c-29d2-4ad9-82b1-c68fedff838d\_20251105\_132852\_886.jpg, 00:01:15, 19.30 m  
Crack, longitudinal at 10 o'clock

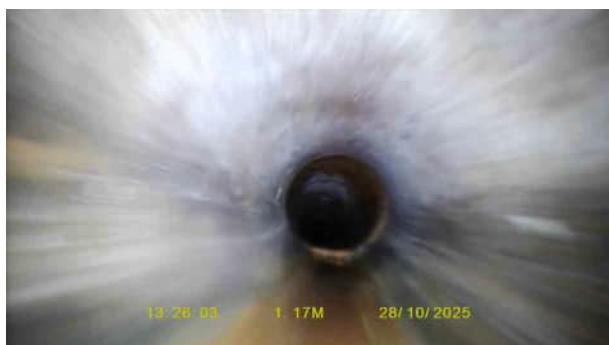
FW10X\_c054f2e3-c390-4d55-a0b2-094de3b03151\_20251112\_092657\_521.jpg, 00:00:07, 1.70 m  
Crack, circumferential from 12 o'clock to 12 o'clock

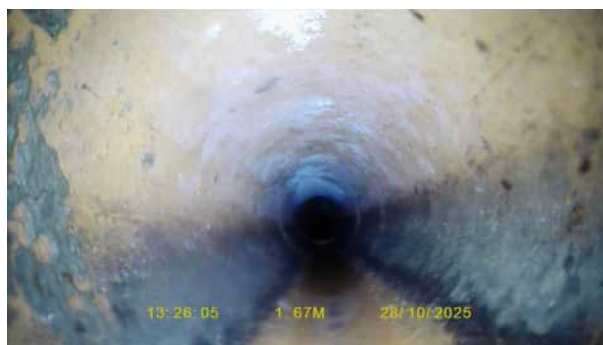
FW10X\_074f6830-182c-4b8e-9ccb-f210aa70bb9e\_20251112\_092814\_001.jpg, 00:00:09, 2.50 m  
Crack, circumferential from 12 o'clock to 12 o'clock

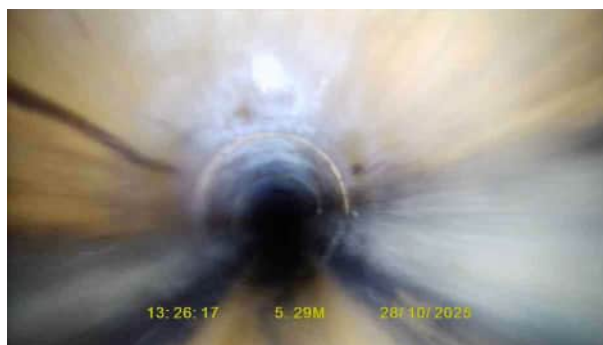
FW10X\_25132659-a6d9-47d5-86e5-cdcfbf520643\_20251112\_093850\_013.jpg, 00:00:20, 5.60 m  
Crack, circumferential from 12 o'clock to 12 o'clock

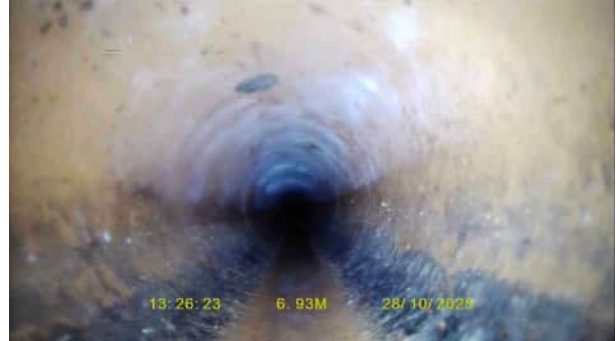
FW10X\_def1cc6c-2b96-405c-a940-7b1131057b74\_20251112\_094113\_288.jpg, 00:00:27, 7.80 m  
Crack, circumferential from 12 o'clock to 12 o'clock

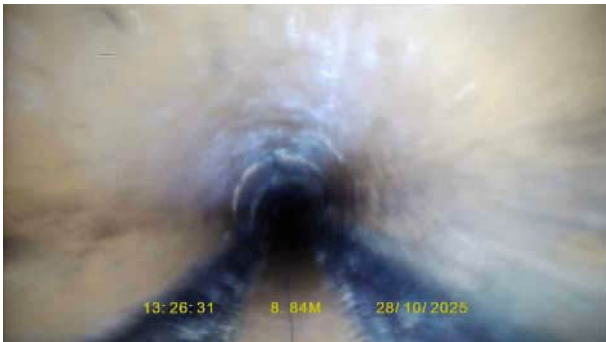
FW10X\_330f6a9a-05a9-4ac3-b717-c846faa110f7\_20251112\_094539\_645.jpg, 00:00:34, 8.90 m  
Crack, longitudinal at 5 o'clock

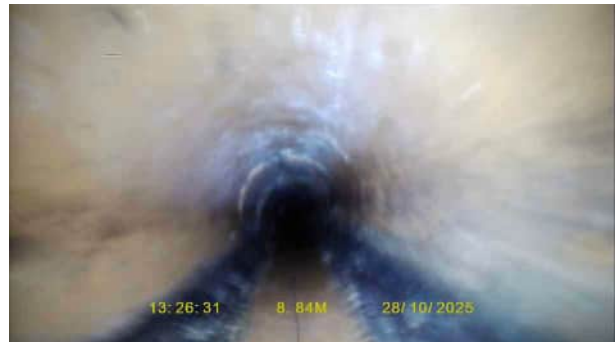
FW10X\_077355ee-fb3b-4b52-b57b-9b671e513dc4\_20251112\_094606\_908.jpg, 00:00:34, 8.90 m  
Crack, longitudinal at 7 o'clock

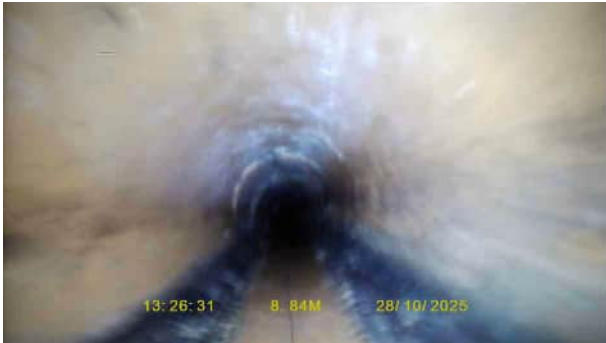
FW10X\_489b6e79-5db5-4ef5-a0f8-95d66fbbe097\_20251112\_094659\_471.jpg, 00:00:34, 8.90 m  
Crack, longitudinal at 12 o'clock

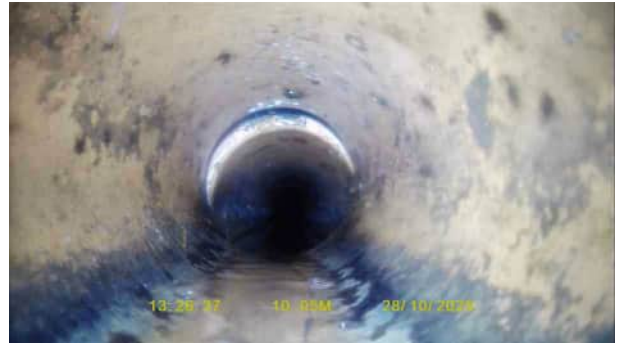
FW10X\_35fc7b96-006a-4807-9626-0c2ef77b51d7\_20251112\_094753\_344.jpg, 00:00:40, 10.20 m  
Joint displaced, large

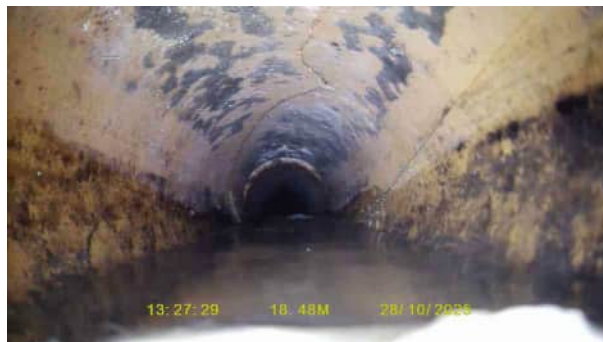
| Section | PLR | Grade | Description |
|---|---|---|---|
| 8 | FW10X | 3 | Cracks, spiral from 9 o'clock to 12 o'clock |

FW10X\_392efeec-5fbf-4afe-8198-d4e8d0fd9419\_20251112\_101920\_471.jpg, 00:01:32, 18.65 m  
Cracks, spiral from 9 o'clock to 12 o'clock

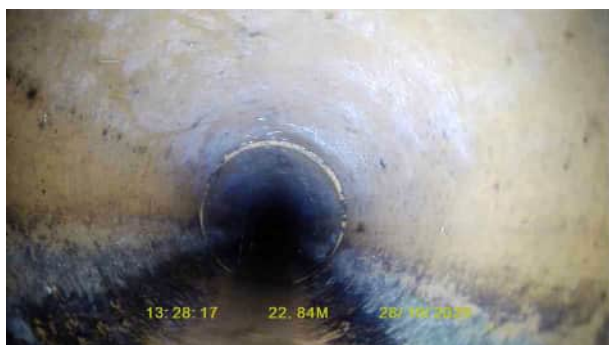
FW10X\_8cb0f7d3-f8f3-4a77-9922-20841c327a18\_20251112\_103149\_500.jpg, 00:02:20, 23.30 m  
Joint displaced, medium

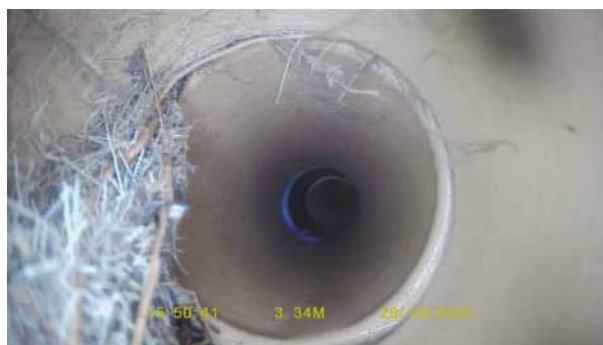
| Section | PLR | Grade | Description |
|---|---|---|---|
| 16 | F16X | 3 | Cracks, spiral at joint from 7 o'clock to 11 o'clock |

F16X\_055a04e2-d450-4994-b564-6fbf0796fd2d\_20251120\_094943\_303.jpg, 00:00:17, 3.40 m  
Cracks, spiral at joint from 7 o'clock to 11 o'clock

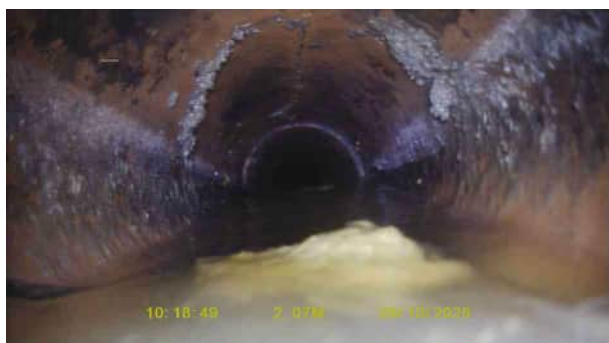
FW11X\_f4fa0d8a-fa89-4324-a3b1-3c5d7799767d\_20251120\_113918\_841.jpg, 00:00:10, 2.10 m  
Crack, longitudinal at joint at 12 o'clock

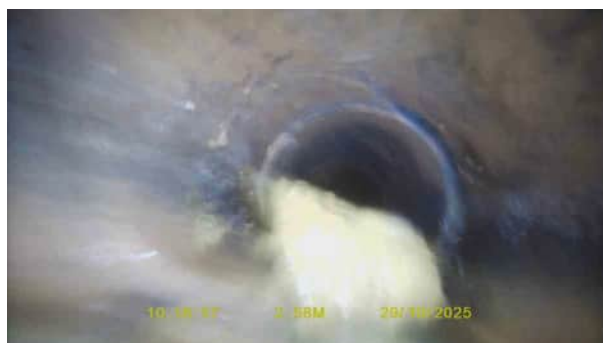
| Section | PLR | Grade | Description |
|---|---|---|---|
| 20 | FW11X | 4 | Fracture, spiral from 10 o'clock to 8 o'clock |

FW11X\_6a9dff3-148d-45b8-b387-6fbfaa13c859\_20251120\_114008\_688.jpg, 00:00:18, 2.30 m  
Fracture, spiral from 10 o'clock to 8 o'clock

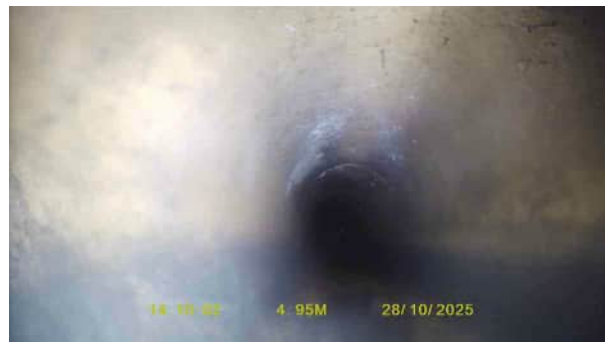
SW7X\_ced3cadb-0bb5-4313-9763-cc7a7c42bef9\_20251112\_145649\_468.jpg, 00:00:23, 5.40 m  
Crack, circumferential from 12 o'clock to 12 o'clock

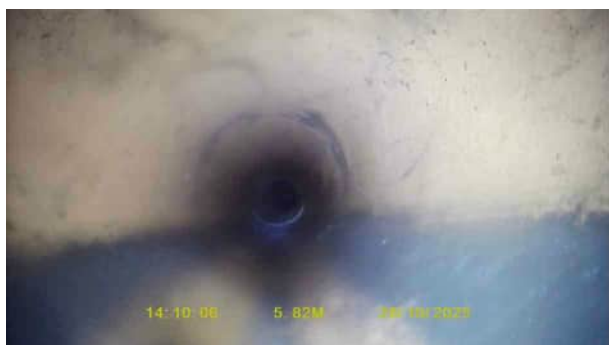
SW7X\_079cd011-9634-4749-aeb6-94feb0fdc26\_20251112\_145956\_410.jpg, 00:00:26, 6.20 m  
Crack, circumferential from 12 o'clock to 12 o'clock

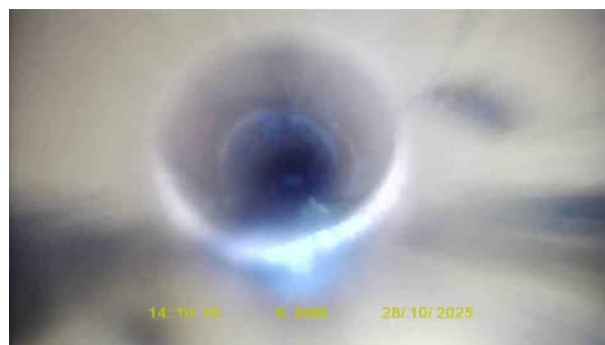
SW7X\_607232eb-aa84-48b9-8e56-52da56959268\_20251112\_150450\_649.jpg, 00:00:30, 7.00 m  
Joint displaced, large

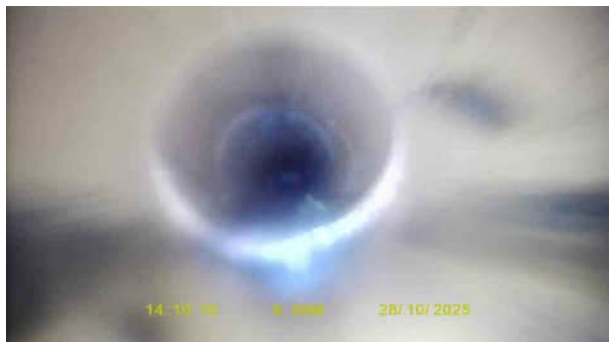
SW7X\_166bd7a7-3827-45ca-9213-111b38a73bc2\_20251112\_150617\_885.jpg, 00:00:30, 7.10 m  
Crack, circumferential from 12 o'clock to 12 o'clock

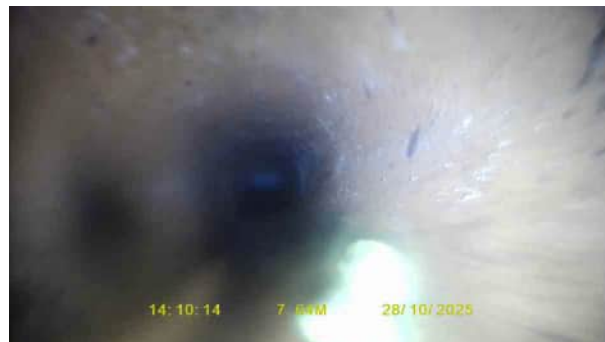
| Section | PLR | Grade | Description |
|---|---|---|---|
| 7 | SW7X | 3 | Cracks, spiral from 12 o'clock to 12 o'clock |

SW7X\_caea7f4e-565c-40fa-838f-788255641e35\_20251112\_150945\_664.jpg, 00:00:35, 8.20 m  
Cracks, spiral from 12 o'clock to 12 o'clock

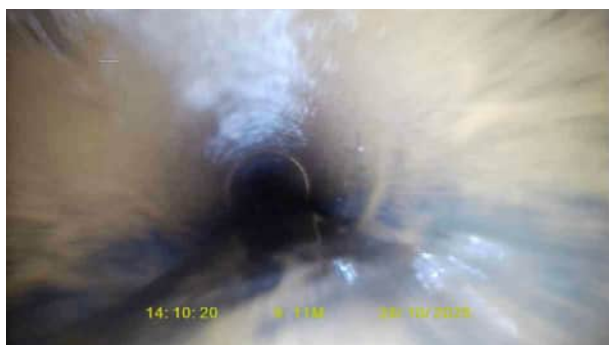
SW7X\_3fc92219-8920-4a3a-a375-ff03a9f21cbc\_20251112\_152551\_534.jpg, 00:00:41, 9.60 m  
Joint displaced, medium

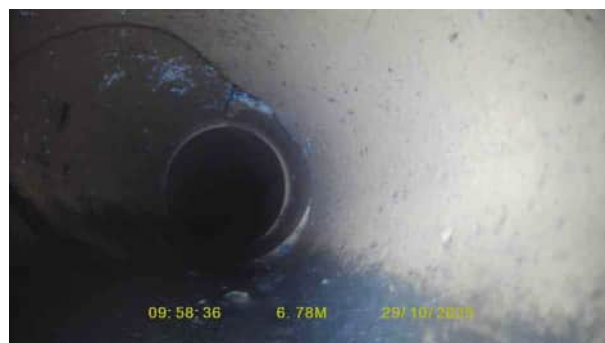
| Section | PLR | Grade | Description |
|---|---|---|---|
| 14 | SW8X | 3 | Fracture, circumferential at joint from 12 o'clock to 12 o'clock |

SW8X\_106a91c9-6d69-4953-8b4d-d6b8dc7cecd\_a\_20251120\_110445\_438.jpg, 00:00:27, 7.00 m  
Fracture, circumferential at joint from 12 o'clock to 12 o'clock

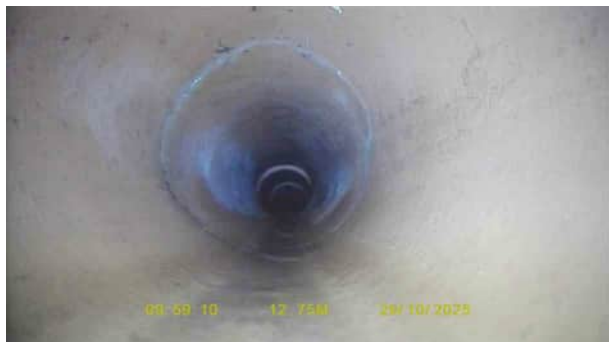
SW8X\_1e420b4b-68cd-4a27-bdd6-f47a0e51f55b\_20251120\_111411\_622.jpg, 00:01:00, 12.90 m  
Crack, circumferential from 12 o'clock to 12 o'clock

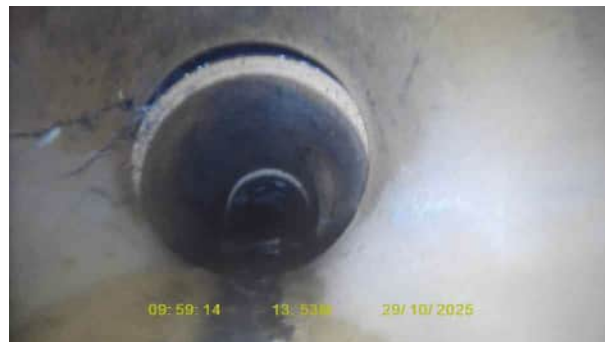
SW8X\_69134f3b-dfb0-48c4-a638-60a7a5ee793f\_20251120\_12009\_894.jpg, 00:01:05, 13.80 m  
Joint displaced, large

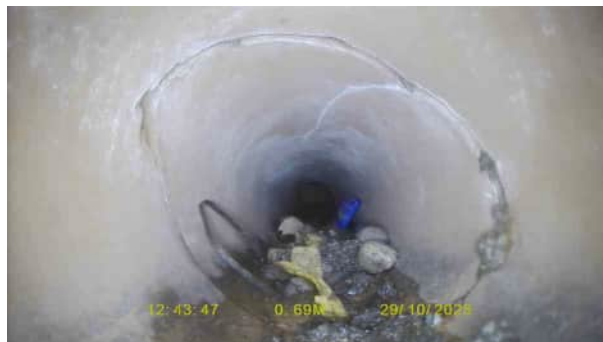
| Section | PLR | Grade | Description |
|---|---|---|---|
| 27 | S27X | 3 | Fracture, circumferential from 7 o'clock to 5 o'clock |

S27X\_75b41ab2-d5f4-4b5d-b5e1-61a0704ed9ac\_20251120\_1  
141706\_698.jpg, 00:00:06, 0.70 m  
Fracture, circumferential from 7 o'clock to 5 o'clock
