# Site Investigation Report

## Overview

Auger were commissioned by Crawford & Co to undertake a site investigation and CCTV inspection of the underground drainage within the area of concern (AOC) at the property.

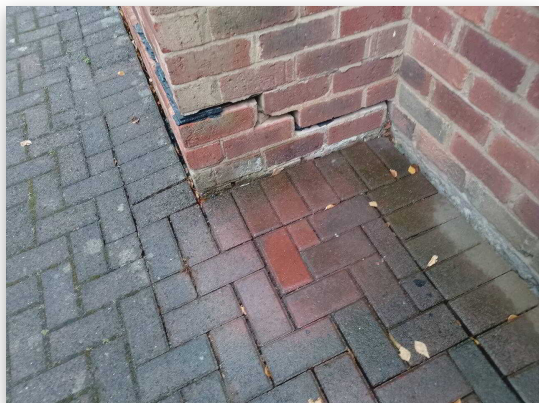
Fig 1.1: Trial Hole 1 Location

TH1 was completed in the proposed location and revealed the footing. Soil and root samples were taken.

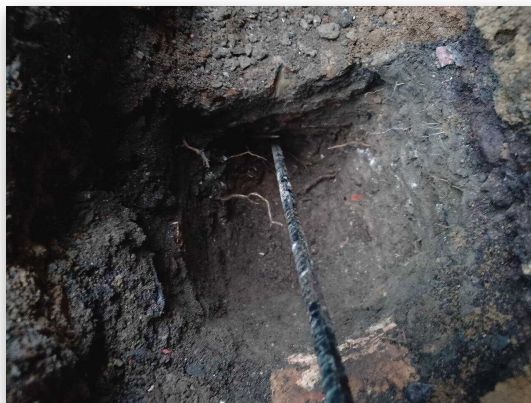
Fig 1.2: Trial Hole 1 Footing

Depth (m)	Symbolic Log	Strata Description	Insitu Tests		Soil Sample	Root Sample
			SV(19)			
0.0		Ground Level Block Paving Brickwork Concrete				
0.5		Very dry very stiff brown fine gravelly silty CLAY	98kpa		Soil @ 0.5m	Root @ 0.5m
1.0			102kpa		Soil @ 1m	Root @ 1m
1.5			104kpa		Soil @ 1.5m	
2.0			112kpa		Soil @ 2m	
2.5		Dry very stiff brown silty CLAY	130kpa		Soil @ 2.5m	
3.0		TRIAL HOLE TERMINATED	122kpa

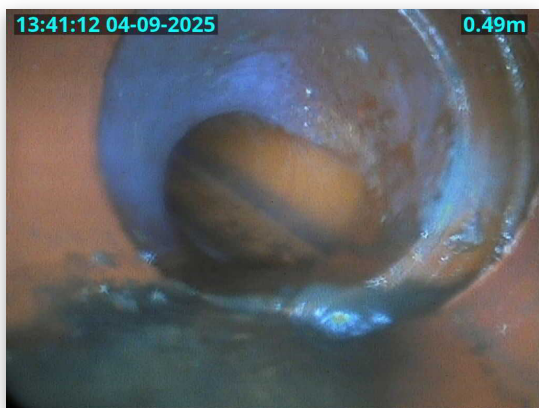
Our survey of line 4 revealed joint displacements.

Fig 2.1: Line 4 Displacement

0.1m	Joint Displacement - Medium
0.5m	Joint Displacement - Large
0.7m	Finish of Survey Length (LINE3)

Excavate and replace RWG1 and 1m of 100mm pipework including a branch connection at a depth no greater than 1.0m through block paving.

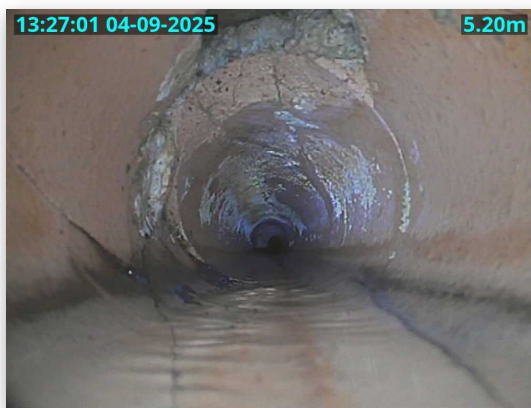
Our survey of line 2 revealed fractures.

Fig 2.2: Line 2 Fracture

4.4m	Finish of Survey Length (OUT OF AOC )
5.2m	Fracture - Multiple
5.2m	H

Install a 100mm patch liner approximately 5.3m upstream of MH1.
