Arboricultural Appraisal Report

Subsidence Damage Investigation at:

51 Penistone Road
Fenay Bridge
Huddersfield
HD8 0AW

CLIENT: Crawford & Company
 CLIENT REF:
 MWA REF:
 MWA CONSULTANT: John Graham B.Sc. Hons PhD
 REPORT DATE: 24/10/2025

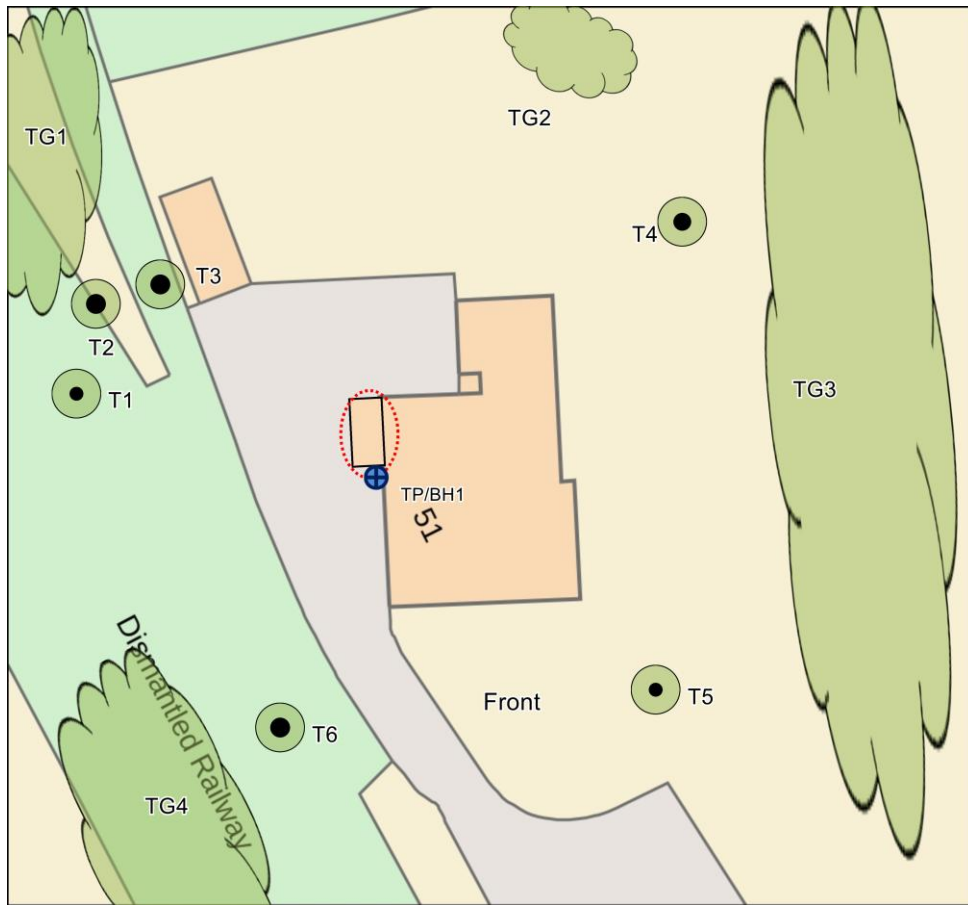
Site Plan

Approximate areas of damage

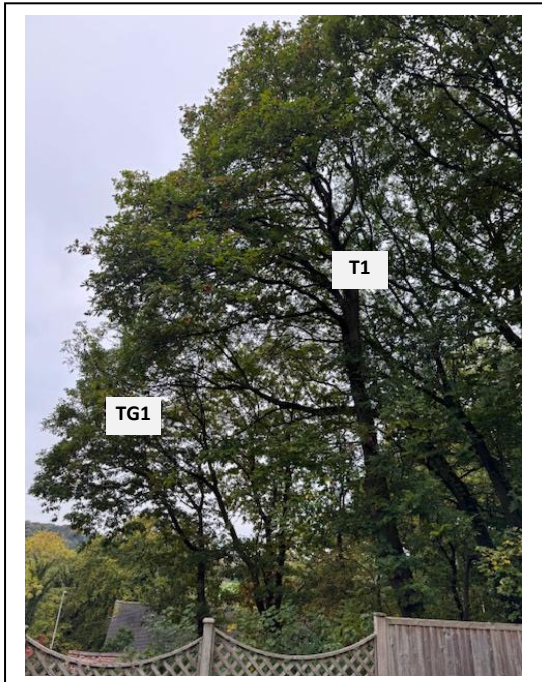
View of trees to the left of garage

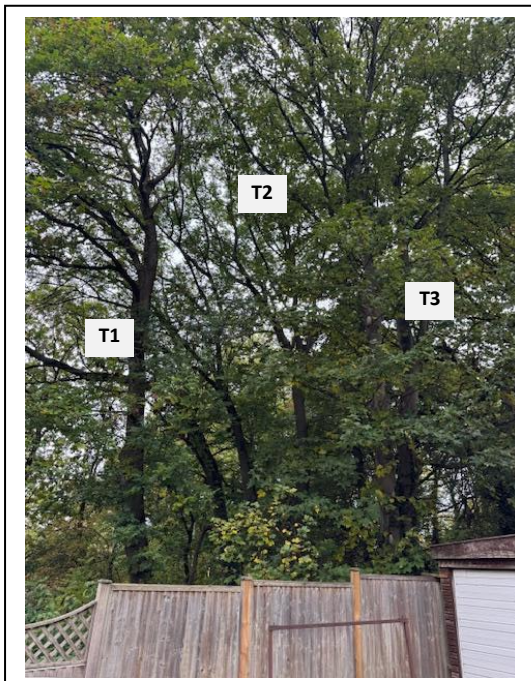
View of trees to the left

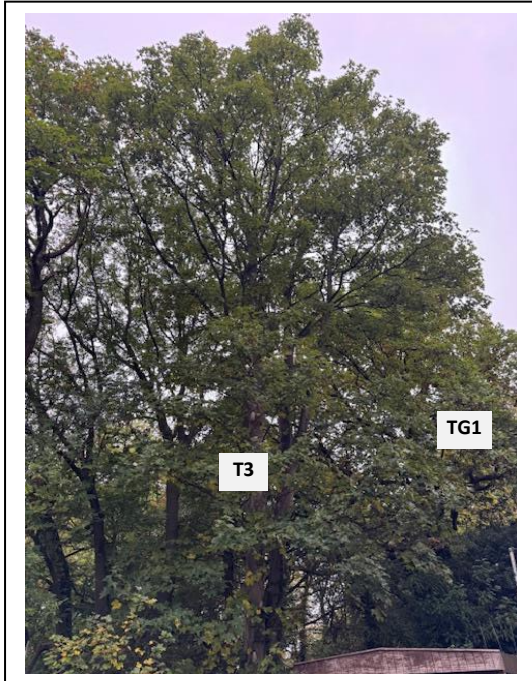
View of trees to the rear left.

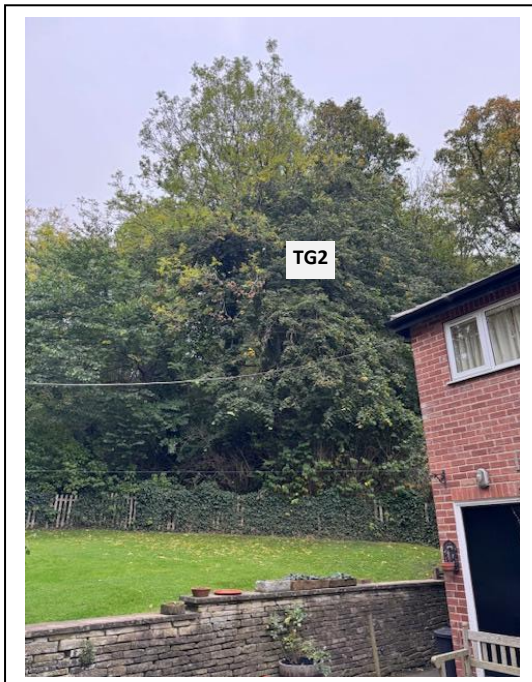
View of trees to the rear right.

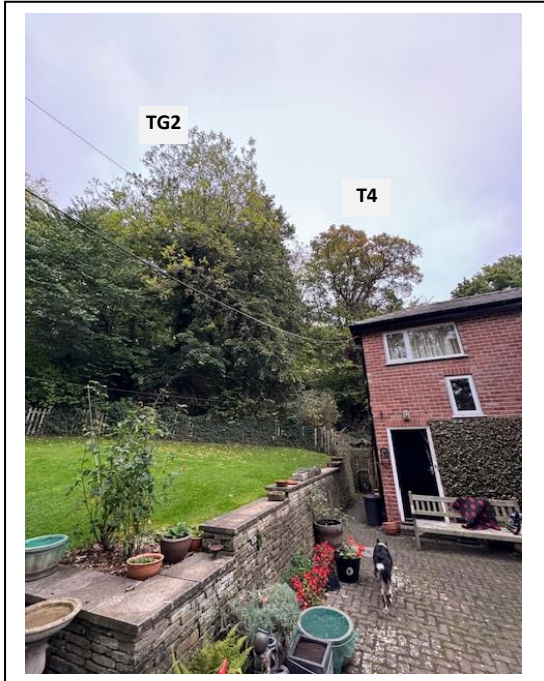
View of rear right trees.

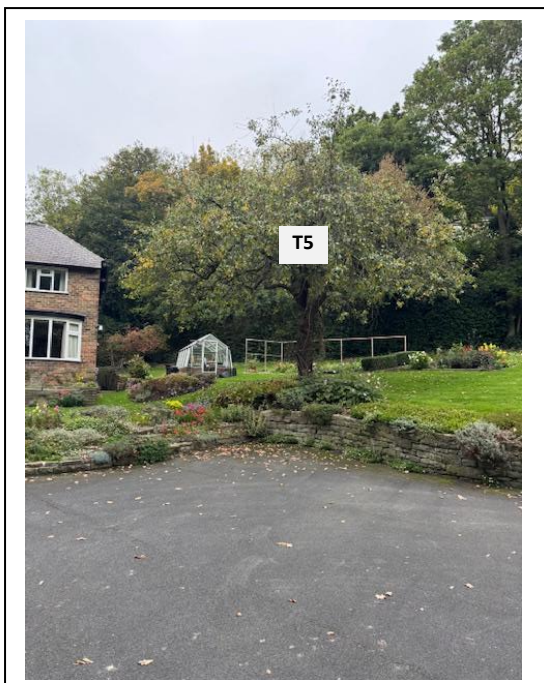
View of T5.

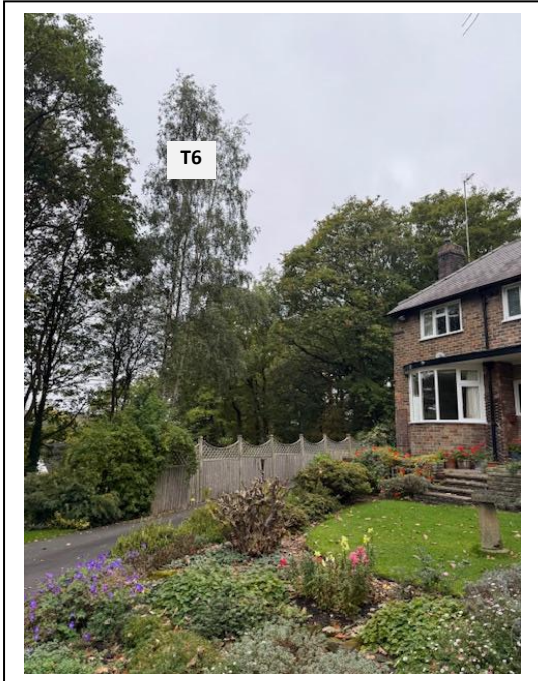
View of T6.

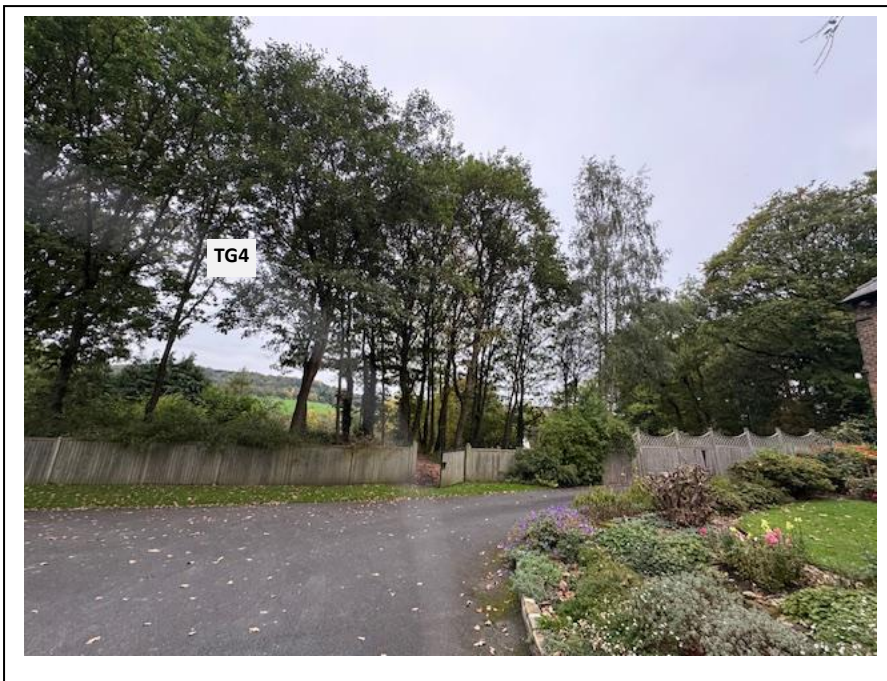
View of front left.
