## Arboricultural Appraisal Report

### Subsidence Damage Investigation at:

51 Penistone Road  
Fenay Bridge  
Huddersfield  
HD8 0AW

CLIENT: Crawford & Company  
CLIENT REF:  
MWA REF:  
MWA CONSULTANT: John Graham B.Sc. Hons PhD  
REPORT DATE: 24/10/2025

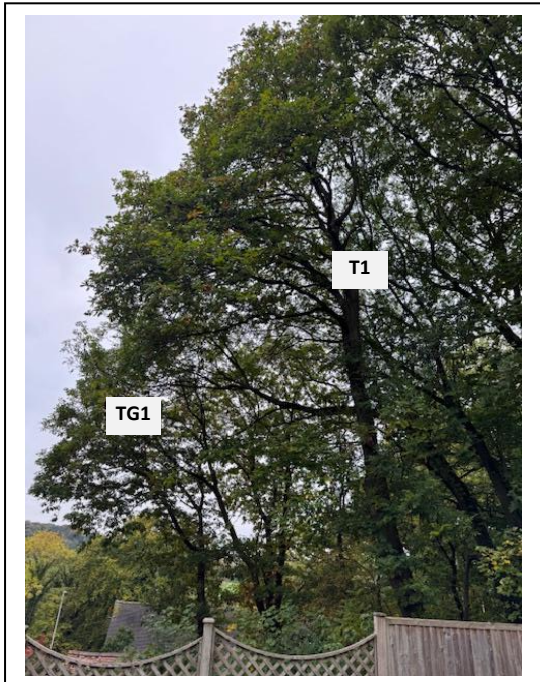
View of trees to the left of garage

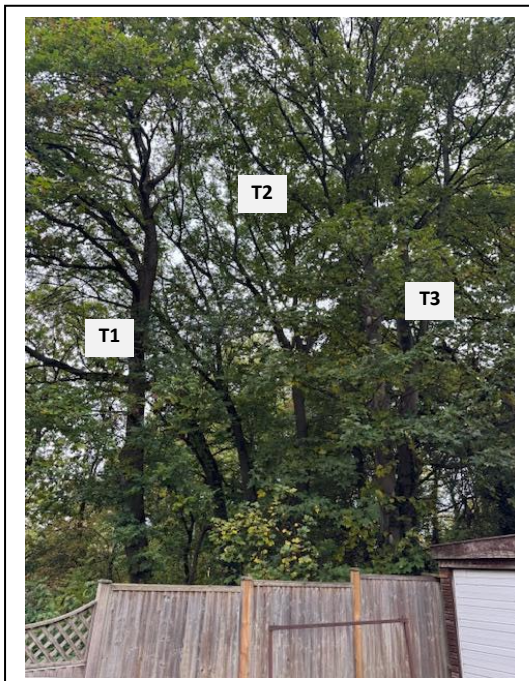
View of trees to the left
