**Address:**  
 4-6 Kirkgate  
 Huddersfield  
 HD1 1QH

**Client:** Ladbrokes Betting & Gaming Ltd

**Title:**  
 Proposed Roof Repair Works

**Drawing No:** A/AJB/2981/26/01

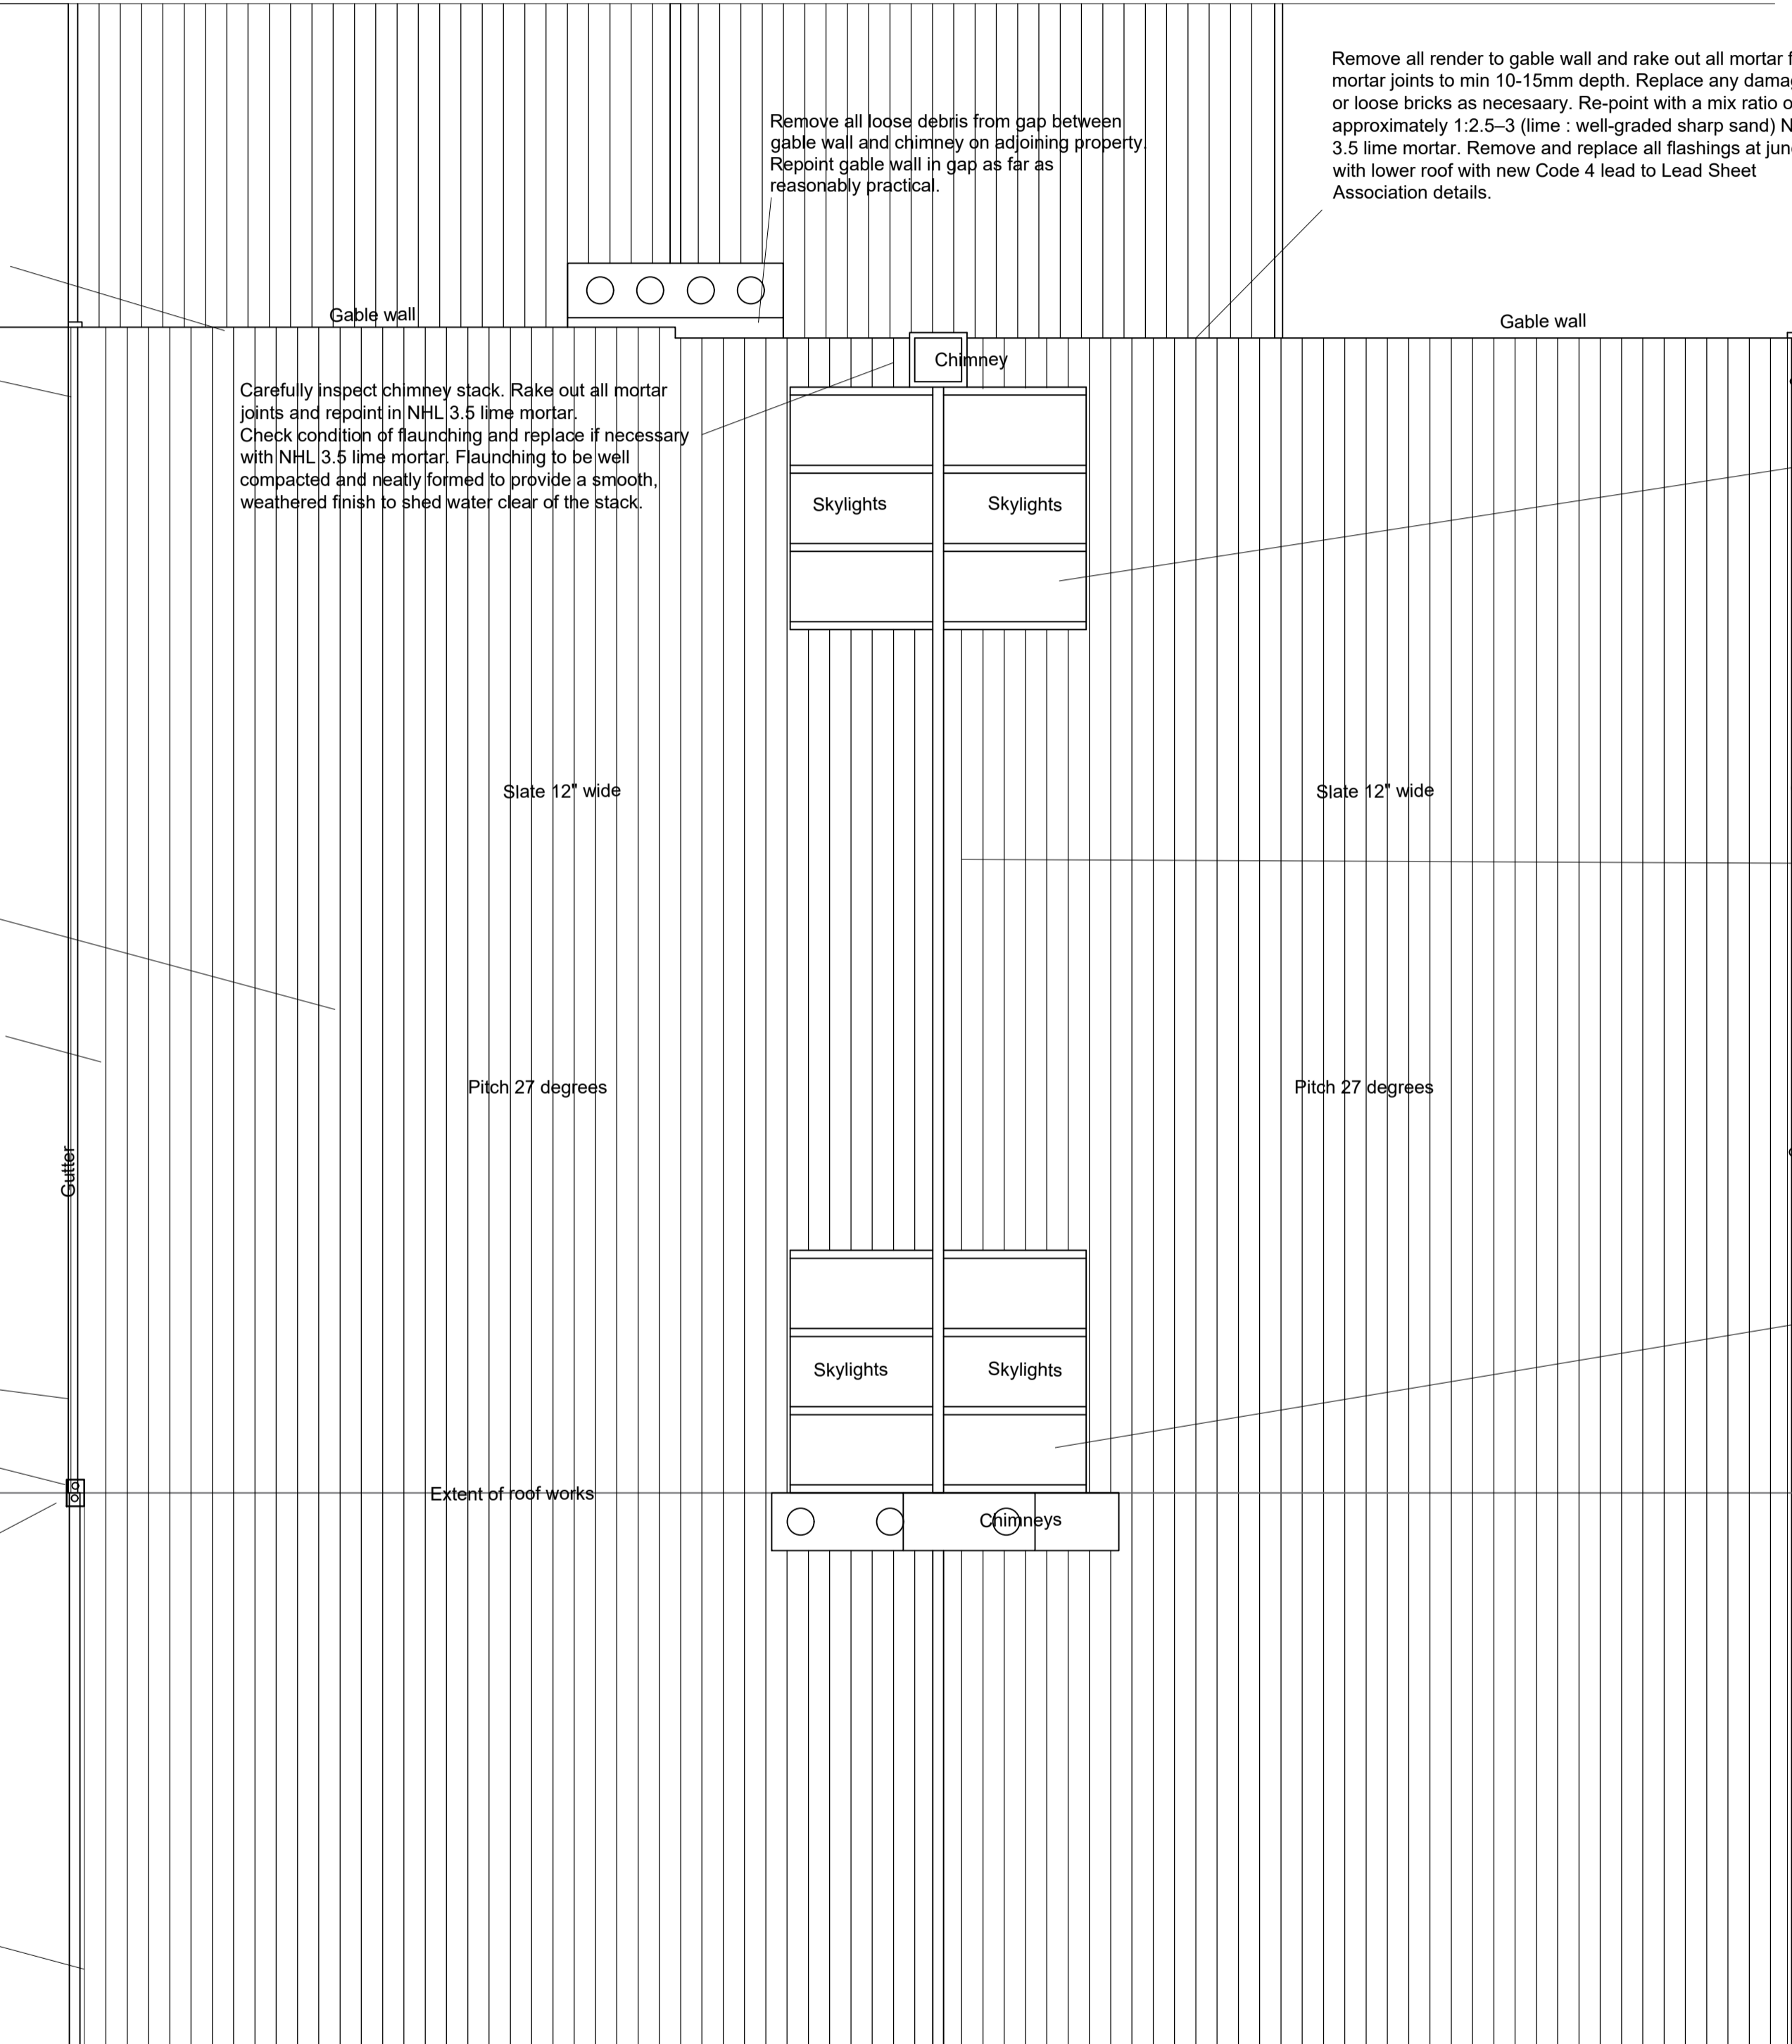
# Roof Plan

Due to the absence of double lapped slates at the eaves, rafter feet may be subject to decay. Following removal of existing roof, inspect rafter ends at eaves level.  
 Any decayed or structurally unsound timber to be cut back to sound material and repaired by splicing in new treated timber to match existing rafter size and grade, securely fixed with stainless steel screws/bolts or proprietary repair plates.  
 Allow a provisional sum for the repair of decayed rafter feet, based on 10% of rafters requiring splice repairs. Where decay is extensive, provide full rafter replacement as required. All new timber to be C24 grade, preservative treated.  
 Reinstate eaves detail to include tilting fillet, eaves support tray with underlay dressed into gutter.  
 Extent of works to be agreed on site with Contract Administrator prior to commencement of remedial works.

At roof verge, carefully remove all existing defective mortar bedding and make good wall, replacing any loose or damaged bricks or stone to match existing. Form new verge with slates bedded and pointed in NHL 3.5 lime mortar. Provide fibre cement undercloak, projecting approximately 50mm from the wall face to fully support verge slates. Roof underlay to be extended over the undercloak. Gap between slates and undercloak to be fully filled with lime mortar and neatly struck to a flush finish to provide a weathertight joint.

Full roof strip of existing roof slates, slate battens, partial felt and all leadwork.  
 Retain best slates for re-use (Allow for re-use of approx. 50%). Re-used slates to be used on rear slope. New slates to front elevation, to be good quality reclaimed slates to match existing.  
 Clear out all debris from loft void.  
 Any additional roof works identified to roof timbers following roof strip to be advised by contract administrator at first site meeting after erection of scaffold.  
 Clean down all structural roof timbers and de-nail all rafters prior to fitting a new breathable underlay over existing rafters, new 25x38mm BS 5534 graded, preservative-treated roofing battens, fixed in accordance with BS 5534 (assuming rafters are at max. 450 centres).  
 Allow for replacing all leadwork to chimneys, chimney flashings with new Code 4 lead to Lead Sheet Association details.  
 Allow for supply and fitting 300mm mineral wool insulation between and above ceiling joists to main pitched roofs to meet current regulations AD Part L2B.

Remove all loose debris from gap between gable wall and chimney on adjoining property. Re-point gable wall in gap as far as reasonably practical.

Remove all render to gable wall and rake out all mortar from mortar joints to min 10-15mm depth. Replace any damaged or loose bricks as necessary. Re-point with a mix ratio of approximately 1:2.5-3 (lime : well-graded sharp sand) NHL 3.5 lime mortar. Remove and replace all flashings at junction with lower roof with new Code 4 lead to Lead Sheet Association details.

Carefully inspect chimney stack. Rake out all mortar joints and re-point in NHL 3.5 lime mortar. Check condition of flaunching and replace if necessary with NHL 3.5 lime mortar. Flaunching to be well compacted and neatly formed to provide a smooth, weathered finish to shed water clear of the stack.

Carefully inspect existing skylights, both sides and associated flashings. Retain and refurbish skylight where possible. Check and make good timber kerbs and supports as required. Thoroughly clean glass and frame and replace any cracked or defective panes to match existing.  
 Carefully remove defective sealant and make good all junctions. Overhaul and renew perimeter flashings in code 4 lead, including apron, side soakers and cover flashings, ensuring correct laps and weathering in accordance with Lead Sheet Association guidelines.  
 Dress flashings neatly over adjacent slates. Ensure adequate upstands and weathering to all edges to prevent water ingress.  
 Ensure all the works maintain the existing appearance and are carried out in a like-for-like manner appropriate to the listed building.

Strip off existing ridge tiles and store safely for duration of roof slate works. Re-bed ridge tiles in lime/sand mortar (1:3) with NHL 3.5 lime. (Allow for re-use of existing ridge tiles of approx. 50%)

Wire brush cast iron gutter to remove any rust and loose flaking paint prior to redecorating in good quality rust inhibiting metal primer, 1no. undercoat and 2no high performance gloss - black exterior metal paint

Outlet  
 Replace 2 no. broken upvc downpipe brackets at base of pipe

Carefully inspect existing skylights, both sides and associated flashings. Retain and refurbish skylight where possible. Check and make good timber kerbs and supports as required. Thoroughly clean glass and frame and replace any cracked or defective panes to match existing (Georgian wired glass).  
 Carefully remove defective sealant and make good all junctions. Overhaul and renew perimeter flashings and chimney flashings in code 4 lead, including apron, side soakers and cover flashings, ensuring correct laps and weathering in accordance with Lead Sheet Association guidelines.  
 Dress flashings neatly over adjacent slates. Ensure adequate upstands and weathering to all edges to prevent water ingress.  
 Ensure all the works maintain the existing appearance and are carried out in a like-for-like manner appropriate to the listed building.
