ADDRESS: St Peter's Church, Kirkgate,
Birstall, Batley, West Yorkshire, WF17 9PB.
JCA REF: 17825/EW

10th October 2025
Our Ref: 12050

Structural Inspection of Dilapidated Boundary Wall to Graveyard St. Peters Church, Birstall

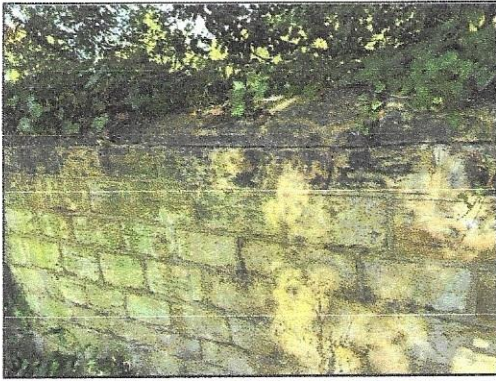
Adjacent to the gateway opening, outward bulging and leaning movement was in evidence caused by the presence of 2No. large mature trees behind the wall. Associated cracking defects were also noted. (Photo's 1 & 2)

Overtime, the extensive growth of the trees has caused their roots to exert pressure onto the wall, with the trunk of the tree also now causing a direct impact on the boundary wall structure. (Photo 3). The heavy presence of Ivy vegetation is also a contributing factor to the structural movement and defects noted.

Photo 1: Lateral Movement of Wall

It is our opinion that the lower section of the boundary wall adjacent to the gateway access is past the end of its serviceable life and major structural intervention will be needed to ensure the safety of the structure and pedestrians along the adjacent highway.

- 1) Remove the 2No. large mature trees directly behind the retaining wall.
- 2) Carefully demolish a 7.0m length (estimated) of the boundary retaining wall setting the stone aside for reuse.
- 3) Ensure that the existing foundation stones of the boundary wall are level and that they have not been compromised during the removal of the large trees or the ongoing movement noted.
- 4) Rebuild the boundary wall, using a strong mortar bonding, ensuring all coursings are aligned with the retained section of wall and that they are all adequately tied into the feature stone gate post.

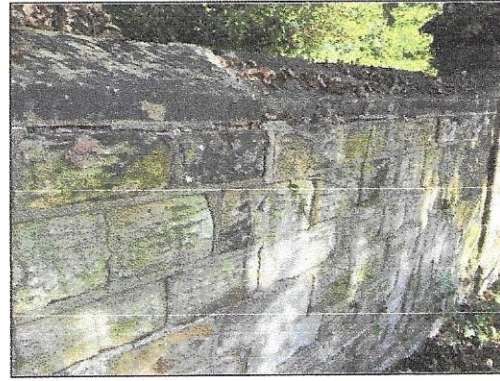
Photo 2: Cracking Noted to Wall

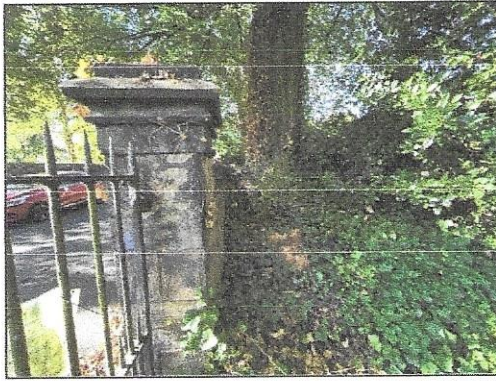
Photo 3: Tree Trunk Impacting Wall

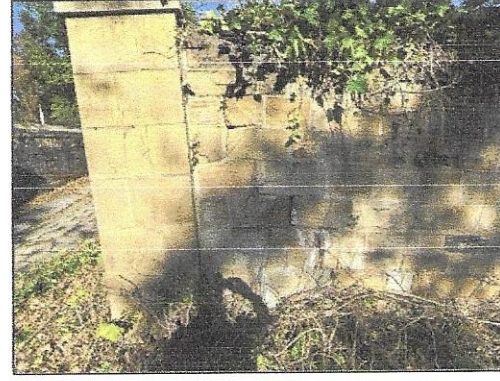
At the upper corner of the wall, where the boundary wall returns to form the driveway access to the graveyard, lateral cracking was noted to the mortar joints to both sides of the wall. However, no outward bulging or leaning movement was noted in this location (Photo's 4 & 5).

Photo 4: Cracking Noted to Wall

The upper corner of the wall, adjacent to the driveway access, can easily be repaired by installing Helibar strengthening adopting crack stitching techniques. More information on this type of structural remedial repair can be found here: <https://helifix.co.uk/products/remedial-products/crack-stitching-2/>.

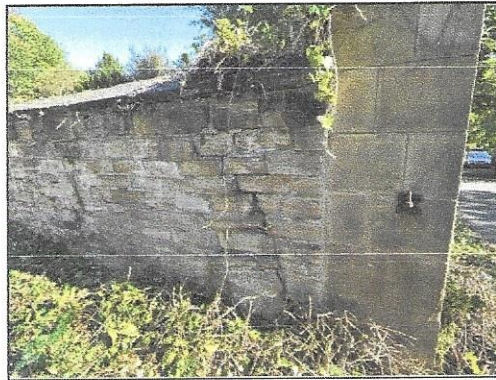
Photo 5: Cracking Noted to Wall

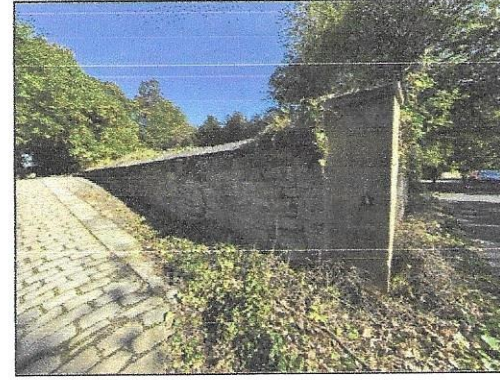
Photo 6: Wall adjacent to Driveway
