External Opening Condition Schedule – East Elevation Only: Kirkby Grange Farm, Flockton, Wakefield, WF4 4AH

May 2026

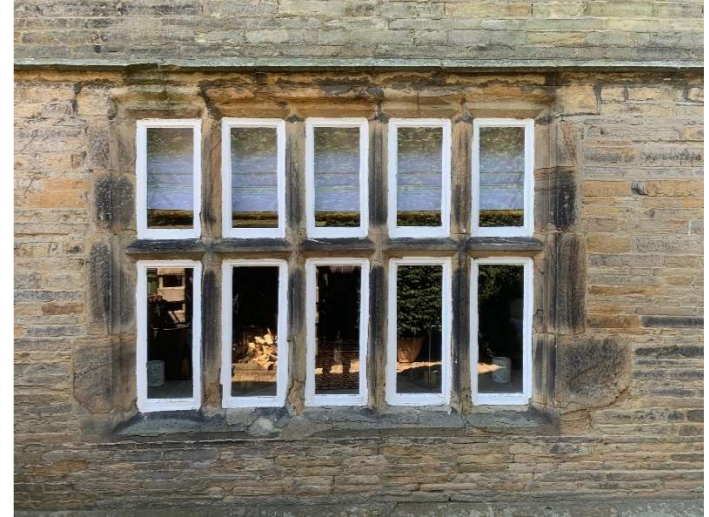
Item	Location and Window Type	Condition	Repair/ Replace recommendation	Image
Ground Floor				
GF.01	Dining Room Stone window surround configured to 10no openings each containing a '1 light' single-glazed timber window.	Original design and stonework. Extensive loss of stonework and points of delamination and deterioration to the stonework, especially to the cill. Numerous open cracks in stonework. Loss of stonework already apparent due to delamination and flaking. Window units generally fair but not original. Loss of surrounding fabric undermines thermal efficiency.	Carefully remove existing timber window units from within the stone surrounds. Carefully defrass the stonework to enable condition assessment. Investigate replacement of spilt stonework. Carefully replace stonework, like for like. Re-point open joints (where required) with lime mortar. Install new painted timber slimline double glazing window units to match existing layout and configuration.

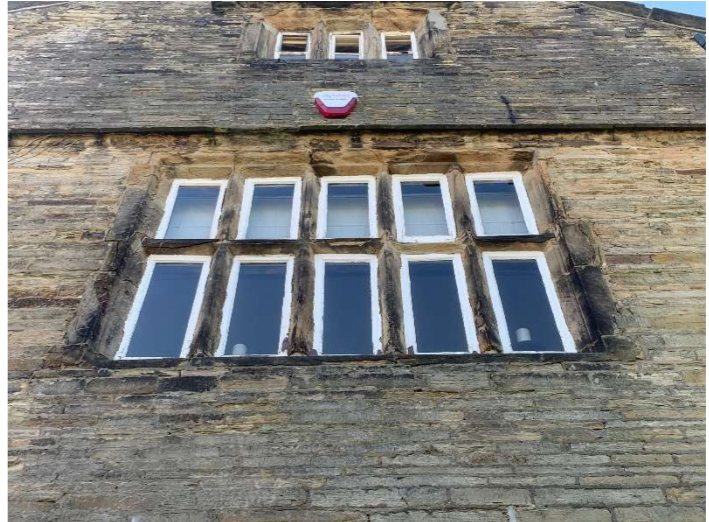
First Floor				
FF.01	Bedroom Stone window surround configured to 10no openings each containing a '1 light' single-glazed timber window.	Original design and stonework. Extensive loss of stonework and points of delamination and deterioration to the stonework, especially to the cill. Numerous open cracks in stonework. Loss of stonework already apparent due to delamination and flaking. Window units in poor state of repair and not original. Loss of surrounding fabric undermines thermal efficiency.	Carefully remove existing timber window units from within the stone surrounds. Carefully defrass the stonework to enable condition assessment. Investigate replacement of spilt stonework. Carefully replace stonework like for like. Re-point open joints (where required) with lime mortar. Install new painted timber slimline double glazing window units to match existing layout and configuration.

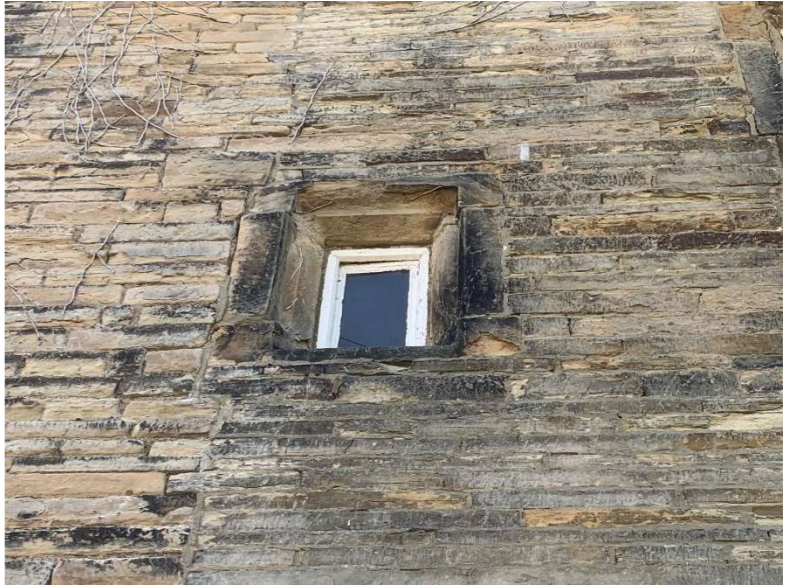
FF.02	<p>Bedroom</p> <p>Stone window surround configured to 1no opening each containing a '1 light' single-glazed timber window.</p>	<p>Original design and stonework.</p> <p>Extensive loss of stonework and points of delamination and deterioration to the stonework, especially to the cill. Numerous open cracks in stonework.</p> <p>Loss of stonework already apparent due to delamination and flaking.</p> <p>Window unit generally fair but not original. Loss of surrounding fabric undermines thermal efficiency.</p>	<p>Carefully remove existing timber window units from within the stone surrounds.</p> <p>Carefully defrass the stonework to enable condition assessment.</p> <p>Investigate replacement of spilt stonework.</p> <p>Carefully replace stonework like for like.</p> <p>Re-point open joints (where required) with lime mortar.</p> <p>Install new painted timber slimline double glazing window units to match existing layout and configuration.</p>
