## **STRUCTURAL CONDITION & DILAPIDATION REPORT**

**REF: MDL - 12499**

Retaining walls adjacent to highways that surround the property at:  
2 Elm Street, Skelmanthorpe, Huddersfield, HD8 9BH

To undertake a structural condition and dilapidation report of the existing retaining walls prior to construction works associated with the proposed alterations of the existing dwelling at 2 Elm Street, Skelmanthorpe, Huddersfield, HD8 9BH.

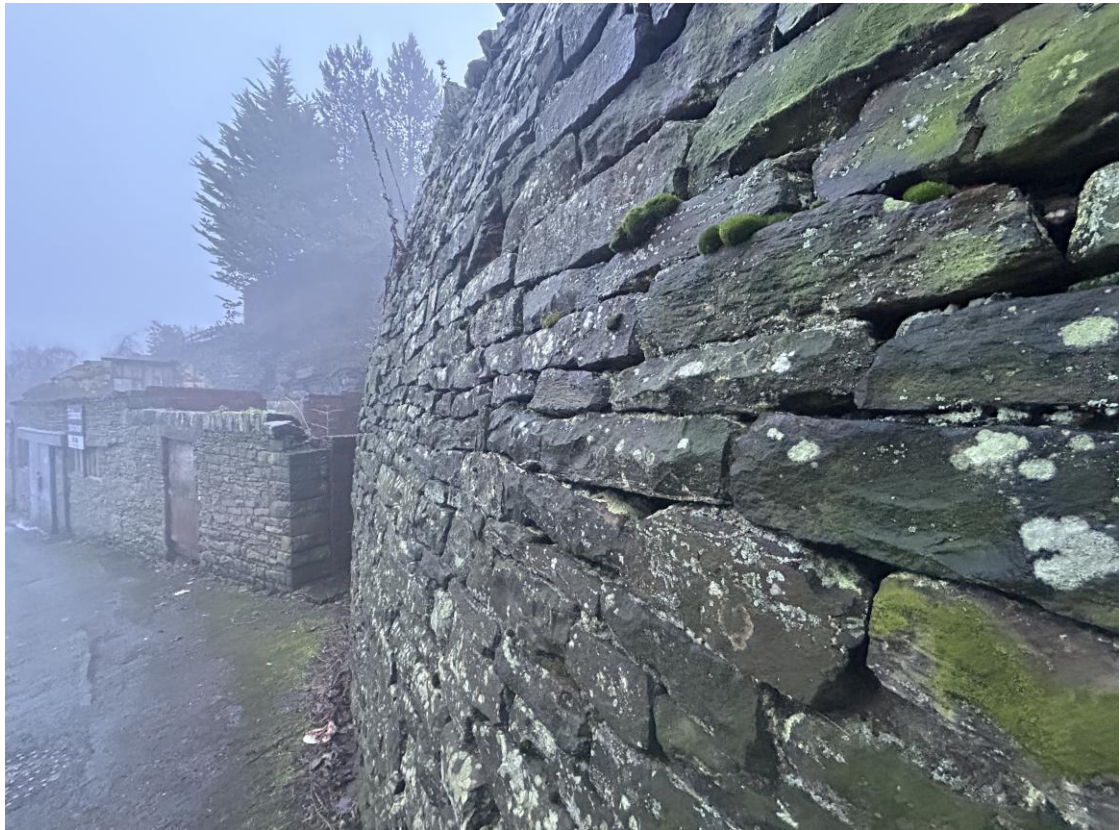
Photo B/F/2T – Wall B, Front Face, ~CH 7.0m (Upper Section)

For retaining Wall B to the southwest of the property, localised bulging is visible in Photographs B/F/2/T & B, B/F/7/T and B/F/9/T in Appendix 'B'
