# Arboricultural Safety Assessment

**WC-527.1a**

Land adjacent to Station Road, Slaithwaite

<b>Report type:</b>	Arboricultural Safety Assessment
<b>Report reference:</b>	WC-527.1
<b>Revision:</b>	a
<b>Client:</b>	Jess Brooke
<b>Site address</b>	Land adjacent to Station Road, Slaithwaite
<b>OS Grid Ref:</b>	SE 08073 14181
<b>Report prepared by:</b>	Jack Delaney MICFor MArborA
<b>Date:</b>	12 <sup>th</sup> May 2026

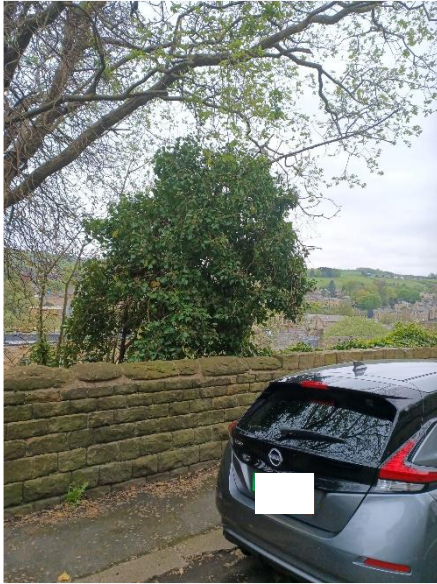
**Plate 1:** T001

**3.5.1.** T001 and T007 are both moribund trees which have been determined to present a RoH of 1/500,000.

Tree Ref:	Species	A	SULE	H	CS	DBH	PC	Comments	Area of Tree Risk Assessed	Target Description	QTRA Factors					Management	Priority Category
											Target Type /Zone	Size	Mass	PoF	RoH		
T001	Goat willow <i>Salix caprea</i>	SM	< 5	6	2.5	22	P	Moribund tree. Dense ivy <i>Hedera helix</i> established throughout the crown, which obscures tree features and potential defects.	Main stem/root plate failure	Parked vehicles	H3	3	100 %	3	1/500K (T)	Remove tree	Moderate
T002	Sycamore <i>Acer pseudoplatanus</i>	EM	5-10	16	6	64	F	Bifurcates between 0-2 m into multiple co-dominant stems; the angles of these branch unions are all < 25°, and therefore, these potentially may contain included bark. Brittle cinder fungus <i>Kretzschmaria deusta</i> fructifications apparent at the base of the main stem. Necrotic bark on several first order branches between 2-4 m with jelly ear fungus <i>Auricularia auricula-judae</i> apparent on the exposed dysfunctional sapwood. Major deadwood > 100 mm in diameter scattered throughout the crown.	Main stem/root plate failure	Parked vehicles	P2	P	100 %	4	1/30K (T)	Carry out further assessment of decay in main stem using resistance micro drill or sonic tomograph, or remove the tree	Moderate

- 4.1.1. To eliminate the RoH which is posed by T001 and T007 it is recommended that these trees are removed.
- 4.1.2. To determine the extent of the decay within the lower main stems and principal roots of T002 and T010, it is recommended that further decay analysis is carried out using a resistance micro drill or sonic tomograph. Alternatively, the RoH which is posed by T002 and T010 could be eliminated by removing the trees.
- 4.1.3. To reduce the RoH posed by T004, T006, and T008 down to a broadly acceptable level, it is recommended that all deadwood within the crowns exceeding 50 mm in diameter is removed.
- 4.1.4. Since all of the remaining trees have been determined to present a broadly acceptable RoH, no further risk mitigation works are recommended.

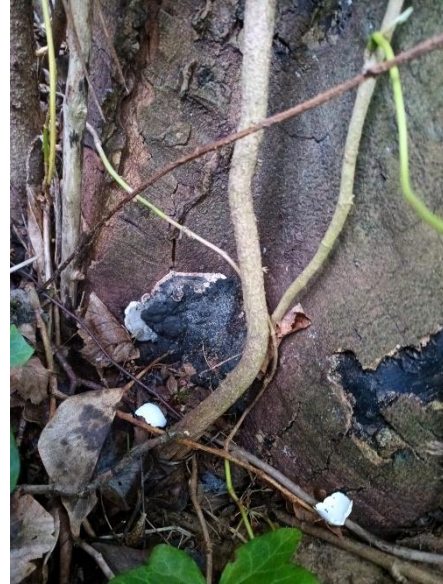
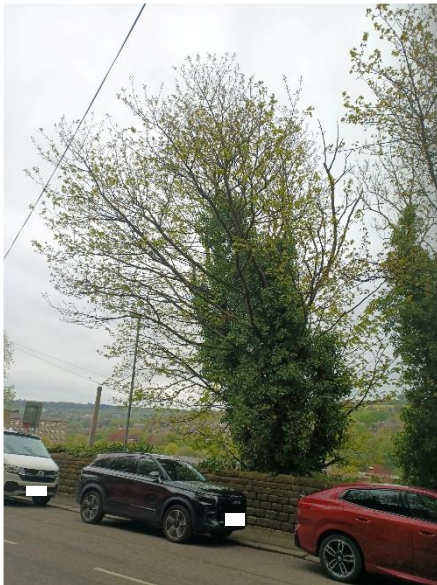
**Plate 3:** T002

**3.5.2.** T002 is a mature sycamore, which displays brittle cinder fungus *Kretzschmaria deusta* fructifications at the base of the main stem. In the early stages of colonisation, brittle cinder fungus can cause a soft rot in the lower main stem and principal roots by preferentially destroying cellulose, which can lead to sudden brittle fracture. T002 has therefore been given a PoF value of 4<sup>9</sup> and has been determined to present a RoH of 1/30,000.

**Plate 2:** *K. deusta* fructifications at the base of T002

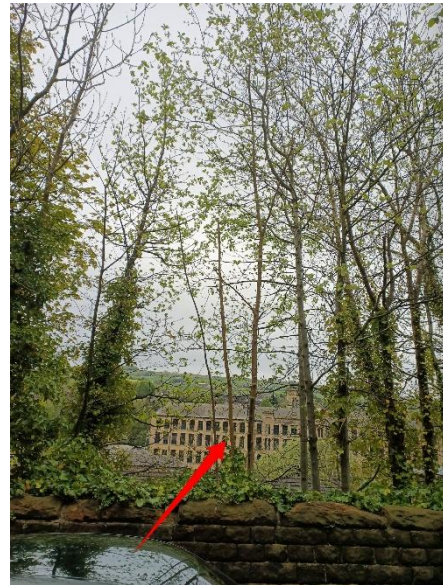
**Plate 4:** T003

T003	Sycamore <i>Acer pseudoplatanus</i>	D	< 5	6.5	2	10 9 8	D	Dead tree.	Main stem/root plate failure	Parked vehicles	H3	4	100 %	3	< 1/1M (BA)	Remove tree	Low
T004	Common ash <i>Fraxinus excelsior</i>	EM	40-80	18	6	43	F	Asymmetrical form due to proximity with adjacent trees. Dense ivy <i>Hedera helix</i> established throughout the crown, which obscures tree features and potential defects. Major deadwood > 100 mm in	Deadwood	Public footpath	H3	3	100 %	3	1/500K (T)	<ul style="list-style-type: none"> <li>Remove deadwood &gt; 50 mm in diameter</li> </ul>	Moderate

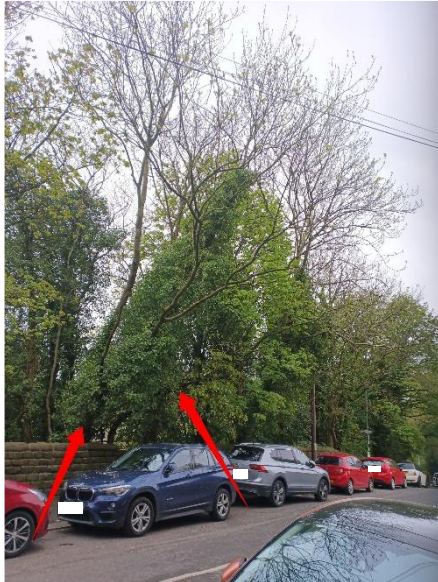
**Plate 5:** T004 (left) & T005 (right)

**3.5.3.** T004, T006, and T008 comprise early-mature common ash, all of which display deadwood within the crowns exceeding 100 mm in diameter. These trees have therefore been determined to present a RoH of 1/300,000.

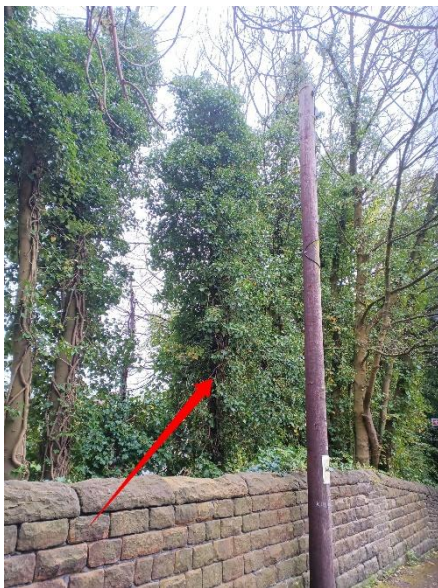
**Plate 7:** T007

Sever ivy at the base of the main stem to facilitate future inspections	Low
T007	Sycamore <i>Acer pseudoplatanus</i>	D	< 5	11	1	32	D	Dead tree. Dense ivy <i>Hedera helix</i> established on main stem, which obscures tree features and potential defects.	Main stem/root plate failure	Parked vehicles	P3	P	100%	3	1/30K (T)	Remove tree	Moderate

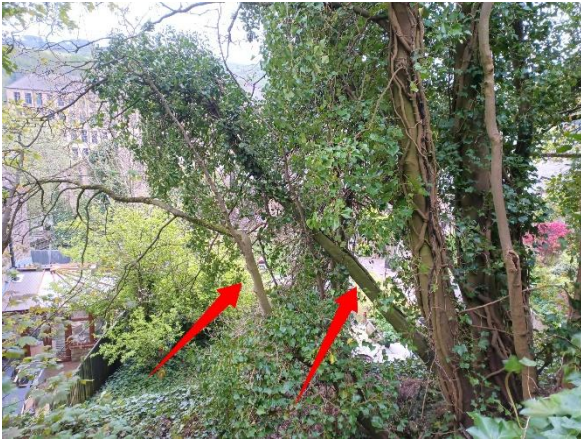
**Plate 9:** Branches from T009 which encroach onto an adjacent property

T009	<ul style="list-style-type: none"> <li>• Reduce or remove 2 x leaning co-dominant stems for clearance to adjacent property</li> </ul>	
G001	<ul style="list-style-type: none"> <li>• Carry out inspection of ash for symptoms of Chalara ash dieback when next in full leaf (August 2026)</li> </ul>	
G002	<ul style="list-style-type: none"> <li>• Sever ivy at the bases of affected trees to facilitate future inspections</li> </ul>	
G003		
G004	<ul style="list-style-type: none"> <li>• Remove the group</li> </ul>

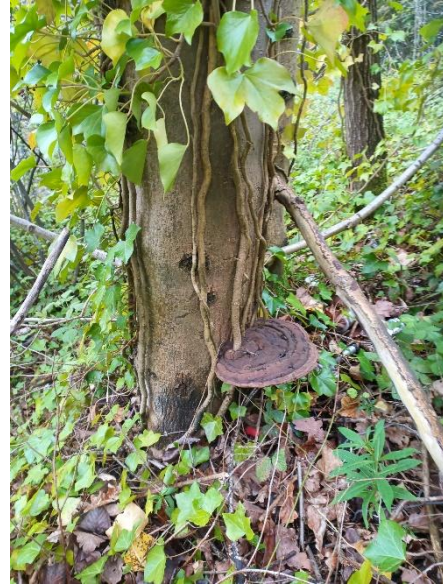
**3.5.4.** T010 is a semi-mature common whitebeam which displays a southern bracket *Ganoderma australe* fructification on the west aspect of the stem. southern bracket is a fungal pathogen, which in the early stages of colonisation causes a localised selective delignification. In very advanced stages of decay the lignin can be almost completely degraded, which can instigate ductile fracture. T010 has therefore been given a PoF value of 4 and has been determined to present a RoH of 1/300,000.

**Plate 10:** *G. australe* fructification at the base of T010

T010	Common whitebeam <i>Sorbus aria</i>	SM	10-20	13	3	27 23	F	Bifurcates at ground level into two co-dominant stems. Southern bracket <i>Ganoderma australe</i> fructification apparent at the base of one co-dominant stem. Minor deadwood < 100 mm in diameter scattered throughout the crown.	Main stem/root plate failure	Parked vehicles	P3	P	100 %	4	1/300K (T)	Carry out further assessment of decay in main stem using resistance micro drill or sonic tomograph, or remove the tree	Moderate

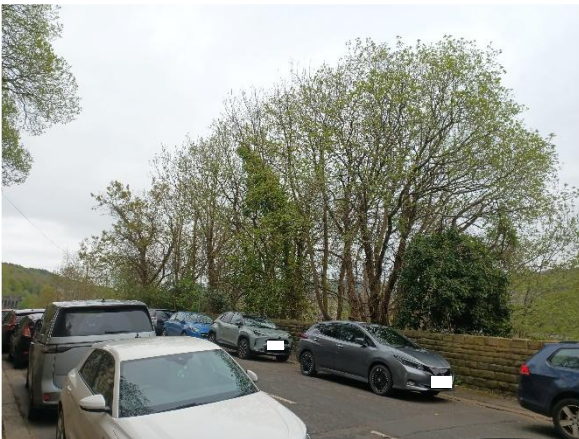
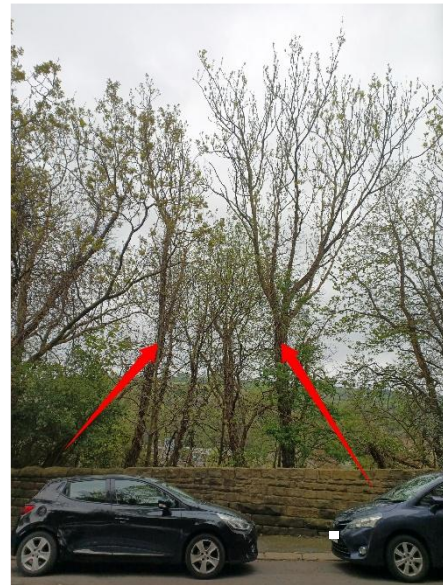
**Plate 11:** G001

**3.6.1.** G001 includes several common ash, which display deadwood around the crown extremities and adventitious shoots on structural branches. These are features that are symptomatic of Chalara ash dieback *Hymenoscyphus fraxineus*. The initial hazard posed by trees that are infected by Chalara ash dieback are these dead or dying branches which can become brittle and fall. Chalara ash dieback can result in the death of mature trees, as sources for food and nutrition are gradually diminished; however, external factors such as the climate, topography, soil type, and local tree cover appear to play important roles in the extent and

rate to which trees are affected. At present, the dead and dying branches pose the principal threat and these have been determined to present a RoH of less than 1/1,000,000.

**Plate 12:** Ash within G001 displaying preliminary symptoms of *Chalara ash dieback*
