ARBORICULTURAL REPORT & Impact Assessment to BS 5837:2012 at:

***Cote Royd House,
7 Halifax Road,
Huddersfield,
HD3 3AN***

Prepared for: *Bradley Stankler Planning*

Reference: *AWA7422*

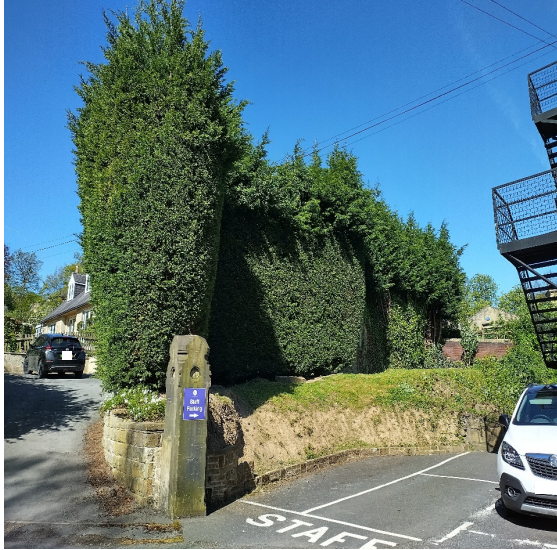
- 3.2.6 Boundary vegetation includes G1 Leyland Cypress, G2 Beech, G26 Holly and G31 Laurel. These groups form local enclosure and boundary screening, all retention category 'C'.

Photo 1: G1, looking northwest

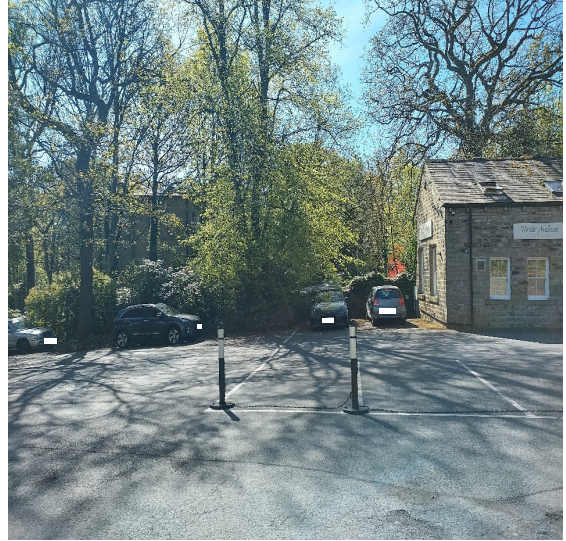
- 3.2.5 The principal arboricultural features are the high quality retention category A trees including, T3, T22 Oak, T4 Lime, T8 Sycamore, T24 Horse Chestnut and T28 Copper Beech. Moderate value retention category B trees also provide significant arboricultural value to the site, this includes T7, T12, T13, T14, T20 Oak, T15 Sycamore and T19 Yew.

Photo 2: T3, T4, and T7, looking south

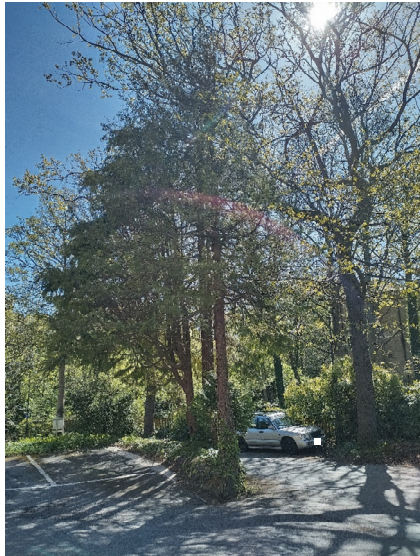
Photo 3: T5 - T7 and T10, looking southeast

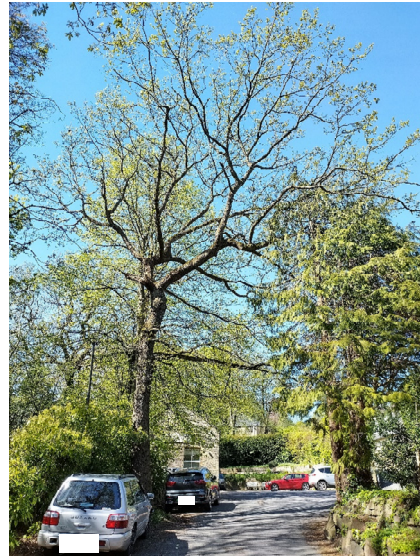
Photo 4: T5 - T7, looking west

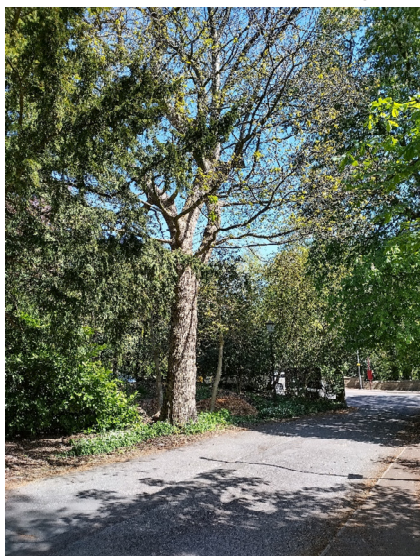
Photo 5: T22 with G26 beyond, looking east

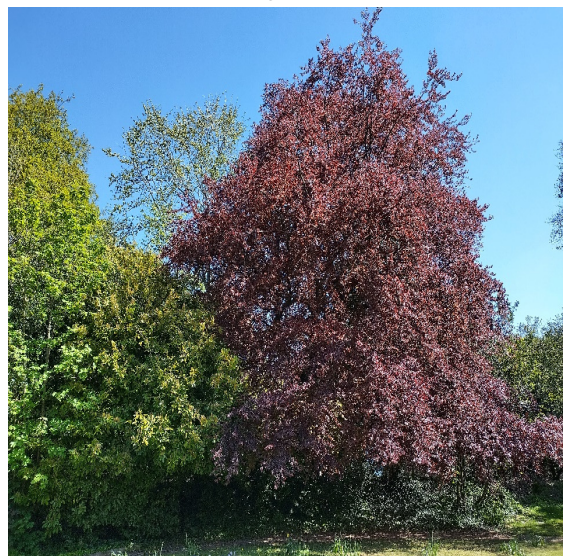
Photo 6: T28, T29 and G26, looking west
