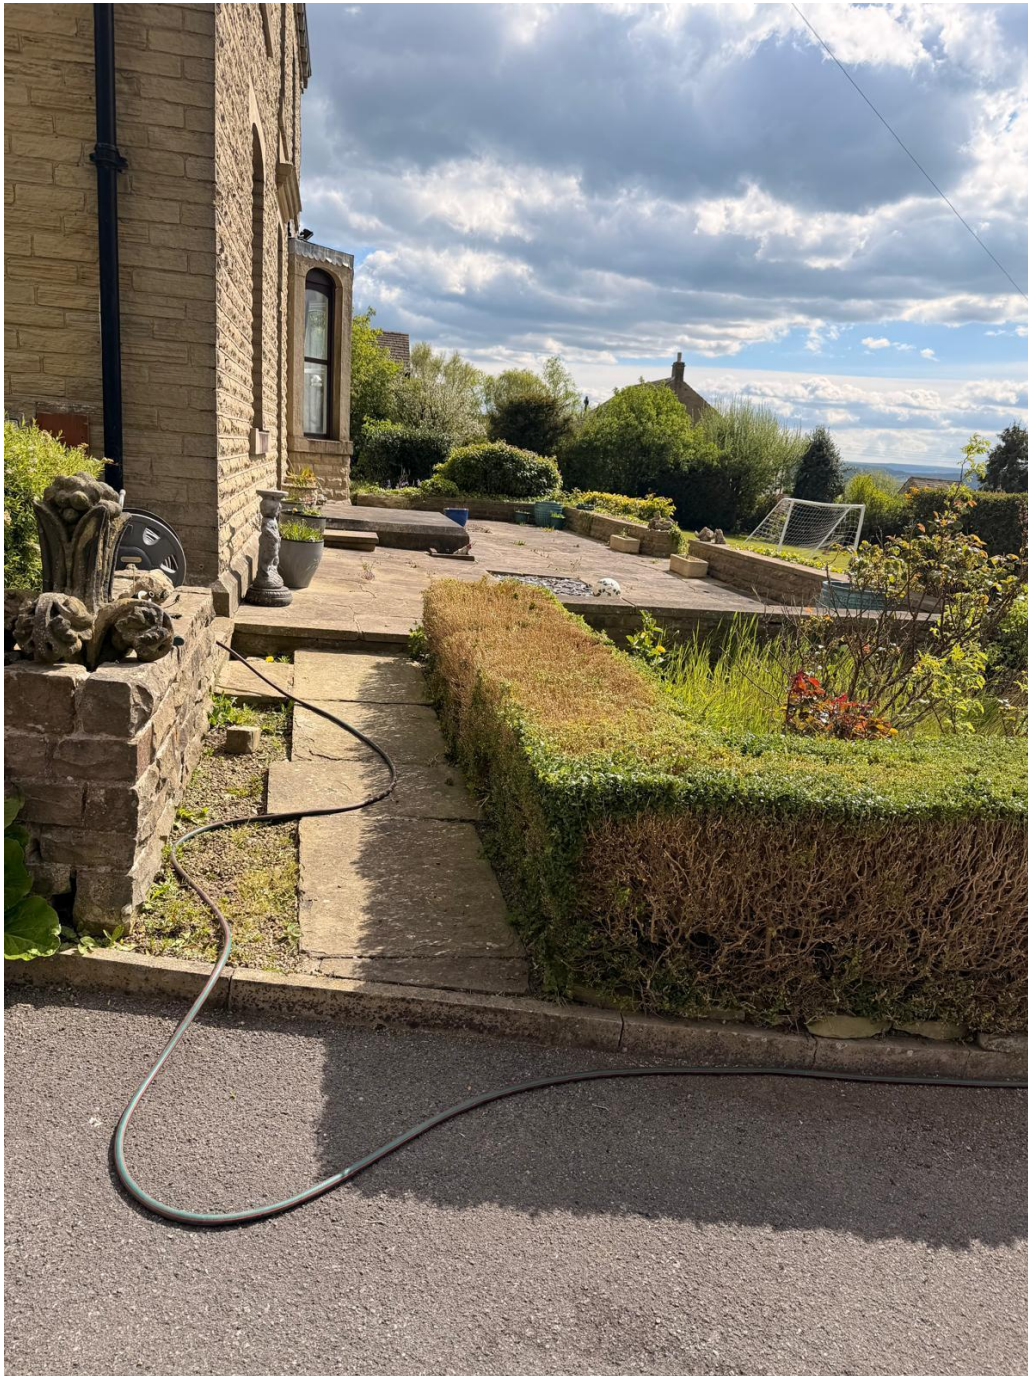
Plate 1: Internal Navigation Obstacles – View showing existing narrow, uneven paved paths and significant stone thresholds that prevent safe independent walker or wheelchair use.

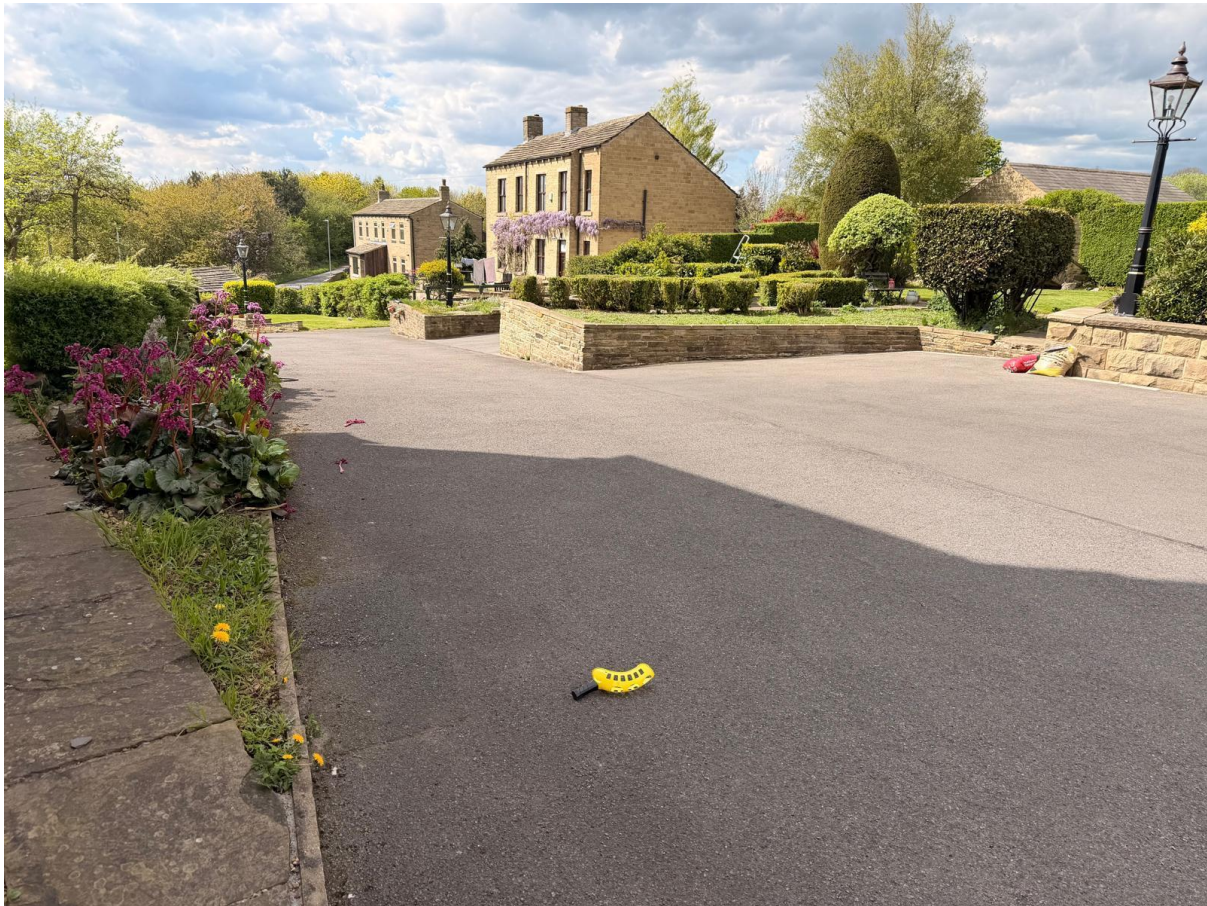
Plate 2: Primary Site Gradient – Illustrating the steep, descending driveway which presents a severe fall risk for Blue Badge holders with restricted mobility.

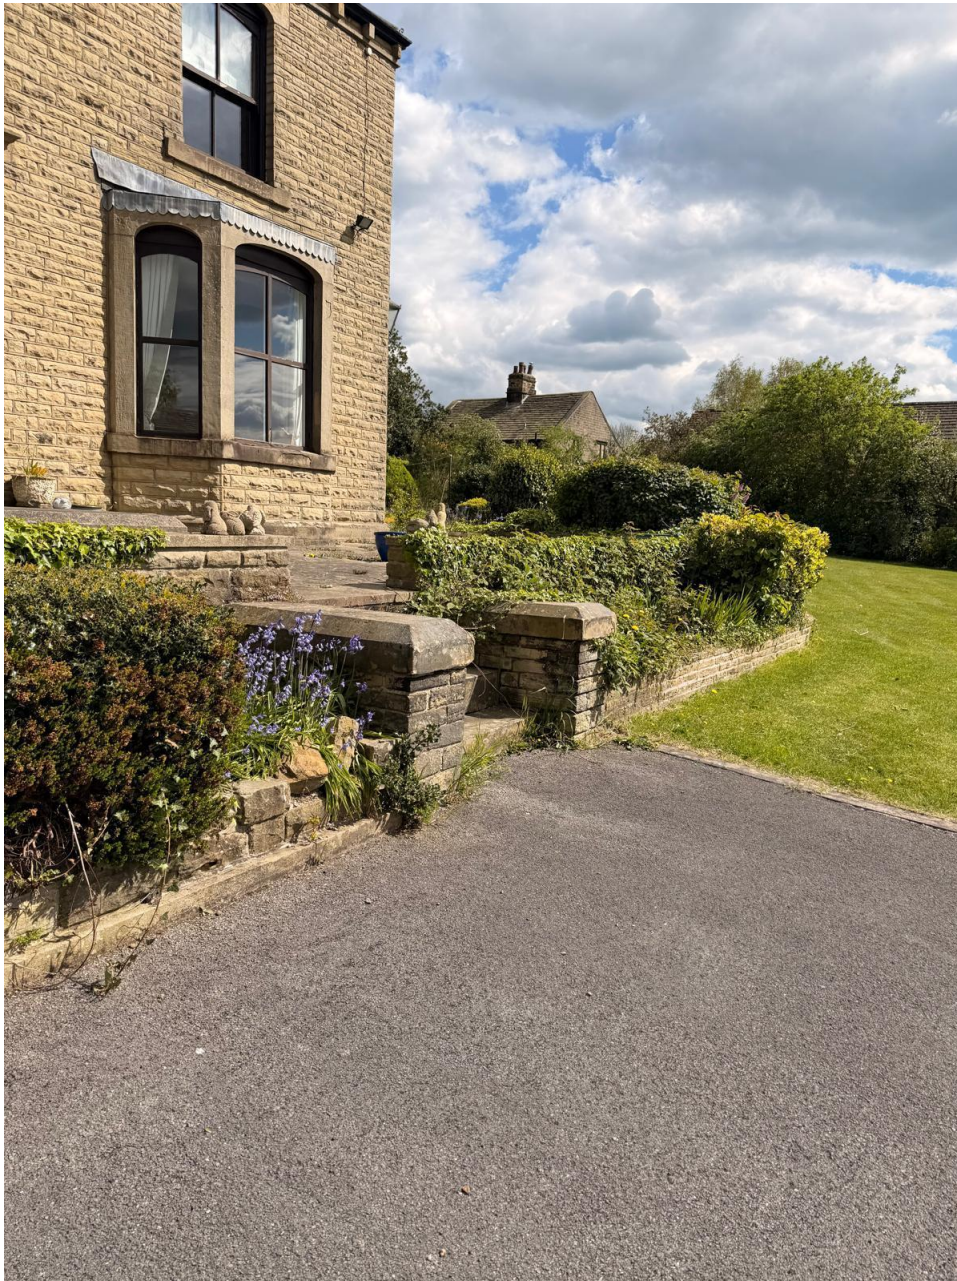
Plate 3: Vertical Access Barrier – Close-up of multi-level stone steps leading to the terrace, demonstrating the "accessibility gap" between the dwelling and the garden.

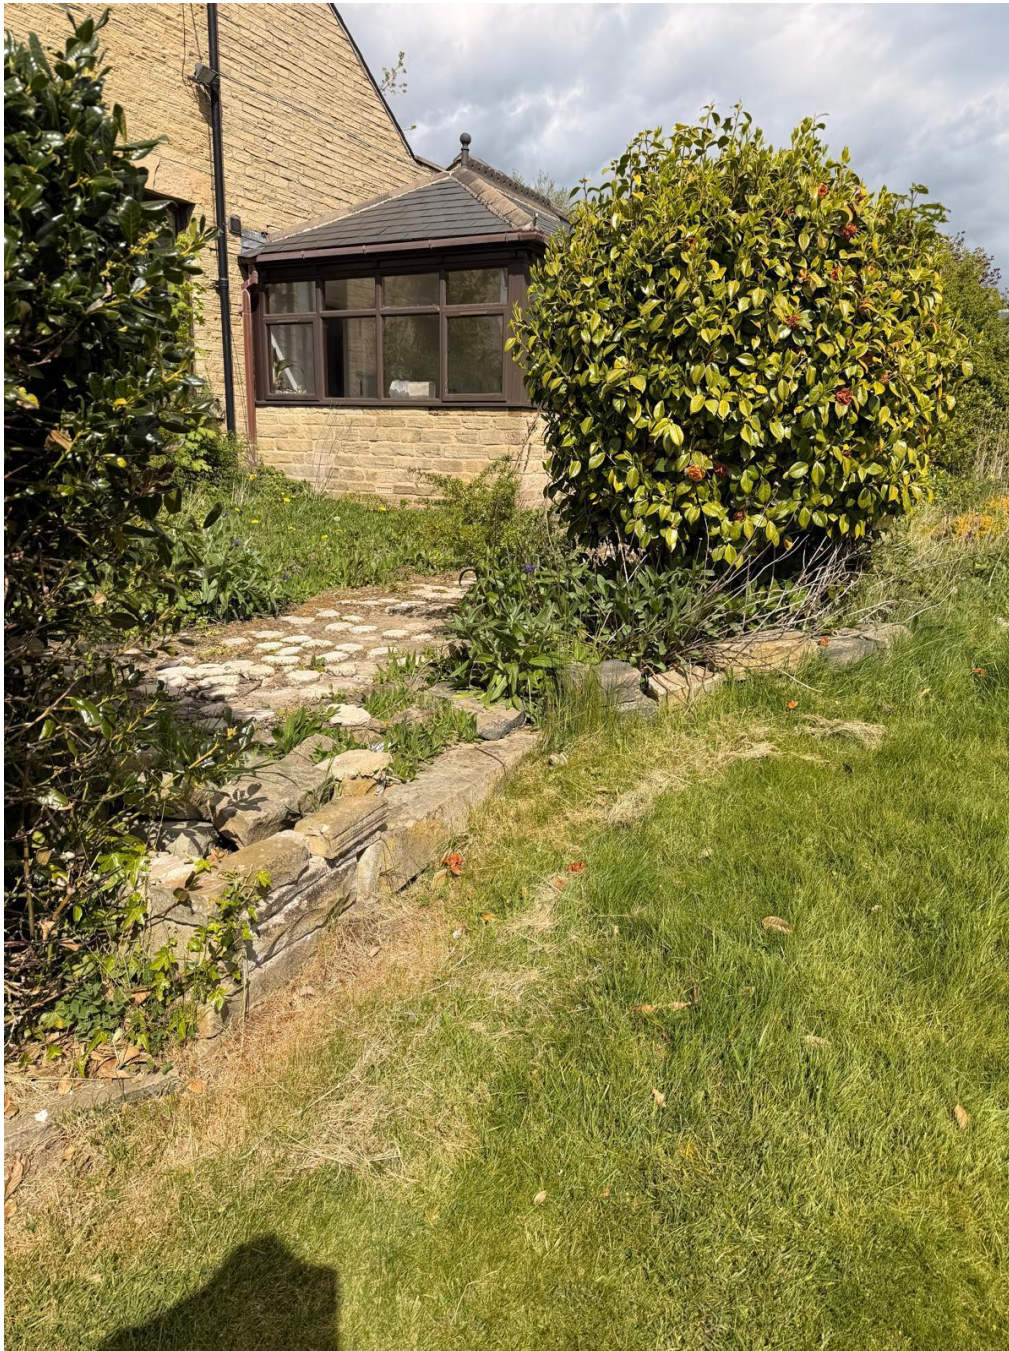
Plate 4: Functional Land Constraint (North-West) – View of unmanaged vegetation and steep embankments that render this portion of the 1.01-acre site medically unusable.

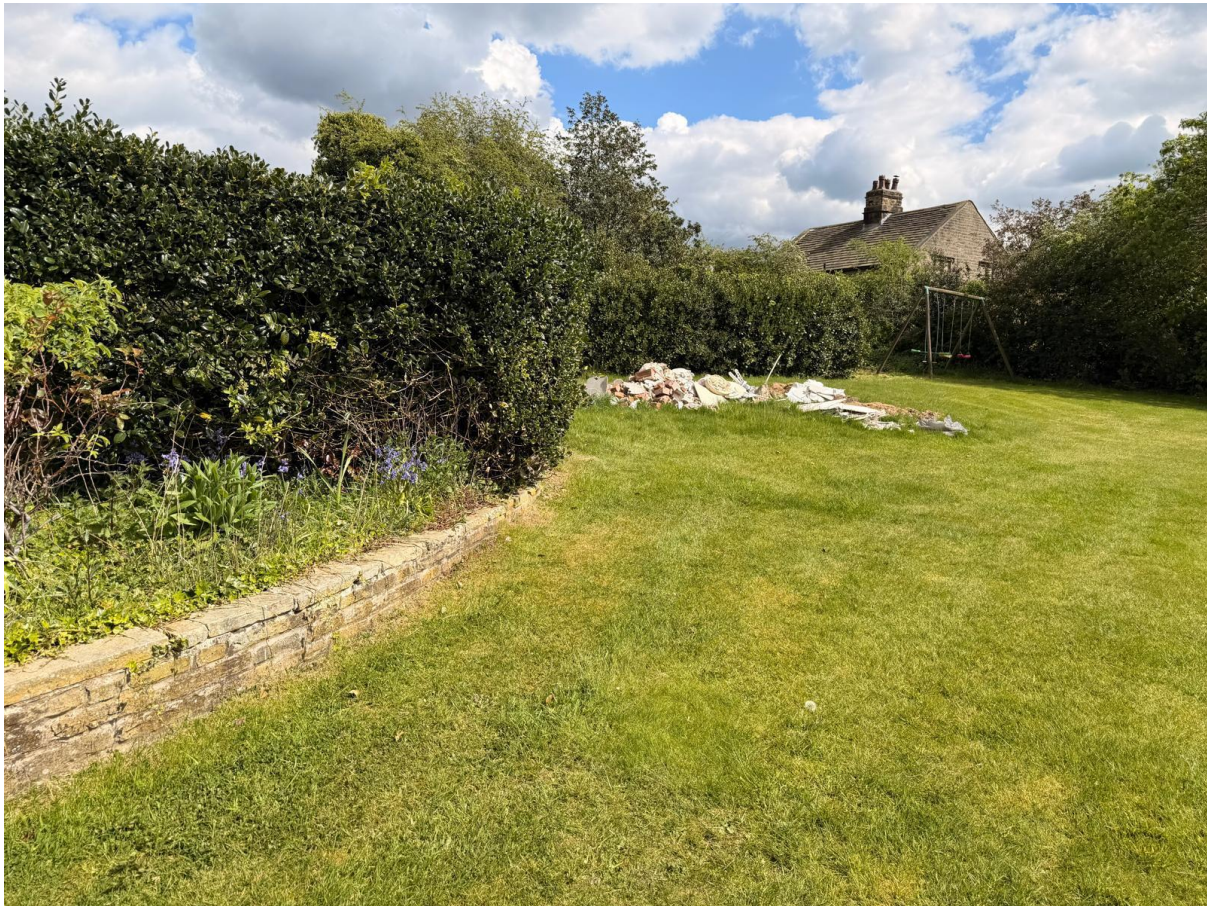
Plate 5: Openness & Screening Analysis – Looking toward the boundary to show established high hedging which will naturally screen the proposed Pavilion from neighbors.

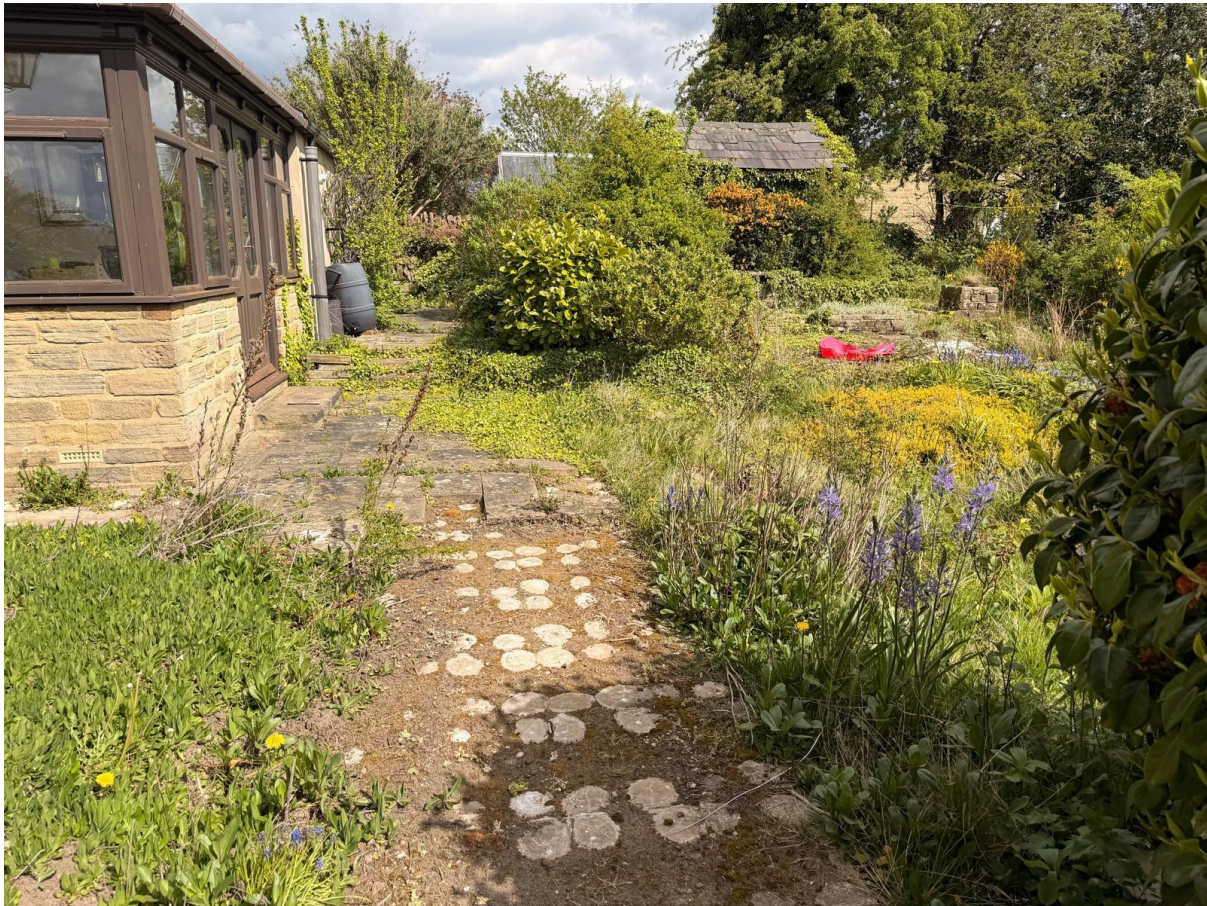
Plate 6: Unsafe External Surfaces – View of broken, overgrown paving and steep drops that necessitate a level, weather-protected internal therapy zone.

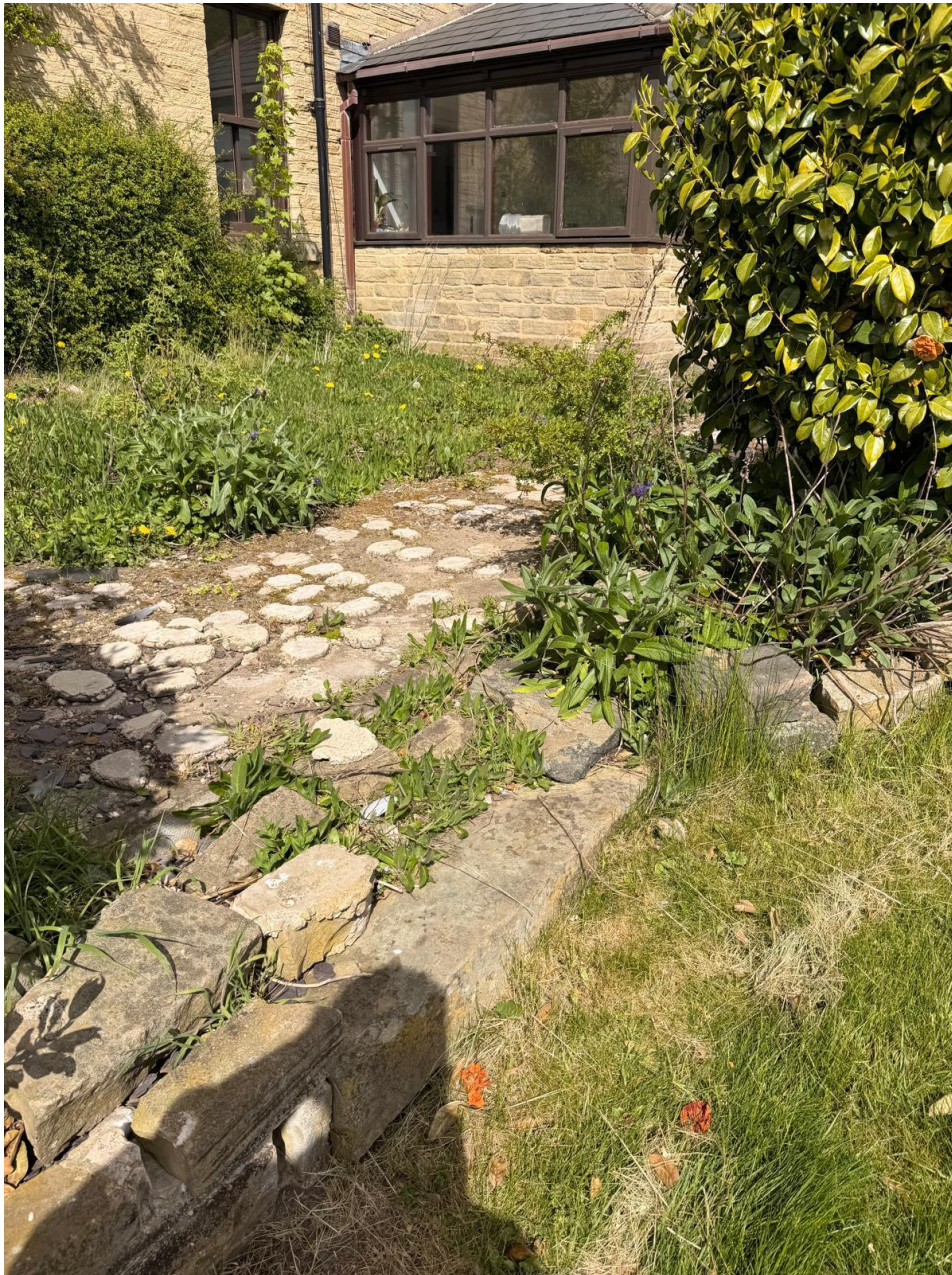
Plate 7: The "Usable Land" Fallacy – Wide-angle shot showing the contrast between a small paved area and the high-gradient lawn, proving a lack of safe physiotherapy space.

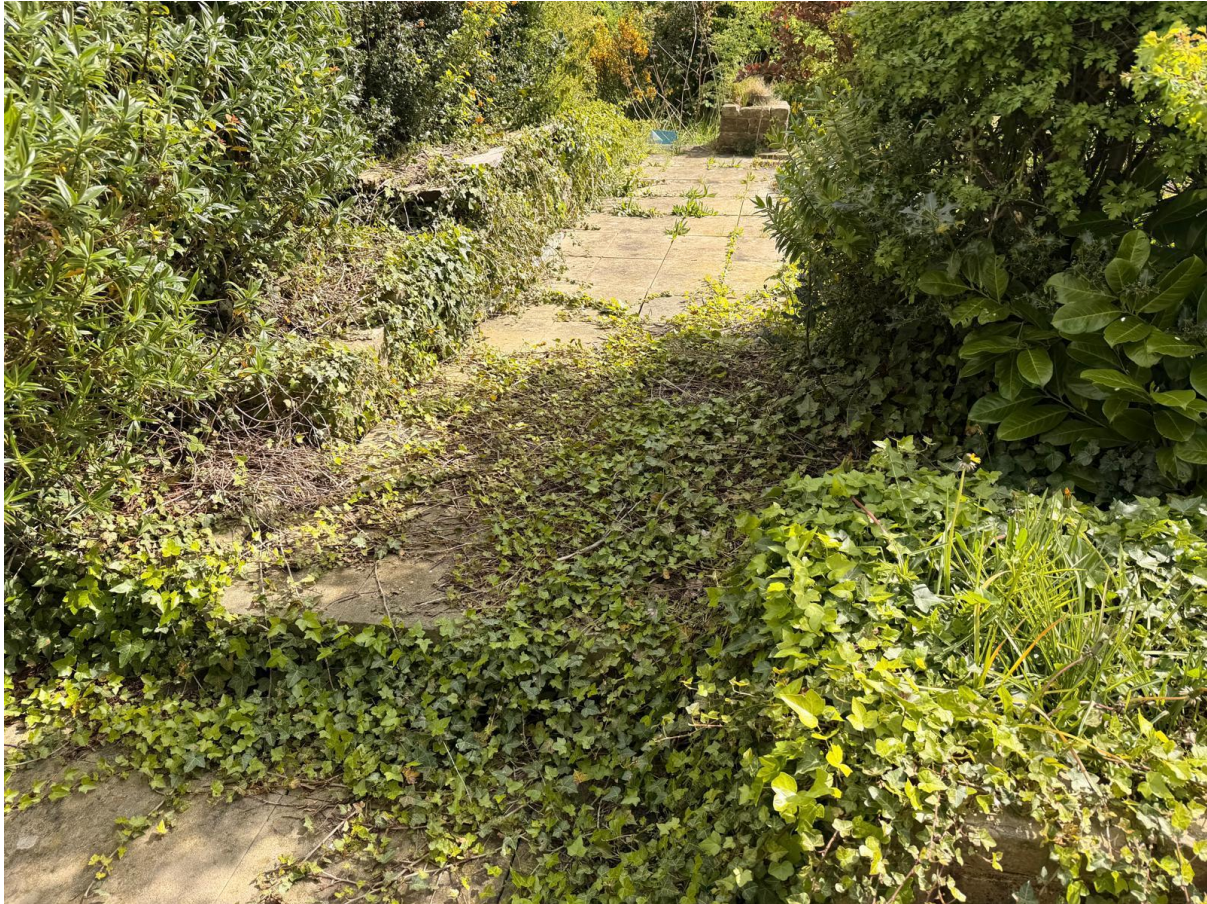
Plate 8: Narrow Access Constraints – View of restrictive pathways between the dwelling and garden walls that fail to accommodate 1500mm turning circles.

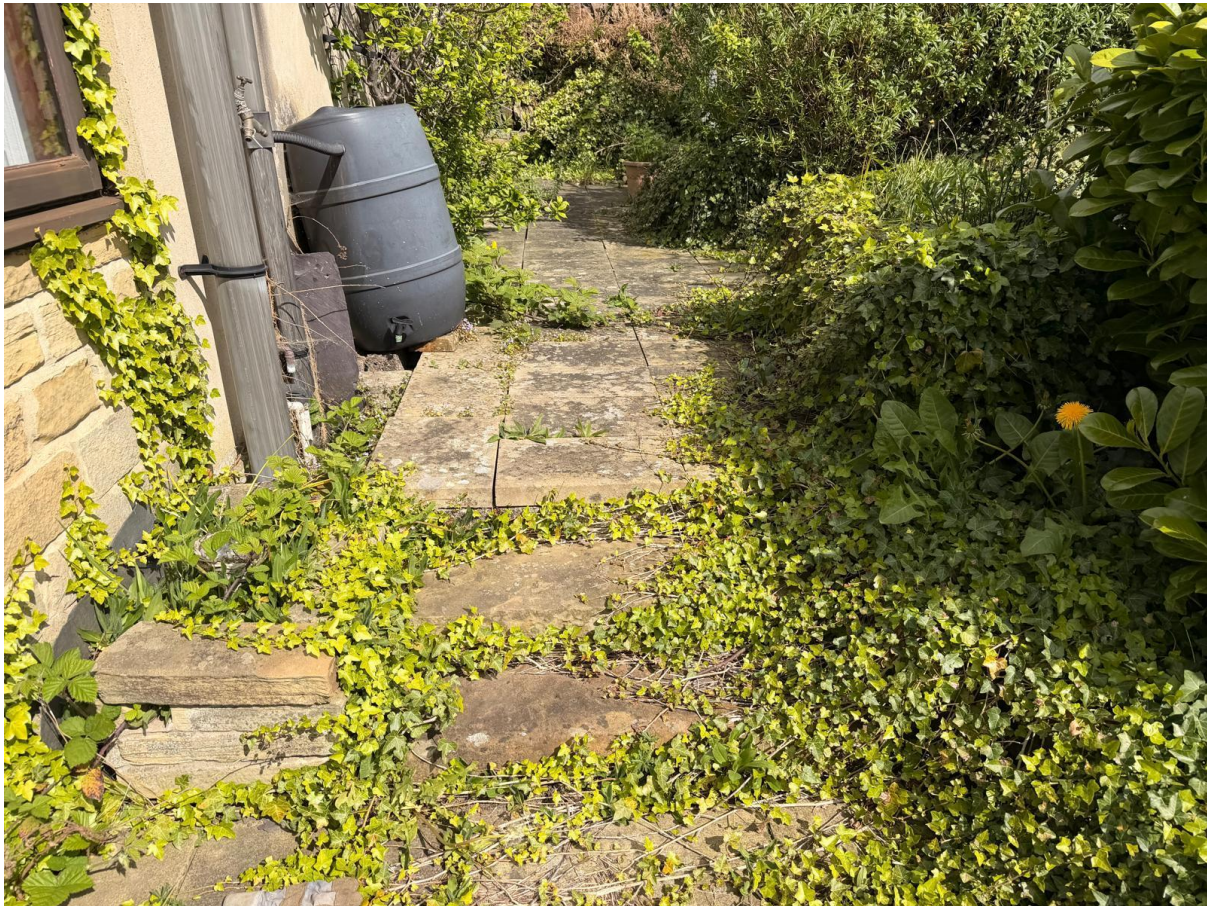
Plate 9: Encroaching Overgrowth – Evidence of significant vine and ivy growth on narrow paths, creating additional trip hazards for residents with neurological gait impairments.

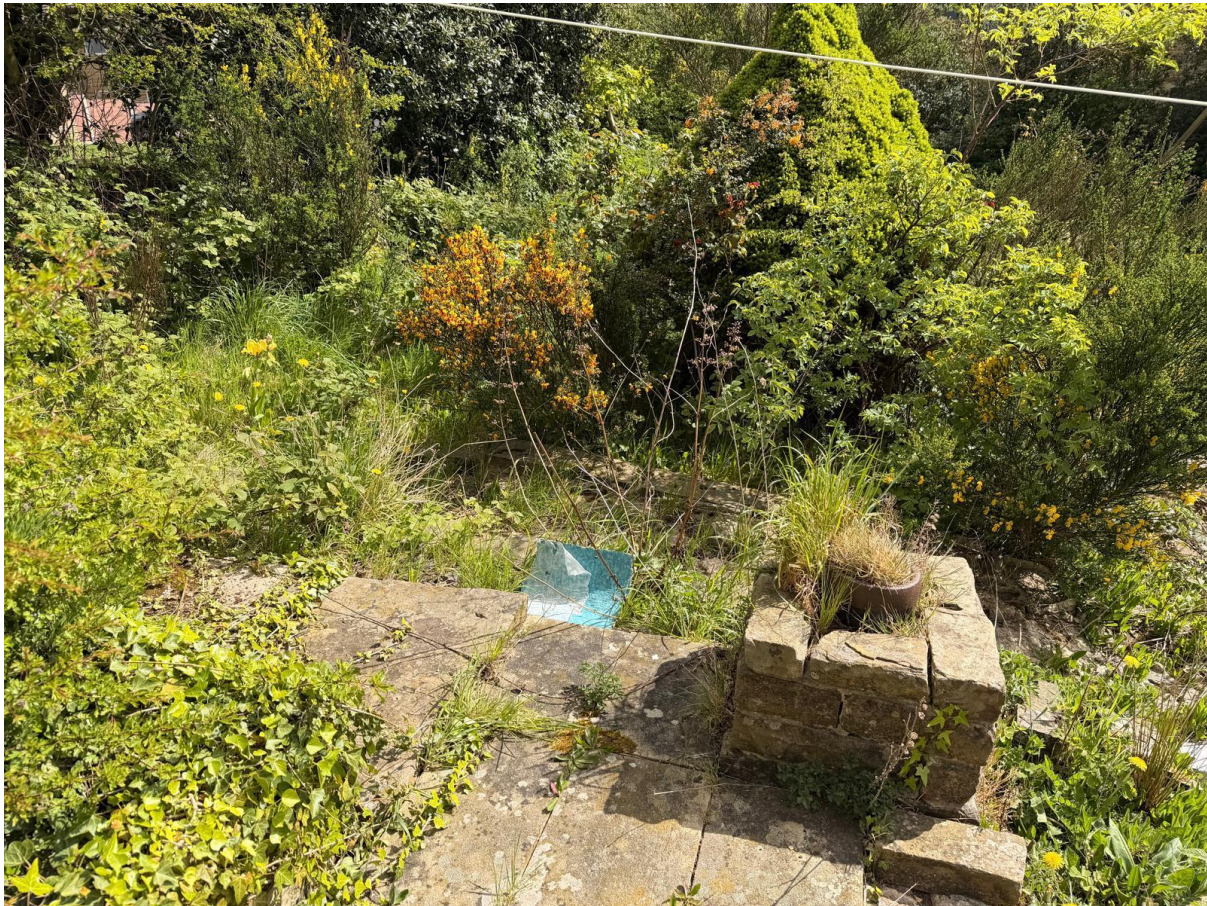
Plate 10: Infrastructure Barrier – View of essential drainage and utility placements located on uneven ground, further restricting the footprint of "safe" land.

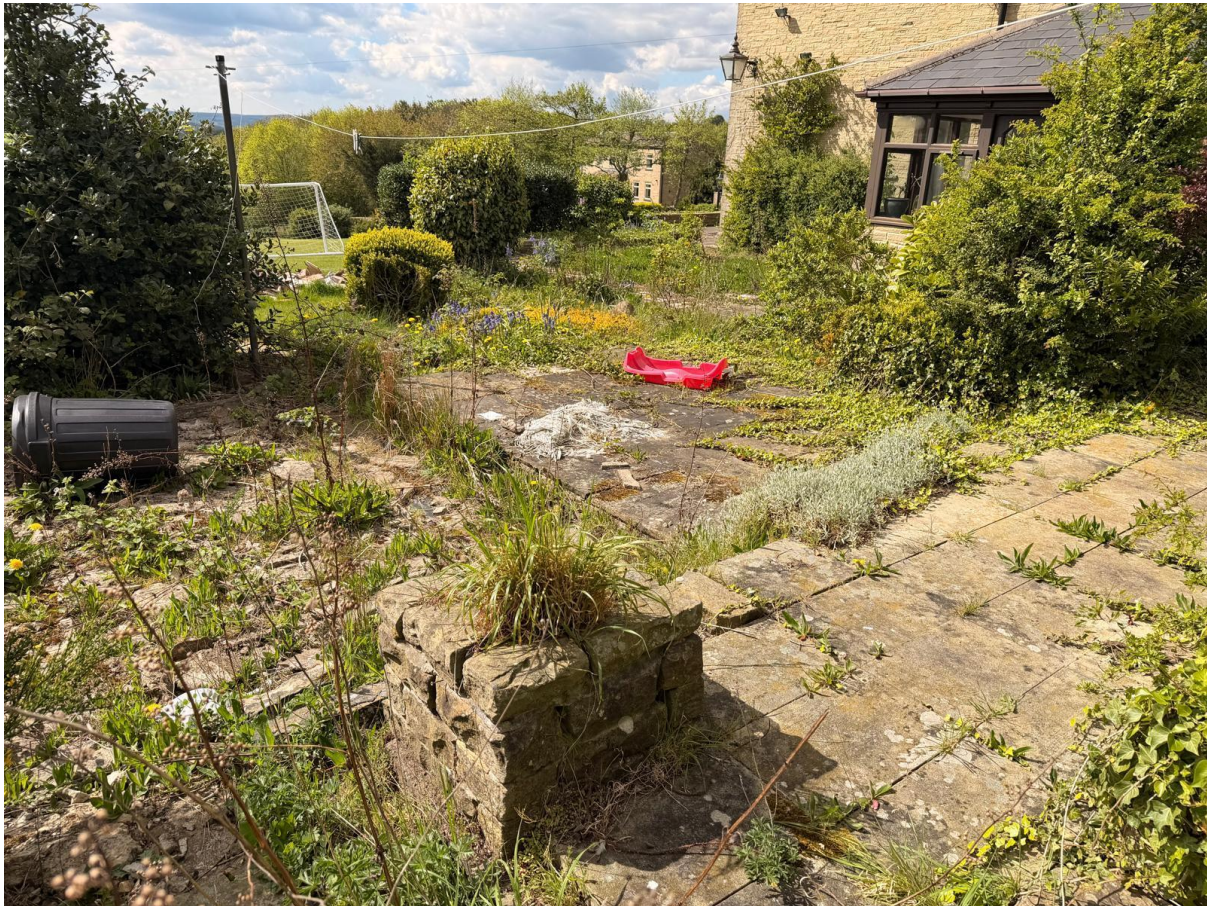
Plate 11: Topographical Drop-Off – Looking down a steep bank toward thick vegetation, illustrating why external acreage cannot meet the residents' clinical exercise needs.

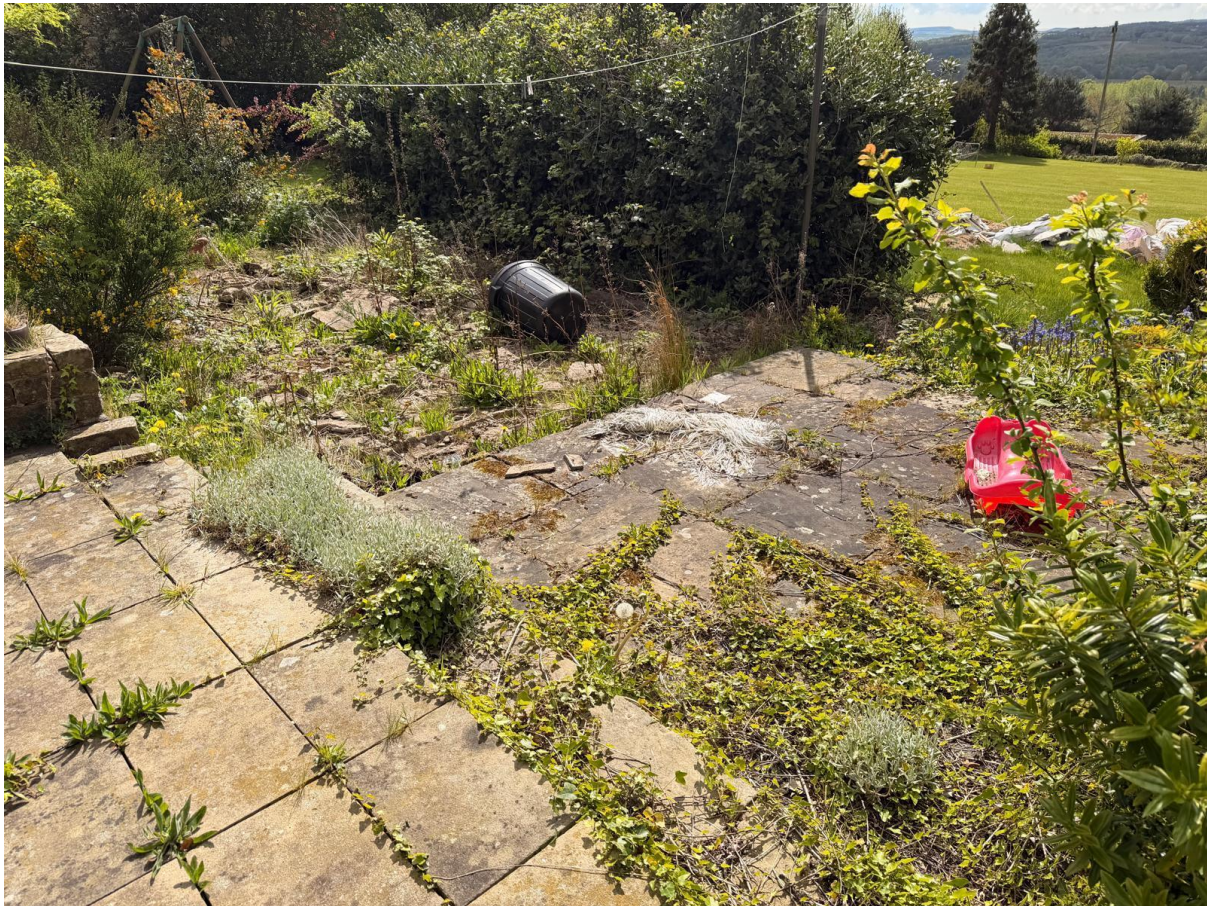
Plate 12: Central Site Coverage Analysis – A view of the existing dilapidated terrace area, showing the proposed location for the Pavilion to minimize Green Belt impact.

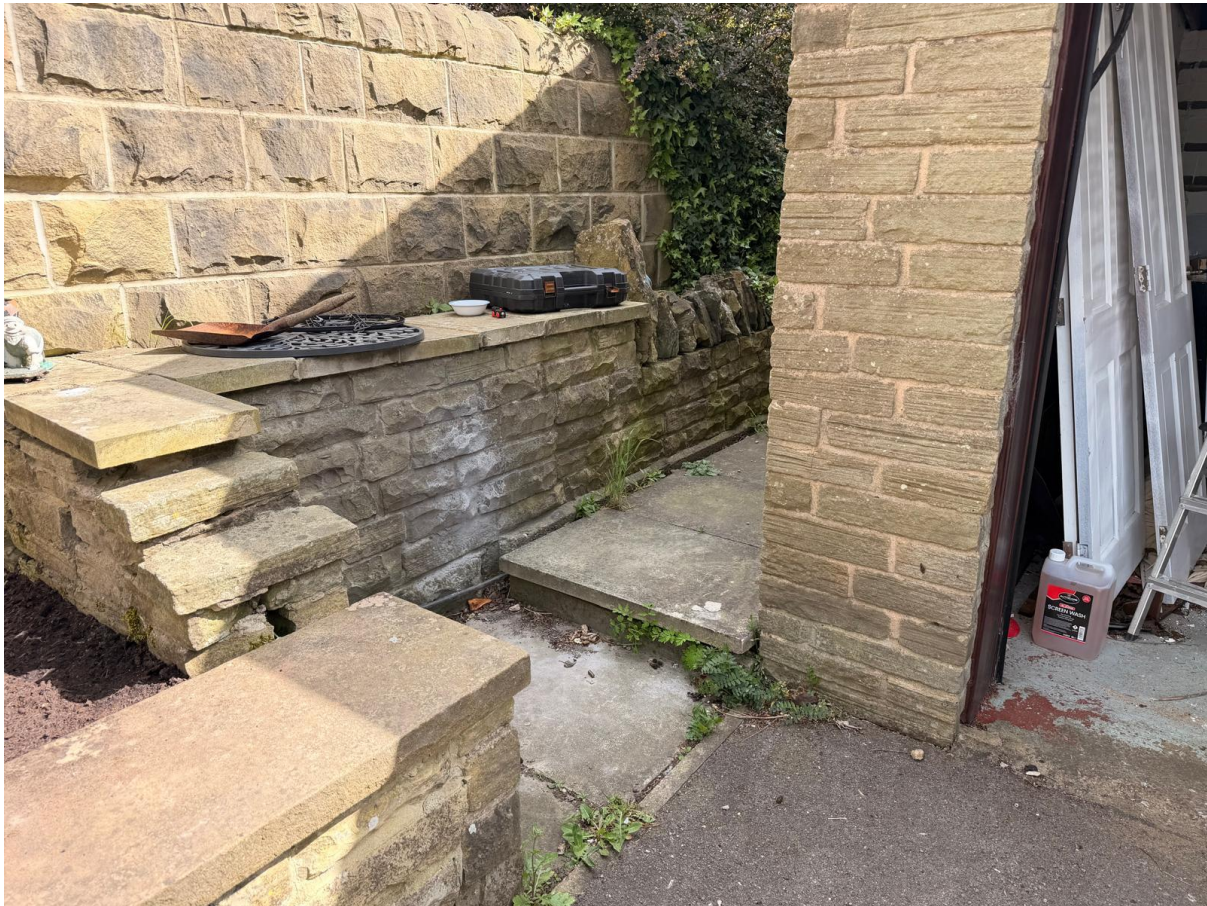
Plate 13: Technical Turning Barrier – View of stone walling and narrow steps that physically block the "continuous gait" required for effective mobility training.

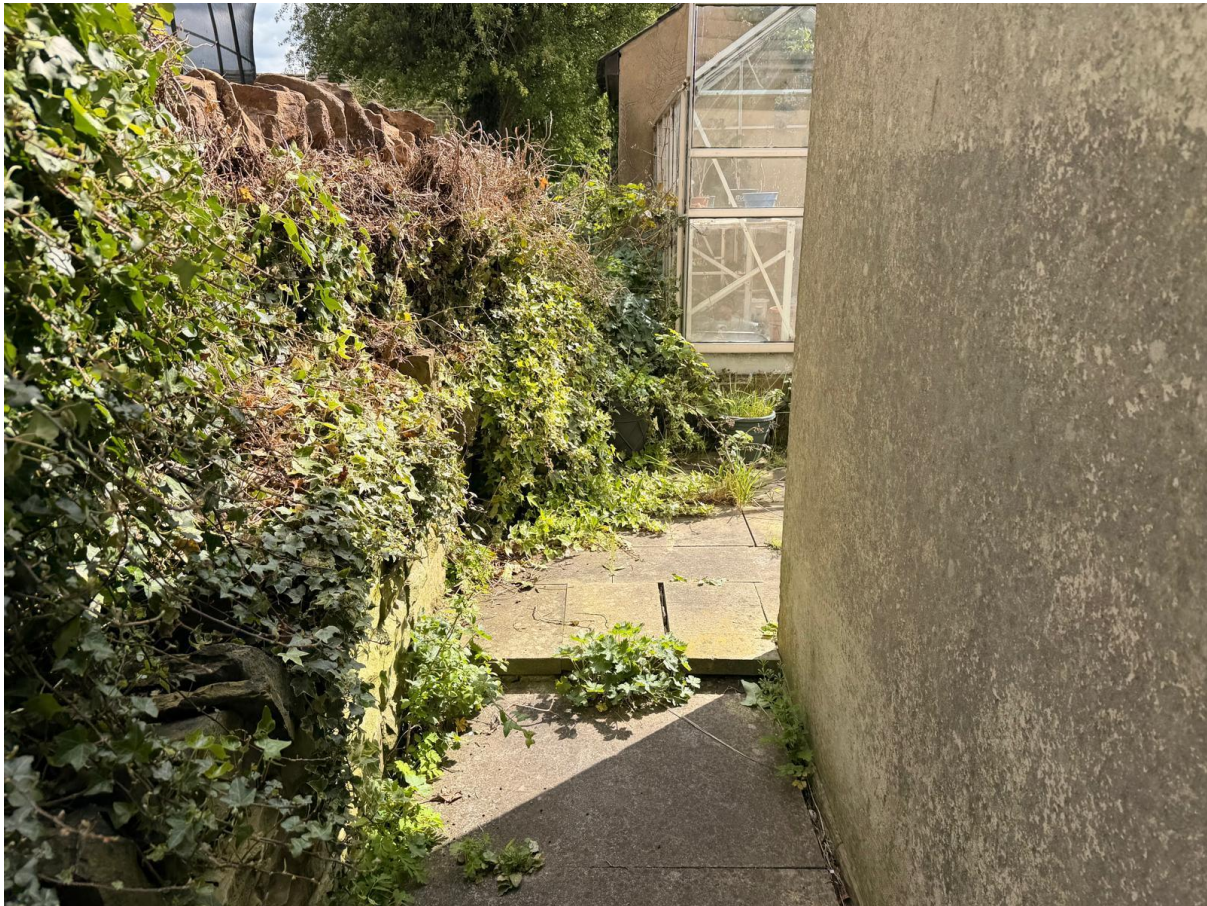
Plate 14: Confined Boundary Access – Final view showing the narrow, unsafe corridors between existing structures that justify the need for a spacious, open-plan Pavilion.
