Bankgate Mills, Bank Gate, Slaithwaite,  
Huddersfield, HD7 5DL

Level 2/3 Historic Building Recording

March 2026

Project No: 1753\_001

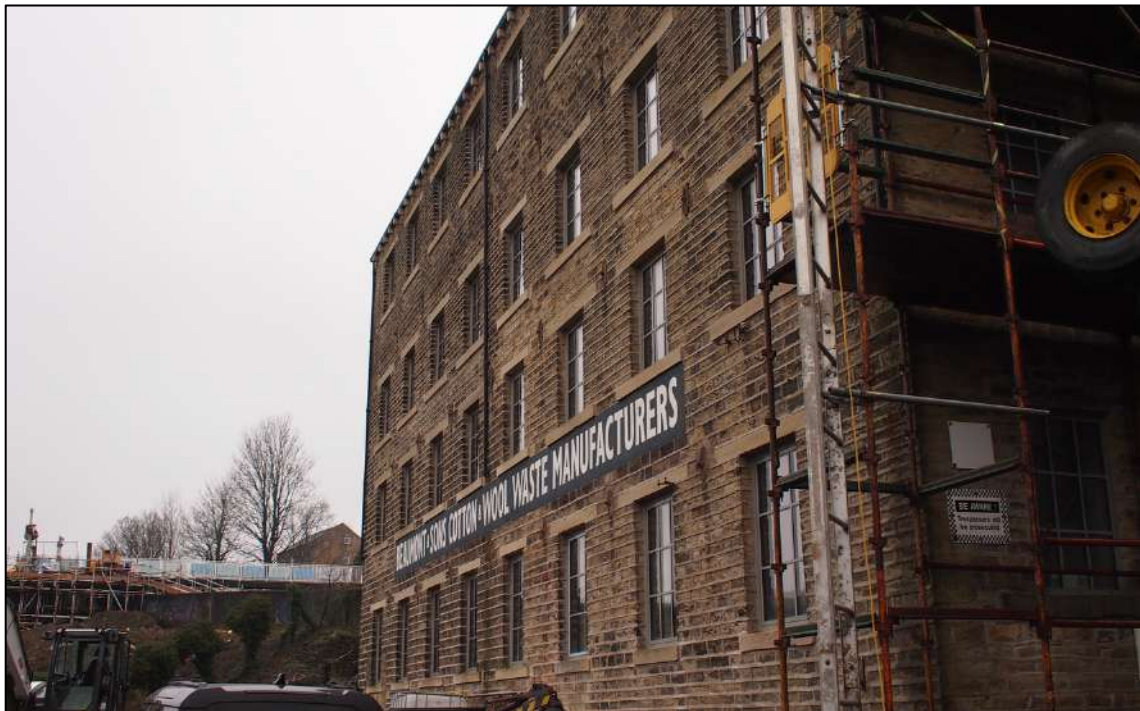
- 7.3 The external elevations are characterised by regular rows of window openings arranged across multiple bays, reflecting the need for high levels of natural light within textile manufacturing spaces (Plates 2–5, 7 and 9). The masonry walls are constructed of coursed stone blocks with stone lintels and sills. In places the masonry shows evidence of repair and modification, suggesting later alterations to the structure.

- 7.4 The principal elevation, facing north-east, displays a consistent pattern of window openings extending across several bays (Plates 2, 4 and 9). Some openings appear to have been altered or replaced during later phases of use, with modern window units now installed in a number of locations (Plate 10).

Plate 2: External oblique view of the mill building (Bankgate Mill (101).JPG, AHP).

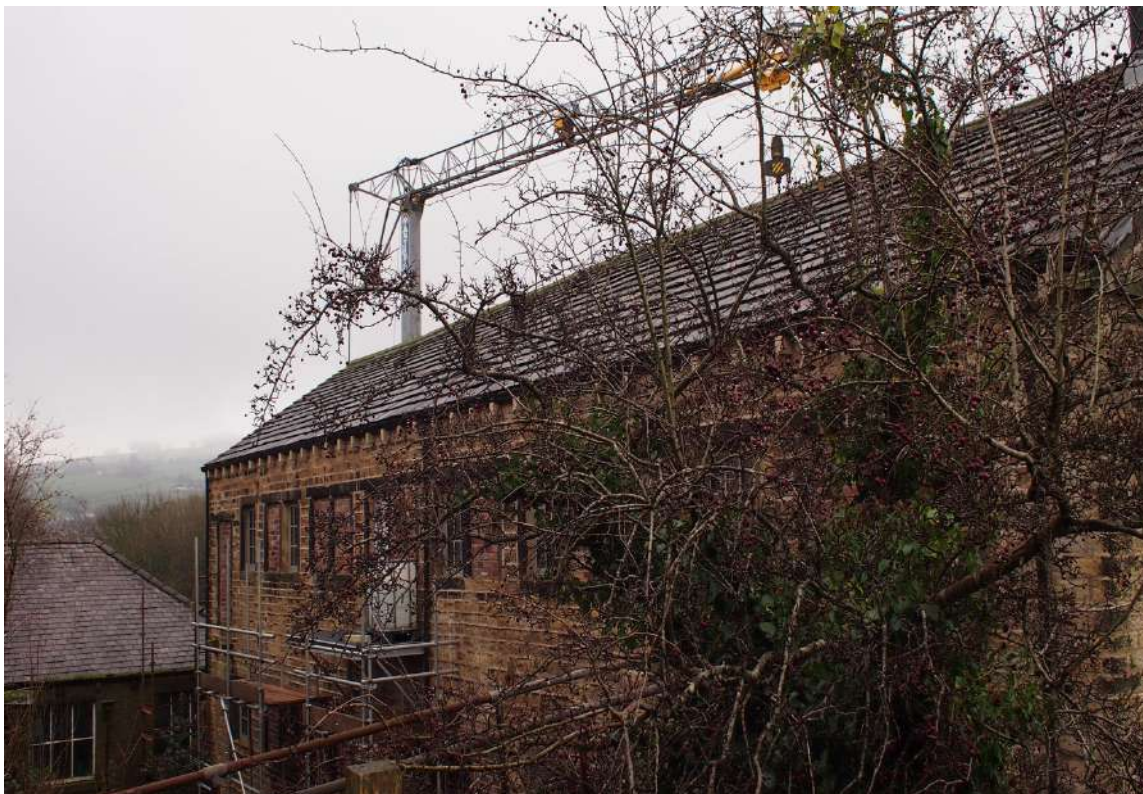
Plate 4: External view of the principal elevation showing multiple rows of window openings (Bankgate Mill (121)).JPG, AHP).

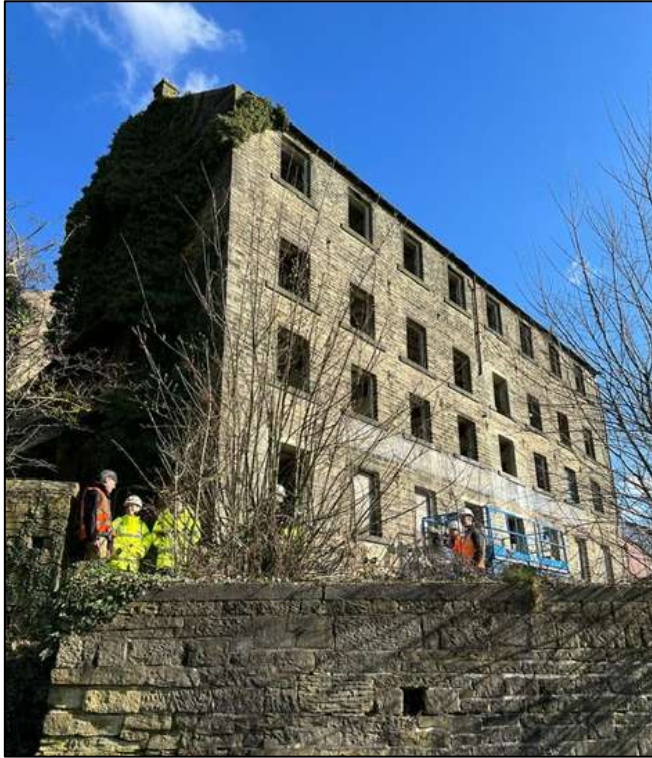
Plate 7: External view of the front elevation from below the retaining wall (25.jpeg, Client).

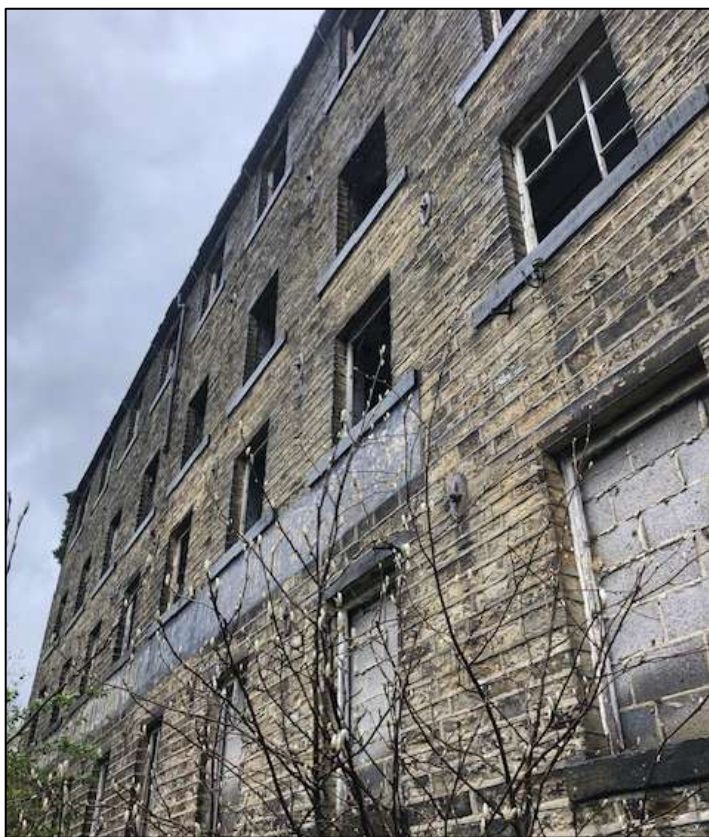
*Plate 9: External view along the principal elevation showing window bays (32.jpeg, Client).*

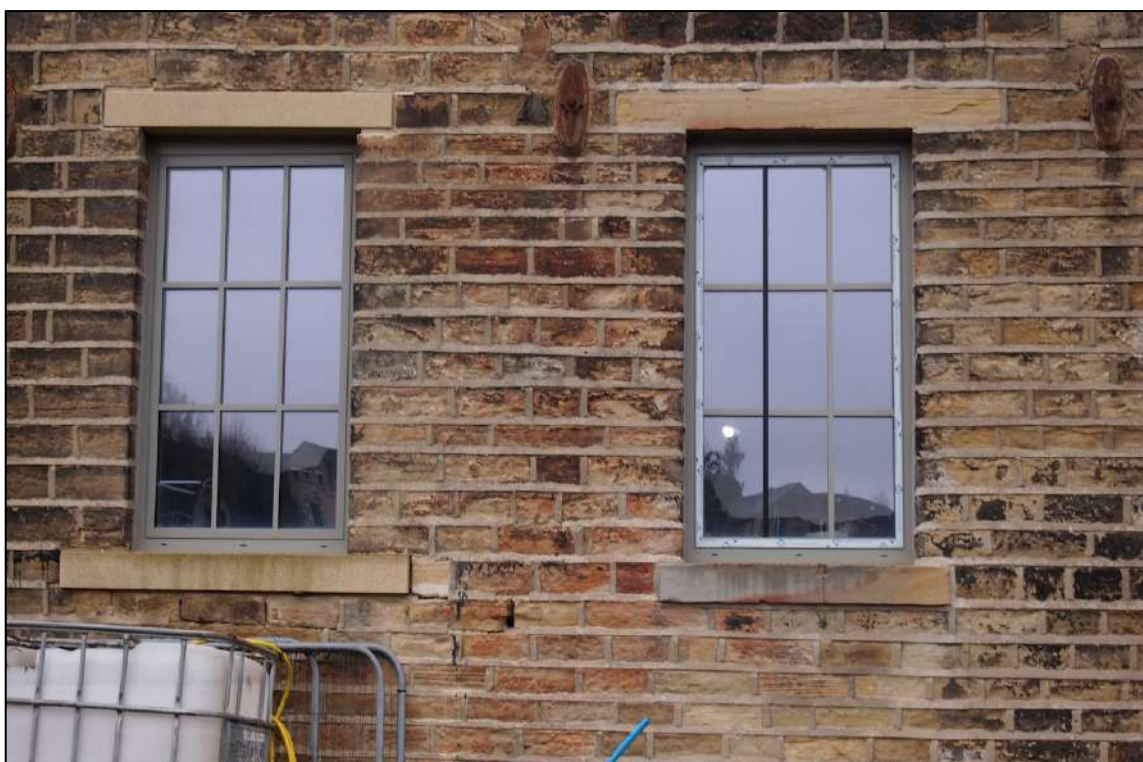
*Plate 10: External detail of stone masonry wall and modern window openings (Bankgate Mill (90).JPG, AHP).*

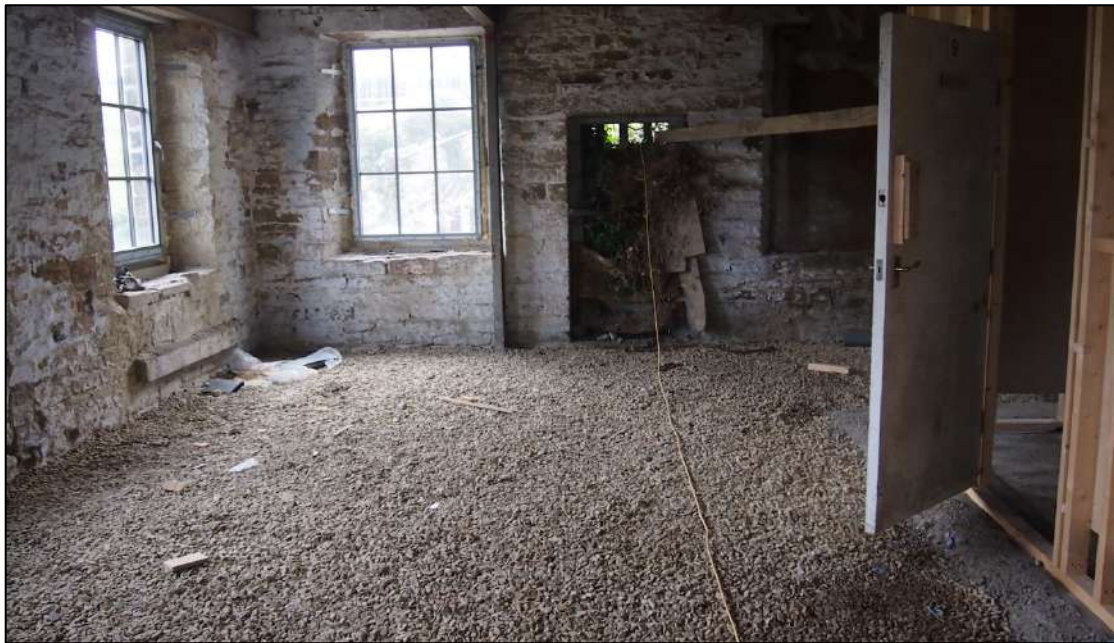
*Plate 18: Interior view showing wall surface condition and internal floor space (Bankgate Mill (81).JPG, AHP).*

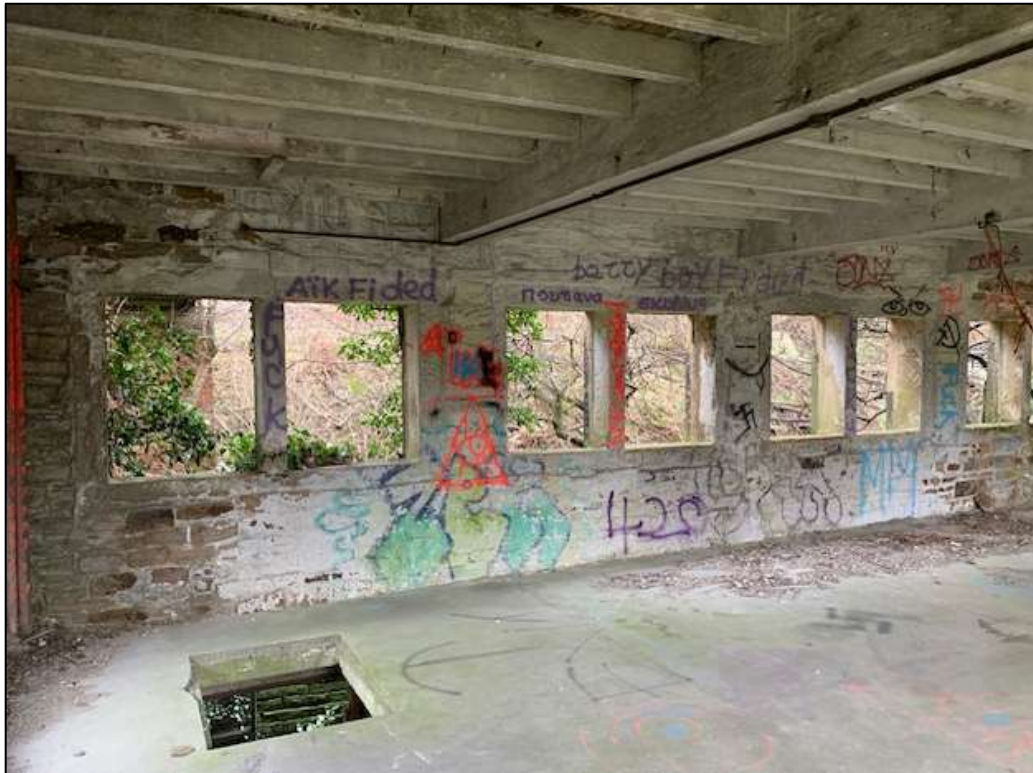
Plate 19: Interior view showing graffiti, access point and wall surfaces (10.jpeg, Client).

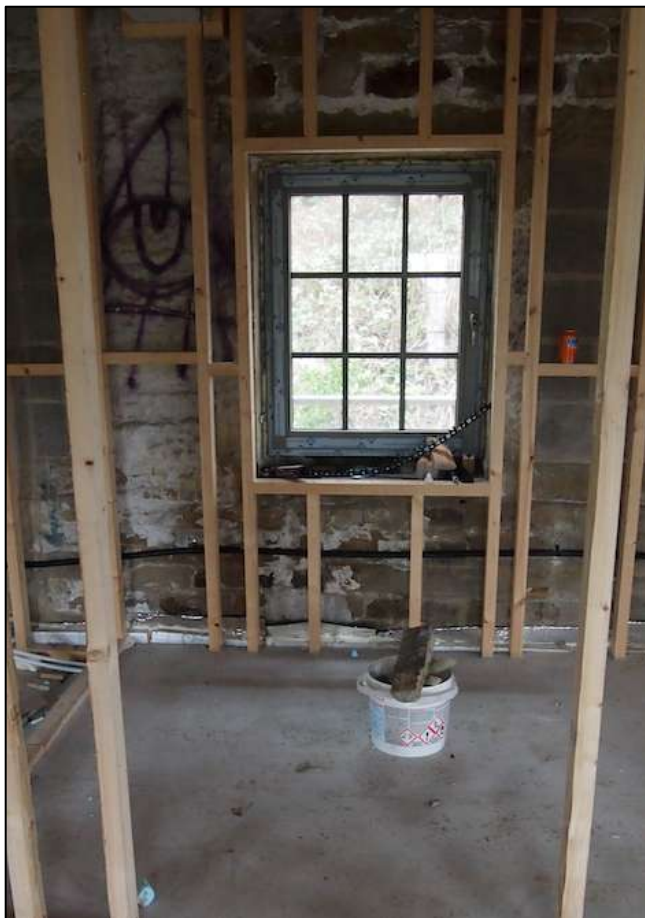
Plate 22: Interior detail showing modern framed opening within an internal partition (Bankgate Mill (42).JPG, AHP).

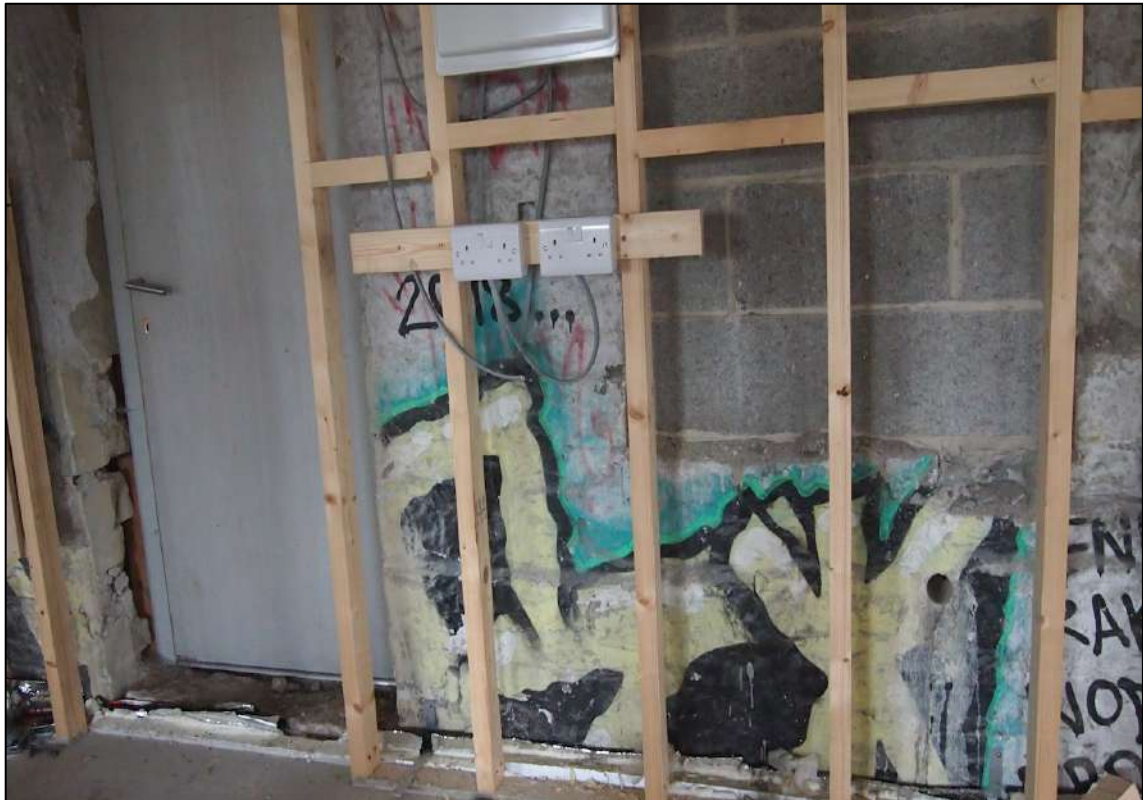
Plate 25: Interior detail showing graffiti behind the modern partitions (Bankgate Mill (10).JPG, AHP).

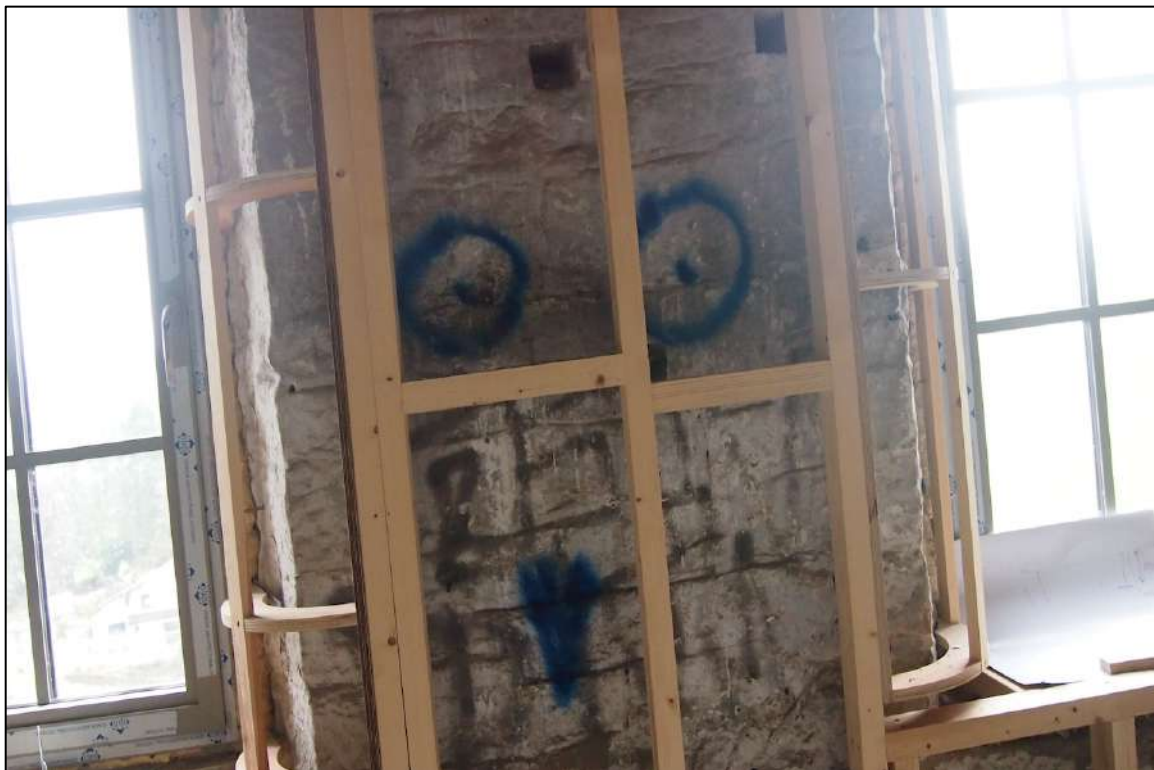
Plate 26: Interior detail showing modern framed opening within an external wall (Bankgate Mill (11).JPG, AHP).
