## Plot 23: Unresolved Waterproofing, Drainage and Lawfulness Issues

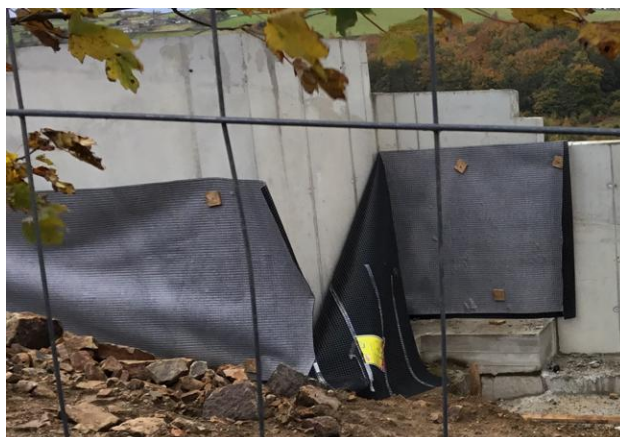
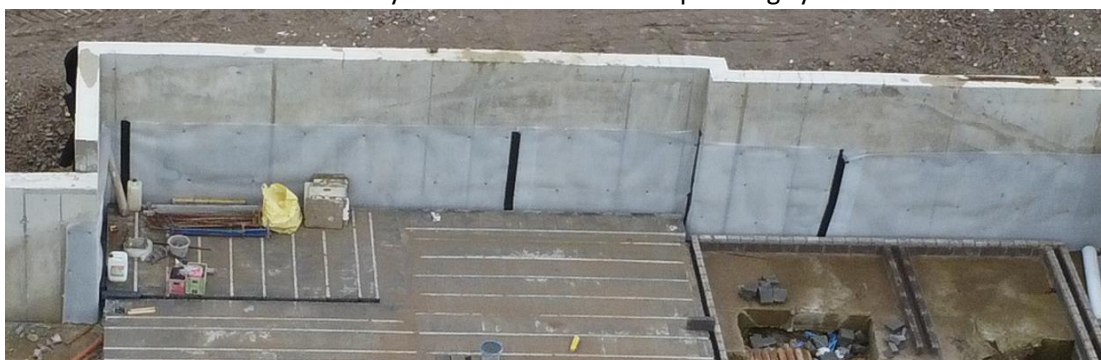
- The **fully bonded waterproofing system** shown in the disclosed detail would be applied to the external, earth-facing concrete face.
- The light-grey membrane installed on that external face has been positively identified as **Wykamol CM8 Geotextile**. This is a drainage and protection product, not the fully bonded waterproofing system itself.
- The white membrane fitted to the internal, Plot 23-facing side of the retaining wall is believed to be **Wykamol CM8 Cavity Drain membrane**. It is a separate product, installed in a different location, and must not be confused with either the grey external Geotextile membrane or the fully bonded external waterproofing system.

Photographs taken before concealment appear to show areas of the external, earth-facing concrete without the fully bonded waterproofing system shown in the disclosed detail.

The light-grey CM8 Geotextile is visible in some areas. Where it already covers the concrete, photographs cannot reveal what is behind it. However, where the earth-facing concrete remained exposed before the CM8 Geotextile was fitted or backfilling occurred, no fully bonded layer is apparent.

Later photographs do not appear to show the fully bonded system being added to those exposed areas before they were covered or became inaccessible. Construction and backfilling subsequently progressed to the point at which a continuous fully bonded external system could not now be installed in the documented manner without excavation, removal of the CM8 Geotextile and disturbance of later construction.

The absence of a visible membrane in photographs is not, by itself, conclusive proof that no system exists elsewhere. The applicant should therefore be required to produce contemporaneous installation photographs, inspection records and certification demonstrating that the fully bonded system was installed throughout before the CM8 Geotextile and backfill concealed it.

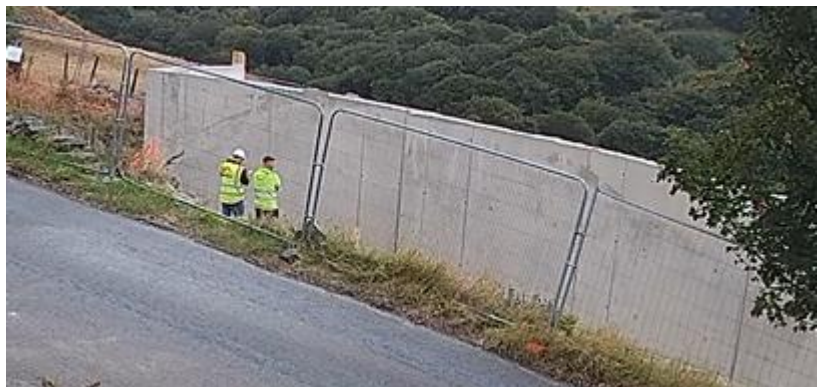
Time-stamped CCTV footage from 1 September 2025, from which the accompanying still has been extracted, shows a person who appears to inspect the retaining works at Plot 23. Within minutes of that person leaving, an excavator begins earth-moving or apparent backfilling in the same area.

The evidence alone does not establish the visitor's identity or the precise purpose of the visit. It does, however, demonstrate how quickly work capable of concealing the external waterproofing and drainage arrangement followed the apparent inspection.

Kirklees should identify the visitor, the purpose and scope of the visit, what was inspected, whether the external face and fully bonded system were visible, what records or photographs were produced, and what evidence was relied upon before backfilling proceeded.

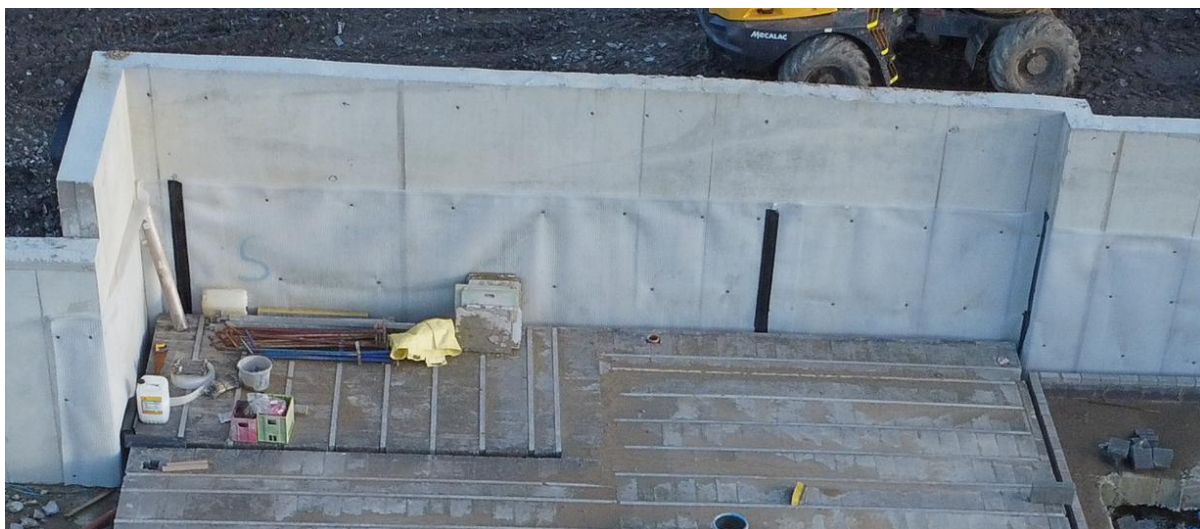
The photograph dated 14 March 2026 shows the white membrane fitted across the internal, Plot 23-facing side of the retaining wall. Large areas remained uncovered above it at that stage.

These photographs are relevant to the identity, continuity and installation sequence of the white membrane. They do not establish whether the fully bonded system was present or absent from the opposite, earth-facing side.

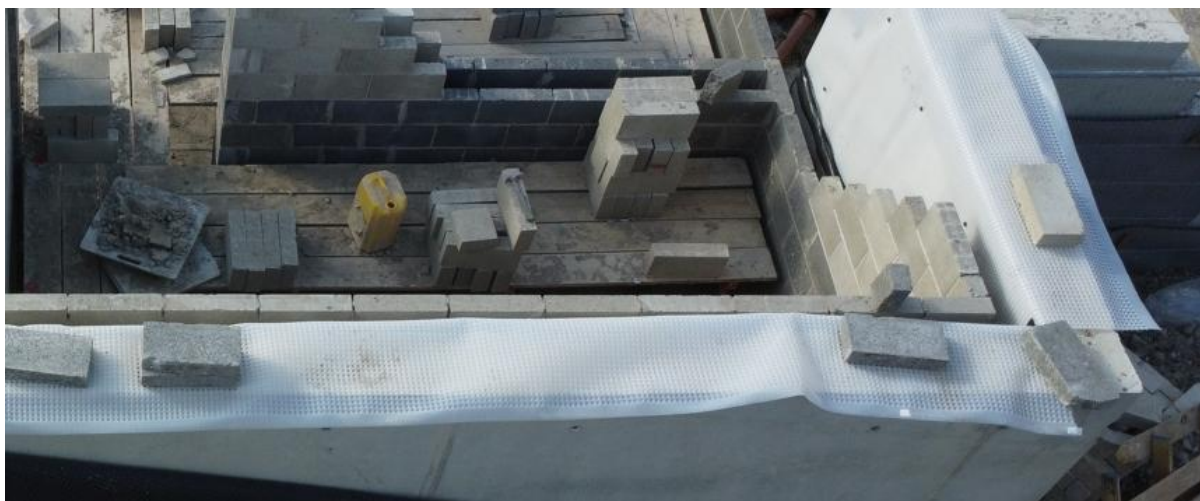
Further rolls were subsequently added, overlapping the earlier material and extending above the top of the retaining wall. By 22 May 2026, the upper material was present on the left-hand section and was apparently being held in position by loose concrete blocks pending construction of the stone wall above. The corresponding upper layer remained absent behind the kitchen area on the right at that time.

If the white product is Wykamol CM8 Cavity Drain membrane, it may form part of a drainage or waterproofing strategy. However, it cannot simply be assumed to constitute the unidentified internal primary system referred to by Building Control.

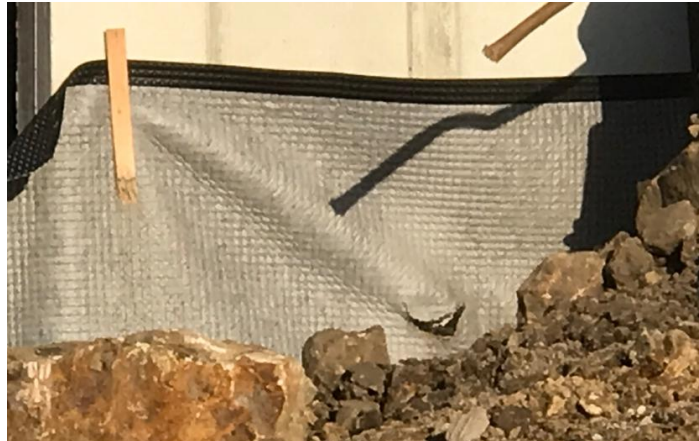
Comparative evidence from Plot 2 shows the same grey product left exposed and unprotected for a prolonged period:

- On 5 September 2025, a distinct tear was visible in the geotextile face.
- By 17 October, the material remained exposed and had become extensively distorted and damaged.
- On 9 November, a large angular stone was bearing directly against it beside an apparent impact tear.

The Plot 2 photographs do not establish what was installed at Plot 23. They do, however, demonstrate how the same external drainage product was handled elsewhere on the development and suggest that inadequate protection and damage may not have been isolated occurrences.

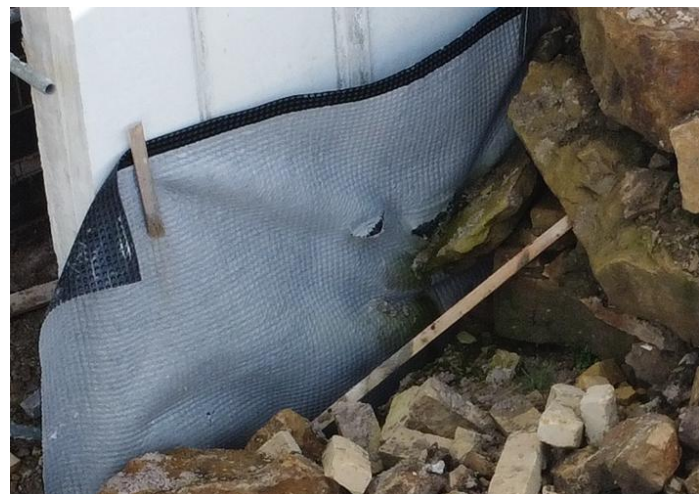
Building Control has indicated that the primary waterproofing system is situated internally and that the external membrane is secondary.

The grey external CM8 Geotextile may properly be described as secondary because it is a drainage and protection layer rather than the fully bonded waterproofing system shown in the disclosed external detail. That description does not, however, explain the apparent departure from the documented arrangement.
