# LONG LANE, EARLSHEATON

## HIGHWAY CONDITION SURVEY REPORT

### WORDSWORTH PROPERTY DEVELOPMENTS LIMITED

Date: May 2026

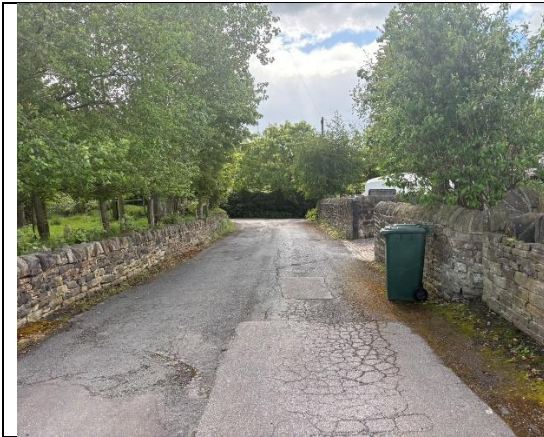
Photo CW-62

| Photo CW-61 to 67 | Trench scarring, patching, crocodile cracking / surface course in poor condition, weed growth, wheelie bin |

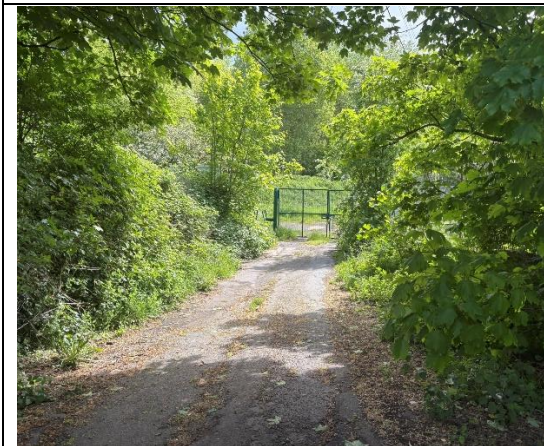
Photo CW-70

| Photo CW-68 to 71 | Patching, crocodile cracking / surface course in poor condition, debris |

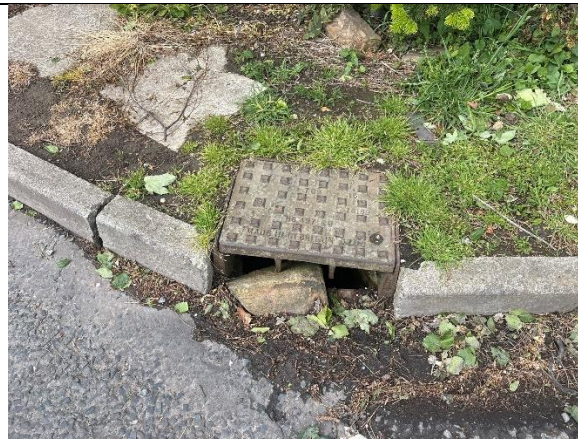
| Area of Survey | Photo Ref. | Defect / Comment |
|---|---|---|
| | Photo G-3 | Kerb drain, poor condition, partially blocked with large stone |

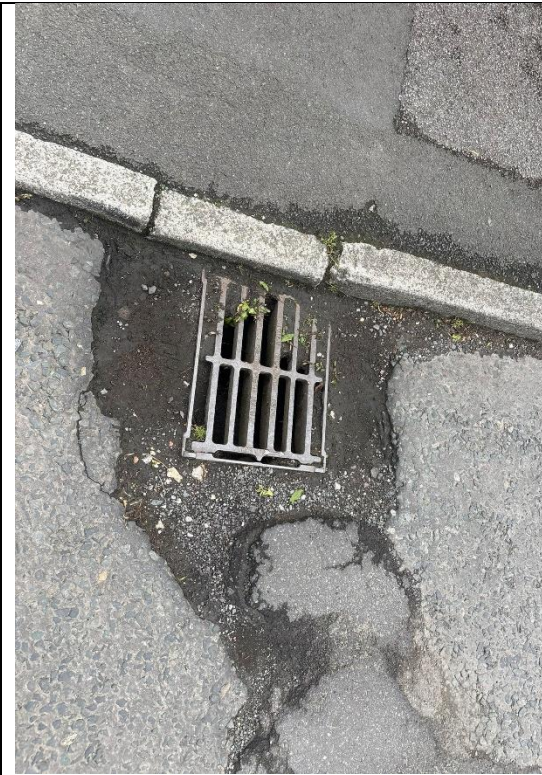
| Area of Survey | Photo Ref. | Defect / Comment |
|---|---|---|
| | Photo G-4 | Suitable condition, slight sediment build up, severe damage to surface course around cover |

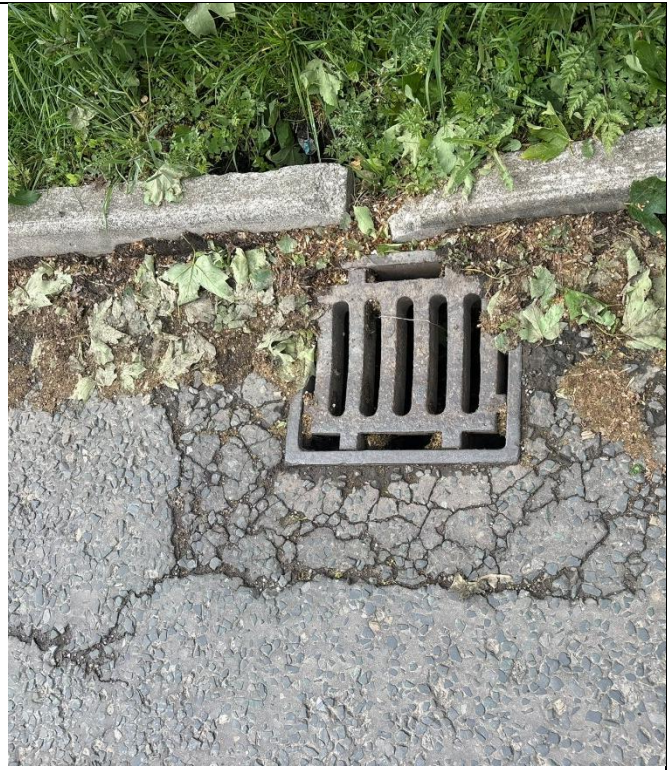
| Area of Survey | Photo Ref. | Defect / Comment |
|---|---|---|
| | Photo G-7 | Poor condition heavy sediment/debris build up, crocodile cracking in surface course around cover |

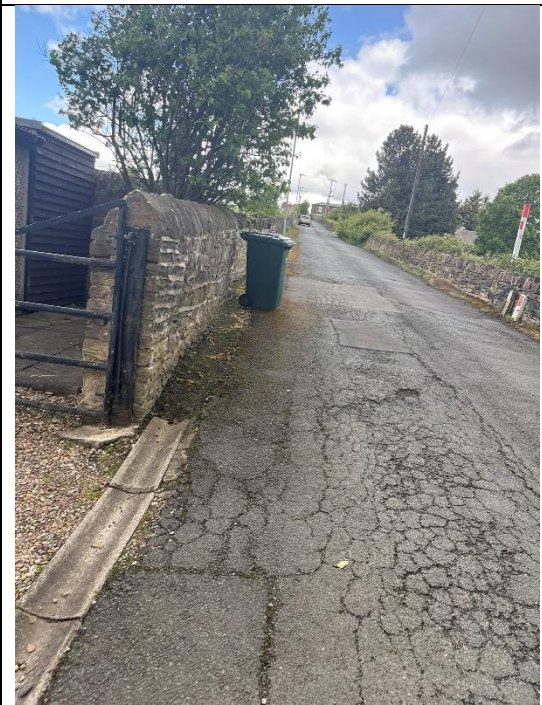
| Area of Survey | Photo Ref. (FE) | Defect / Comment |
|---|---|---|
| | Photo FE-13 | Trench scarring, surface course damage, street name plate missing |

- 2.2.4 Generally, the road markings are in good condition; except the carriageway centreline in photos CW-1 to 2 and CW-8 to 9. All the signage along the surveyed route is in good/average condition, with the exception of the missing street name plate in photo FE-13.

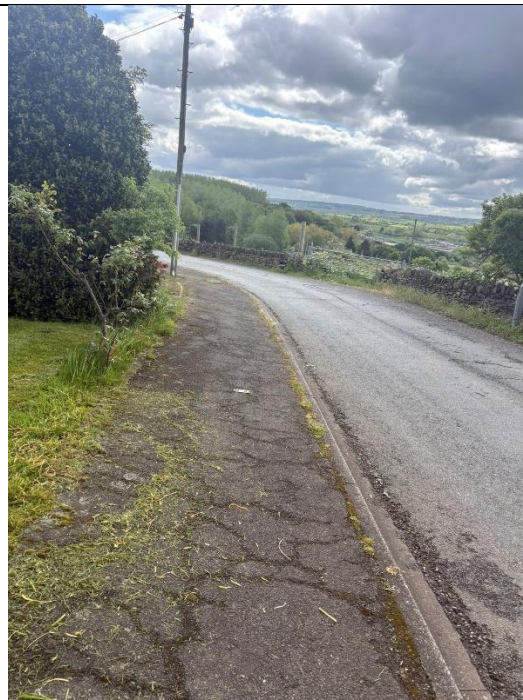
| Photo FE-81 | Debris build up, surface course in poor condition, weed growth |

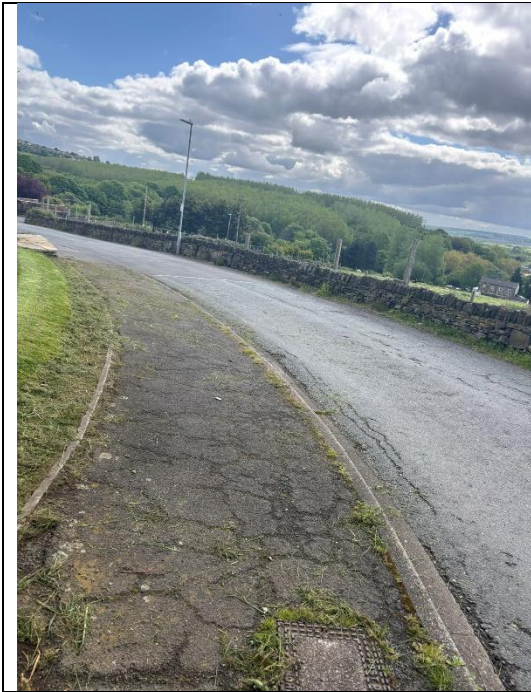
| Photo FE-83 | Debris build up, surface course in poor condition, weed growth, utility pole |

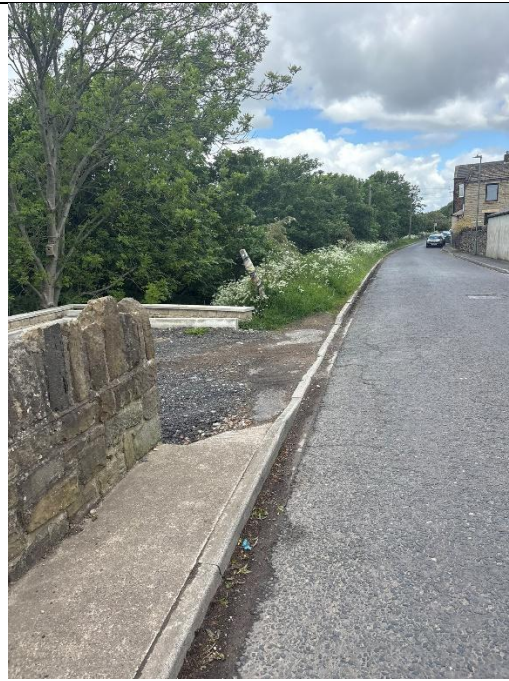
| Photo FW-81 | Footway terminates, change in surfacing type, sediment carried onto footway, surface course damage |
