Post-Works Special Inspection Report

Storthes Hall Bridge

Structure No: K0150

June 2026

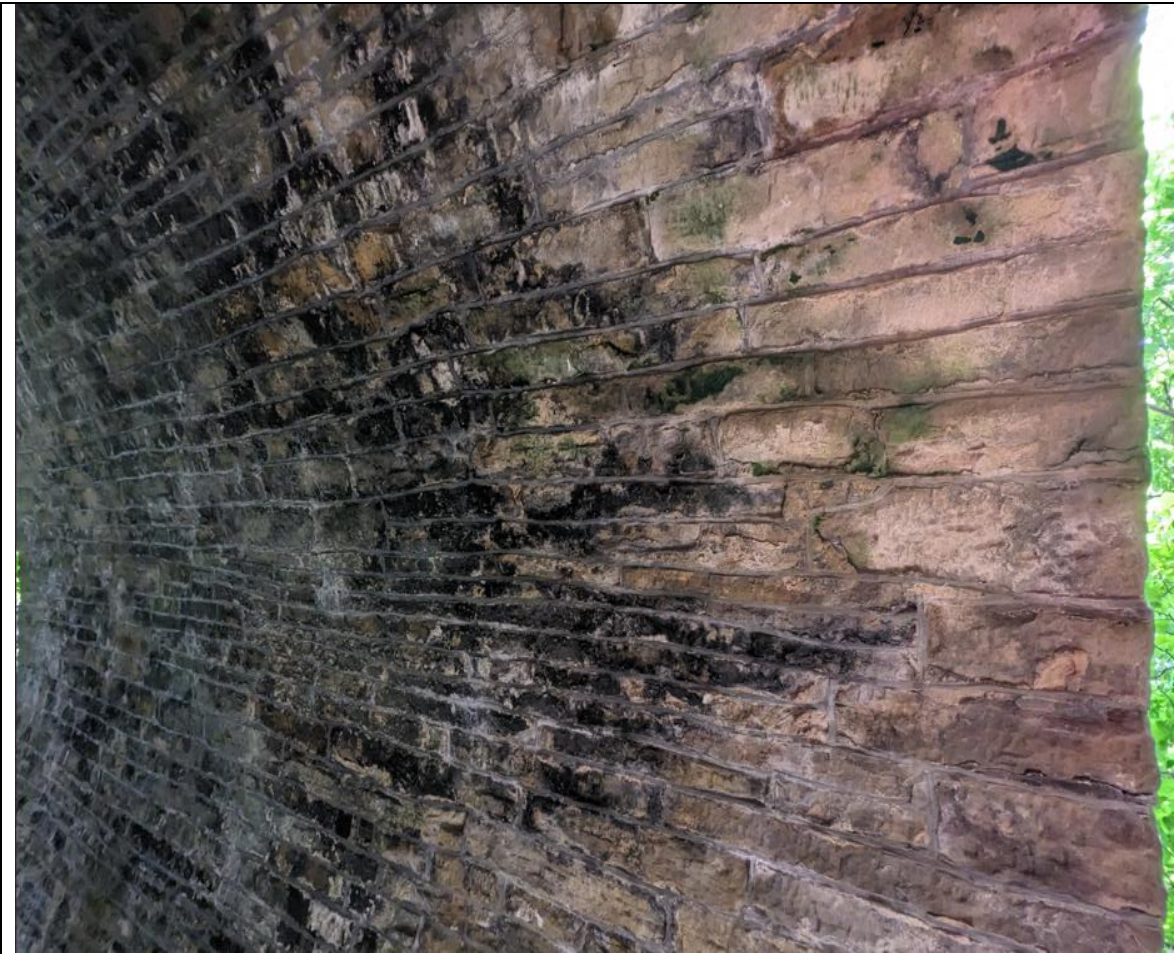
The arch barrel was recently repointed extensively, and remained dry, with the mortar sound. The joints were full, no distortion was visible to the arch profile, and no hollow sounding was found during the inspection.

The arch barrel was pressure pointed in 1982, and saddled in 1992 according to archive information. The saddle was not visible for inspection, however, there were no defects to the structure exhibited which would indicate any issues with the saddling.

Photograph 3 - General View of Arch Barrel

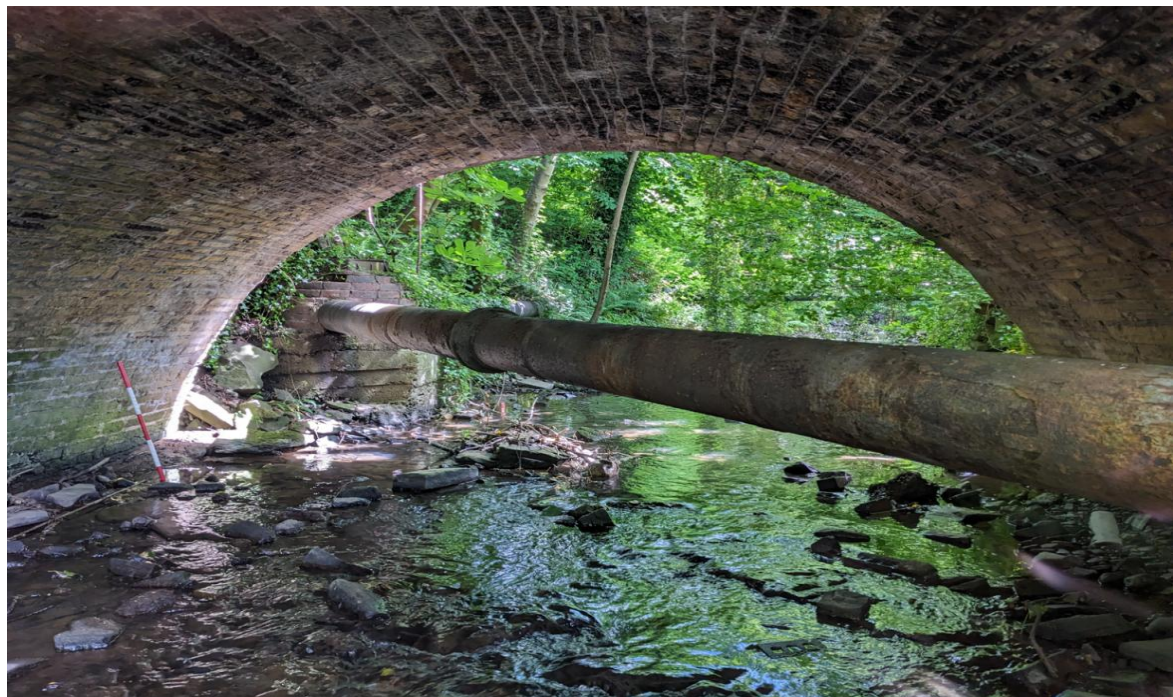
The invert was generally sound, with no notable deterioration observed. It is suggested that a Level 1 Scour Survey is undertaken.

Photograph 4 - General View of Invert

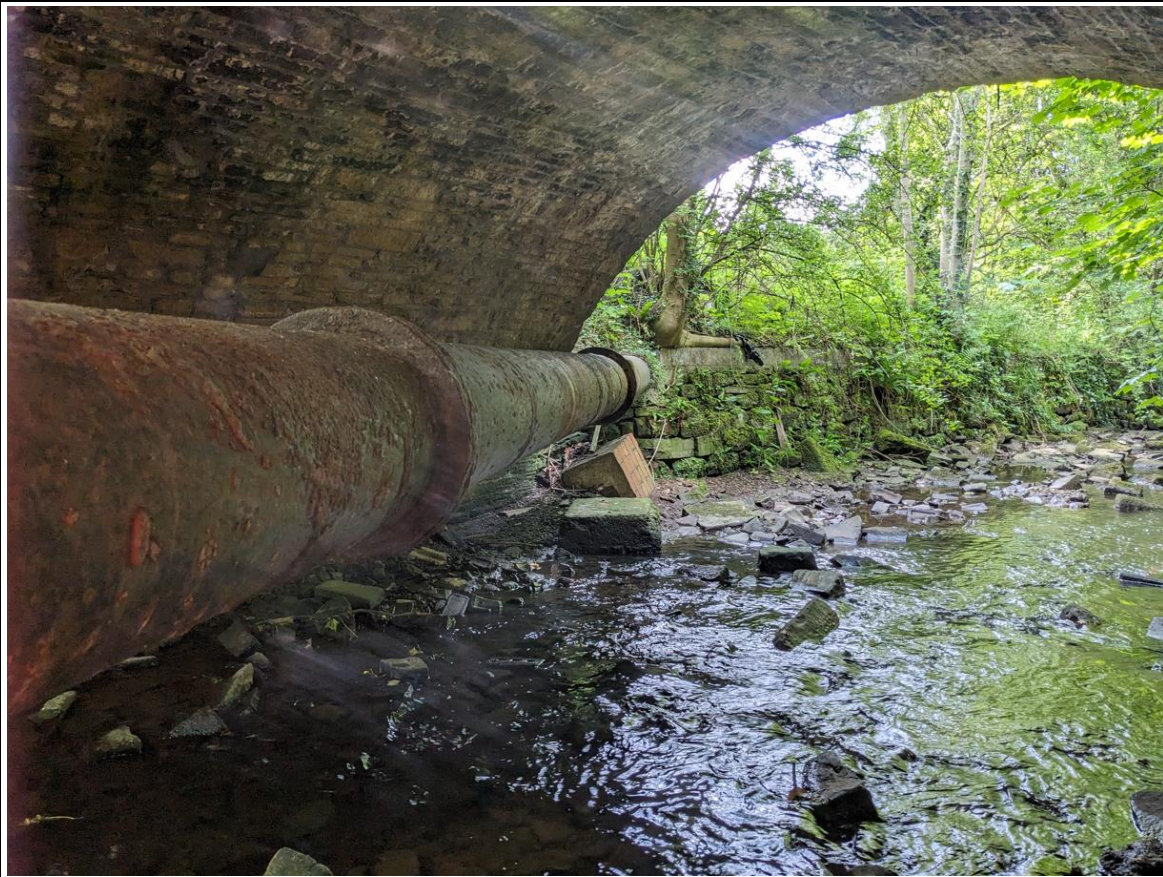
Photograph 7 - Service Pipe Running Beneath Structure

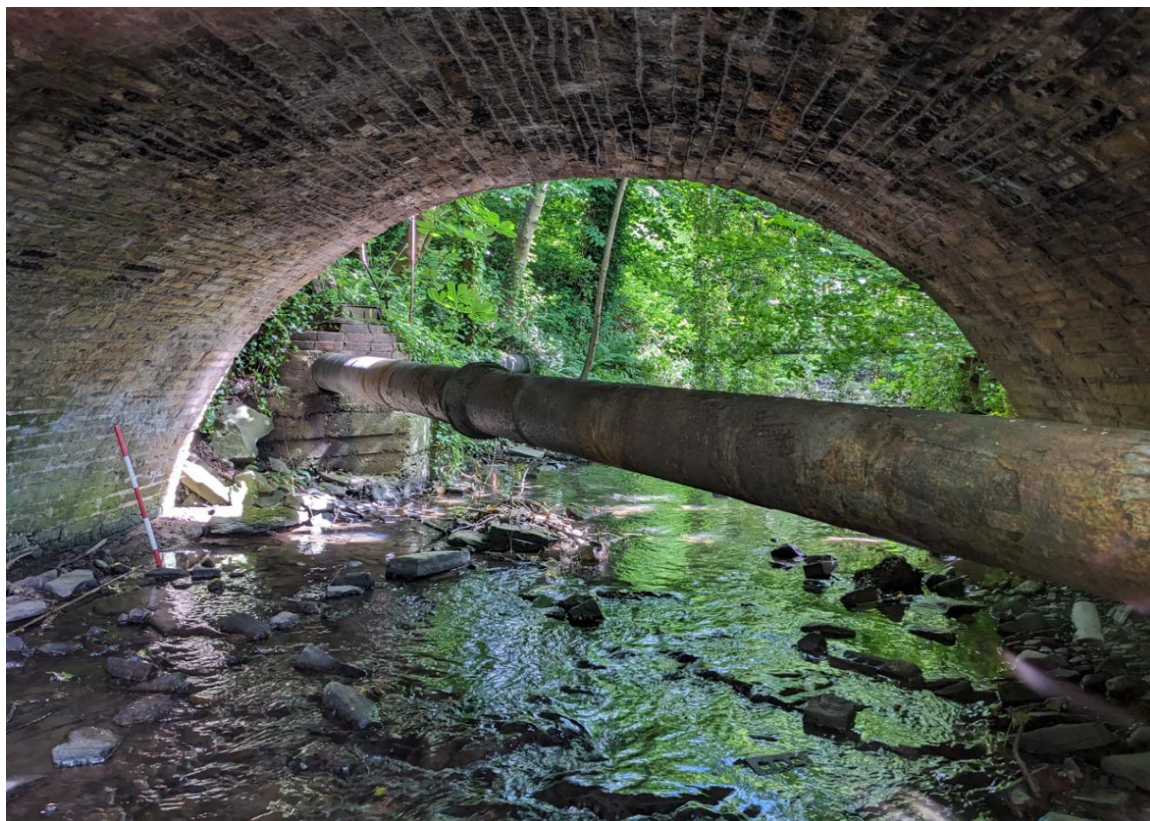
Photograph 8 - Service Pipe Running Beneath Structure

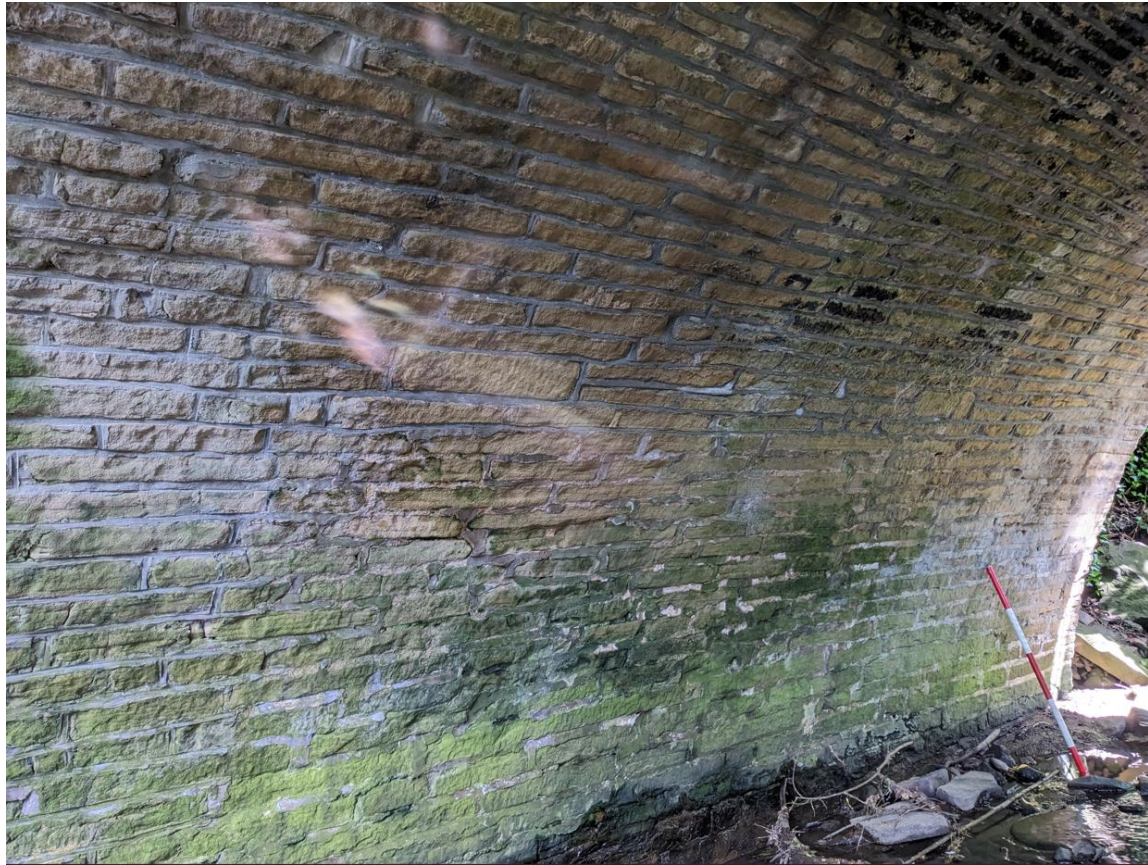
Photograph 9 - Repointing To Arch Barrel Sound

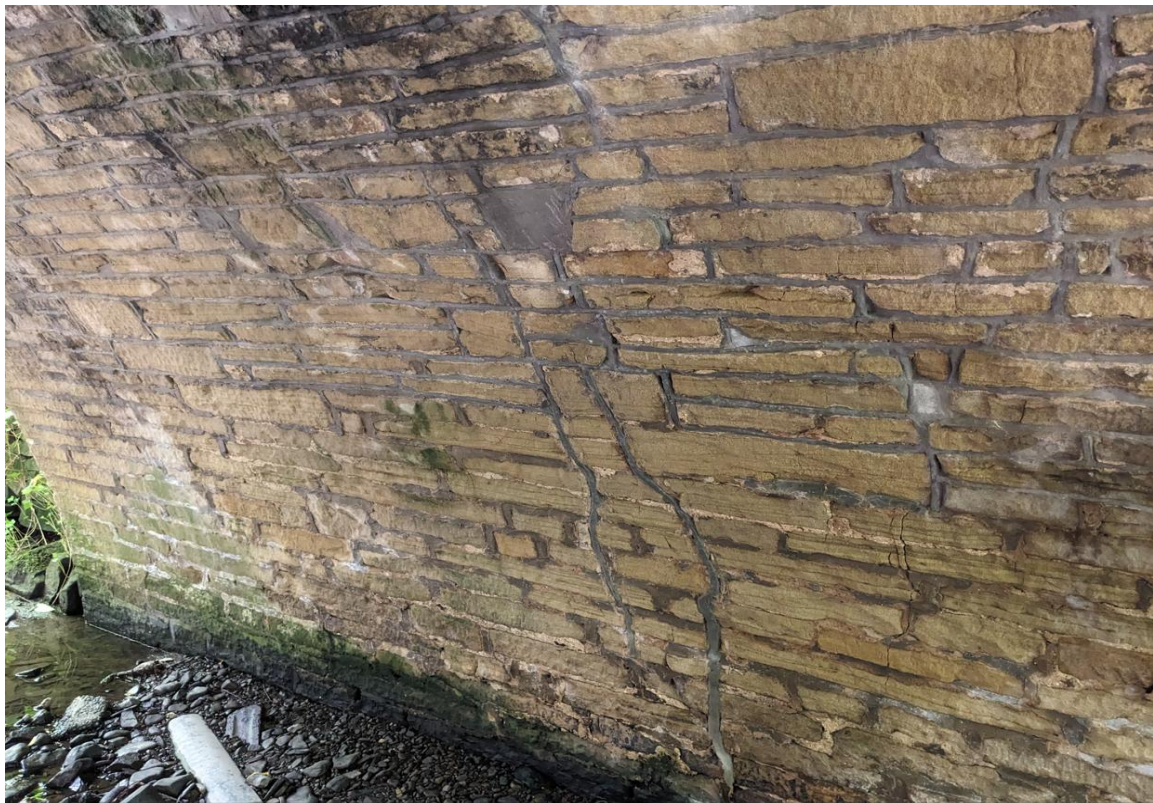
Photograph 10 - Structure Was Recently Repointed, Pointing Remains Sound

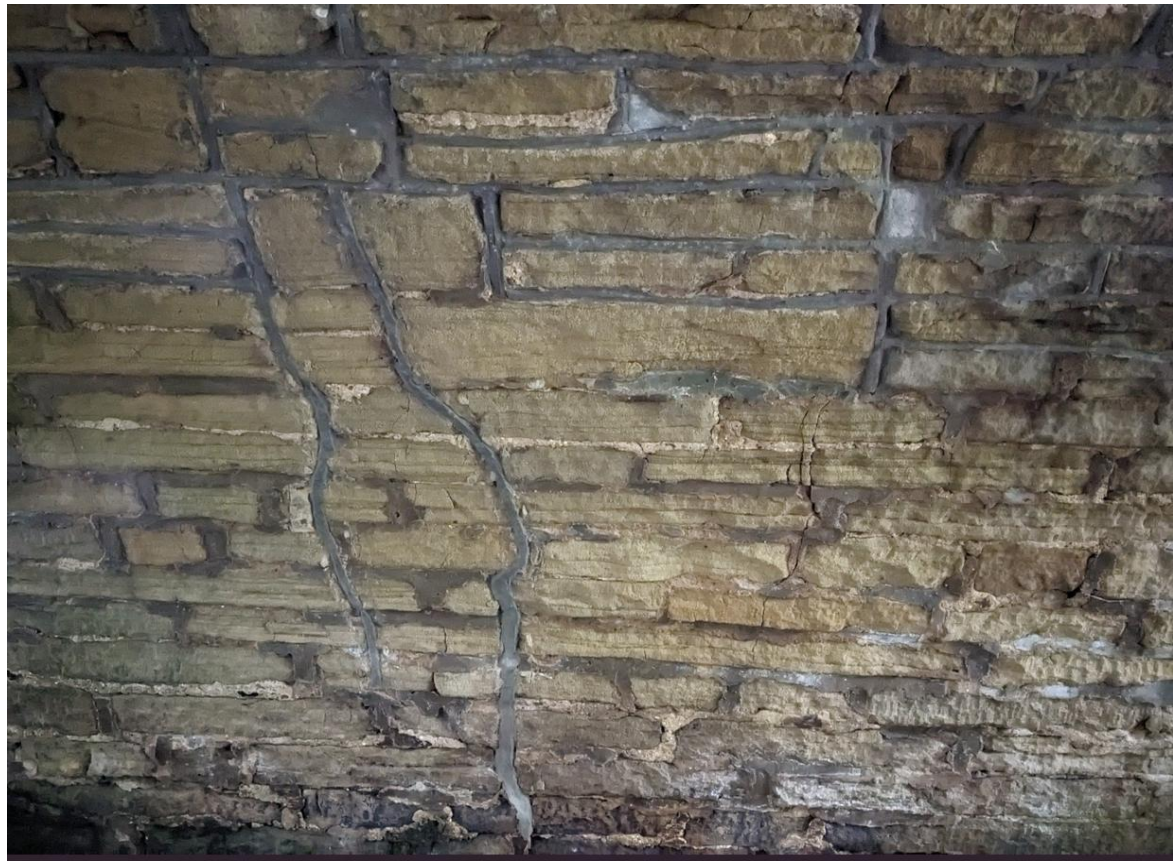
Photograph 11 – Historic Repointed Cracks Remain Sound

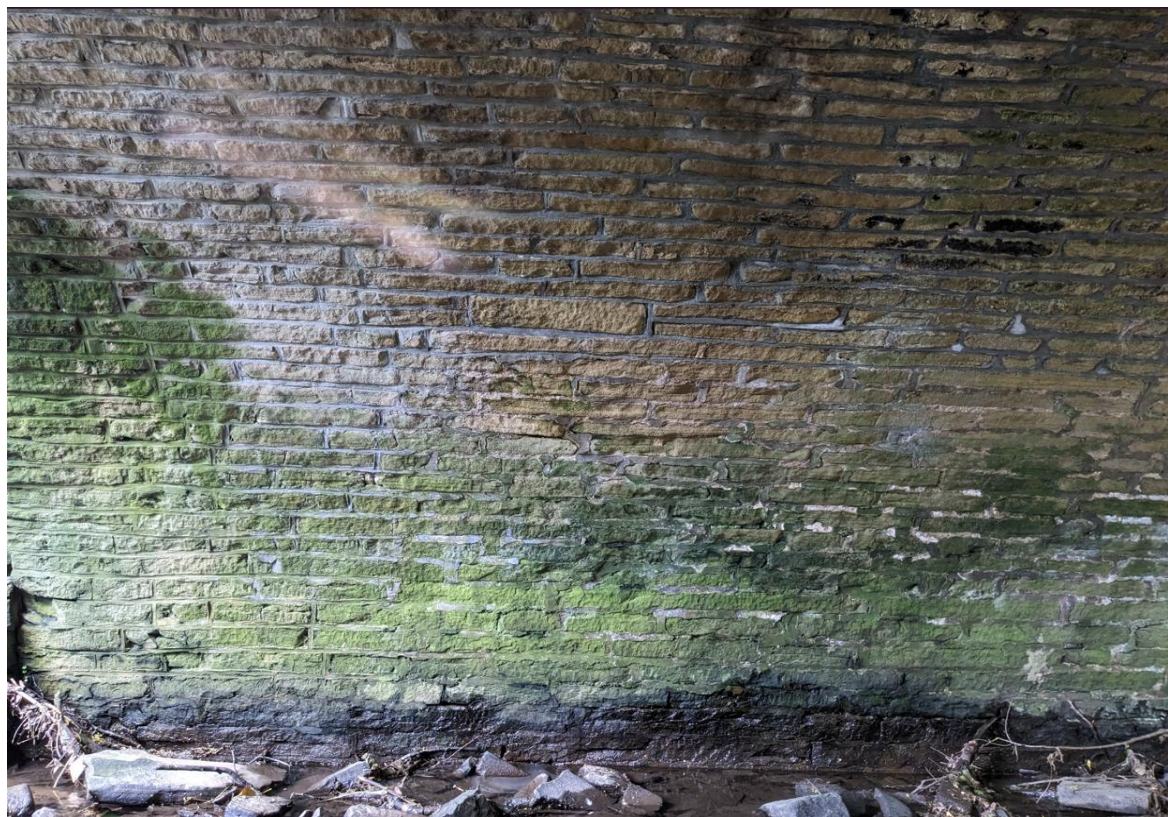
Photograph 12 - Masonry Repairs Remain Sound

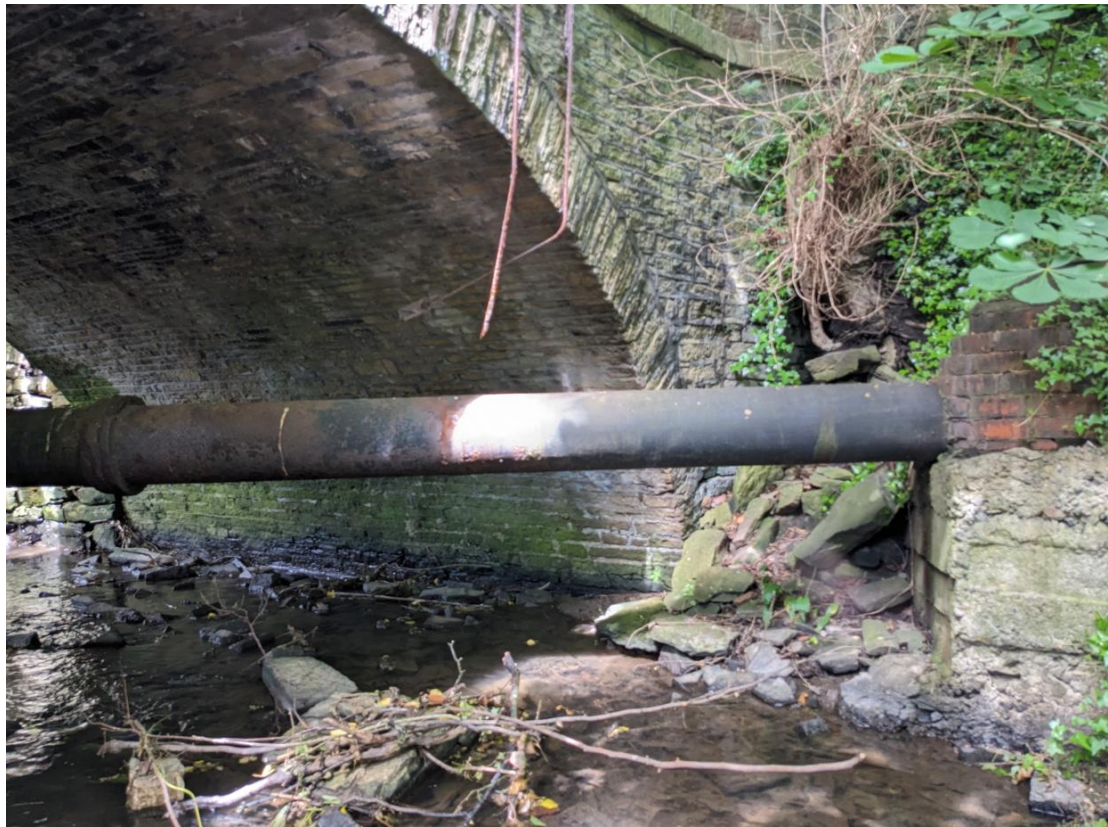
The ownership of the service pipe is unknown, however, the 2no. supports to the service pipe have failed, and it is recommended that the owner and maintainer is found and advised of the requirements for remedial works.

The supports comprised 1no. brick column which has collapsed, and 1no. metal hanger which had fully corroded through and failed. These issues did not appear to have deteriorated since the 2025 Principal Inspection.

Photograph 13 - Failed Support To Service Pipe, Upstream

It is recommended that ownership and maintenance responsibility for the service pipe is established, and the mainainter advised of the requirements to reinstate the supports to the service pipe.

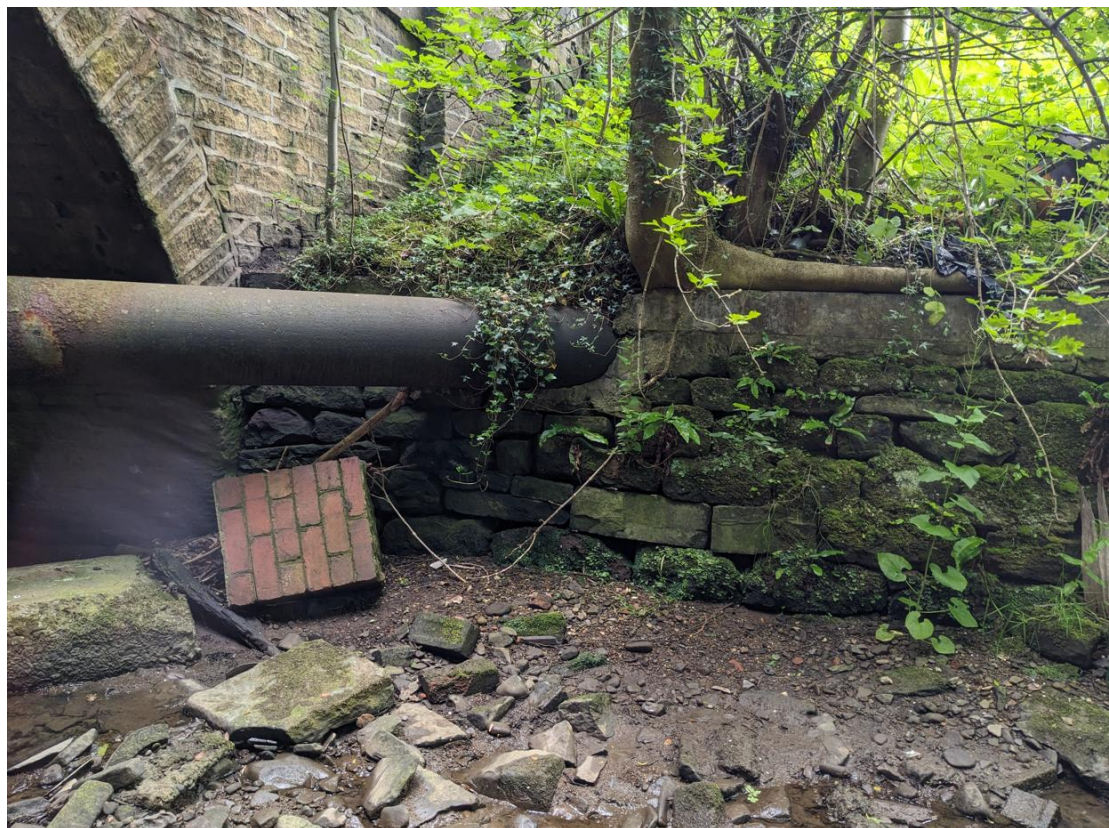
Photograph 14 - Failed Support To Service Pipe, Downstream

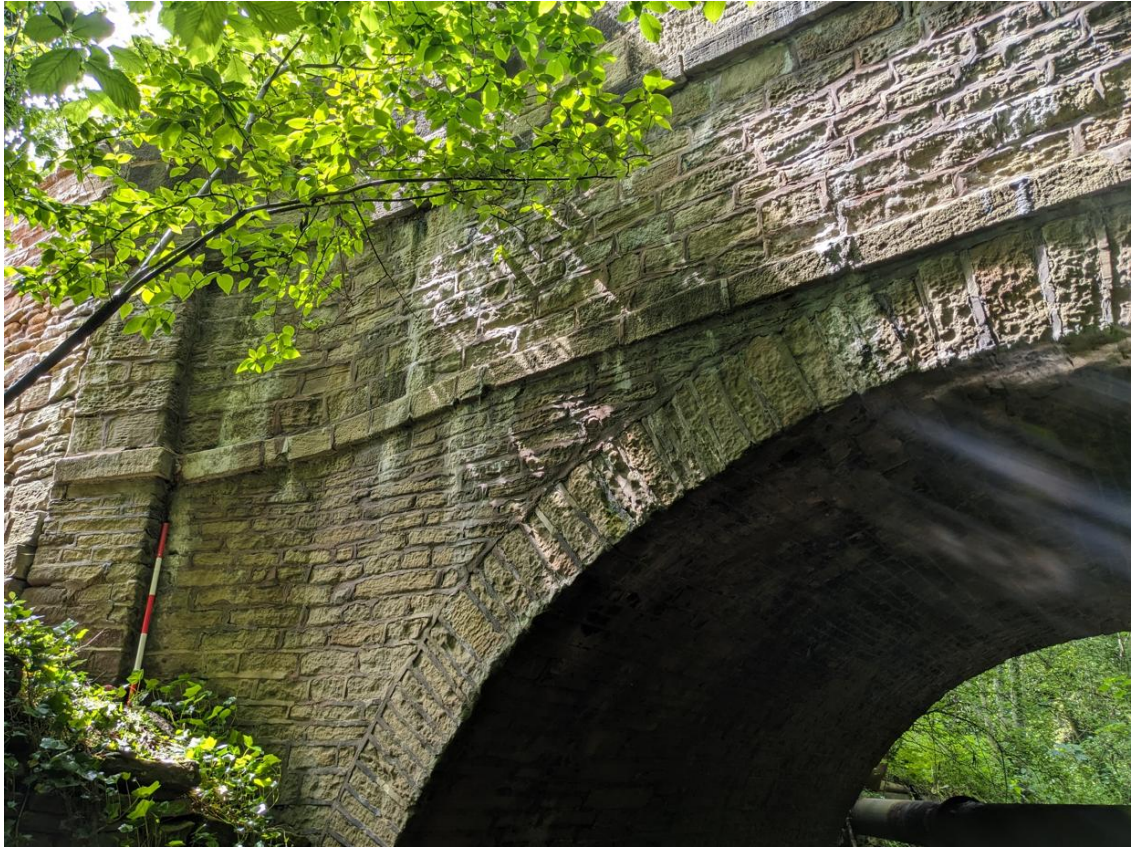
The spandrels for the structure were generally sound, with no notable deterioration exhibited.

Photograph 15 - General View Of South West Spandrel Wall

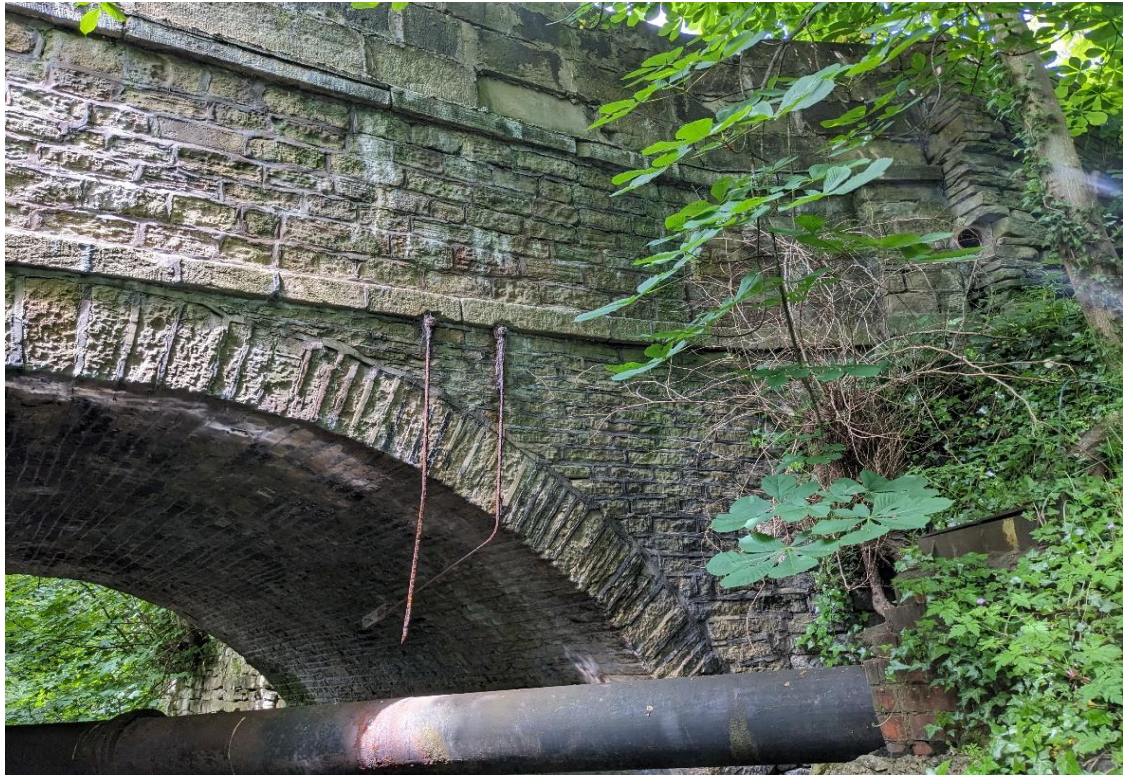
Photograph 16 - General View Of South East Spandrel Wall

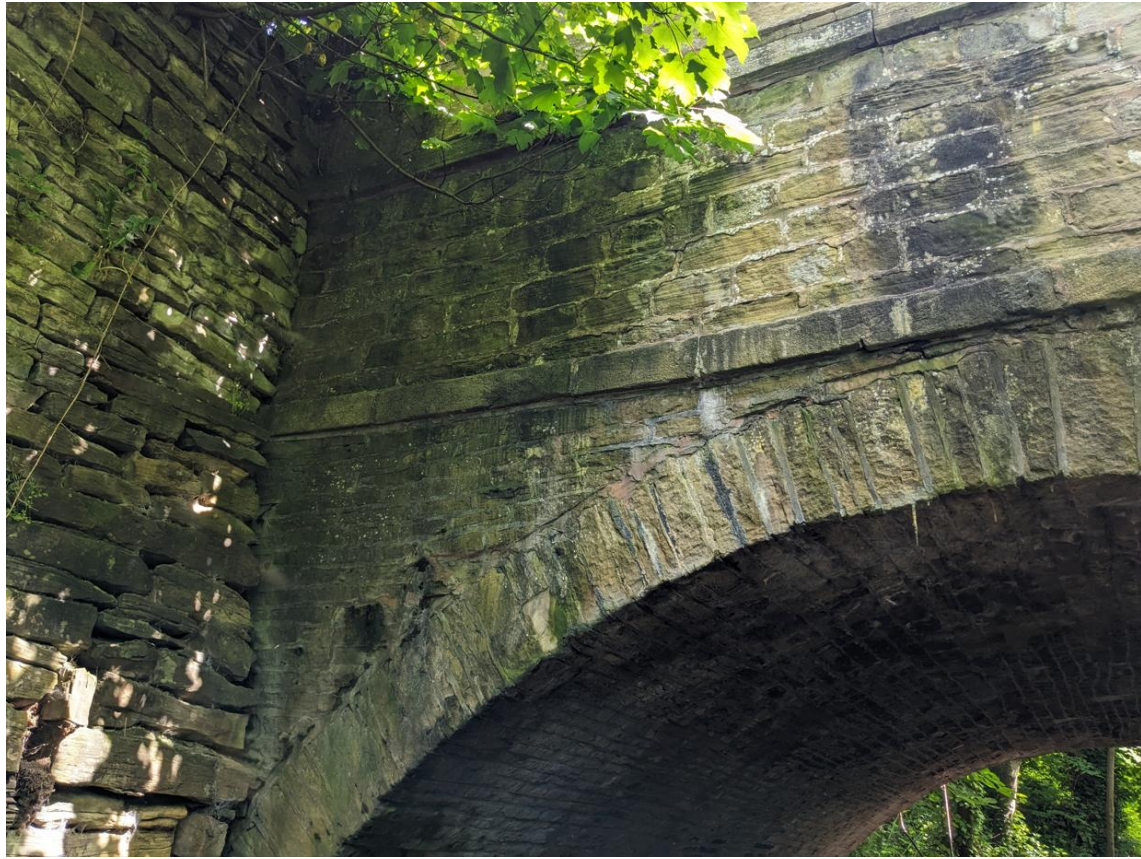
Photograph 17 - General View Of North East Spandrel Wall

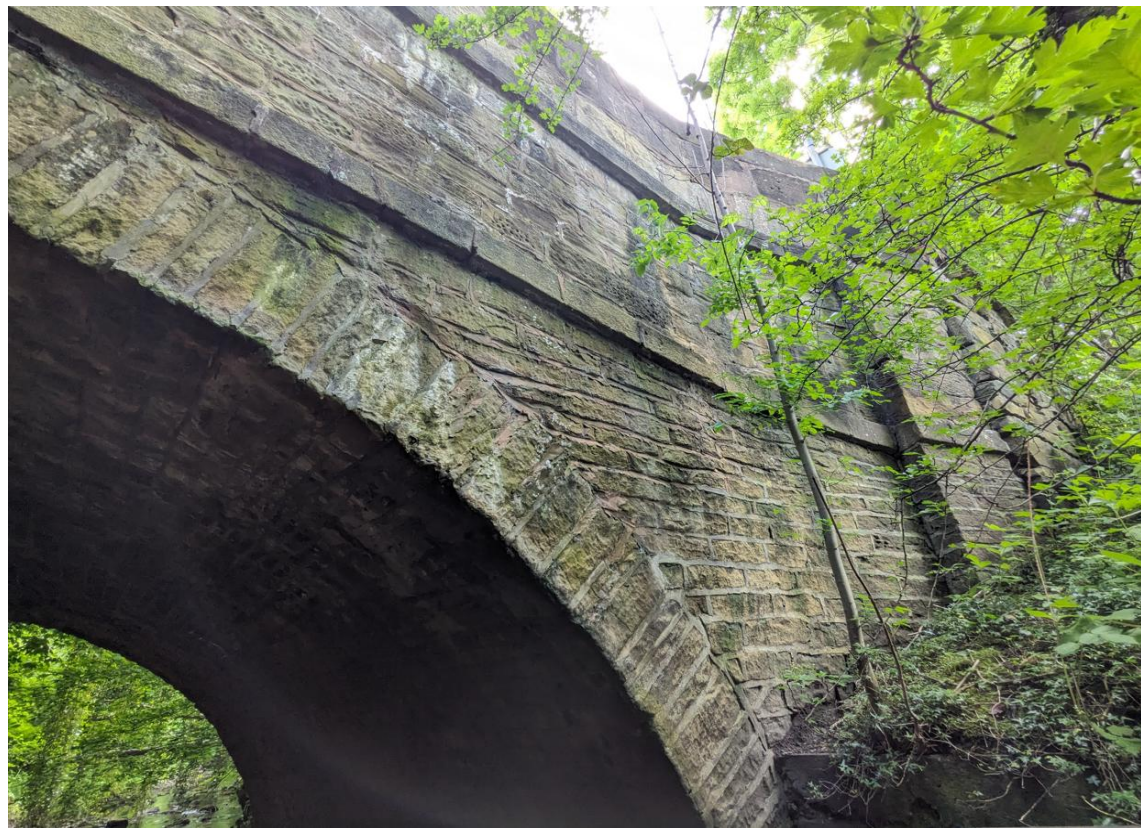
Photograph 18 - General View Of North West Spandrel Wall

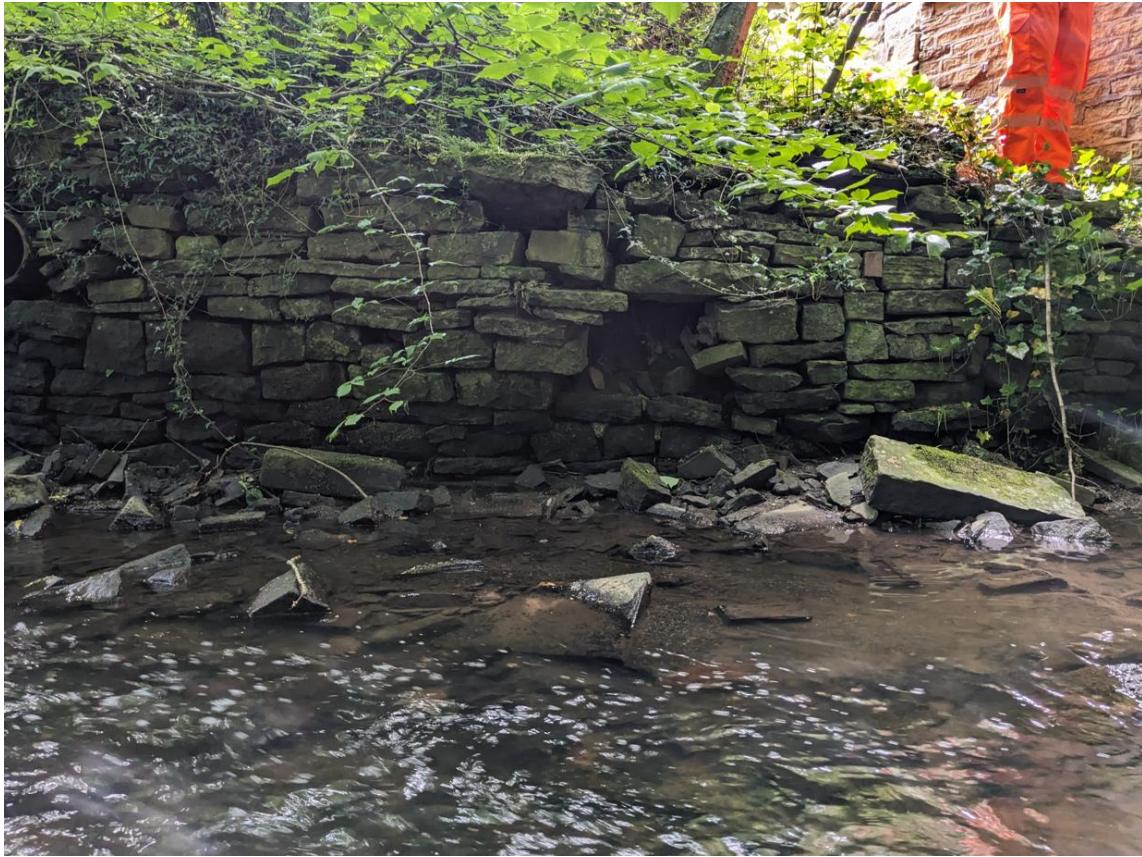
The training walls exhibited vegetation and established tree growth. The established tree growth to the southwest training wall had caused partial collapse to the training wall, circa 2.5m².

This was a slight increase since the 2025 Principal Inspection, but this was attributed to further vegetation growth and high water levels during the winter period, and not vehicle movement as the training wall does not sustain traffic loading.

Photograph 19 - South West Training Wall Exhibiting Partial Collapse Due To Established Tree Growth, Increased Deterioration Since 2025 Principal Inspection

It is recommended that all vegetation growth is removed and treated, and that the area of partial collapse is rebuilt. The bulging should be monitored at subsequent inspections for progression after the sapling growth is removed.

The structure is generally in good condition. Consideration should be given to repairing the training walls which are suffering damage due to tree growth. This existing tree growth should be removed as a minimum to prevent further deterioration.

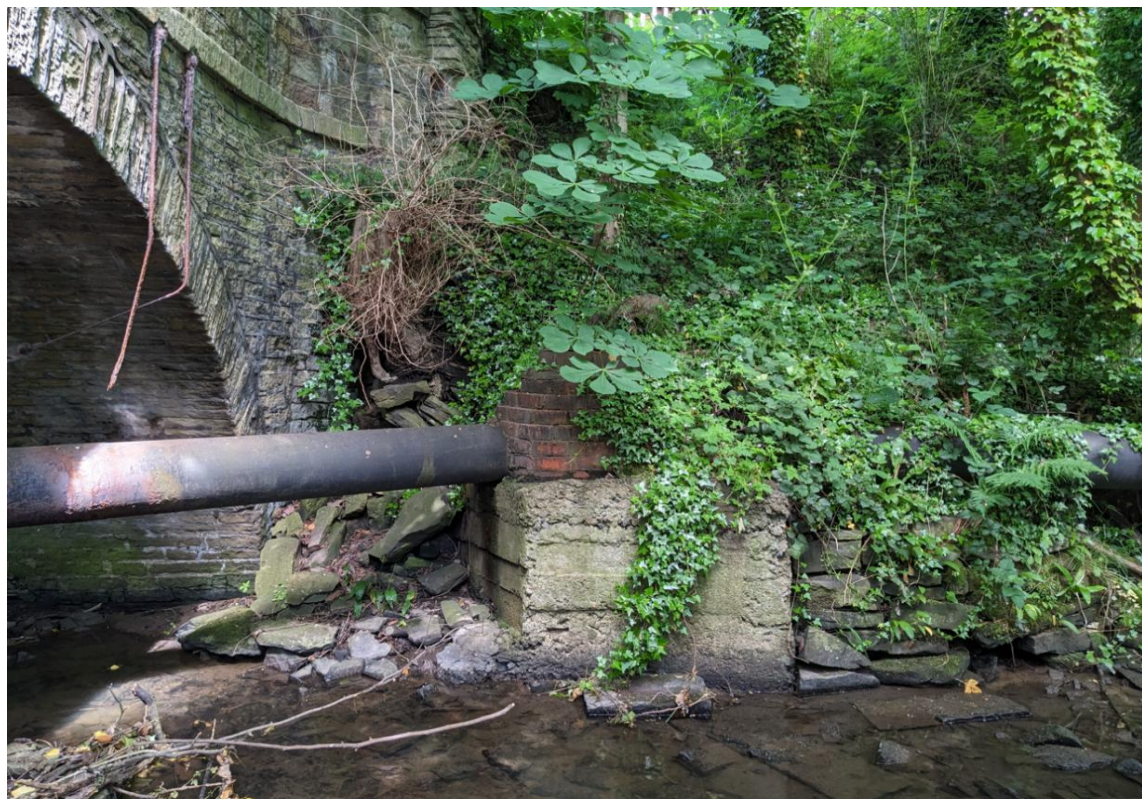
Photograph 20 - South East Training Wall Exhibiting Vegetation Growth

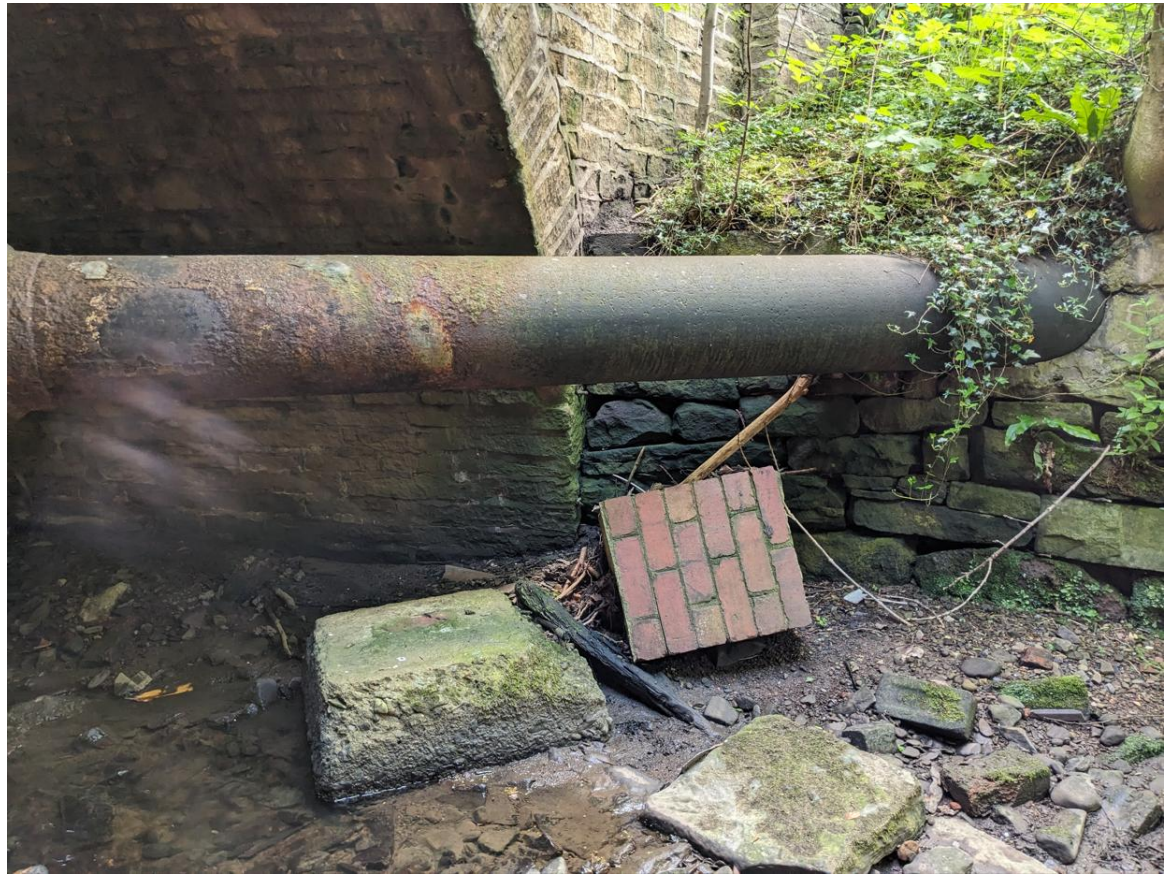
Photograph 21 - North West Training Wall Generally Sound

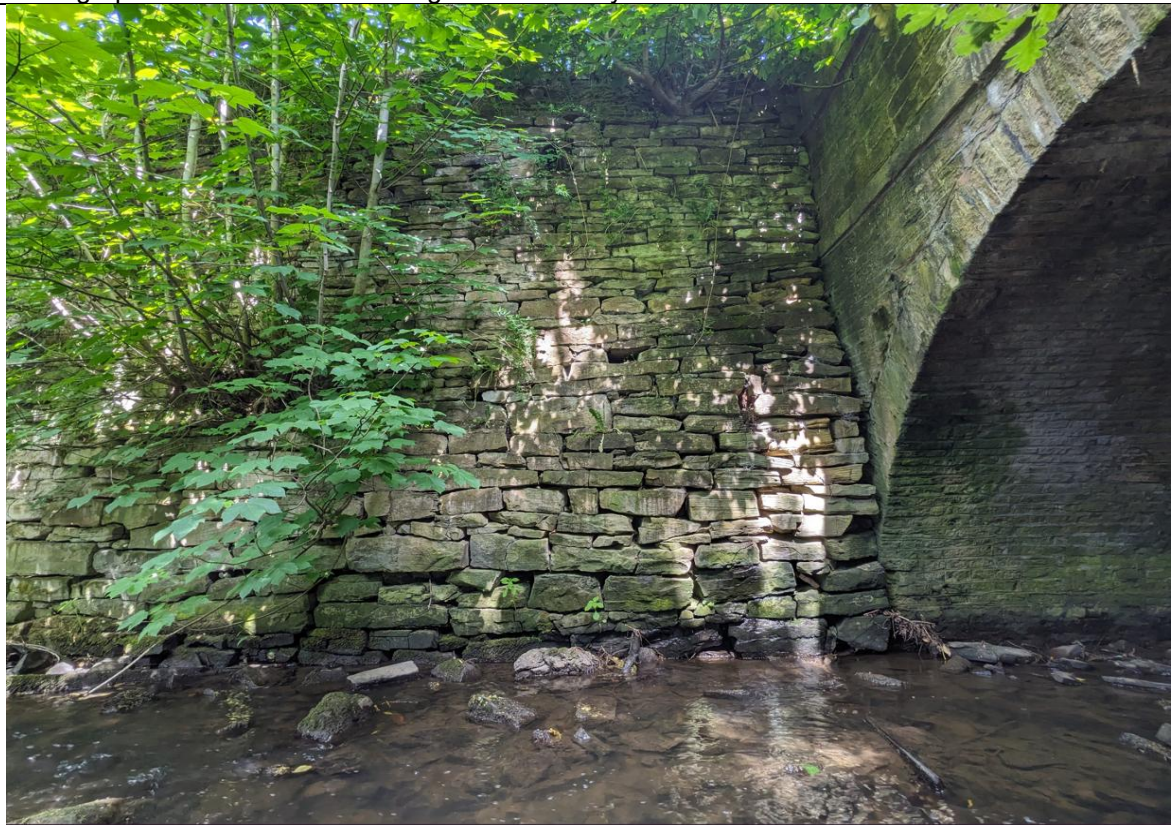
The sapling growth to the northeast training wall had resulted in bulging to the masonry.

Photograph 22 - North East Training Wall Exhibiting Bulging And Established Sapling Growth

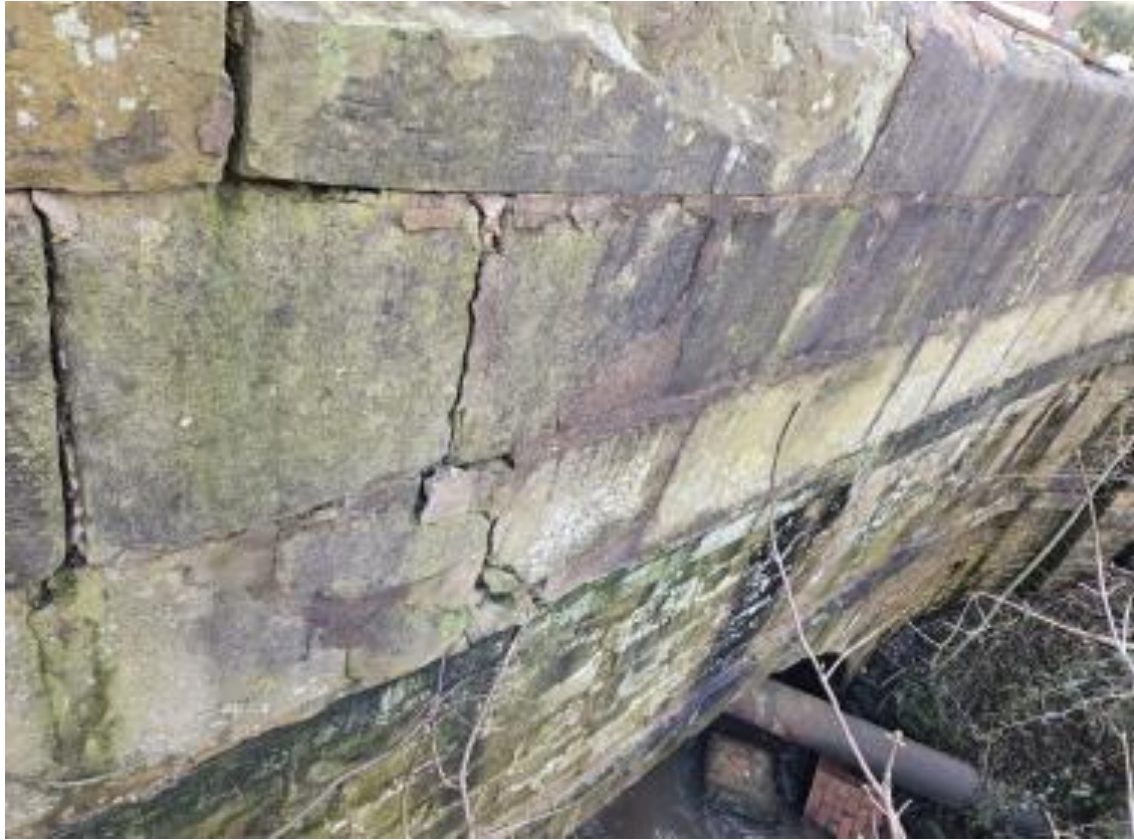
The parapets were generally sound, however, there was cracking through mortar and masonry to the north parapet at the east end, full height, with associated spalled masonry. This crack should be repaired, and dated mortar tabs installed, to allow for monitoring at subsequent inspections.

The damage to the parapet is potentially due to vehicle impact. The cracking did not appear to have deteriorated since the 2025 Principal Inspection.

Photograph 23 – Cracking Through Mortar To North Parapet At East End, Full Height, Open 5-10mm

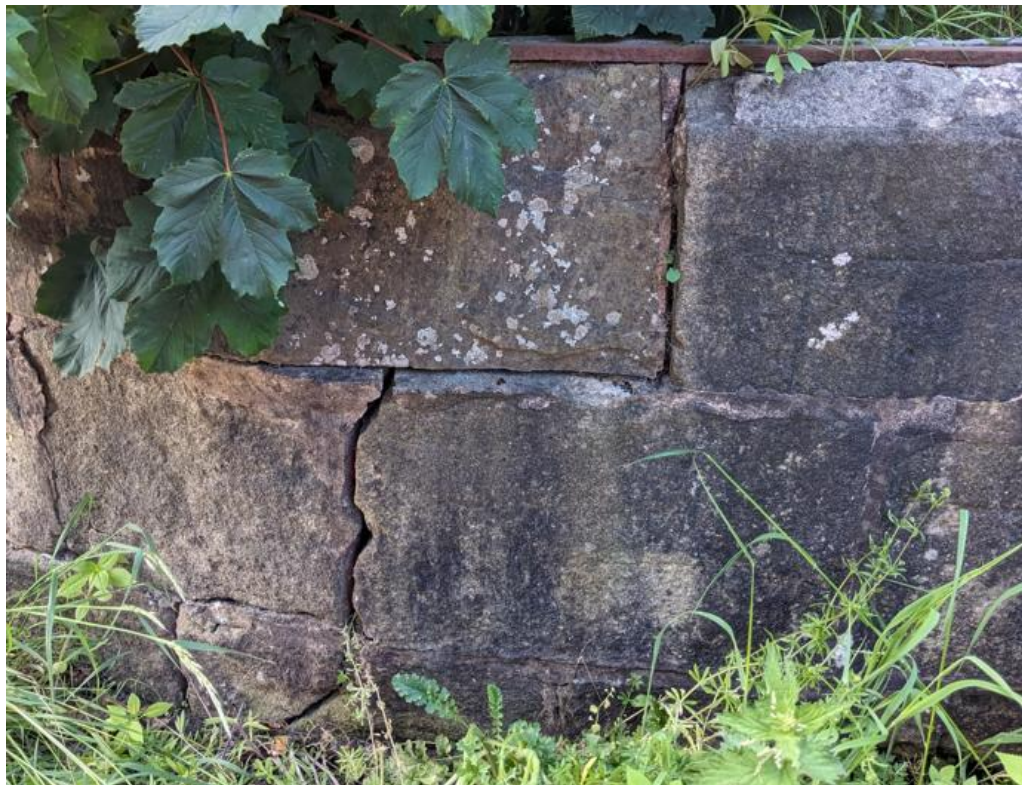
Photograph 24 - Cracking To North Parapet Through Masonry, East End, Full Height, Open 5-10mm

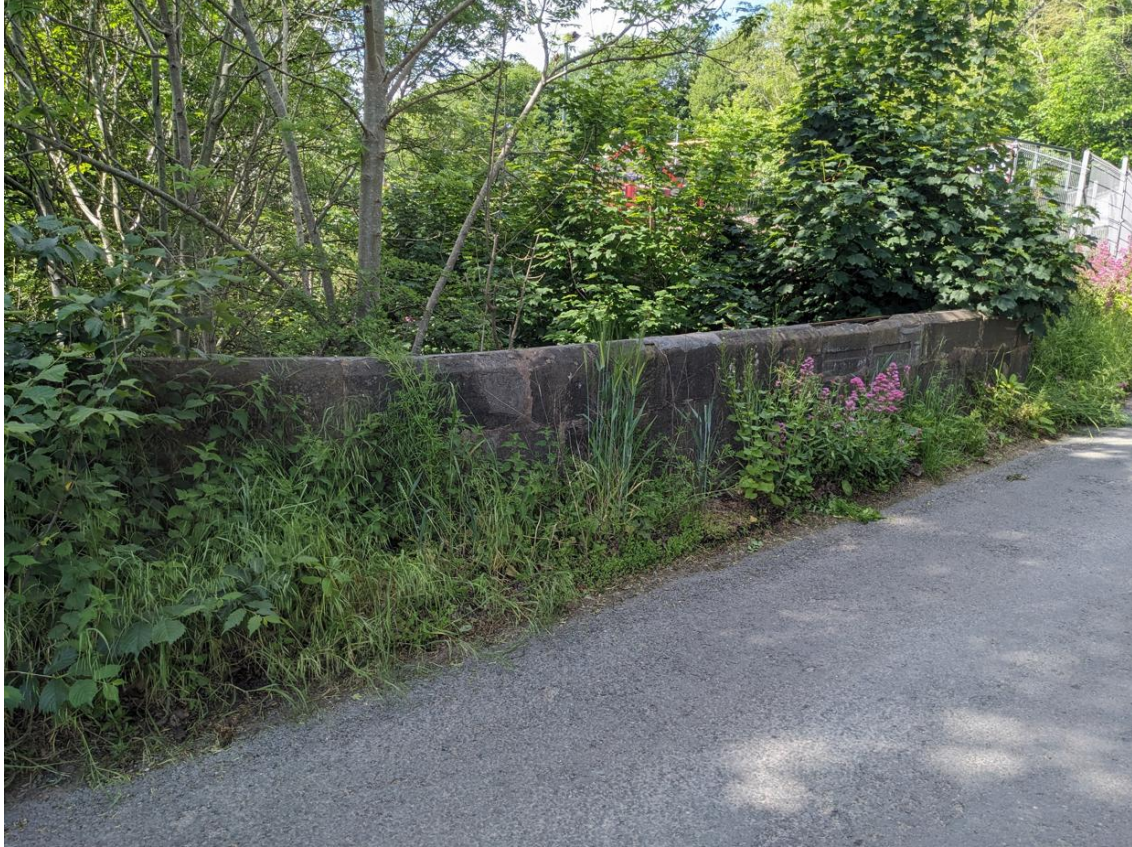
Photograph 25 - General View Along North Parapet And Verge with increased Vegetation

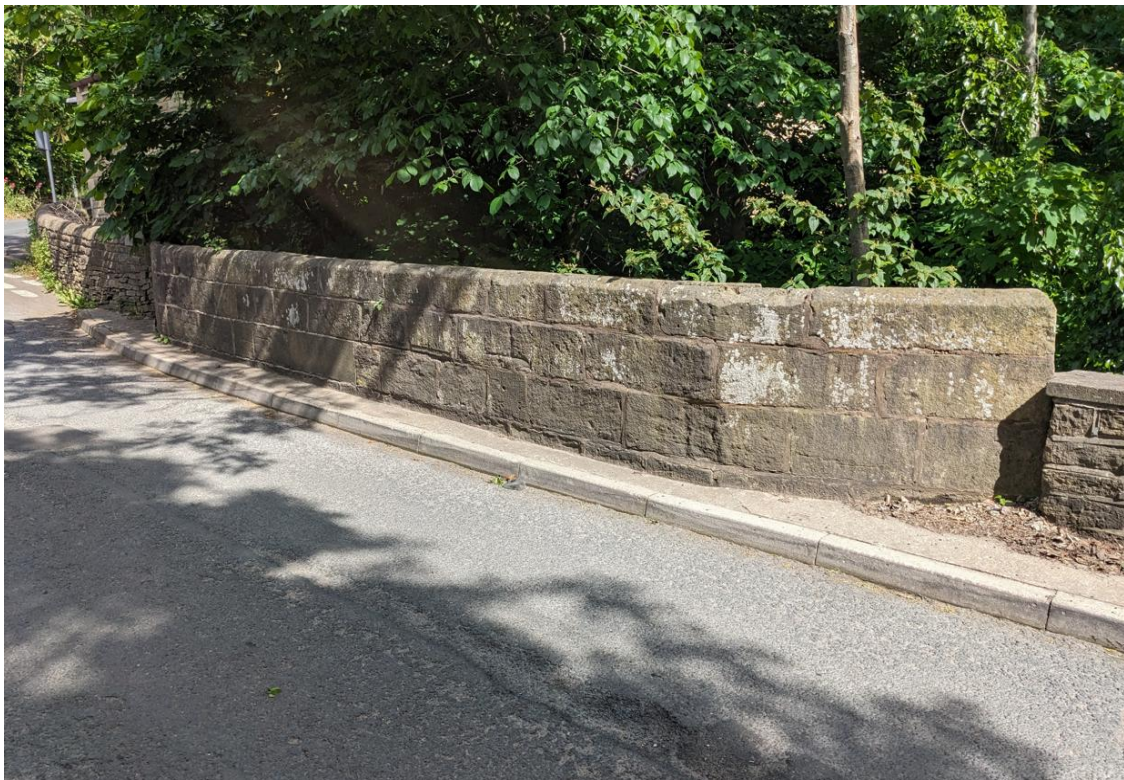
Photograph 26 - General View Along South Parapet And Verge

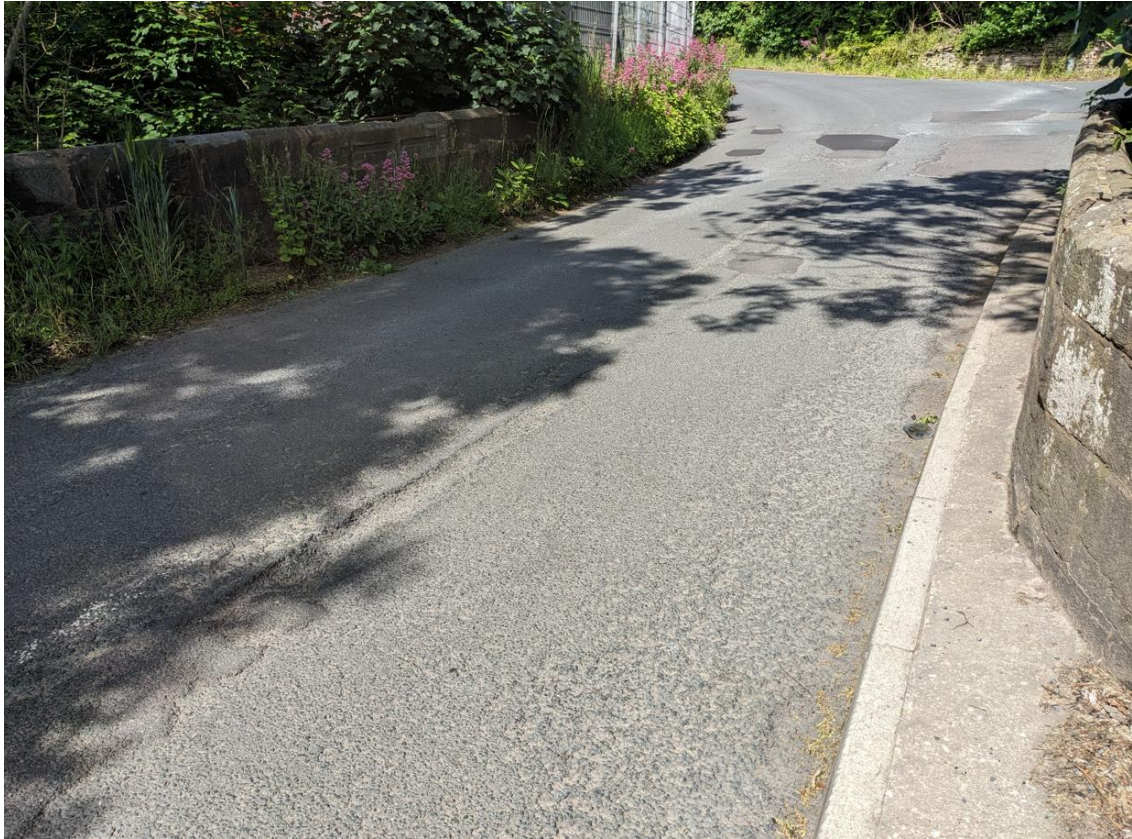
The carriageway over the bridge was largely in good condition, and the previously identified pothole had been infilled.

Photograph 27 - Potholing To Carriageway Surface Now Repaired
