Post-Works Special Inspection Report

Storthes Hall Bridge

Structure No: K0150

June 2026

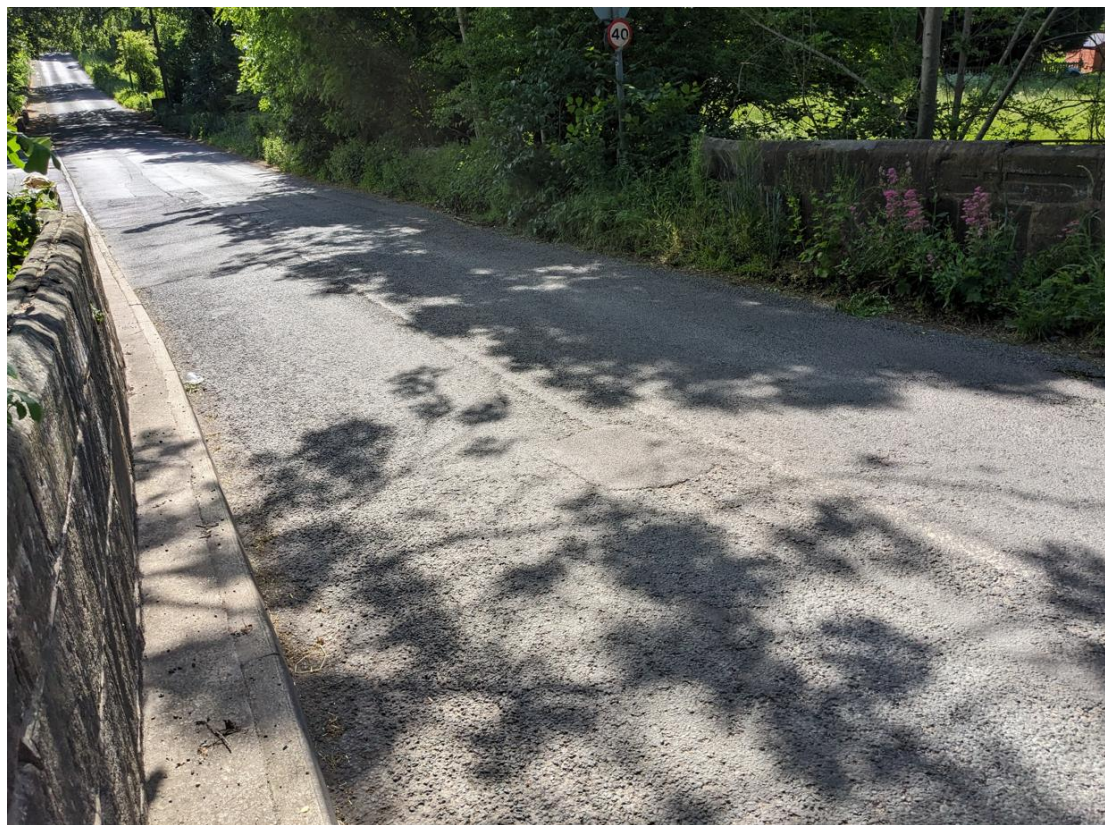
Photograph 28 - General View Over Carriageway Surface Showing Repair To Potholing

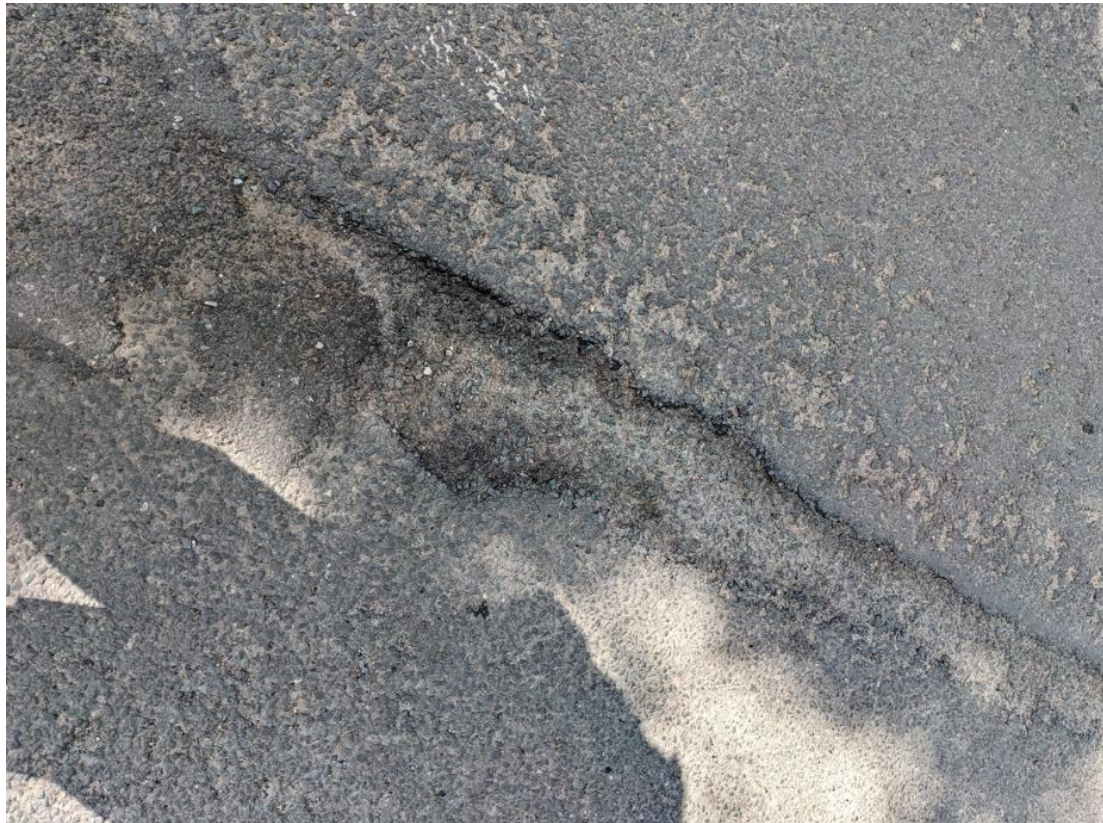
An area of rutting 1.5m by 150mm was noted to the west end of the structure, which did not appear to have deteriorated since the 2025 Principal Inspection.

Photograph 29 – 1.5m By 150mm Wide Rutting To Centreline Of Carriageway, West End Of Structure

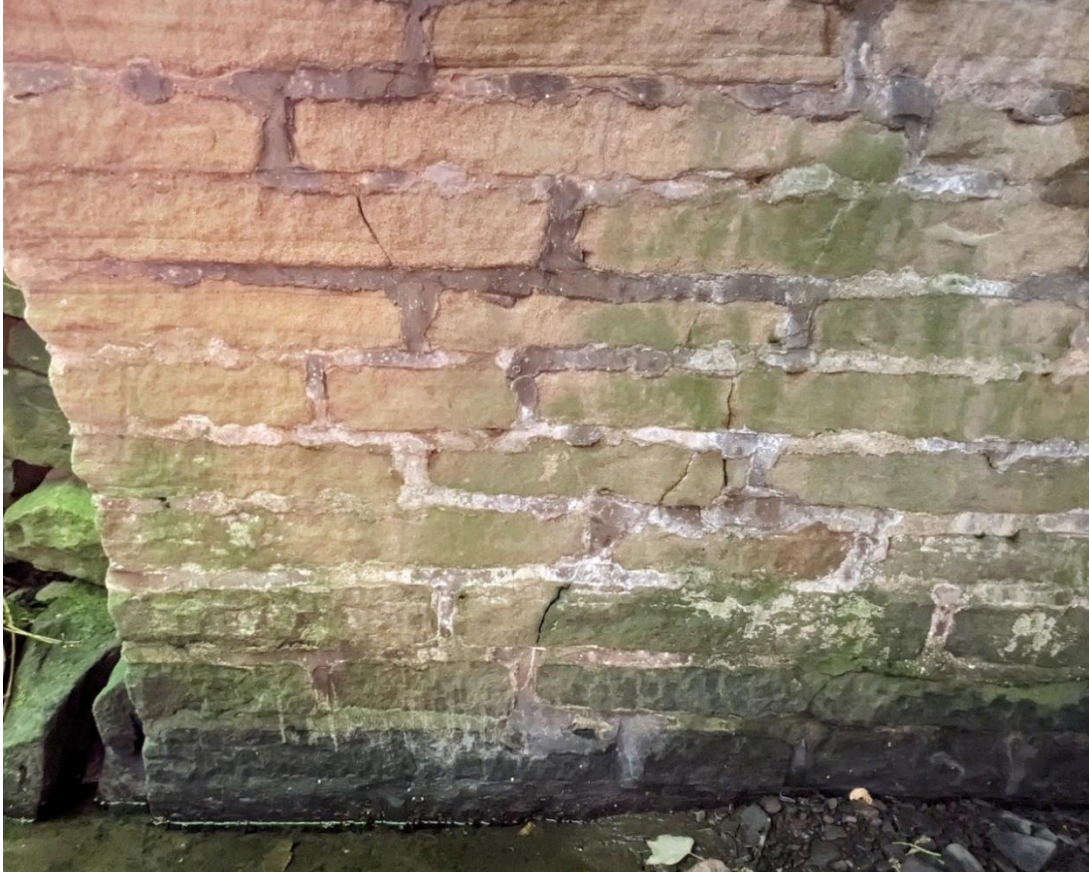
2no. cracks were noted to below the west $\frac{1}{4}$ point, one at the south end and one at midway along the width of the structure. The cracking was measured at 1-2mm width and 0.5m length. It is recommended that the cracking is monitored for deterioration at subsequent inspections. These cracks were not identified during the 2025 Principal Inspection but were believed to be below the waterline.

Photograph 31 – 0.5m diagonal cracking open 1-2mm to south end of structure below west $\frac{1}{4}$ point

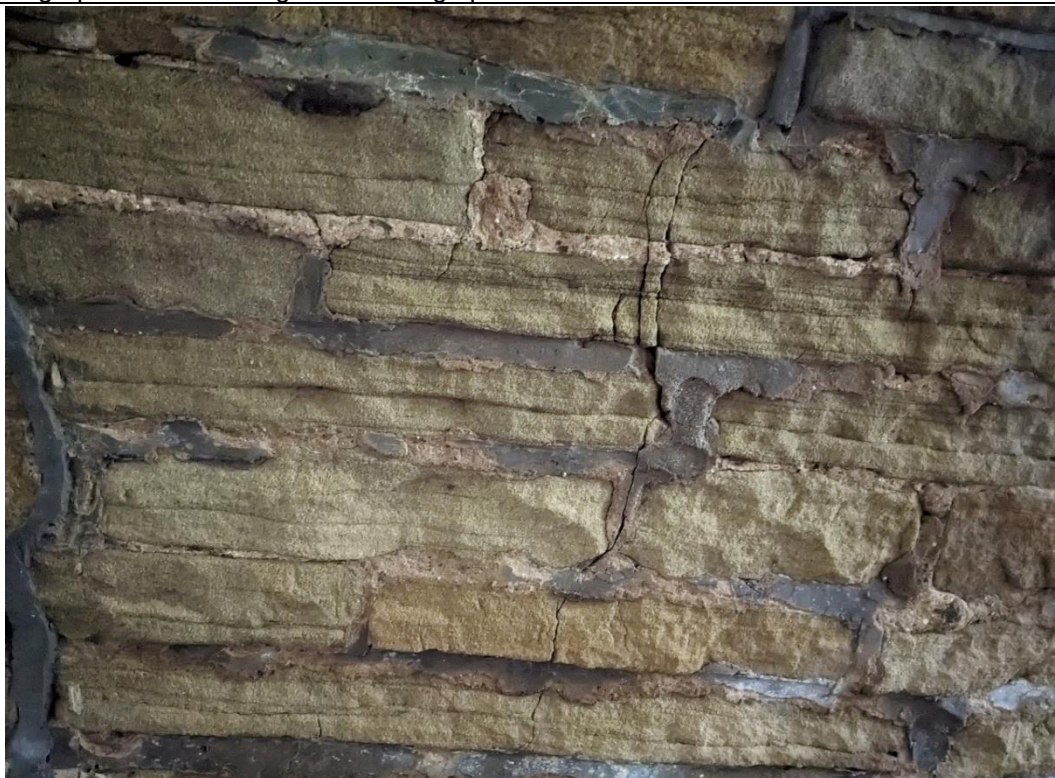
Photograph 32 – 0.5m Length Cracking Open 1-2mm Through Mortar And Masonry To west $\frac{1}{4}$ Point, Midway Along Structure Width
