**Storthes Hall, Kirkburton
Highway Condition Survey 2**

June 2026 (Initial Issue)

Prepared on behalf of
Ubrique Investments Limited.

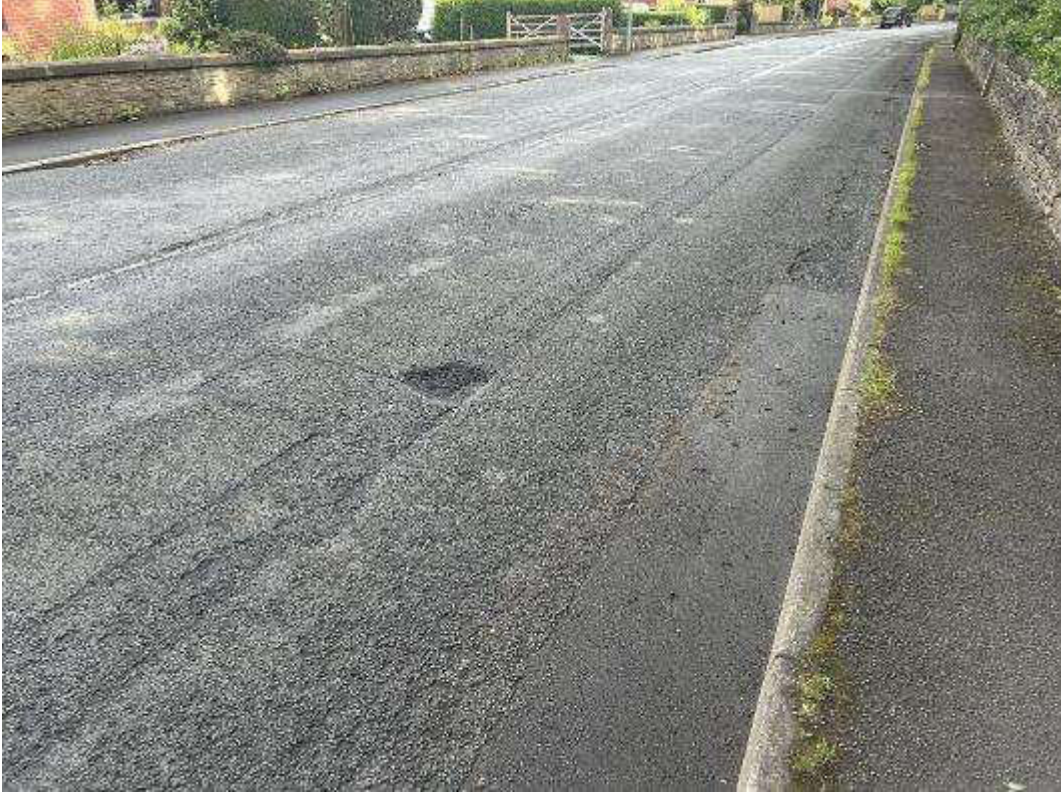
Table 2.1 Defect A (Image 27)

DEFECT	
Location	Facing northbound c. 125m north of the Southern Site Access.
Summary	<p>An area of patchwork surfacing has deteriorated further in the period between Survey 1 and 2, as shown in Image 14 within Appendix A of Survey 1.</p> <p>The additional defect is not considered to represent a highway safety concern and is generally comparable in nature and severity to existing defects already present along Storthes Hall Lane.</p> <p>The damage cannot be directly attributed to the construction activity.</p>

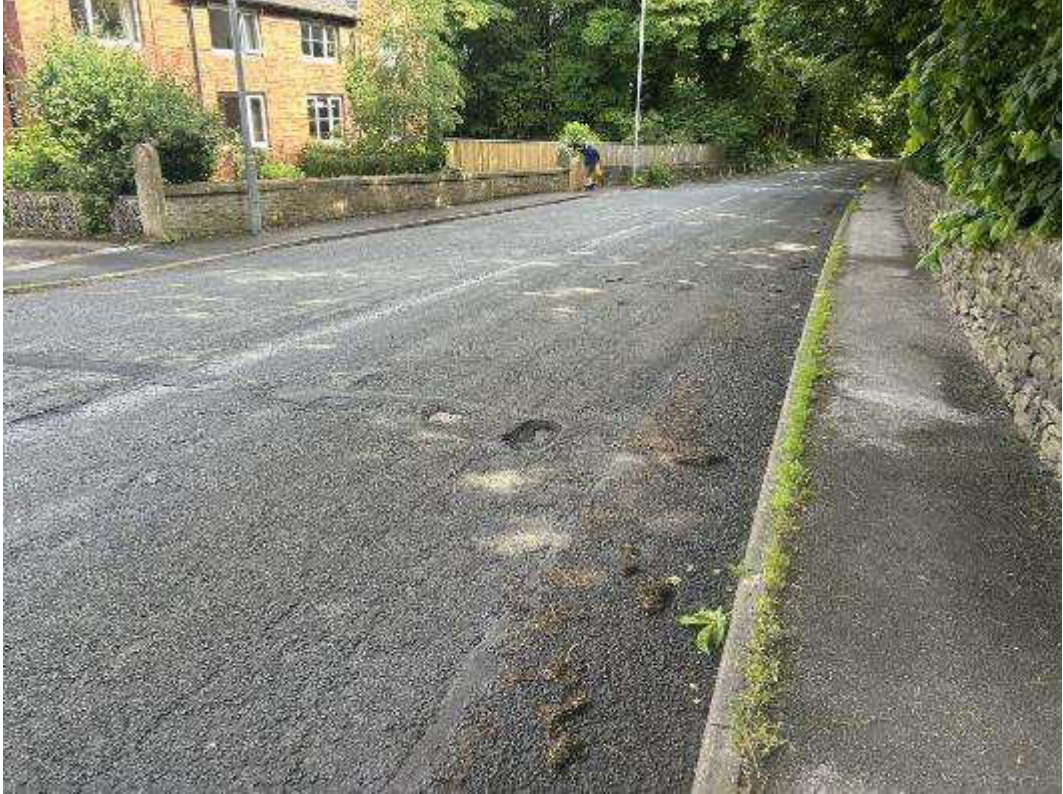
Table 2.2 Defect B (Image 34)

DEFECT	
Location	Facing northbound c. 200m north of the Southern Site Access.
Summary	<p>An area of patchwork surfacing has deteriorated further in the period between Survey 1 and 2, as shown in Image 14 within Appendix A of Survey 1.</p> <p>The additional defect is not considered to represent a highway safety concern and is generally comparable in nature and severity to existing defects already present along Storthes Hall Lane.</p> <p>The damage cannot be directly attributed to the construction activity.</p>

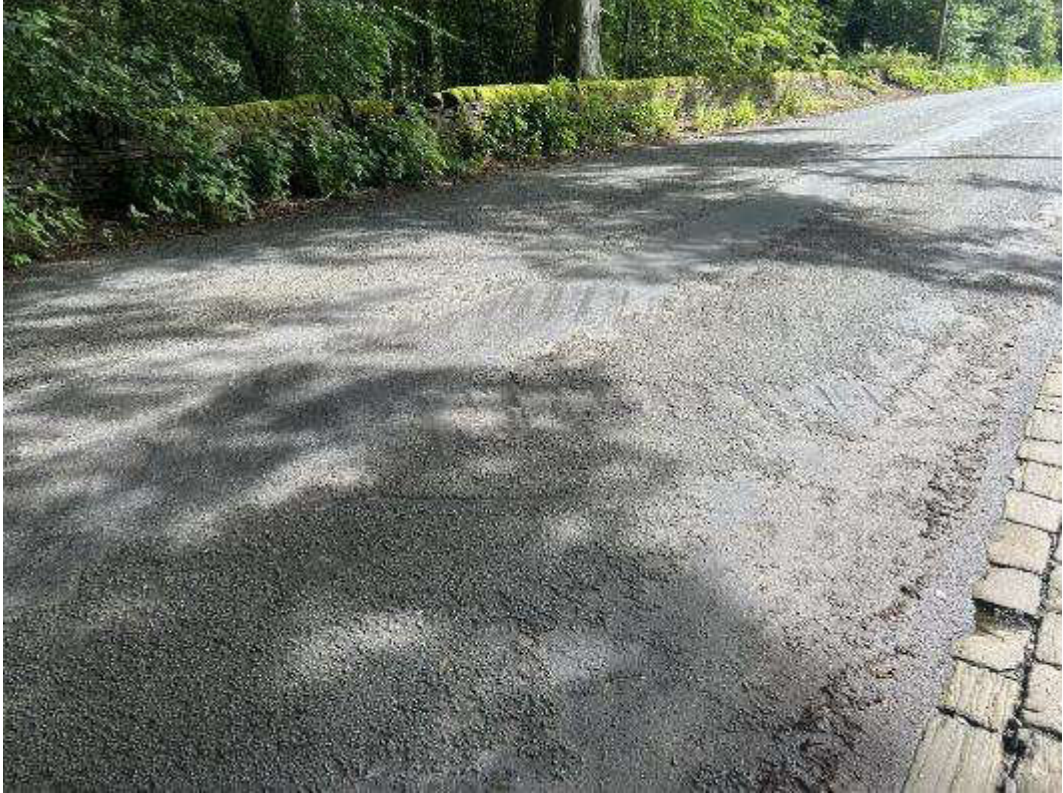
Table 2.3 Defect C (Image 87-88)

DEFECT	
Location	Facing northbound opposite a private gated access, c. 25m north of the Northern Site Access.
Summary	An isolated area of minor rutting within the carriageway was noted during Survey 2, compared to Image 68 within Appendix A of Survey 1. The rutting is minor in nature, does not represent a highway safety concern and is comparable to existing carriageway defects present elsewhere along Storthes Hall Lane.

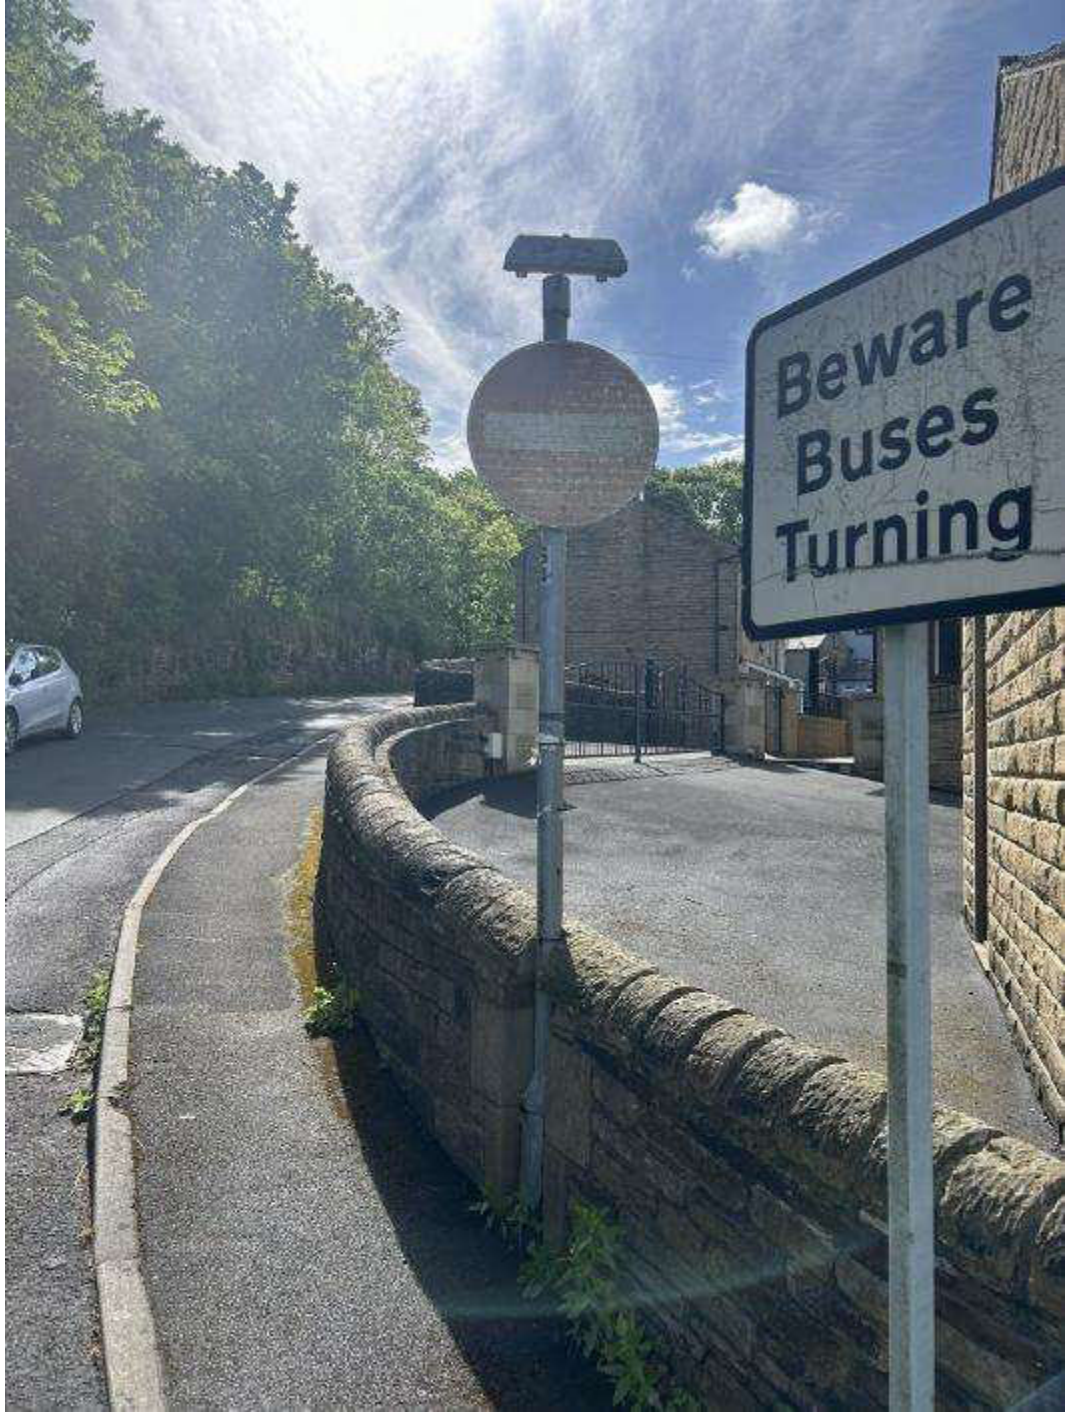
Table 2.14 Defect 10 (Image 154)

DEFECT	
Location	Facing southbound on Storthes Hall Lane, just east of Storthes Hall Bridge.
Summary	Slightly damaged and faded 'no-entry' sign.

Survey 2 Comparison	No significant changes noted between Survey 1 and 2.

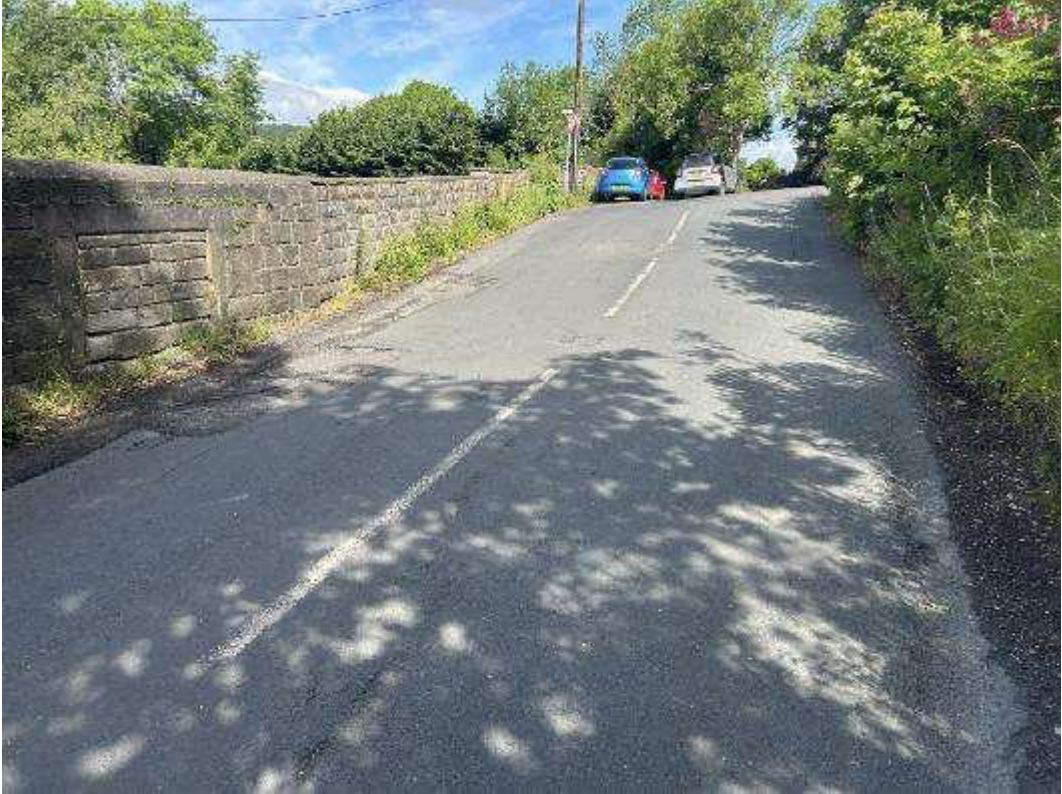
Table 2.16 Defect 12 (Image 159)

DEFECT	
Location	Facing northbound on Storthes Hall Lane, just south of A629 Penistone Road junction.
Summary	Patchwork along carriageway edge and cracking along centreline.

Survey 2 Comparison	No significant changes noted between Survey 1 and 2.

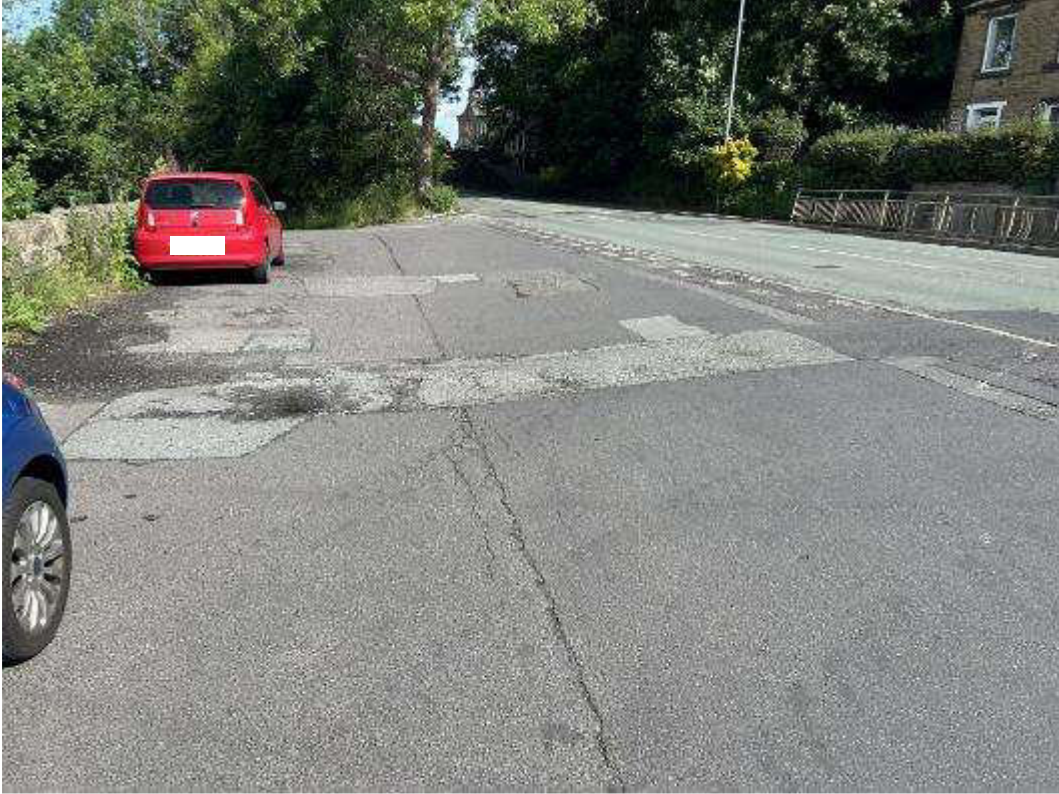
Table 2.17 Defect 13 (Image 163)

DEFECT	
Location	Facing northbound on Storthes Hall Lane at the A629 Penistone Road junction.
Summary	Patchwork along carriageway, cracking, worn road markings and damaged railings.

Survey 2 Comparison	No significant changes noted between Survey 1 and 2.

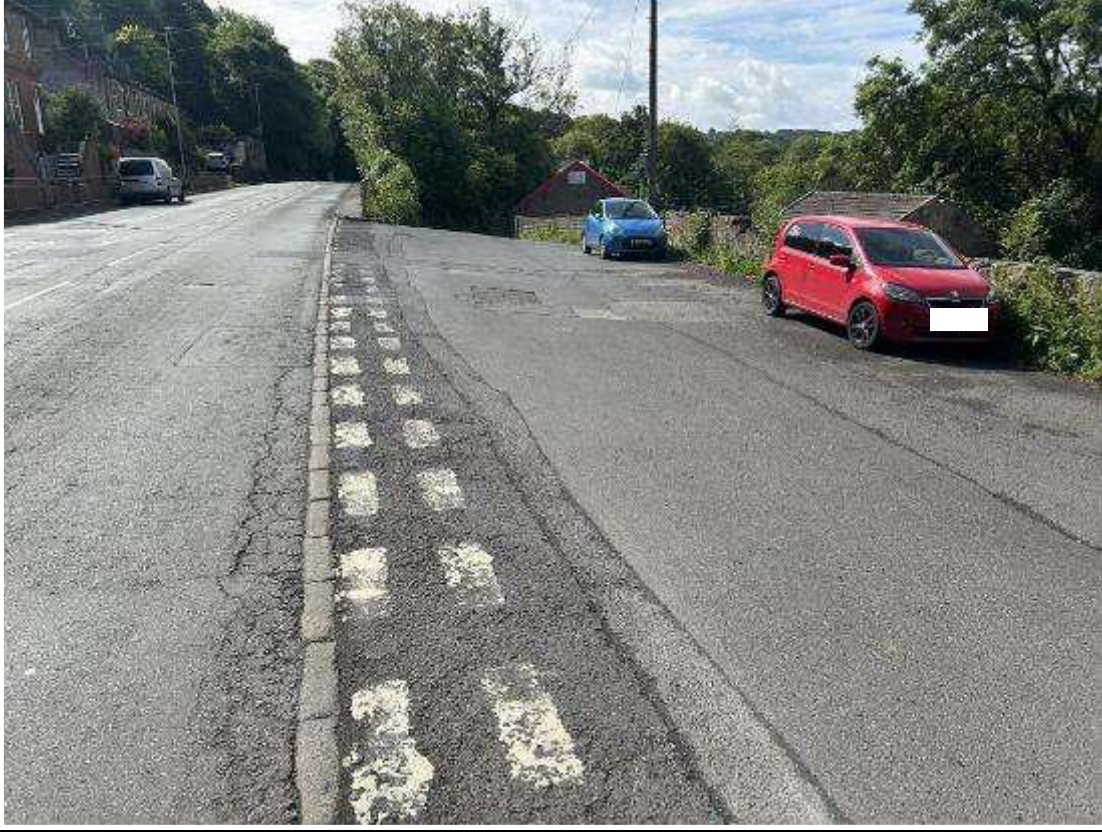
Table 2.18 Defect 14 (Image 165)

DEFECT	
Location	Facing southbound on Storthes Hall Lane at the A629 Penistone Road junction.
Summary	Patchwork along carriageway and cracking along give-way line.

A photograph showing a road junction. The road surface is asphalt and shows significant wear, including patchwork and cracking along the give-way line. A red car is parked on the right side of the road, and a blue car is parked further down the road. The background shows trees and a building.	
Survey 2 Comparison	No significant changes noted between Survey 1 and 2.

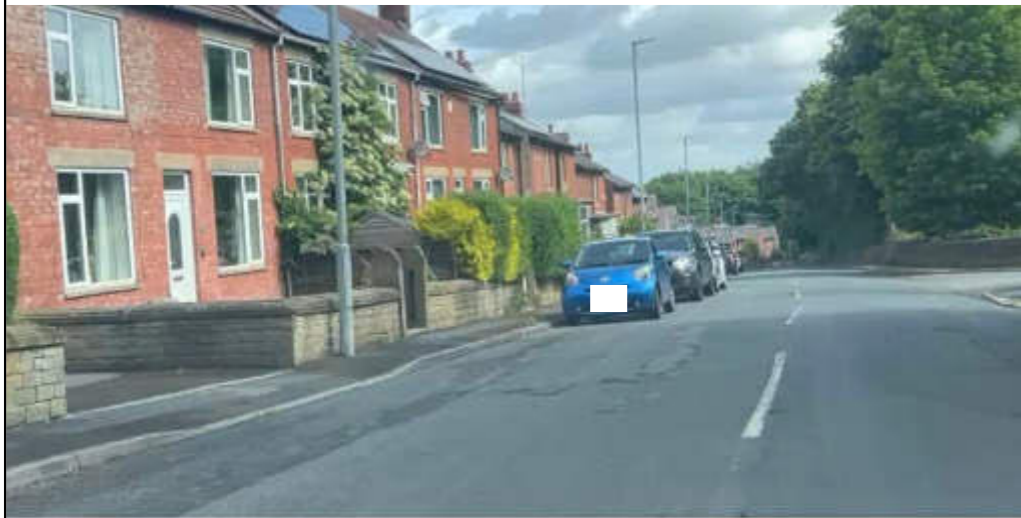
172

DEFECT	
Location	Facing west at Storthes Hall Lane/Southern Site Access junction.
Summary	Carriageway fretting, fatting and sunken ironworks.

Survey 2 Comparison	No significant changes noted between Survey 1 and 2.
