# The Arcade and 18-20 Corporation Street and 17 Foundry Street, Dewsbury

## Summary of Amendments

Doc No. 1705-BDP-AD-XX-RG-Z-00005  
Revision: P01  
Date: 18 June 2026

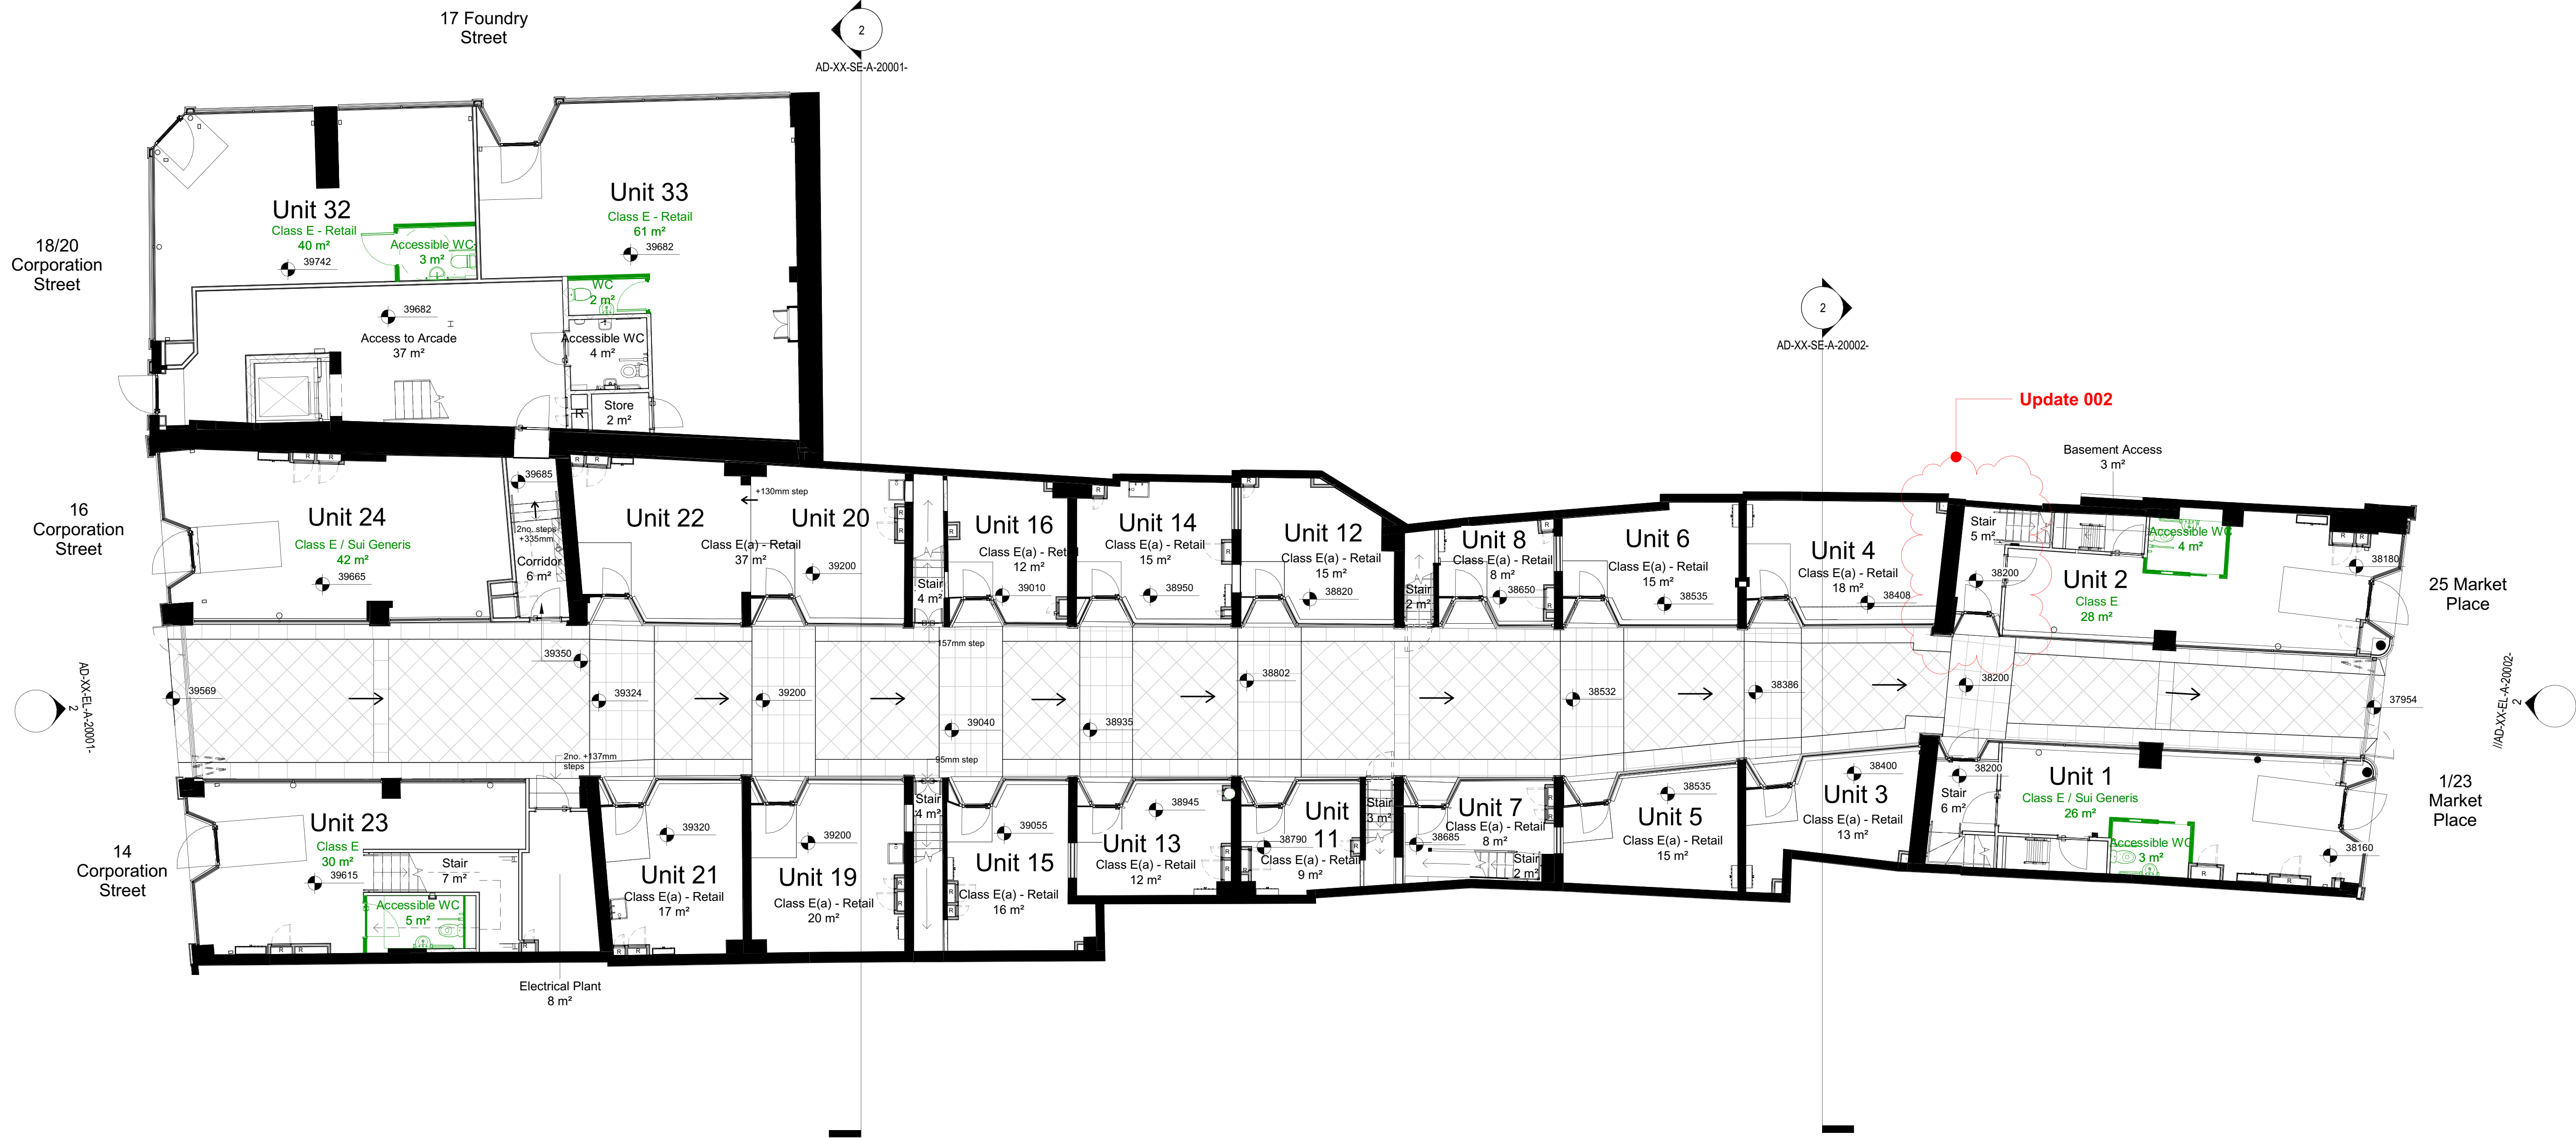
1 Ground Floor Plan\_Proposed  
1 : 100

| | Location | Element | Original proposals | Difference from what was expected (where applicable) | Problem caused / Opportunity for improvement | Proposed solution | Relevant drawing/s as approved | Updated drawings |
|---|---|---|---|---|---|---|---|---|
| 001 | 23-25 Market Place<br>Units 1 and 2 | Floors | Existing steel post and beams within timber suspended floor to be removed. | Existing timber floor structure was found to have wet rot, with numerous steel beams added. | The structural engineer confirmed the existing structure was unsuitable for the proposed building use. | Replace the suspended timber floor. The location of the floor below the surrounding external ground levels would make the ends of any timber joists prone to rotting (as evidenced on the existing joists and extensive unsuccessful past repair attempts). It is therefore proposed that a concrete suspended floor is installed in these two units. | 1705-BDP-AD-00-PL-A-20002_T01 | 1705-BDP-AD-00-PL-A-20002_T02 |
| 002 | 25 Market Place<br>Unit 2 | Internal partitions | At ground floor, the stair would exit into unit 2. | n/a | For building regulations and fire evacuation, it is necessary for the stair exit to be separated from unit 2. | Minor change to internal layout with new partition added to separate the stair exit from unit 2. | 1705-BDP-AD-00-PL-A-20001_T01<br>1705-BDP-AD-SL-PL-Z-00003_T01 | 1705-BDP-AD-00-PL-A-20001_T02<br>1705-BDP-AD-SL-PL-A-00003_T02 |
| 003 | 23-25 Market Place and 14-16 Corporation Street | Masonry walls | Existing wall to be retained. | Following the removal of modern finishes (e.g. plasterboard), several sections of wall have been found to be recent blockwork. | These blockwork infills are mostly poorly built, not meeting the fire performance requirements or modern structural requirements. | Replace poor quality blockwork infills with new, to meet modern requirements. | 1705-BDP-AD-00-PL-A-20002_T01<br>1705-BDP-AD-02-PL-A-20002_T01 | 1705-BDP-AD-00-PL-A-20002_T02<br>1705-BDP-AD-02-PL-A-20002_T02 |
| 004 | Central Arcade, 14-16 Corporation Street, 18-20 Corporation Street and 17 Foundry Street<br>Units 3-8, 11-15, 19-24, 32 and 33 | Floors | Existing floor slab to be locally removed for new building services and then reinstated. | The floor slabs in these units were found to be several thin layers of poor quality screed directly onto the soil, rather than actual slabs. The overall thickness of these layers was considerably thinner than would have been expected for a proper slab. | It would not be possible to dowel into the existing 'slabs' to reinstate areas of slab following the installation of new building services. This would be likely to lead to differential settlement between the existing areas of slab and the new infill areas. | Remove more of the existing screed layers and install complete slabs to these units, to avoid future differential settlement. This strategy has already had consent in unit 16. | 1705-BDP-AD-00-PL-A-20002_T01 | 1705-BDP-AD-00-PL-A-20002_T02 |

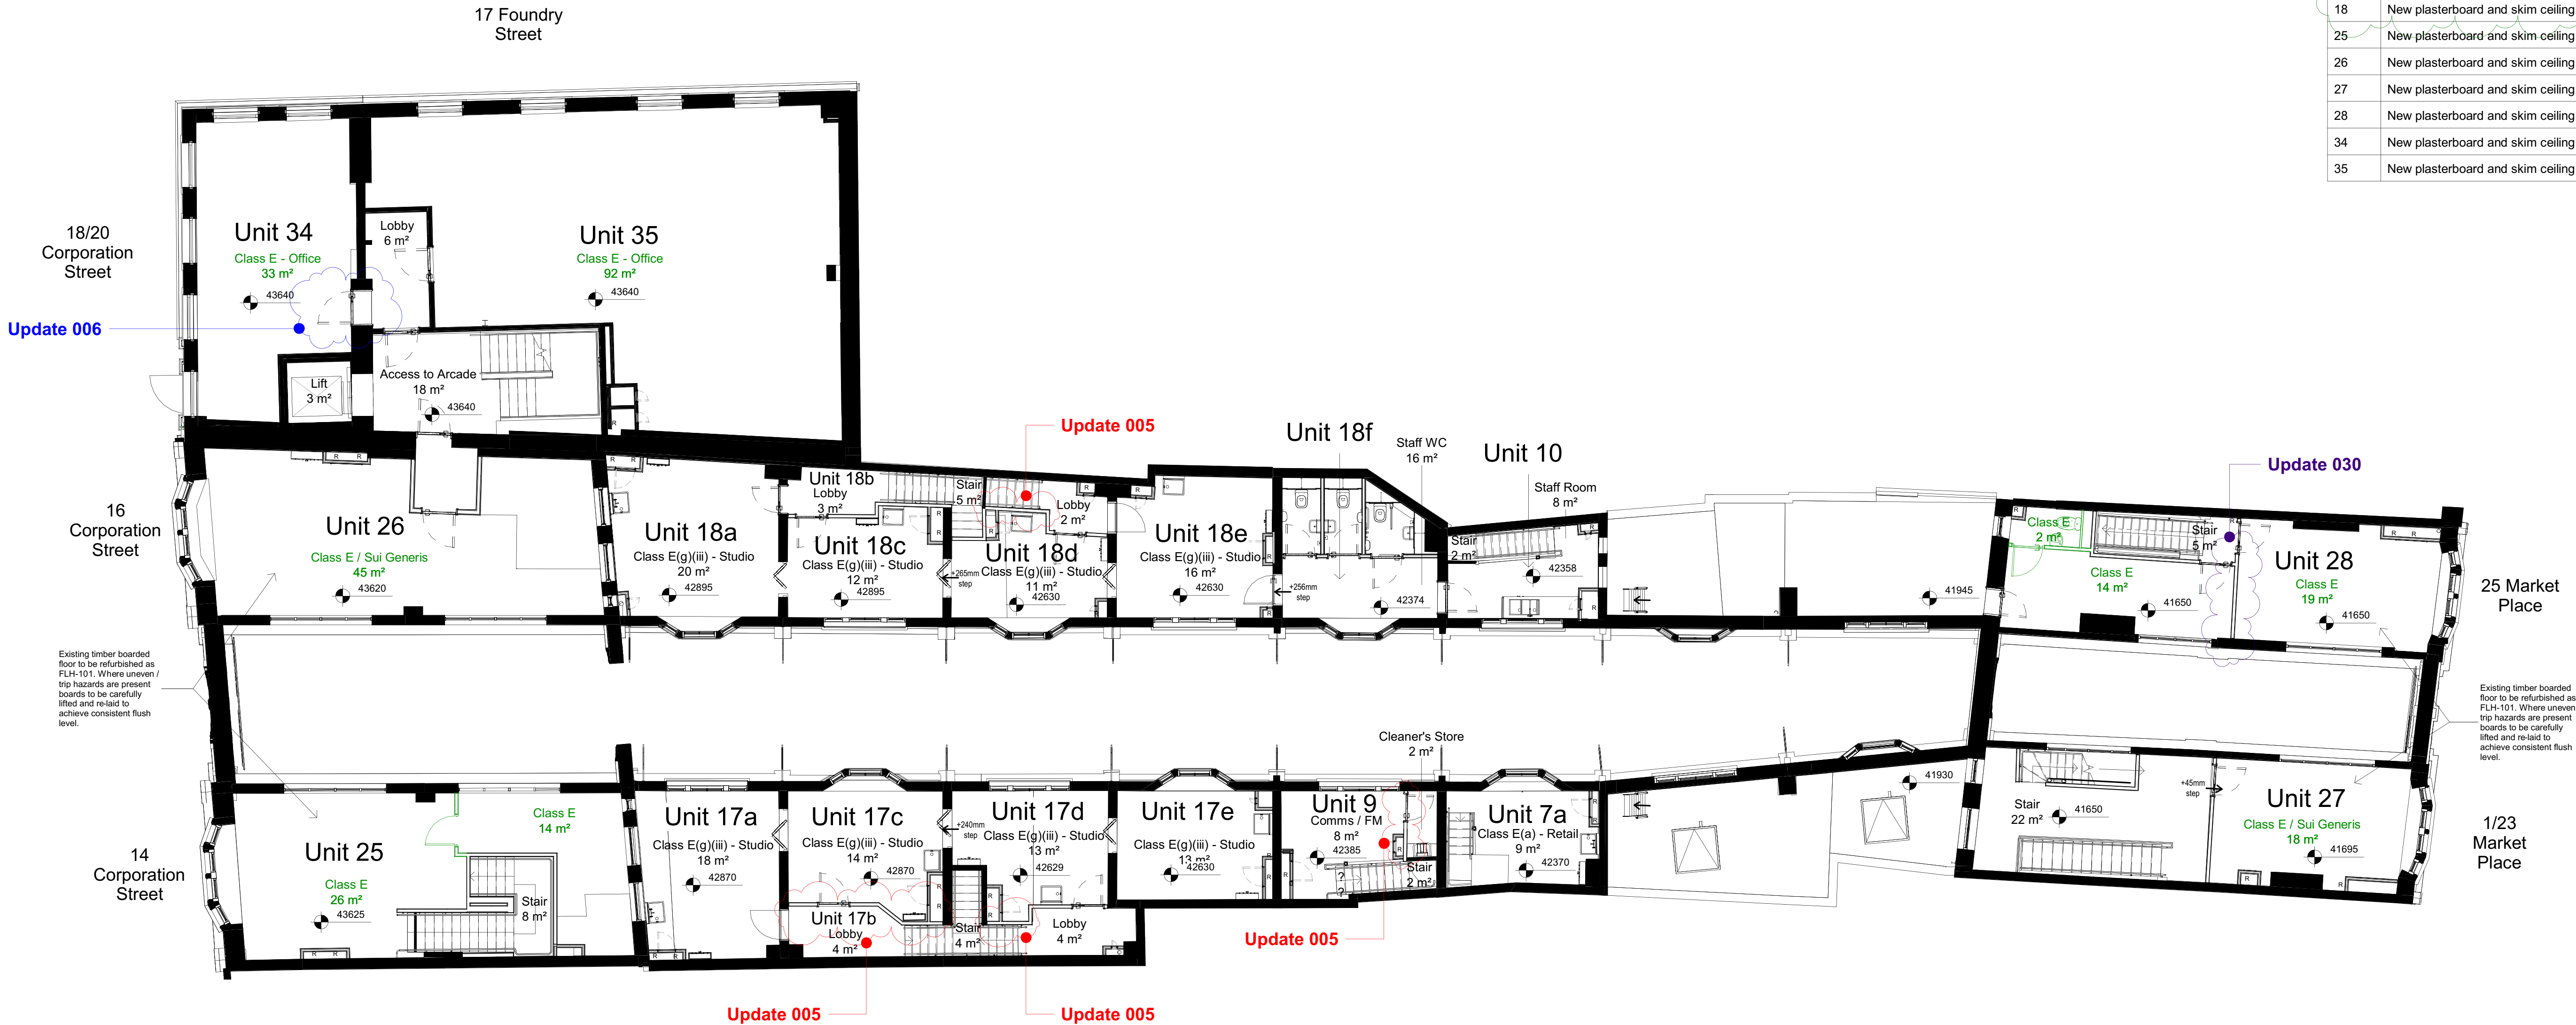
1 First Floor Plan\_Proposed  
1:100

| | Location | Element | Original proposals | Difference from what was expected (where applicable) | Problem caused / Opportunity for improvement | Proposed solution | Relevant drawing/s as approved | Updated drawings |
|---|---|---|---|---|---|---|---|---|
| 005 | Central Arcade<br>Units 9 and 17b | Internal partitions | Existing partitions were assumed to be historic lath and plaster partitions to be retained and upgraded to meet the new fire performance requirements for a 60-minute protected stairway where applicable. | The partitions were found to be a mix of more modern construction and were generally poorly built incorporating hard board / MDF. | These were not historic elements of the building, and it would not be practical to upgrade them to provide 60 minute fire resistance. | Replace these sections of partition with new plasterboard partitions to provide the required fire resistance. This is the same approach that had already had consent for the partitions forming the fire-protected stair in unit 18b on the opposite side of the arcade. | 1705-BDP-AD-01-PL-A-20001_T01<br>1705-BDP-AD-01-PL-A-20002_T01 | 1705-BDP-AD-01-PL-A-20001_T02<br>1705-BDP-AD-01-PL-A-20002_T02 |
| 006 | 18-20 Corporation Street and 17 Foundry Street<br>Unit 34 / 35 | Stairwell and door | No lobby to top of stair. New door to swing outwards. | n/a | For building regulations and fire evacuation, it has been proposed that these units should be lobbied from the protected stair, and the door to unit 34 should swing into unit 34, to avoid impacting the escape route from unit 35. | Lobby added. Door to swing inwards (into unit 34) | 1705-BDP-AD-01-PL-A-20001_T01<br>1705-BDP-18-ZZ-PL-A-00002_P06 | 1705-BDP-AD-01-PL-A-20001_T02<br>1705-BDP-18-ZZ-PL-A-00002_P07 |

| 027 | Central Arcade<br>Units 7a, 9, 10, 17, 18 | Ceilings | Repair damaged lath and plaster ceilings. | The ceilings were found to be in a poorer state than expected. | The plaster had debonded from the laths and therefore was not suitable for patch repair. | Remove damaged material and replace with plasterboard. This approach has already had consent for units 25, 26, 27, 28, 34 and 35. | 1705-BDP-AD-01-PL-A-20001_T01 | 1705-BDP-AD-01-PL-A-20001_T02 |

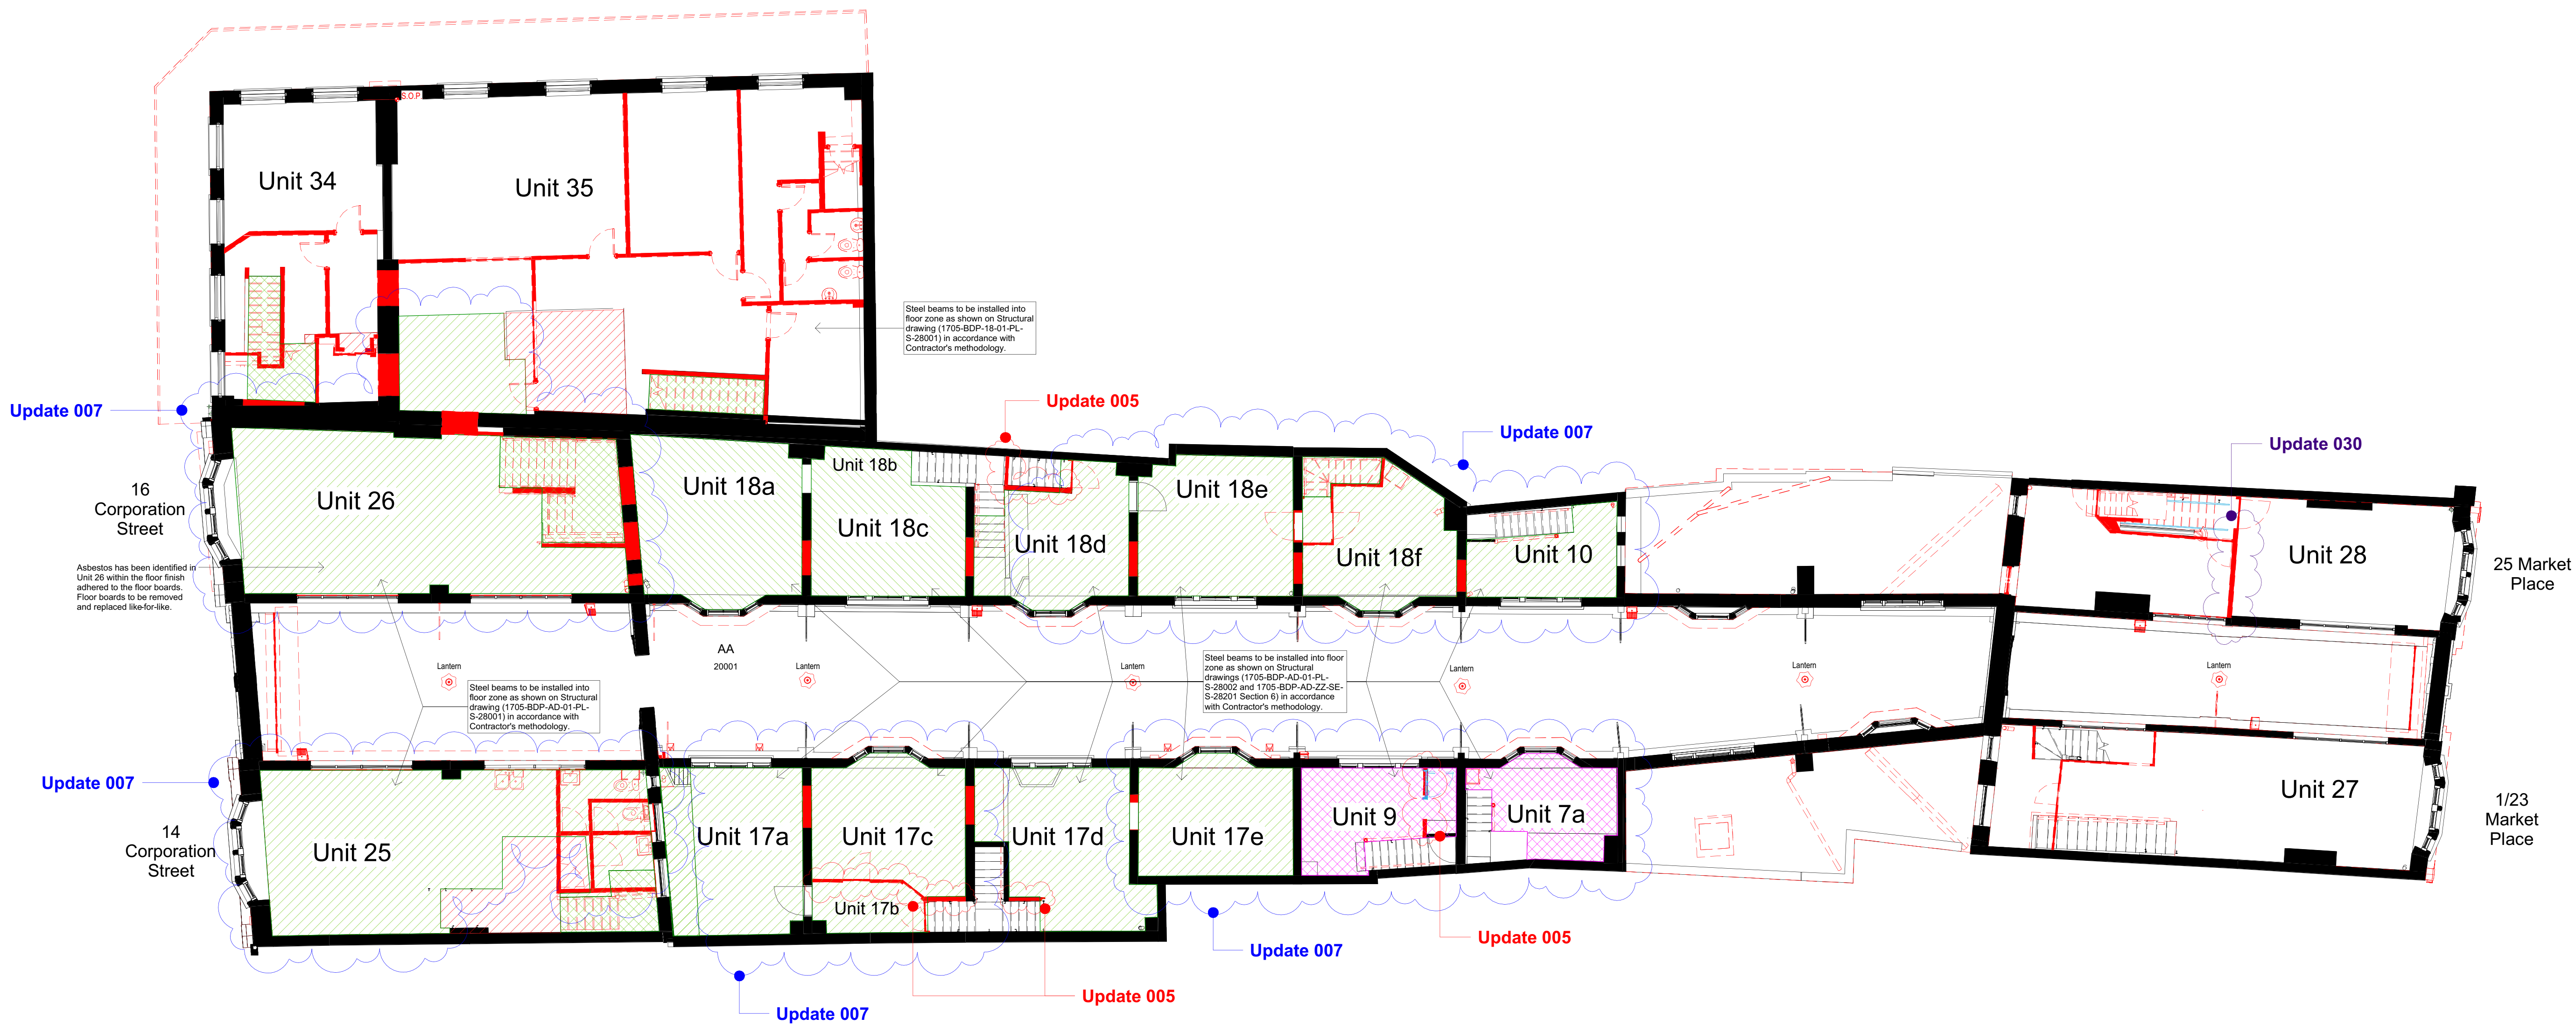
1 First Floor Removals Plan  
1 : 100

| | Location | Element | Original proposals | Difference from what was expected (where applicable) | Problem caused / Opportunity for improvement | Proposed solution | Relevant drawing/s as approved | Updated drawings |
|---|---|---|---|---|---|---|---|---|
| 007 | Central Arcade<br>First floor units | Floors | Units 17d, 18a, 18b, 18c and 18d: replace the floors due to wet and dry rot.<br><br>Units 7a, 9, 10, 17a-c, 17e, 18d-f, 25, 26 and 35: Refurbish the floors: lift boards, strengthen and repair existing joist structure. Reinstate existing boards wherever practical and supplement with new. | Extensive wet and dry rot had already been identified in units 17d, 18a, 18b, 18c and 18d, 25, 26 and 35. Further wet and dry rot was found in the remaining units affecting the joists and floorboards. | The existing joists were damaged by wet and dry rot to the extent that strengthening them was not practicable. The floorboards were similarly damaged so that only short lengths could be recovered for reuse. | Replace the timber joist floor structure to the remaining units in the areas that have been affected by wet and dry rot (as had already been had consent for units 17d, 18a, 18b, 18c and 18d). Recover all lengths of floorboard which are suitable for reuse and install them in units 7a and 9, with new floorboards used elsewhere. This will allow two units to retain the appearance of their original floor. | 1705-BDP-AD-01-PL-A-20002_T01 | 1705-BDP-AD-01-PL-A-20002_T02 |

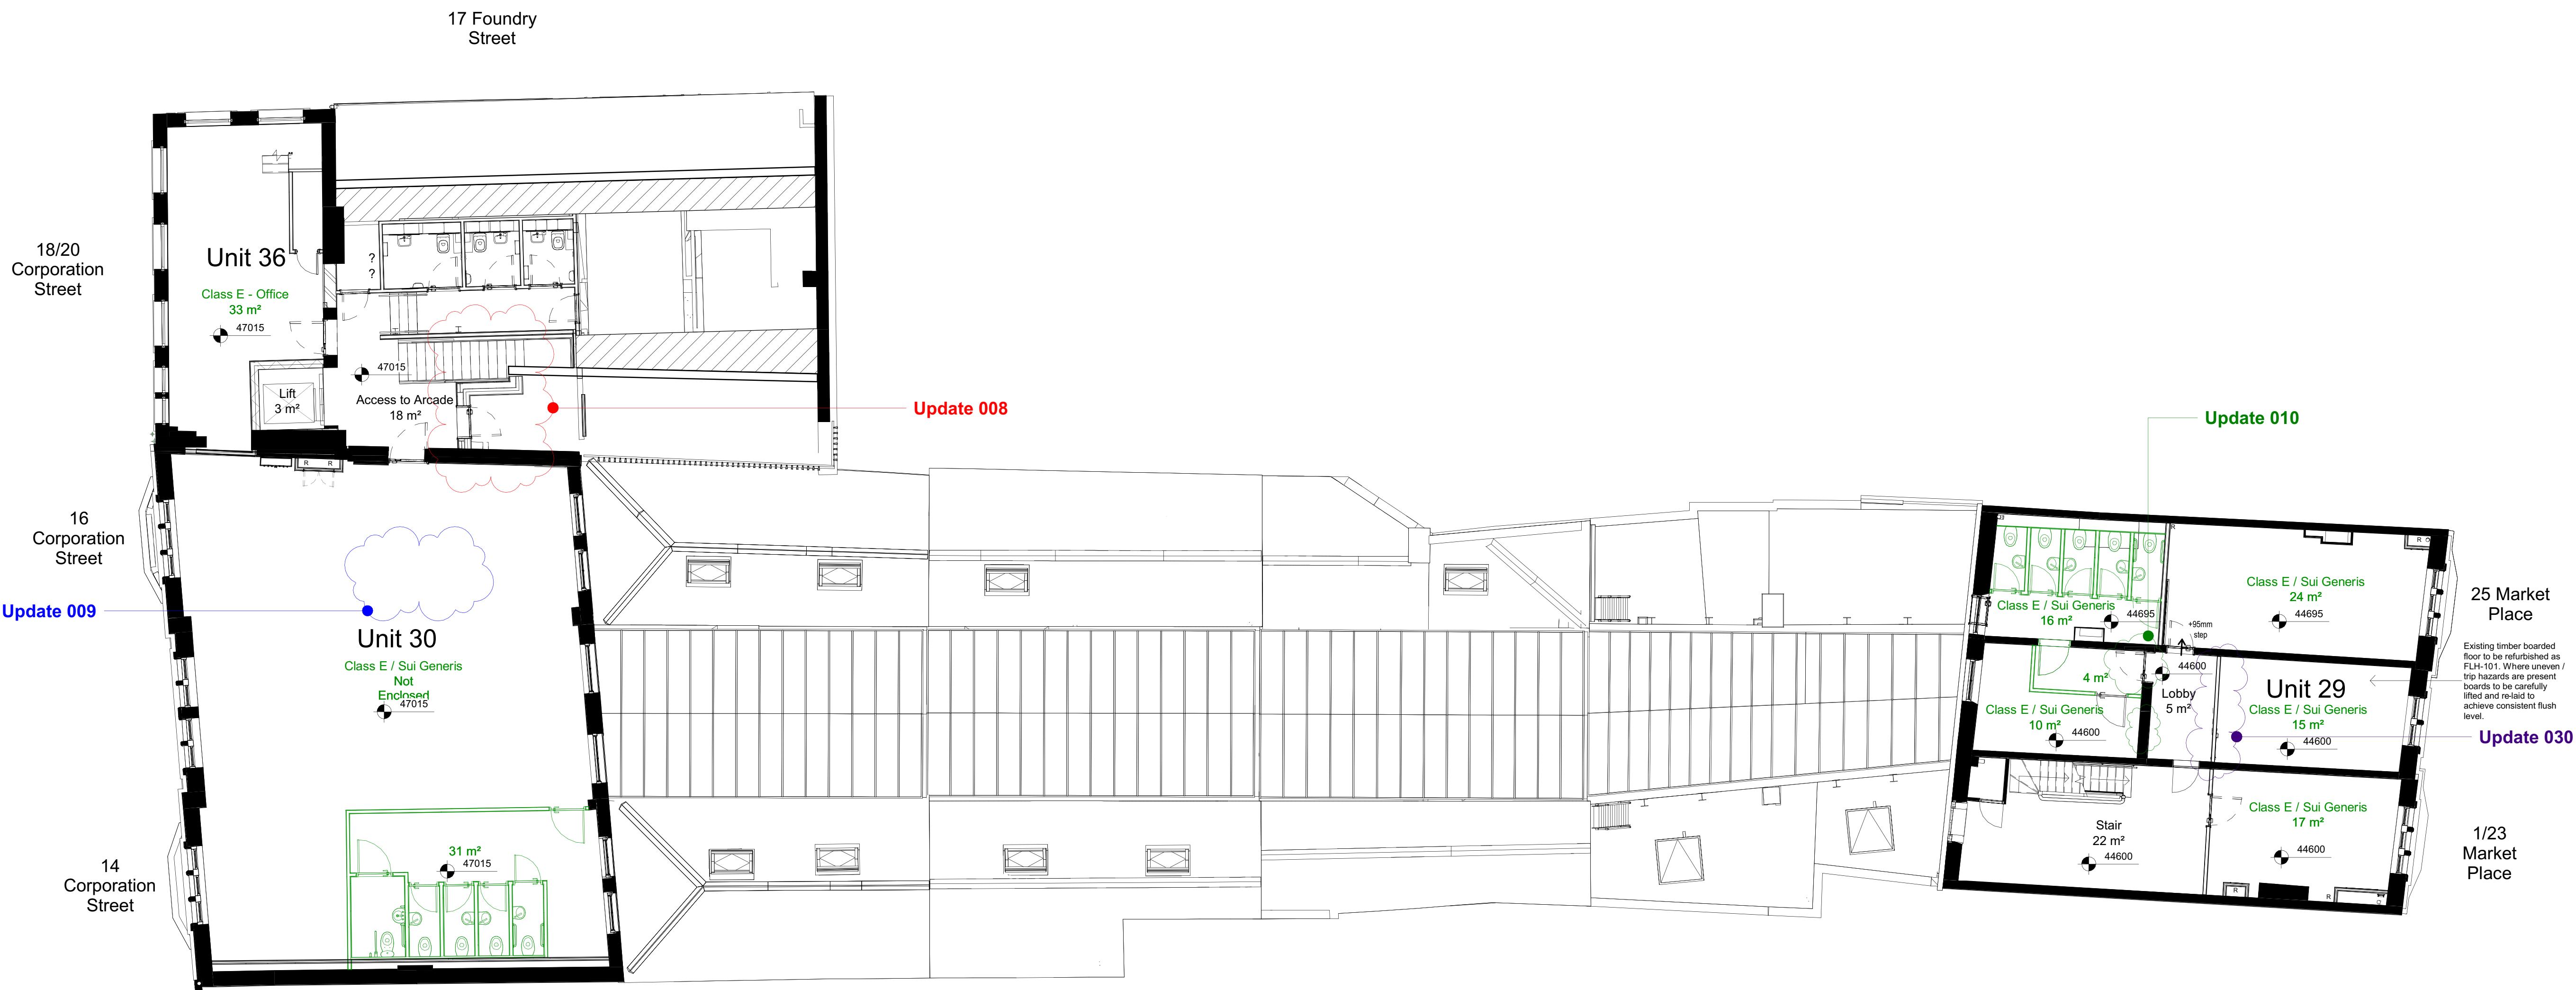
1 Second Floor Plan\_Proposed  
1:100

| 030 | 23-25 Market Place<br>Units 28 and 29 | Walls | Repair damaged masonry walls and replace plaster finish where irreparably damaged. | The walls were found to be a mixture of timber framing and unbonded masonry. | The walls were structurally unstable, and moved visibly when pushed. | Remove structurally unstable parts of walls and replace with new stud wall. | 1705-BDP-AD-01-PL-A-20001_T01<br>1705-BDP-AD-01-PL-A-20002_T01<br>1705-BDP-AD-02-PL-A-20001_T01<br>1705-BDP-AD-02-PL-A-20002_T01 | 1705-BDP-AD-01-PL-A-20001_T02<br>1705-BDP-AD-01-PL-A-20002_T02<br>1705-BDP-AD-02-PL-A-20001_T02<br>1705-BDP-AD-02-PL-A-20002_T02 |

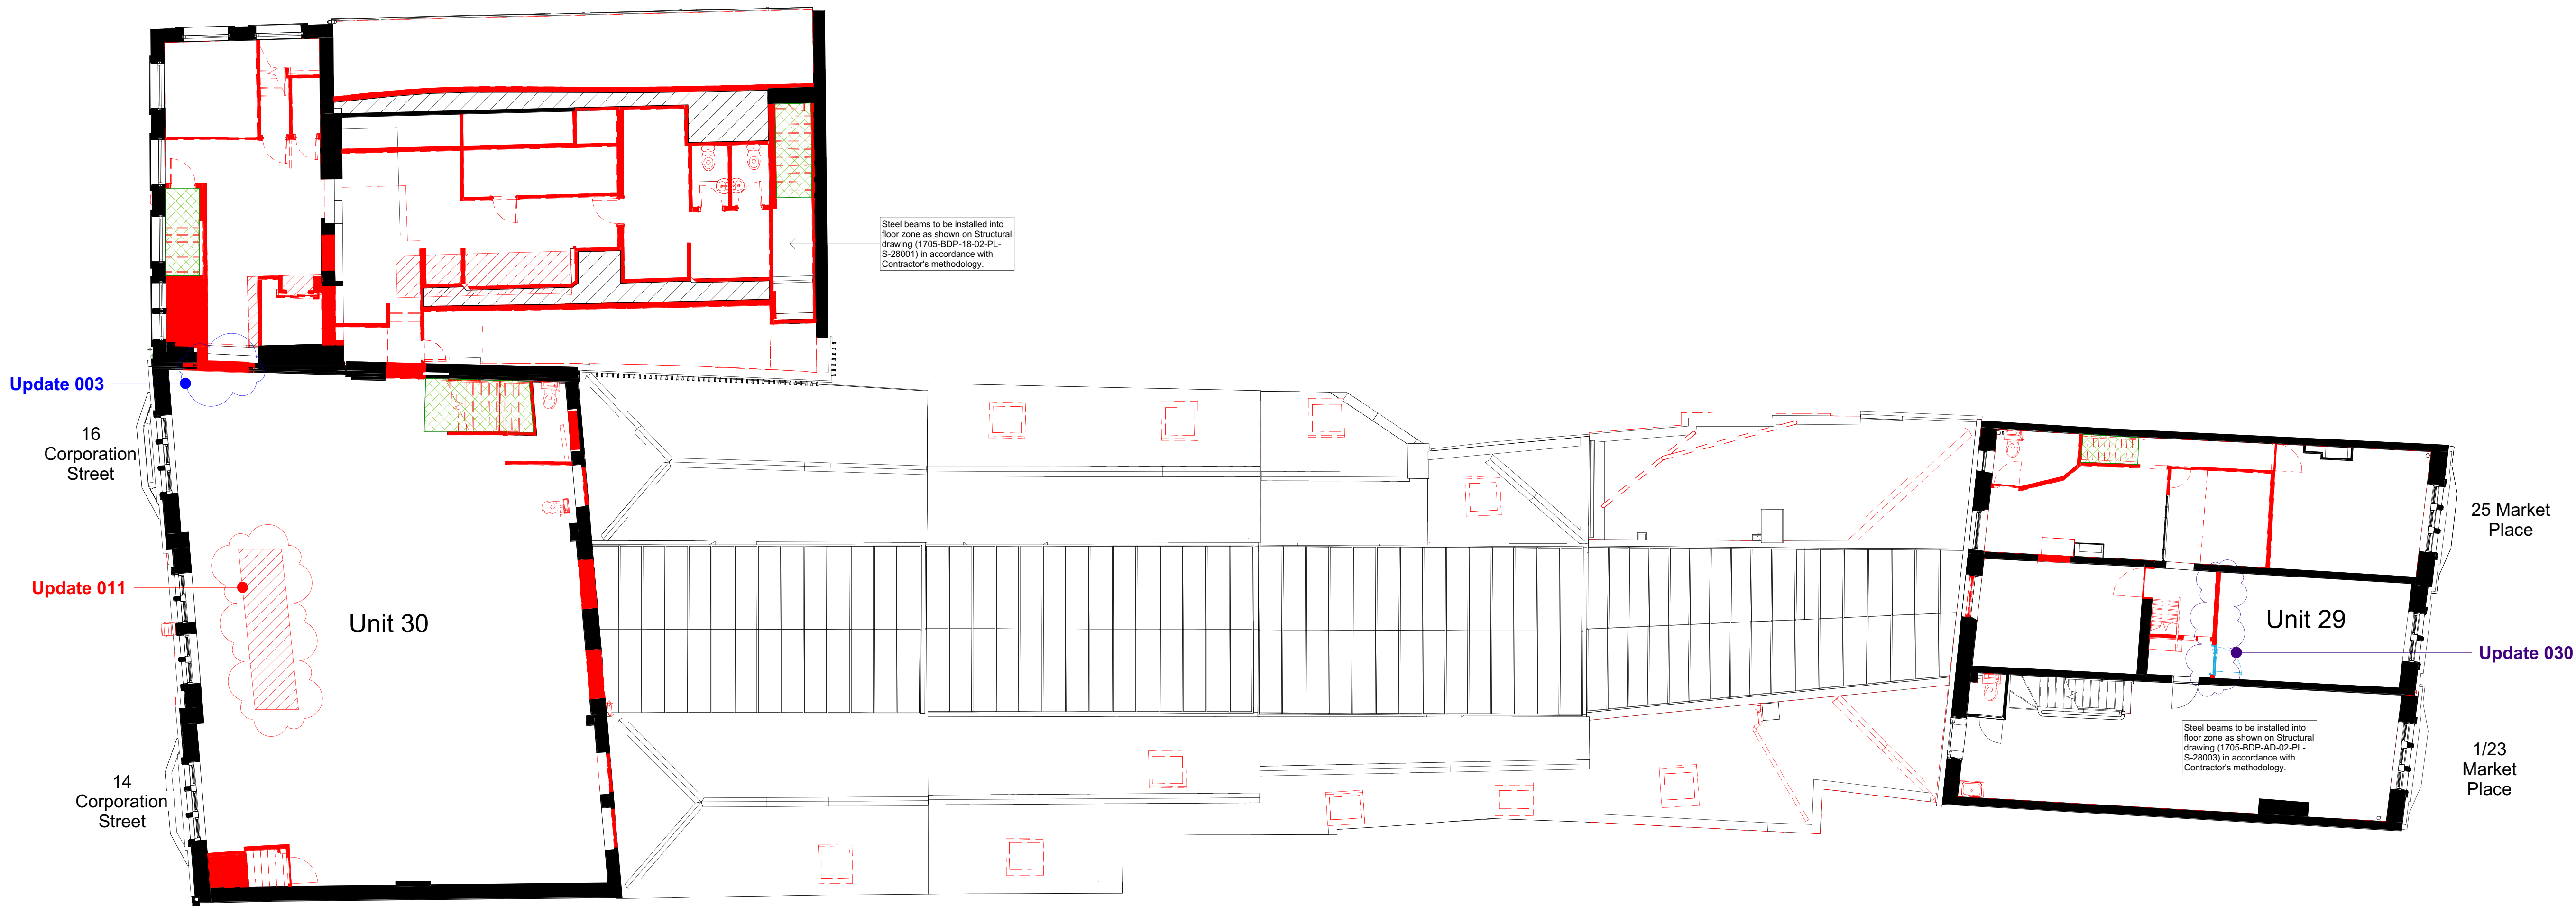
## 1 Second Floor Removals Plan

| 011 | 14-16 Corporation Street<br>Unit 30 | Floor hatch | Retain existing floor hatch. | The floor hatch and the trimming around it was found to be structurally unsafe. | The structural engineer confirmed the existing structure was unsuitable for the proposed building use. | Remove the access hatch and trimming, and infill the area with concrete to tie into the existing concrete (filler joist) floor structure in this area. | 1705-BDP-AD-02-PL-A-20002_T01 | 1705-BDP-AD-02-PL-A-20002_T02 |

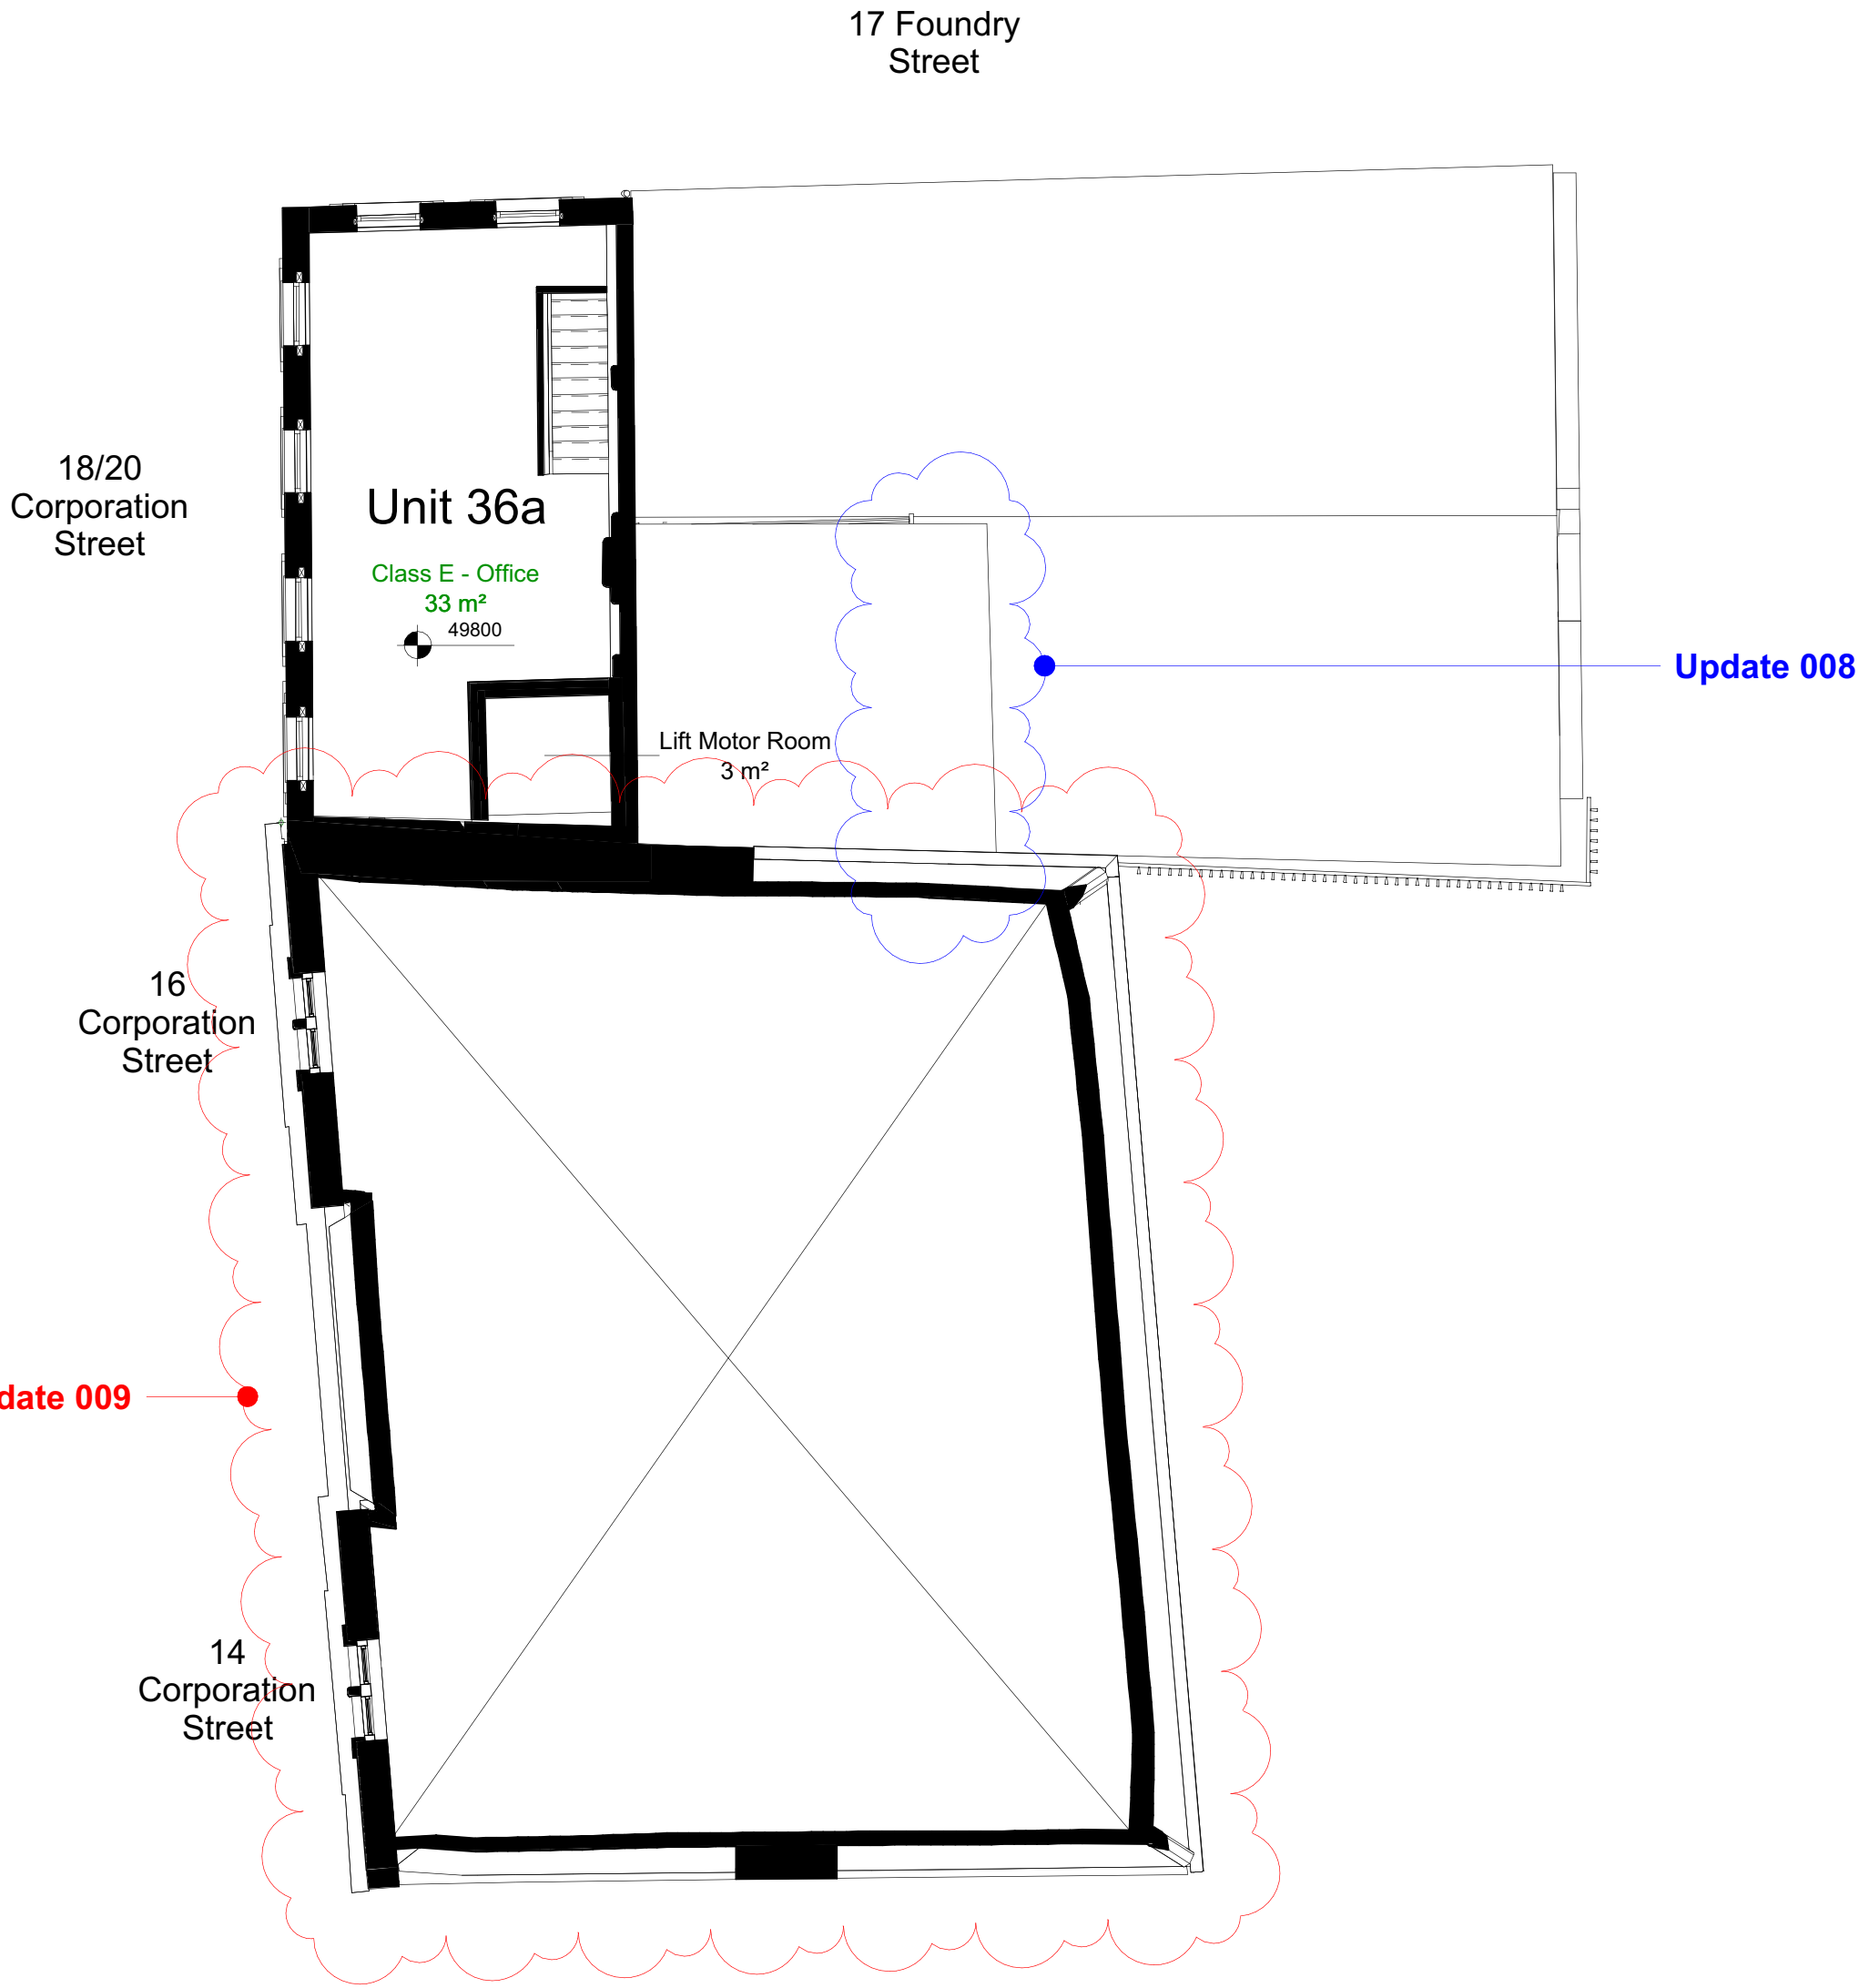
1 Third Floor Plan\_Proposed  
1 : 100

| 009 | 14-16 Corporation Street<br>Unit 30 / Unit 30a | Storage deck | Repair the existing timber joisted storage deck above unit 30 (forming a storage area known as unit 30a). Remove the permanent stair, and provide an access hatch and sliding ladder. | Accessing this storage area (which was previously unsafe to access) has revealed that the pattern painted onto the bottom chords of the trusses visible in unit 30 continues onto the rest of these queenpost trusses (the principal rafters and struts). The original archive construction drawings also do not show a storage deck in this location. Because of this, and closer inspection of the structure of the storage deck, it is now believed that this deck is not original to the building. | Opportunity to return part of the building to its earlier configuration, improving the spatial quality of this room which was originally constructed as a workshop for the stores below. | Remove this storage deck to return the space to its original configuration. Omit the ladder and access hatch previously proposed. | 1705-BDP-AD-02-PL-A-20001_T01<br>1705-BDP-AD-03-PL-A-20001_T01<br>1705-BDP-AD-03-PL-A-20002_T01 | 1705-BDP-AD-02-PL-A-20001_T02<br>1705-BDP-AD-03-PL-A-20001_T02<br>1705-BDP-AD-03-PL-A-20002_T02 |
